# **Report of Marine Survey**

**Vessel: 2016 Sea Ray 510 Sundancer**

**Purpose: Condition & Valuation**

**Date of Survey: November 27th, 2023**

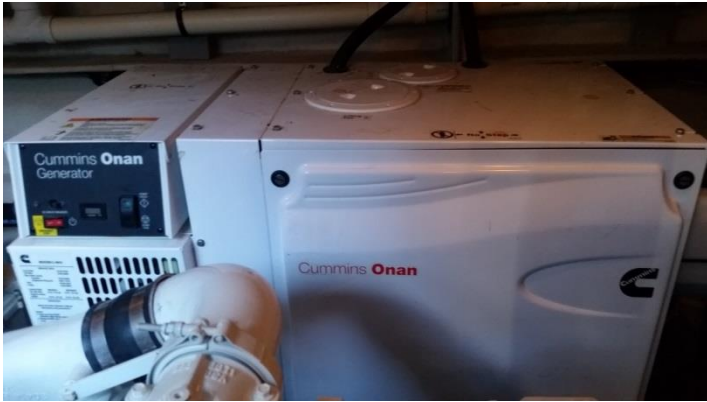
**Oil Condition:** *NOTE: Generator oil is dirty. Service generator with fresh oil and filters.*

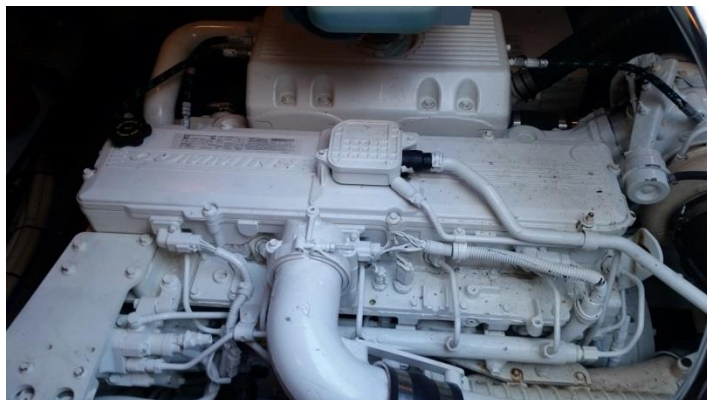
Starboard Engine

Wet exhaust hose, metal piping and stainless 1/2" hose clamps. Hoses are secured with two clamps at each connection as per ABYC recommendations. **NOTE:** Engine exhaust hoses from engine to muffler have several cracks and rust marks in places on both engines. Replace exhaust hoses.

Each engine equipped with exhaust muffler/silencer. **NOTE:** Starboard engine exhaust muffler is leaking. Repair.

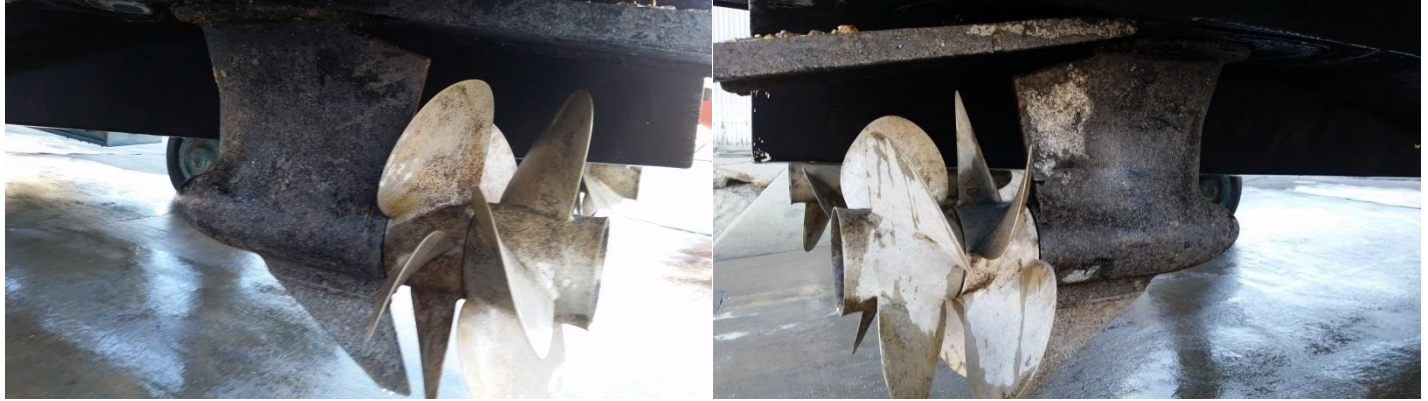
**NOTE:** Both IPS pod drives have moderate corrosion and pitting. Due to this, the lifespan can be expected to be decreased on each pod. Sand/repaint each drive, monitor frequently and replace anodes regularly to reduce further corrosion. Ensure the slip where vessel is berthed does not have stray current in the water which could be causing electrolytic corrosion to pods.

Port Pod

Starboard Pod

7. NOTE: Starboard engine exhaust muffler is leaking. Repair.
8. NOTE: Both IPS pod drives have moderate corrosion and pitting. Due to this, the lifespan can be expected to be decreased on each pod. Sand/repaint each drive, monitor frequently and replace anodes regularly to reduce further corrosion. Ensure the slip where vessel is berthed does not have stray current in the water which could be causing electrolytic corrosion to pods.

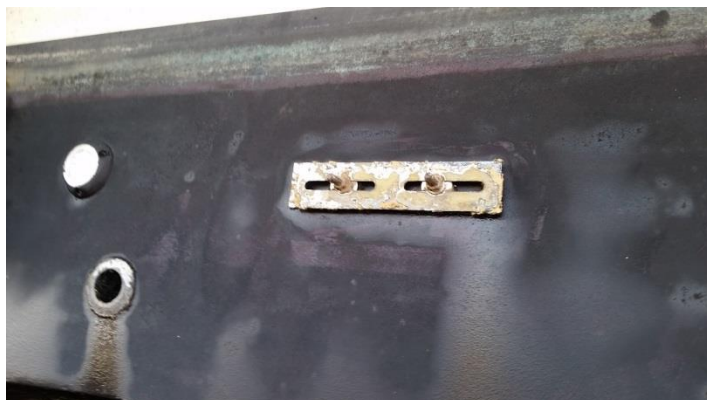
Ten anodes: (4) two on each side of swim platform bracket (1) Hull/transom mount anode (4) two on each trim tab. **NOTE:** (1) Hull anode is missing from transom. Replace. (2) Anodes on swim platform bracket are missing. Replace. (3) Trim tab anodes have corrosion build-up and also appear “shiny,” which is indicative of electrolytic corrosion (also known as stray current corrosion) which could be a result of the slip where the vessel is being kept. Have electrician measure for electric current in the nearby water and if necessary move vessel to a different slip.

Missing Hull Anode

**15. NOTE:** (1) Hull anode is missing from transom. Replace. (2) Anodes on swim platform bracket are missing. Replace. (3) Trim tab anodes have corrosion build-up and also appear “shiny,” which is indicative of electrolytic corrosion (also known as stray current corrosion) which could be a result of the slip where the vessel is being kept. Have electrician measure for electric current in the nearby water and if necessary move vessel to a different slip.

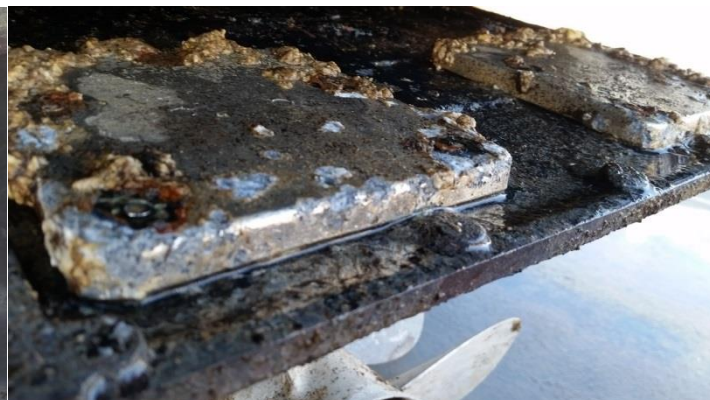
“Shiny” Looking Anodes
