Report of Marine Survey

Vessel: 2007 Searay 310 Sundancer

Purpose: Inspection and Valuation

Date of Survey: December 17th, 2019

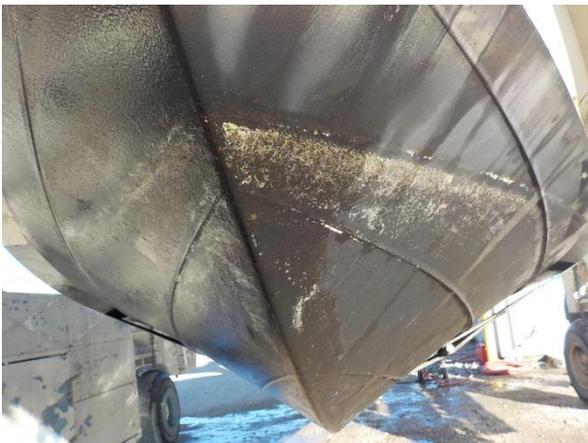
Bottom Paint:	Black colored ablative bottom paint. NOTE: Bottom paint is thin and flaking off in multiple areas. Sand and re-paint hull bottom with bottom paint.
Thru-Hulls:	Five bronze thru hulls sighted on hull bottom. All are bedded properly as sighted from exterior. Percussion tested and found to be serviceable.
Transducers:	Two transducers for depth and speed, mounted centerline on hull bottom. Both appear adequately sealed and bonded to the hull as sighted from exterior.
Hull Blistering:	No hull blistering was sighted.
Rudders:	Bronze rudders. No play or damages sighted.
Struts & Shafts:	Bronze struts and stainless shafts. No damages sighted. Struts appear properly bedded.
Shaft Bearings:	Shafts spin freely. No damage sighted to bearings.
Propeller(s):	Two bronze three bladed propellers. Size/Pitch: 18x19 No cracks, dings, bends, excessive cupping or chips sighted.
Sacrificial Anodes:	Seven magnesium anodes: (4) two on each shaft. (2) one on each trim tab (1) hull camp mounted on transom. All have approximately 75% life remaining. (Replace anodes when less than 50% remaining.)

Bow Looking Aft Bottom Paint Flaking

11. NOTE: Trim tab mounting brackets are missing screws (three on port side and two on starboard). Repair and seal screw holes from water egress.
12. NOTE: Bottom paint is thin and flaking off in multiple areas. Sand and re-paint hull bottom with bottom paint.

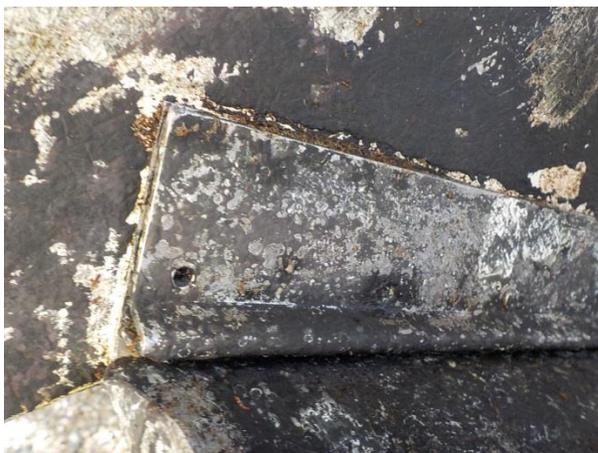
"Bennet" hydraulic trim tabs operable via switch at helm dash. Trim pump in engine space is secure and full on fluid. NOTE: Trim tab mounting brackets are missing screws (three on port side and two on starboard). Repair and seal screw holes from water egress.

Missing Screws Port Trim Tab
