Report of Marine Survey

Vessel: 1998 Searay Aft Cabin 415

Purpose: Condition and Valuation

Date of Survey: January 14th, 2020

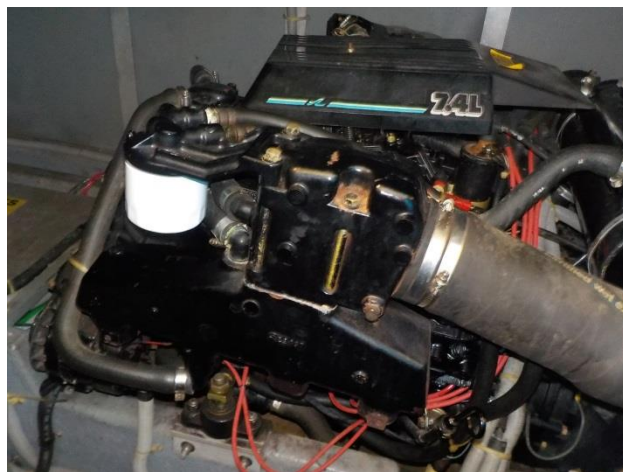
Starboard Engine

Carburetor:Rochester Quadrajets carburetors on each engine. **NOTE: Fuel return line is not connected to carburetor on starboard engine. Reconnect fuel return hose.****Engine mounts/beds:**
