# Draft Capital Efficiency Plan™

Wayland, Massachusetts

**TATA & HOWARD**  
INCORPORATED

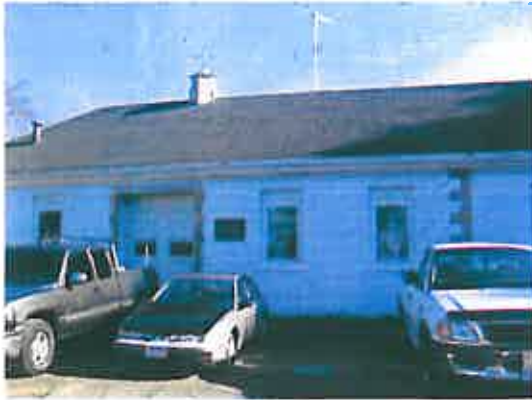
The Baldwin Pond Wells consists of three wells, a control building and an operations building. The control building was built in 1927 and turned into the current pump station in 1962. The building houses the chemical storage for Wells No. 1 and 2, the master venturi meter, emergency generator and the motor control center for all three wells. The building walls are in good condition, but the roof is missing shingles. The generator is the original generator from 1962. Wells No. 1 and 2 are currently offline, therefore, the chemical storage tanks at this location are empty.

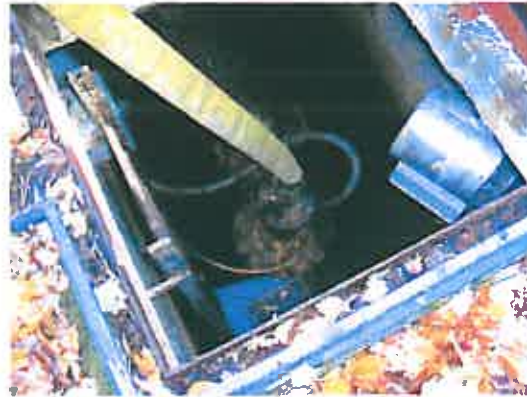
Well No. 1 was replaced in 2001 and is located in the original concrete vault. Well No. 1 is currently offline due to high iron and manganese levels and is used as a sampling location only.

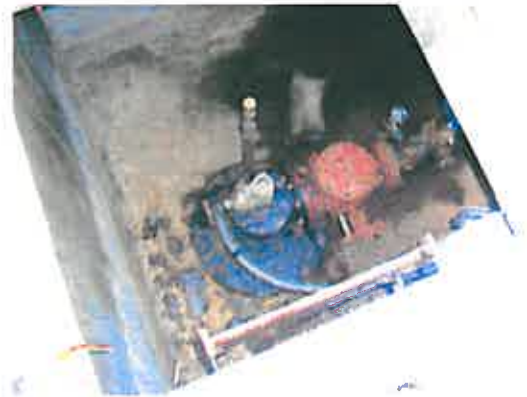
Well No. 2 was installed in 1944. The current pump was installed in 1993 and the pump motor was replaced in 2003. The pump and motor are located in the original concrete vault. The well was inspected in 2007 and found to be in good condition. Well No. 2 is currently offline due to high iron and manganese levels.

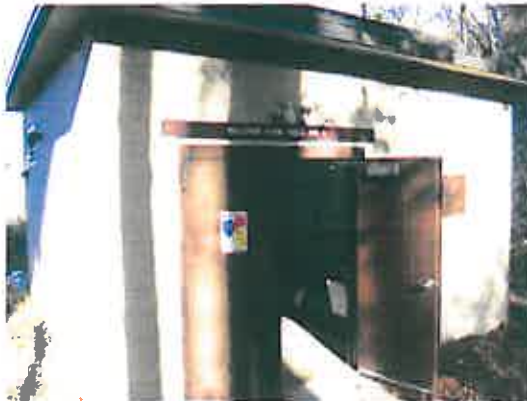
Well No. 3 was installed in 1955 and is located in a concrete building with a concrete slab roof installed in 1998. The pump and pump motor were replaced in 1993. The well was redeveloped in 1998. The 2007 well inspection report recommends the pump be pulled and inspected. Chemical storage and injection was added to the building in 1999.

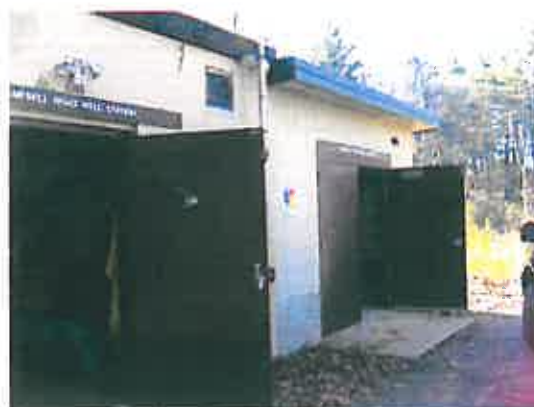
The Campbell Well and station was originally installed in 1965. The station is a concrete building with a concrete slab roof. It is the original building and roof from 1965. An addition was added to the building in 1999 for the chemical storage and injection. Both portions of the building are in good condition. A new pump and pump motor were installed in 1994. The 2007 well inspection report recommends the well be cleaned and redeveloped.

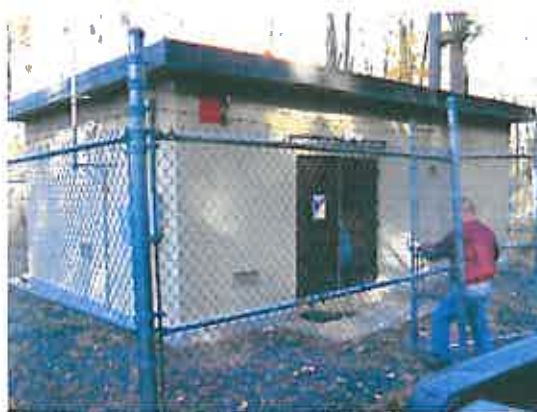
The Chamberlain Well and station was constructed in 1991. The well station houses all the original equipment including a direct drive generator that runs the pump only. A motor control center was installed in 1999 with chemical storage and feed equipment. The station is in good condition, but the direct drive generator is of minimal benefit because it will run only the pump and not the chemical feed equipment if there is a power outage. The 2007 well inspection report requests information on the well and pump.

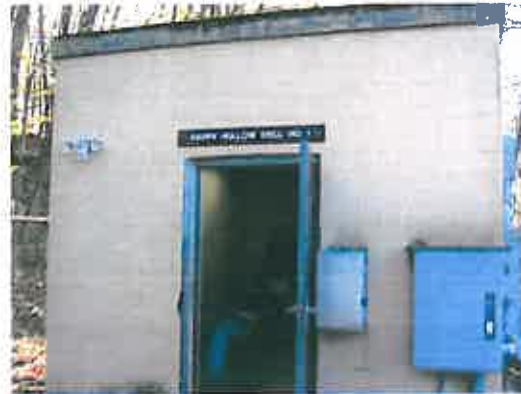
Happy Hollow Well No. 1 was originally installed in 1949 in a concrete building with a concrete slab roof. The well was cleaned and redeveloped in 2003. It is unknown if the pump and pump motor has been replaced since they were installed, and no repairs have been made to the roof or building since construction. Chemical storage and feed equipment were added in 1999 along with a new motor control center for Wells 1 and 2. There is a master venturi located in a pit outside of the building. The exact location is currently unknown. The 2007 well inspection report recommends that the well be cleaned and redeveloped.

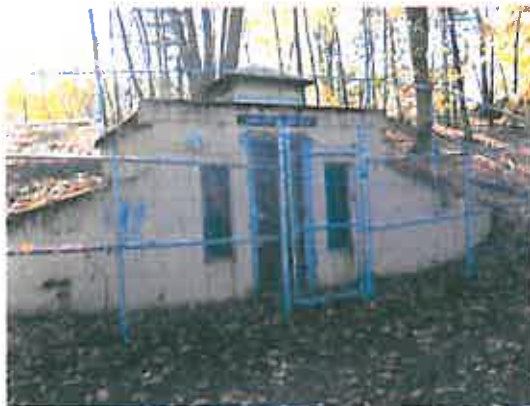
Happy Hollow Well No. 2 was originally installed in 1951 in a concrete building with a concrete slab roof. The pump motor was rebuilt in 2006, but it is unknown if the pump has been replaced. No repairs have been made to the roof or building since construction. The 2007 well inspection report claims that the well and pump appear to be in good condition.

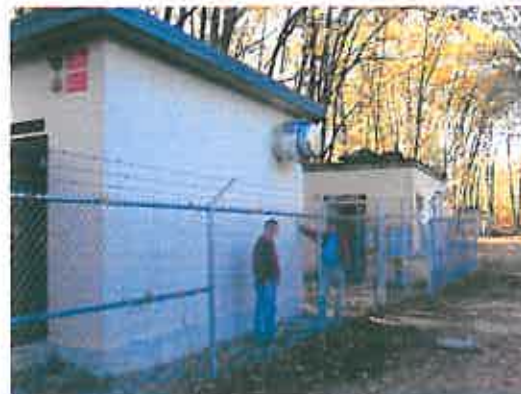
A new building was constructed near the Well No. 1 building for chemical storage in 1999. All of the chemicals for Well No. 2 are stored here, along with some of the chemicals for Well No. 1. Chemical injection occurs in a manhole outside of the building.

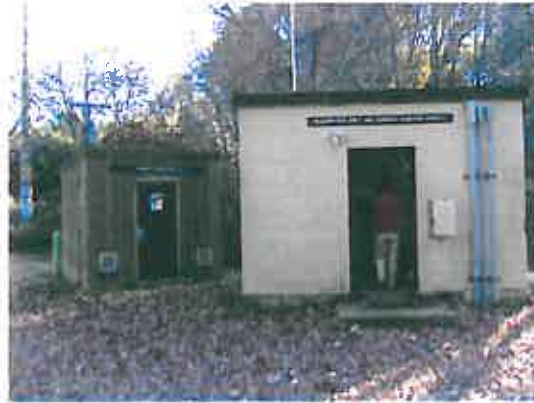
The Meadowview well pit was originally installed in 1970. The well was cleaned and redeveloped in 2001 and the pump and motor were replaced in 1993. Two concrete buildings were constructed in 1999 for chemical injection and storage. One building houses the potassium hydroxide tank and the other building houses the rest of the chemical storage, the chemical injection equipment, motor control center and the magnetic meter. The chemical tanks are all empty and the well is not in use due to high manganese concentrations. The 2007 well inspection report requests information on the pump.

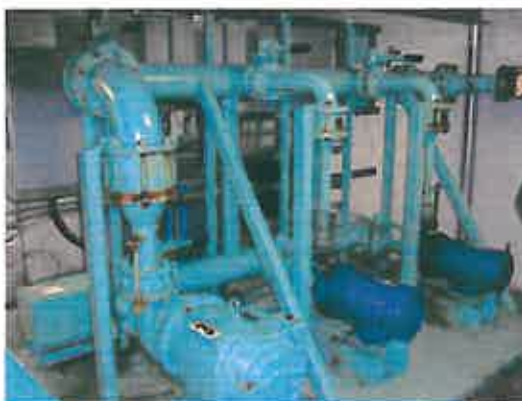
The Reeves Hill Booster Pump Station was installed in 1973 at the same site as the two water storage tanks. The building is a concrete building with a concrete slab roof. There is one fire pump and two domestic pumps inside the station. There is also natural gas generator inside of the building. The pump station was rehabilitated in 1999, when an EFI skid was installed. The domestic pumps were replaced again in 2006.

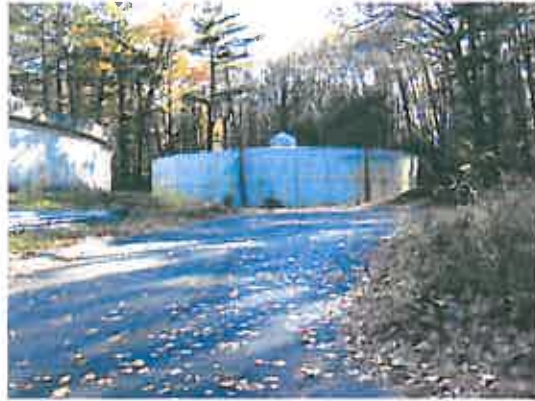
The Reeves Hill Water Storage Tank No. 1 is a steel standpipe constructed in 1927. The tank interior and exterior were repainted in 1985. The interior of the tank was again painted in 2004. The exterior of the tank is in very poor condition with severe pitting at the base. The tank was inspected in 2006.

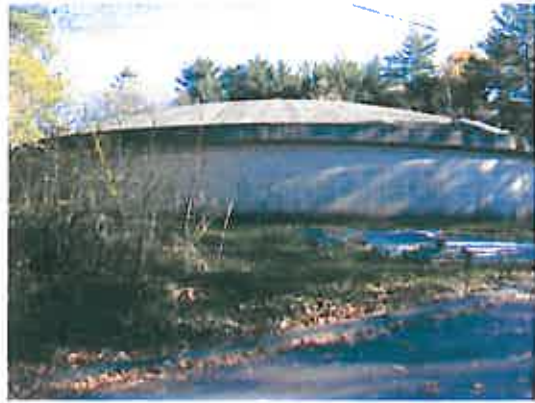
The Reeves Hill Water Storage Tank No. 2 is a prestressed concrete tank constructed in 1958. This tank was cleaned in 2002. The tank was inspected in 2006 and was considered to be in very good condition. The Wayland Water Department is planning to power wash the tank in the summer of 2008.
