TATA & HOWARD
INCORPORATED

Section 5 Asset Management Considerations

Capital Efficiency Plan
Wayland, Massachusetts

Section 6 Above Ground Facilities

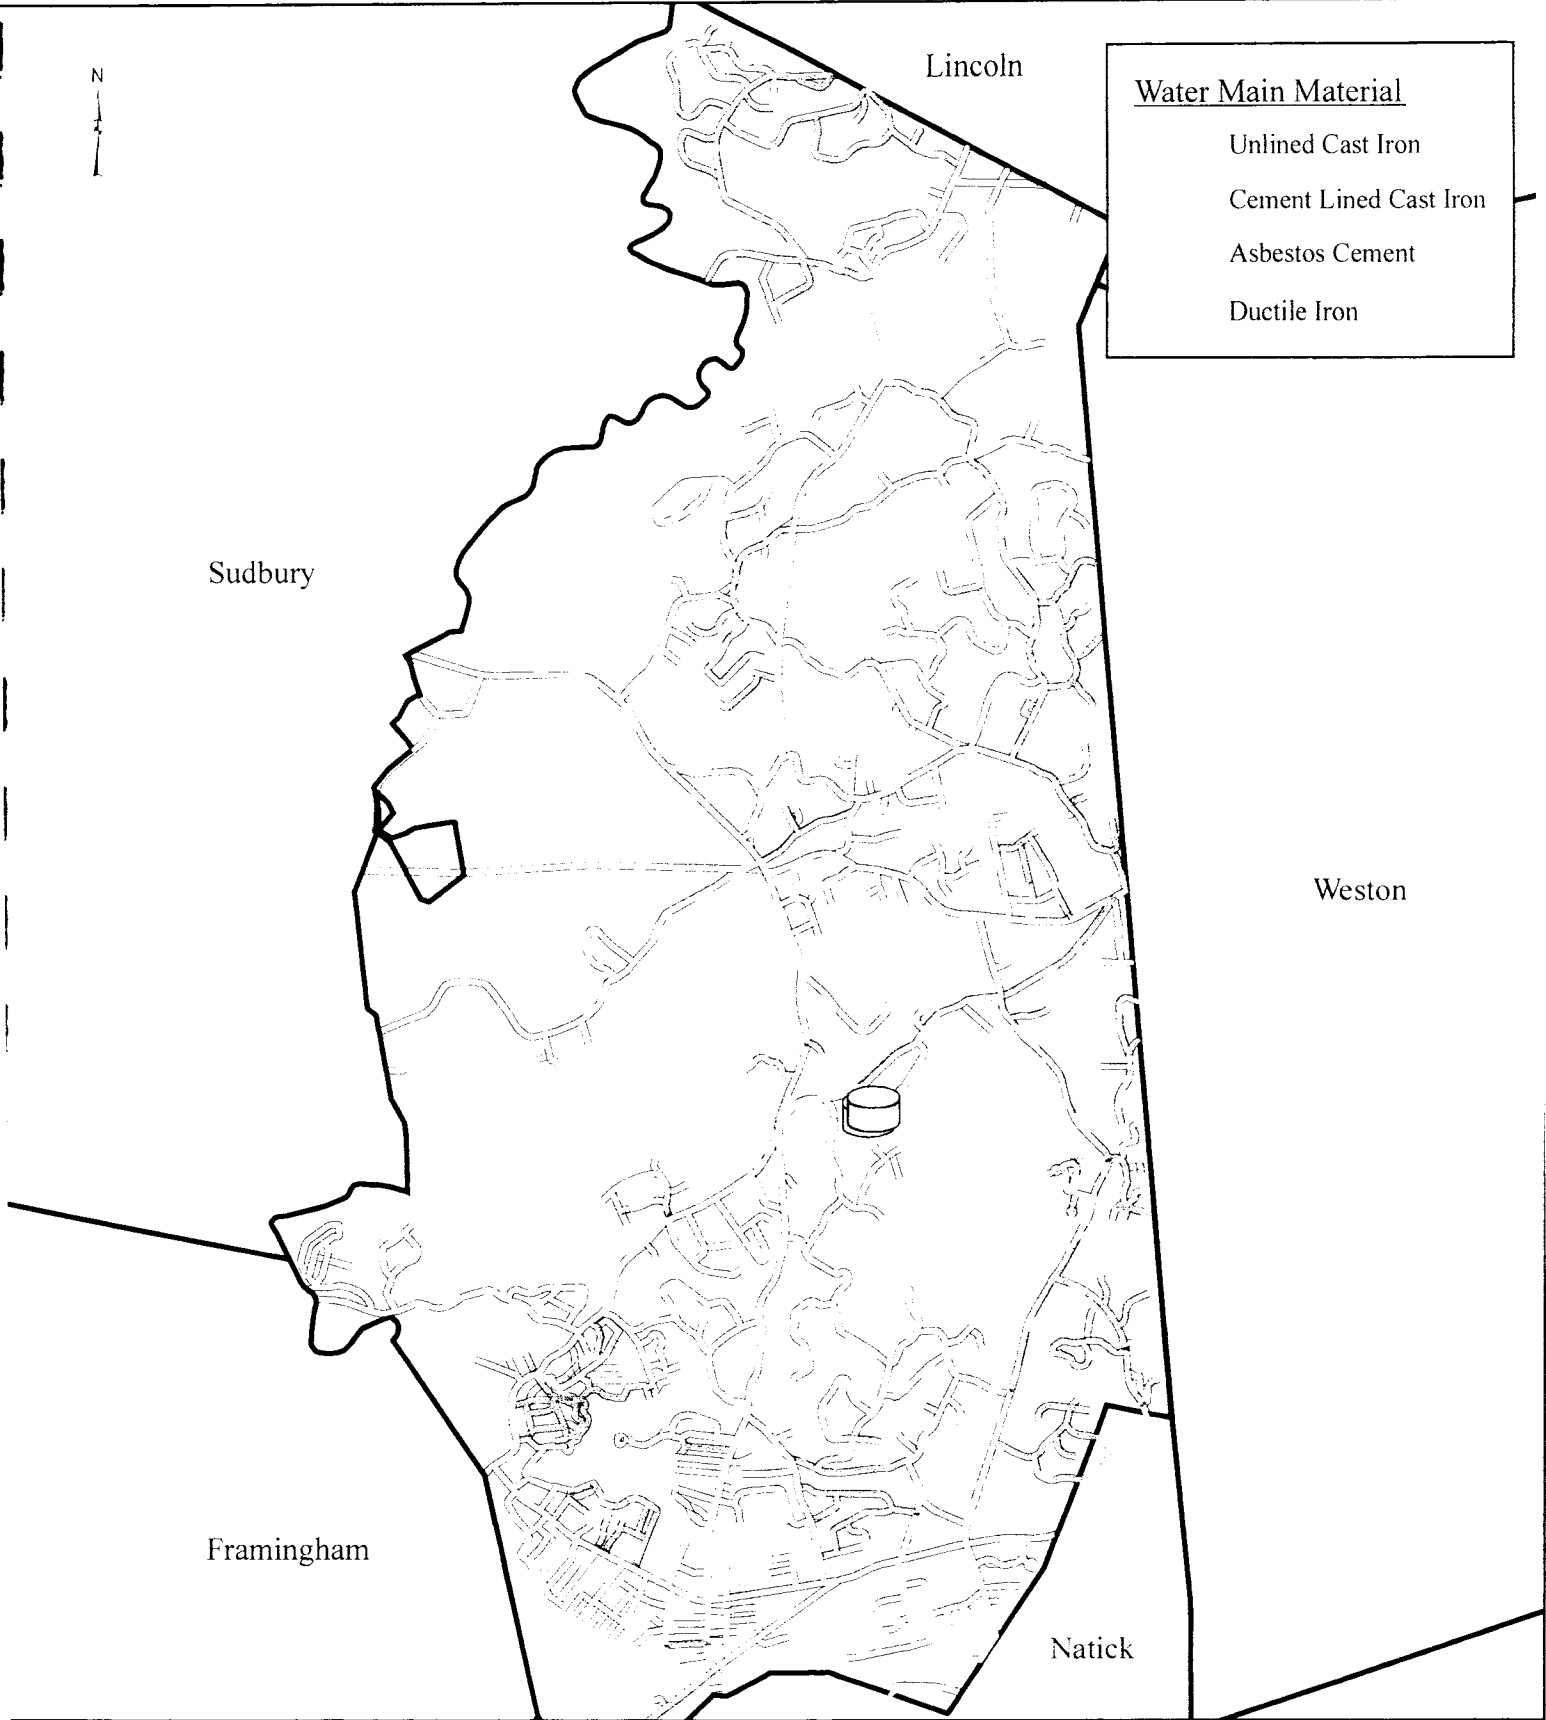
Figure No.

In general, the oldest water mains in the system received a high rating of 100, while the newest received a rating of zero. A ratings decrease occurs after 1932, which reflects the switch in Wayland from a surface water source to groundwater sources. Surface water in this area of the country is typically more corrosive to the interior of water mains than groundwater and this is reflected in the rating decrease. Another significant rating decrease can be seen in the materials score around 1958, which reflects the introduction of factory lining. Figures No. 5-1 and 5-2 present the installation year of the water mains and the materials, respectively.

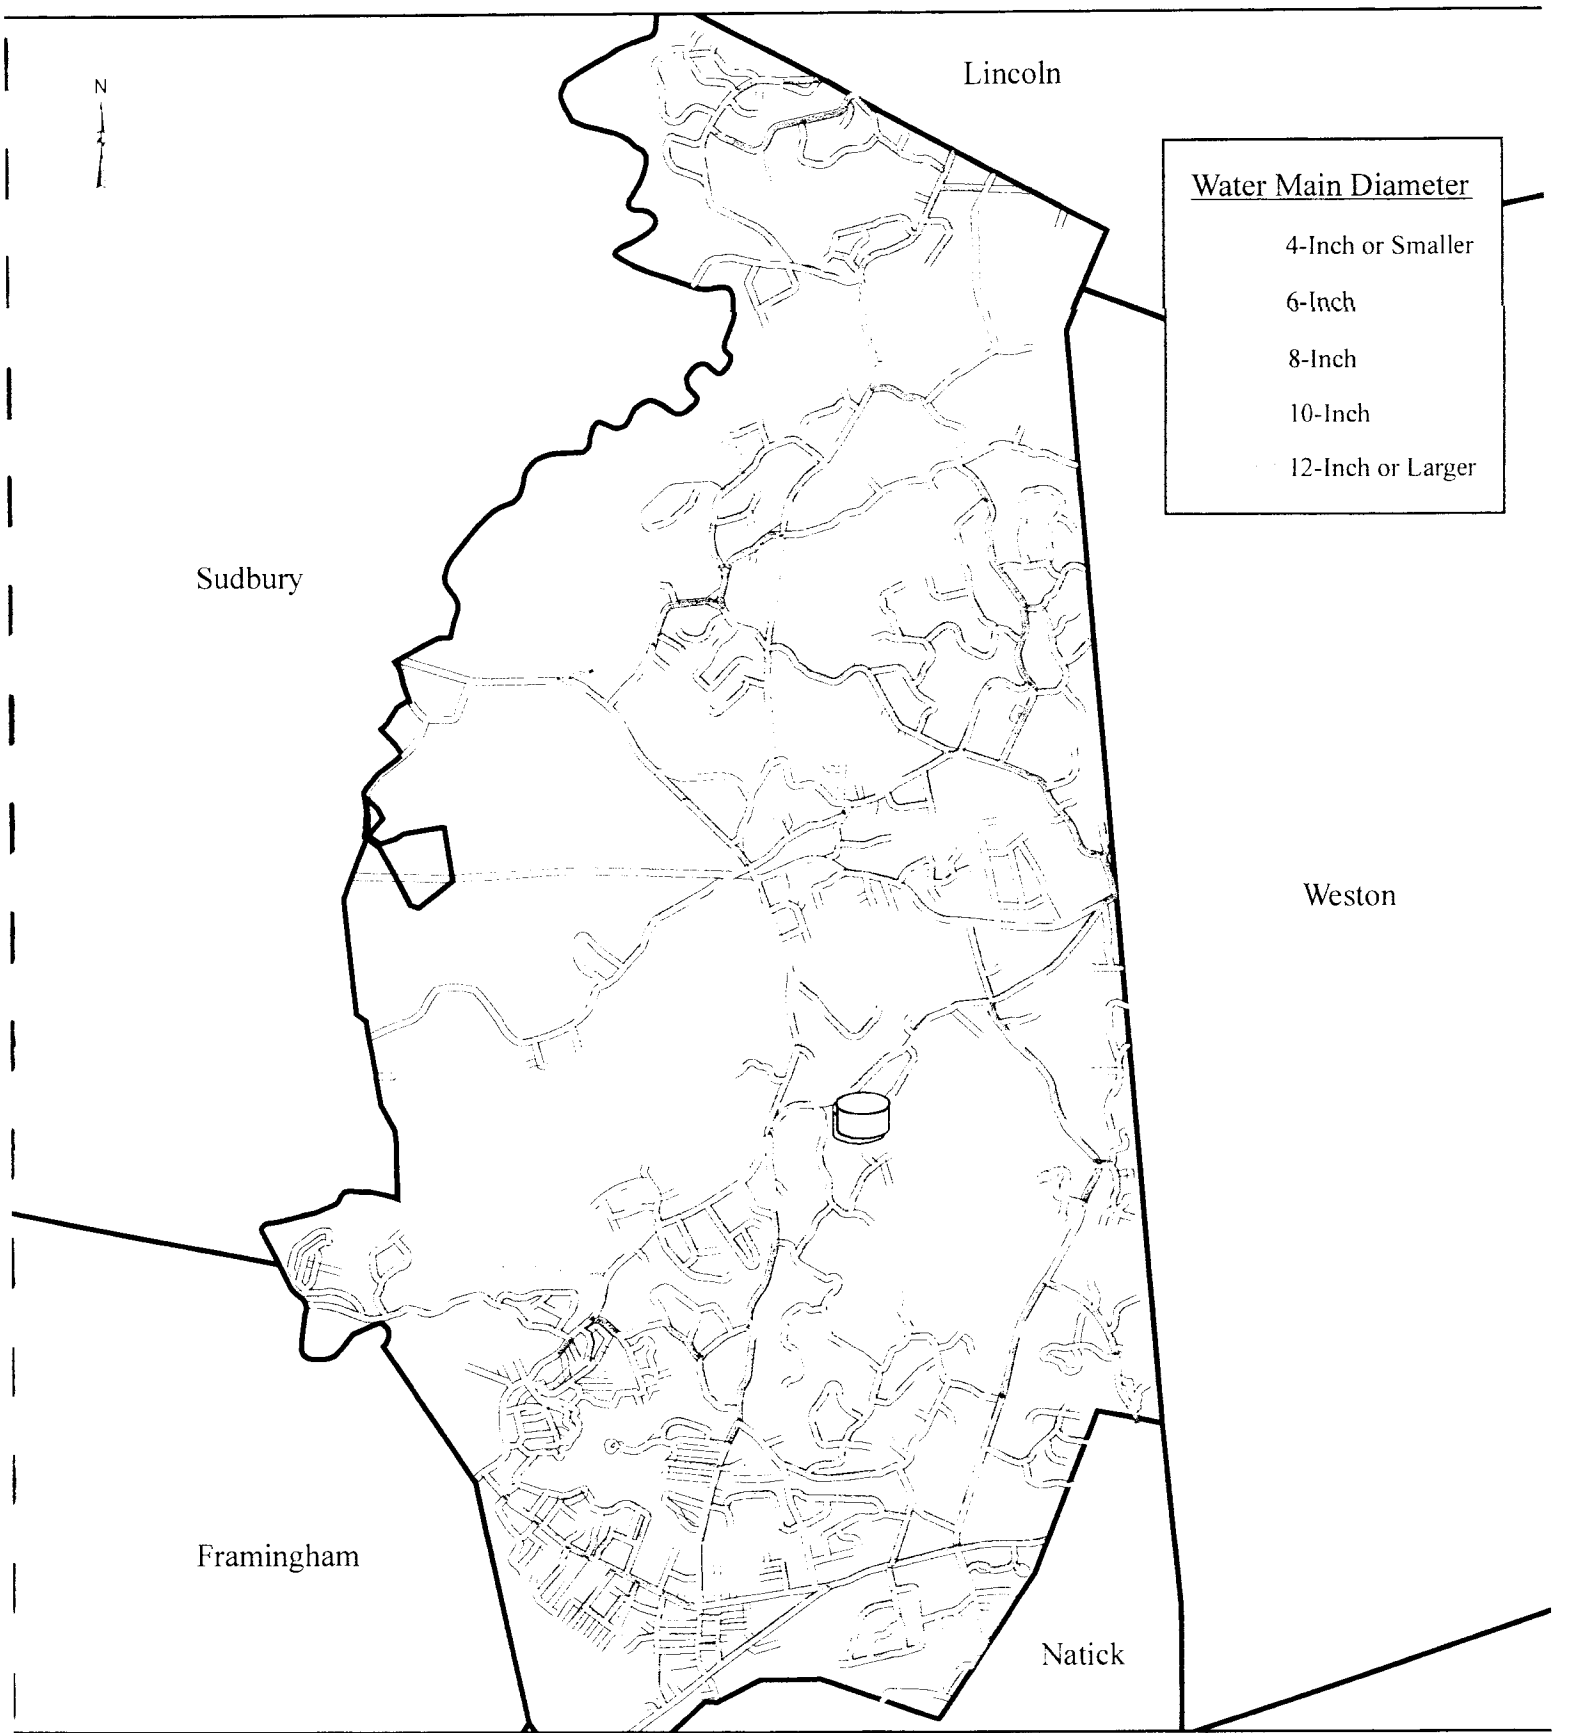
Water Main Diameter

An 8-inch diameter water main has proven to have nearly twice the bending strength of a 6-inch diameter water main. In general, 8-inch diameter water mains are stronger and less likely to break than 6-inch diameter pipes. Mains which are 4-inch diameter or less should be replaced with at least an 8-inch diameter main because an 8-inch diameter main has a 77 percent greater carrying capacity than a 6 inch main resulting in lower headloss and water velocities during fire flow events. Figure No. 5-3 presents the various diameters throughout the distribution system.

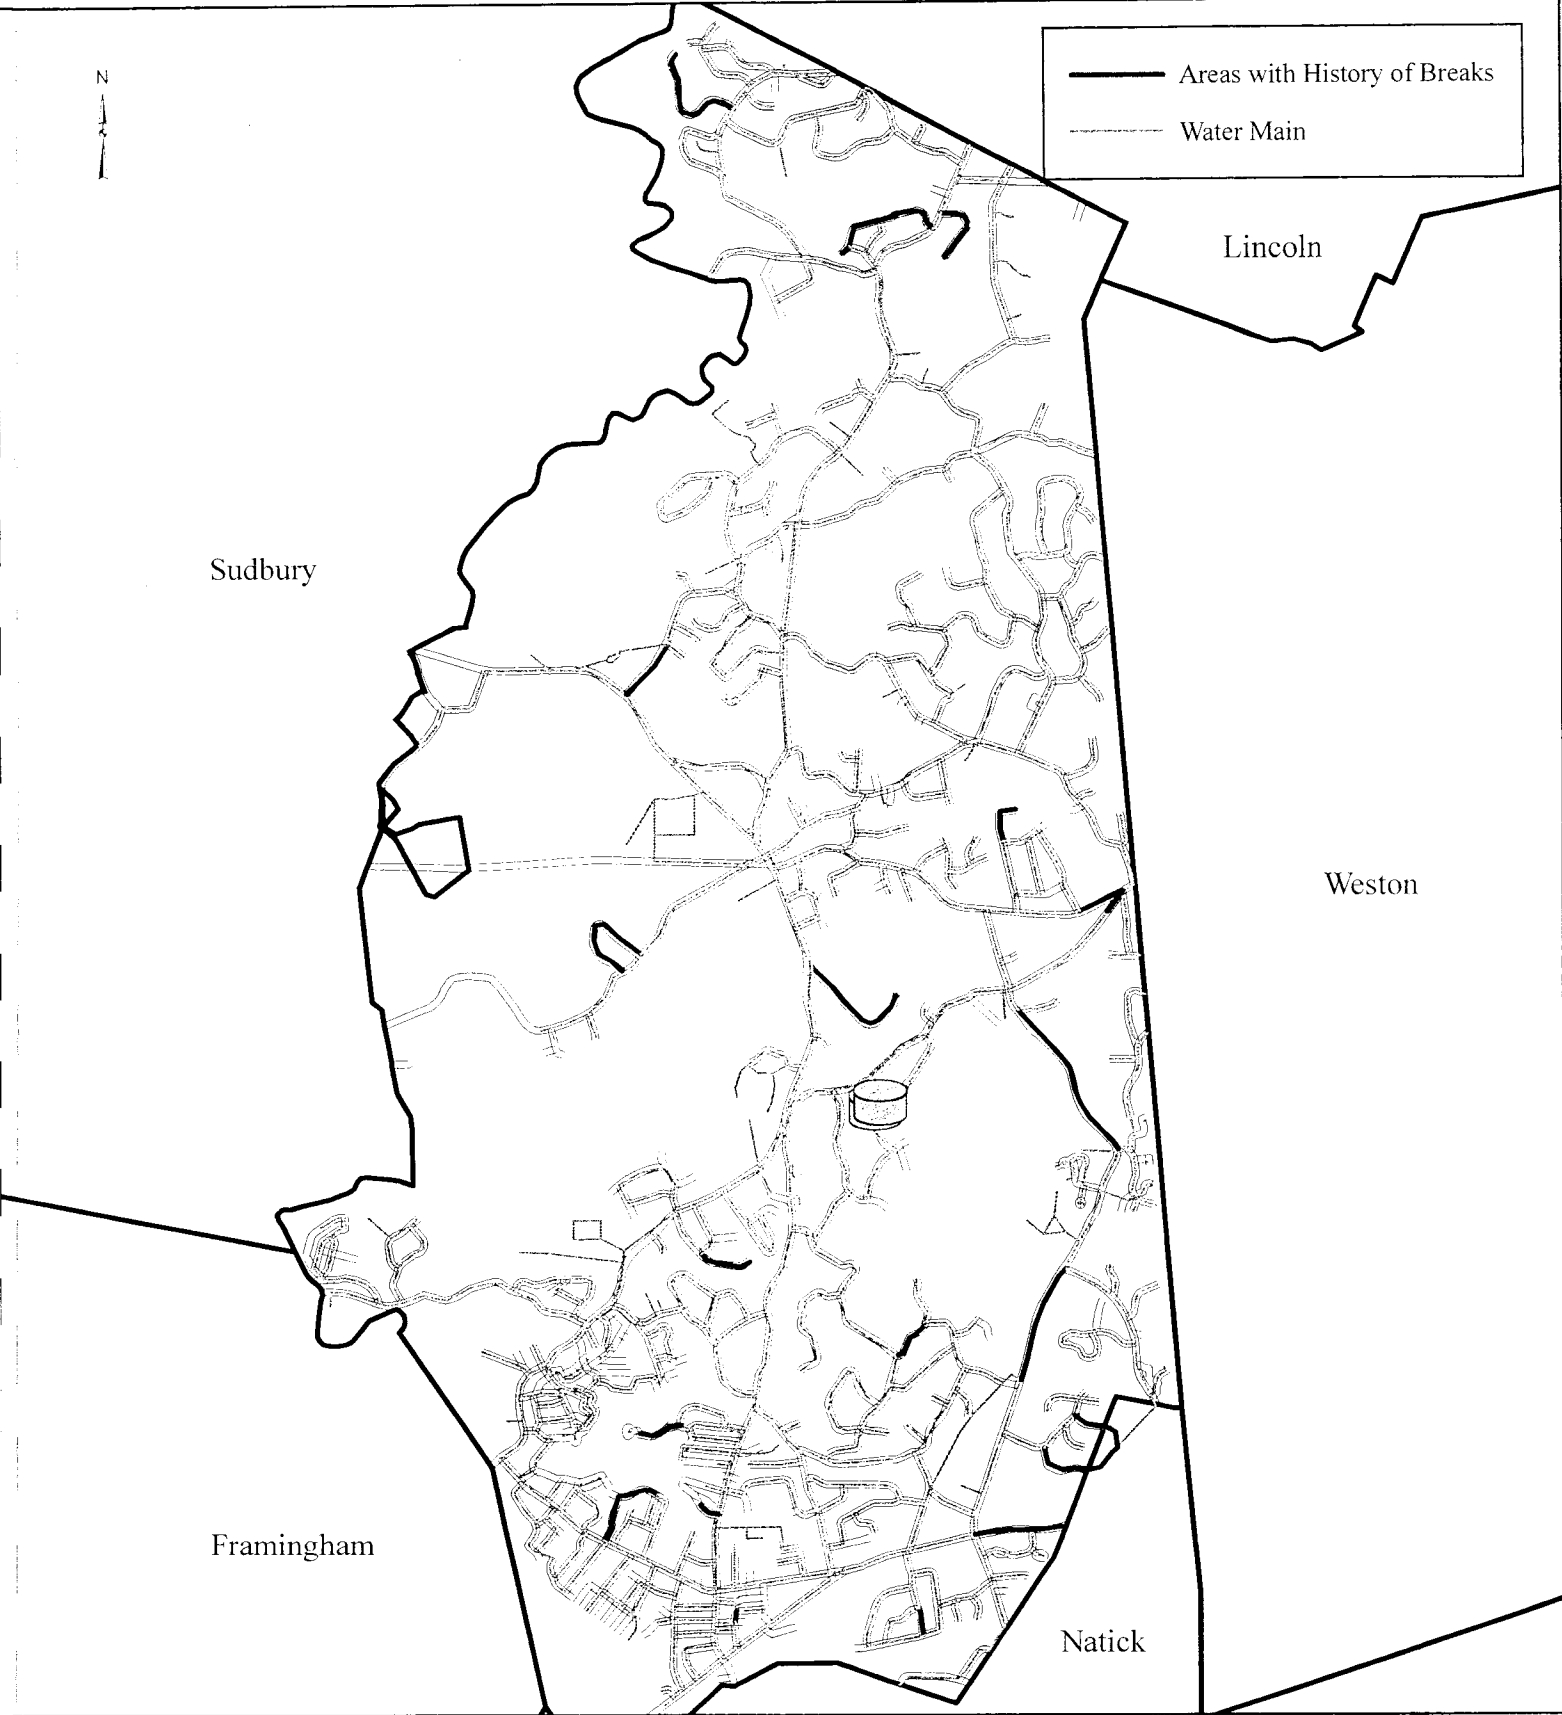
Each water main break costs the water Town time and labor. They also cause disruption to the public and water consumers. At some point, it becomes more efficient to replace the main than to continue repairing it. Based on discussions with WWD staff, there are several areas in the system that have experienced breaks. These areas are given a rating of 100 while areas with no known breaks received a rating of zero. Figure No. 5-4 presents areas with a history of breaks.

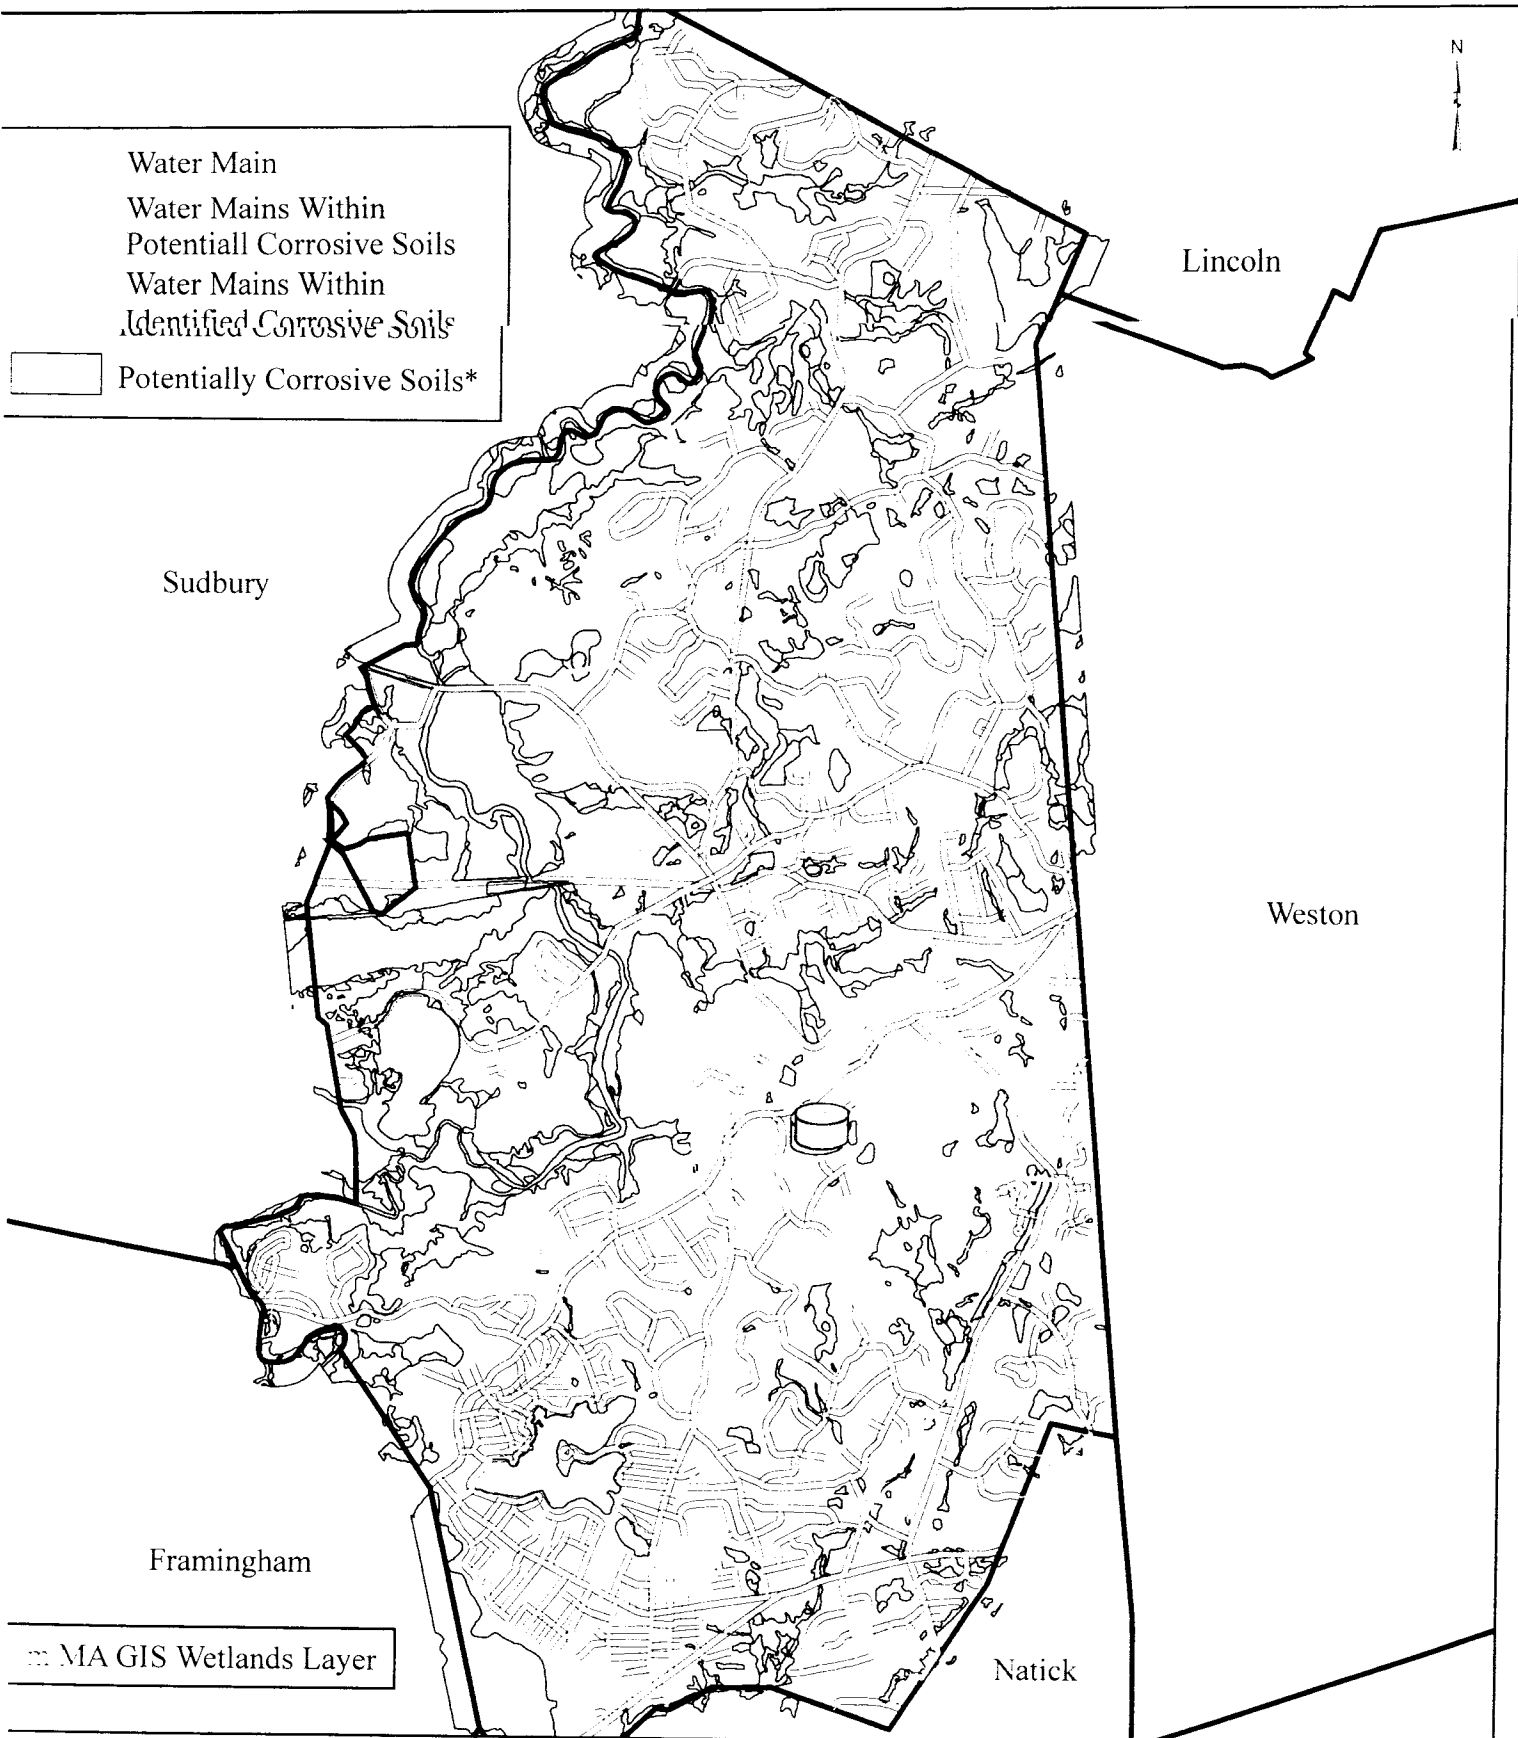
5-6

Water main degradation can occur both internally and externally. Factors that increase the rate of external corrosion include high groundwater, clay soils, potentially contaminated soils, soils with low calcium carbonate, or soils with high acidity or sulphate. Wetland areas have greater potential to cause external corrosion of water main than other soil conditions. As shown on Figure No. 5-6, wetland areas are scattered throughout Wayland. Areas where the water system and the wetlands coincide were considered areas of potential exterior corrosion. There were also areas identified to have a high groundwater level or known corrosive soils based on soil conditions observed during main repairs. These areas were given the highest rating (100) because they were known areas of potential corrosion. Areas identified as wetlands through soils maps were given a rating of 80. All other pipe was assigned a rating of zero.

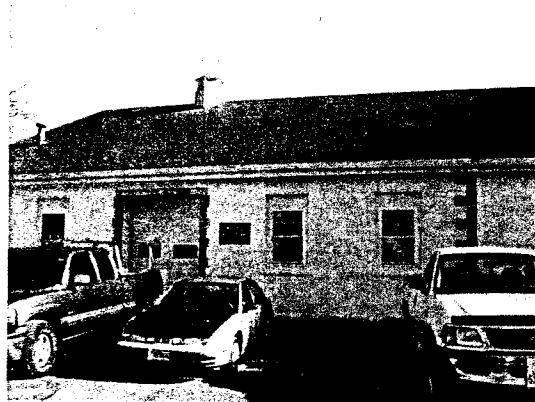
The Baldwin Pond Wells consists of three wells, a control building and an operations building. The control building was built in 1927 and turned into the current pump station in 1962. The building houses the chemical storage for Wells No. 1 and 2, the master venturi meter, emergency generator and the motor control center for all three wells. The building walls are in good condition, but the roof is missing shingles. The generator is the original generator from 1962. Wells No. 1 and 2 are currently offline, therefore, the chemical storage tanks at this location are empty.

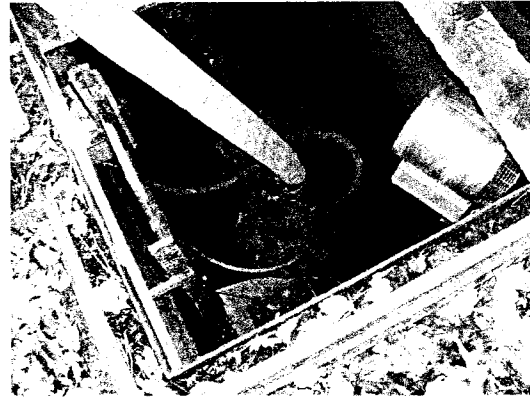
Well No. 1 was replaced in 2001 and is located in the original concrete vault. Well No. 1 is currently offline due to high iron and manganese levels and is used as a sampling location only.

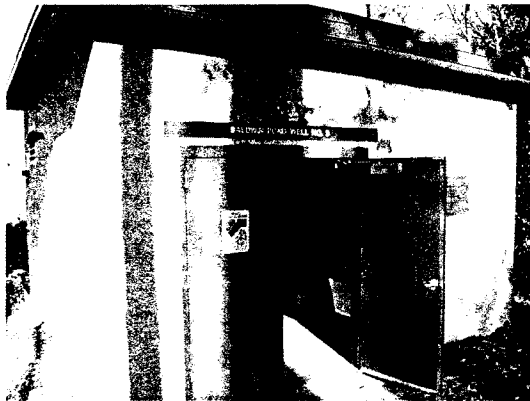
Well No. 3 was installed in 1955 and is located in a concrete building with a concrete slab roof installed in 1998. The pump and pump motor were replaced in 1993. The well was redeveloped in 1998. The 2007 well inspection report recommends the pump be pulled and inspected. Chemical storage and injection was added to the building in 1999.

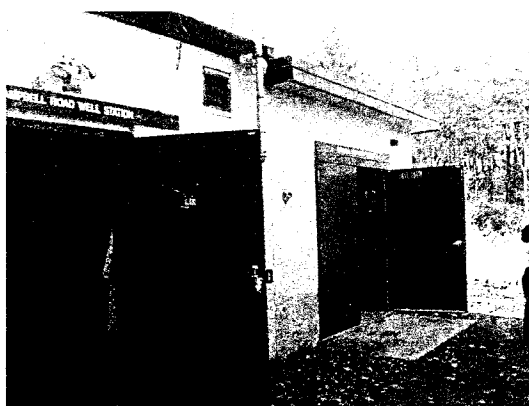
The Campbell Well and station was originally installed in 1965. The station is a concrete building with a concrete slab roof. It is the original building and roof from 1965. An addition was added to the building in 1999 for the chemical storage and injection. Both portions of the building are in good condition. A new pump and pump motor were installed in 1994. The 2007 well inspection report recommends the well be cleaned and redeveloped.

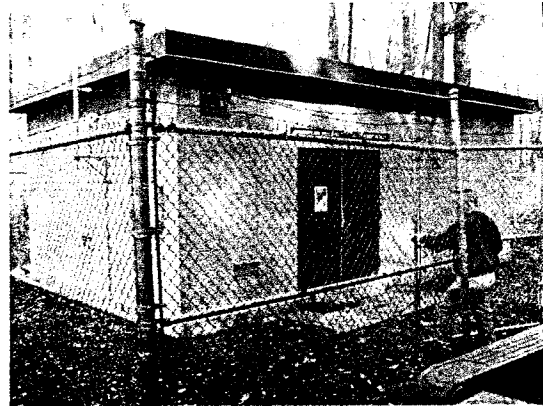
The Chamberlain Well and station was constructed in 1991. The well station houses all the original equipment including a direct drive generator that runs the pump only. A motor control center was installed in 1999 with chemical storage and feed equipment. The station is in good condition, but the direct drive generator is of minimal benefit because it will run only the pump and not the chemical feed equipment if there is a power outage. The 2007 well inspection report requests information on the well and pump.

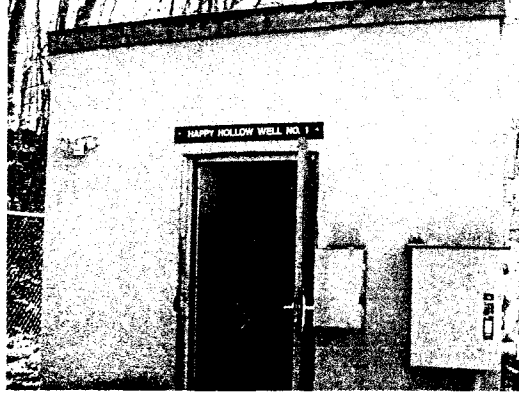
Happy Hollow Well No. 1 was originally installed in 1949 in a concrete building with a concrete slab roof. The well was cleaned and redeveloped in 2003. It is unknown if the pump and pump motor has been replaced since they were installed, and no repairs have been made to the roof or building since construction. Chemical storage and feed equipment were added in 1999 along with a new motor control center for Wells 1 and 2. There is a master venturi located in a pit outside of the building. The exact location is currently unknown. The 2007 well inspection report recommends that the well be cleaned and redeveloped.

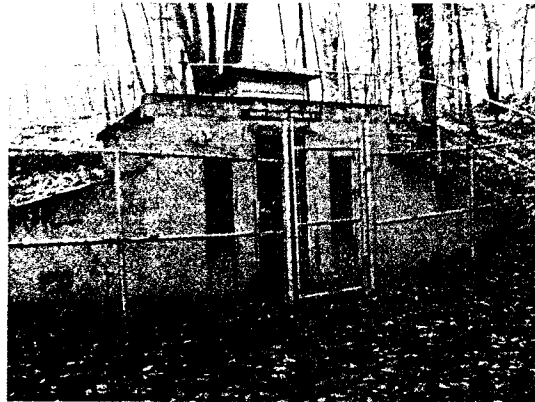
Happy Hollow Well No. 2 was originally installed in 1951 in a concrete building with a concrete slab roof. The pump motor was rebuilt in 2006, but it is unknown if the pump has been replaced. No repairs have been made to the roof or building since construction. The 2007 well inspection report claims that the well and pump appear to be in good condition.

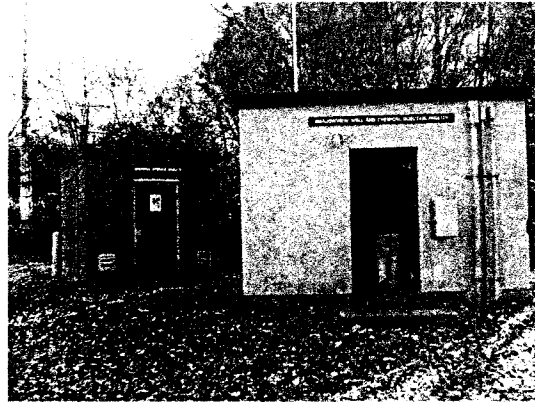
The Meadowview well pit was originally installed in 1970. The well was cleaned and redeveloped in 2001 and the pump and motor were replaced in 1993. Two concrete buildings were constructed in 1999 for chemical injection and storage. One building houses the potassium hydroxide tank and the other building houses the rest of the chemical storage, the chemical injection equipment, motor control center and the magnetic meter. The chemical tanks are all empty and the well is not in use due to high manganese concentrations. The 2007 well inspection report requests information on the pump.

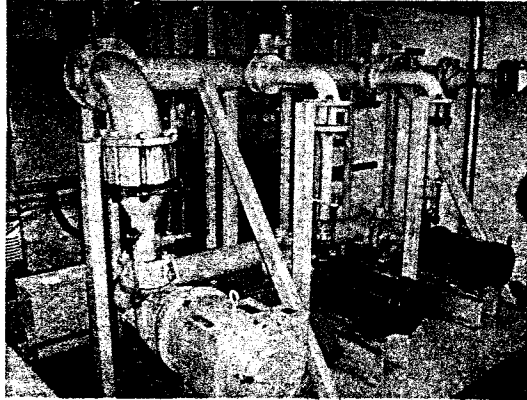
The Reeves Hill Booster Pump Station was installed in 1973 at the same site as the two water storage tanks. The building is a concrete building with a concrete slab roof. There is one fire pump and two domestic pumps inside the station. There is also natural gas generator inside of the building. The pump station was rehabilitated in 1999, when an EFI skid was installed. The domestic pumps were replaced again in 2006.

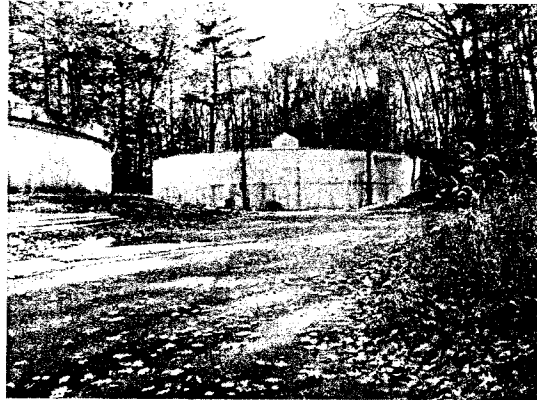
The Reeves Hill Water Storage Tank No. 1 is a steel standpipe constructed in 1927. The tank interior and exterior were repainted in 1985. The interior of the tank was again painted in 2004. The exterior of the tank is in very poor condition with severe pitting at the base. The tank was inspected in 2006.

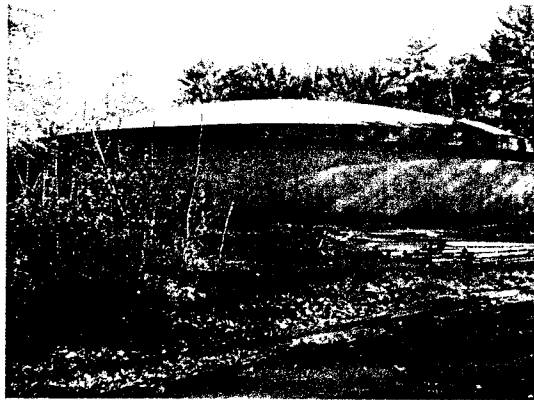
The Reeves Hill Water Storage Tank No. 2 is a prestressed concrete tank constructed in 1958. This tank was cleaned in 2002. The tank was inspected in 2006 and was considered to be in very good condition. The Wayland Water Department is planning to power wash the tank in the summer of 2008.
