Sameera Thantirige  
Build Estimate Limited

# Sample Snagging

19 Sep 2024

## 6 George Dewhurst Way

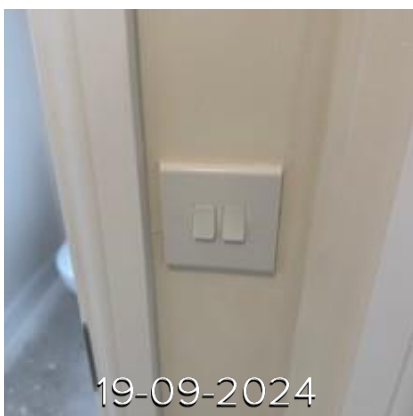
12

WC door is not closing properly and requires adjustment or repair.

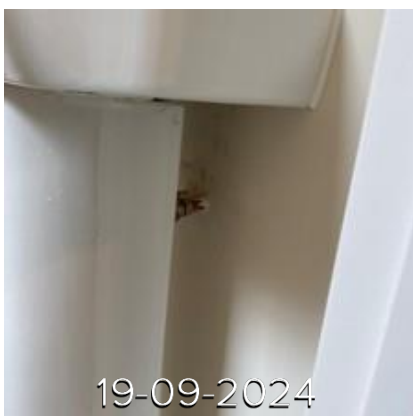
16

WC mirror is missing and requires installation.

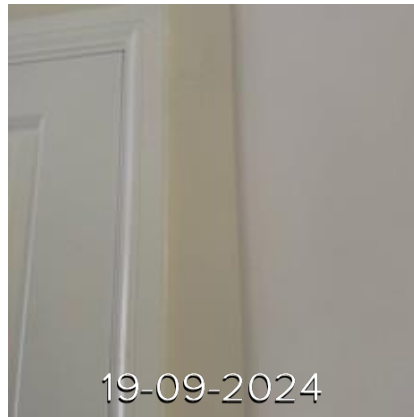
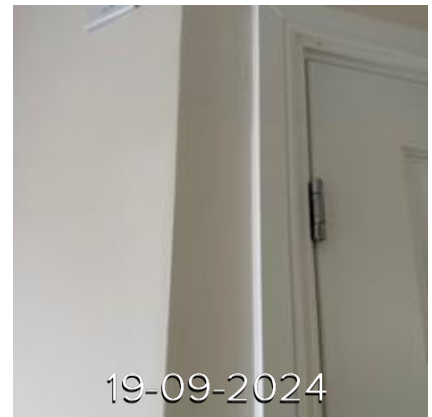
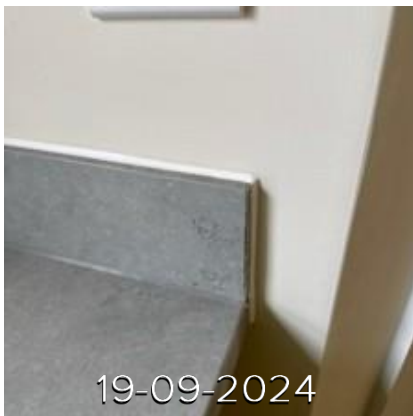
19

Paint scratches around the kitchen door need repairing and repainting for a smooth finish.

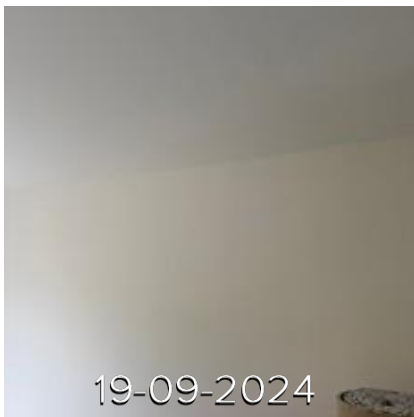
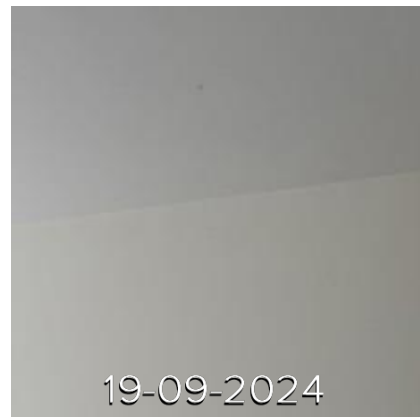
**25**

Ceiling paint scratches require repair and repainting for a seamless finish.

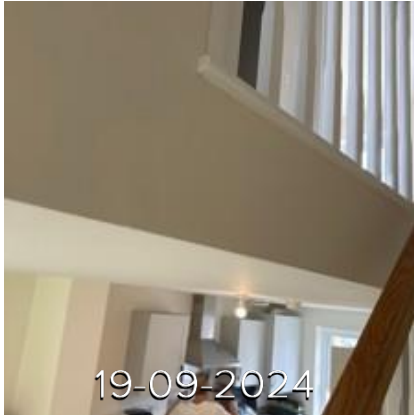
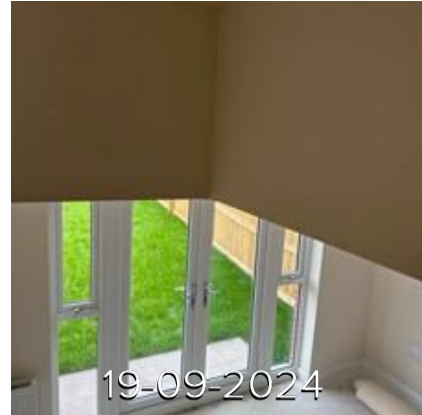
34

Scratches on the ceiling edge require repair and repainting for a smooth finish.

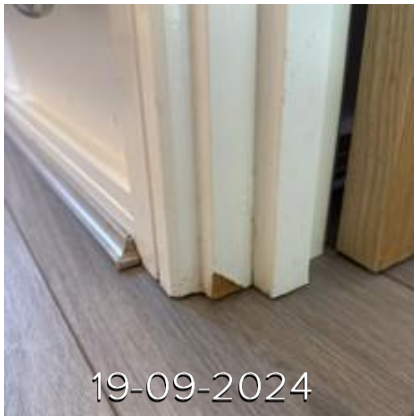
**48**

Living Entrance door mastic crack

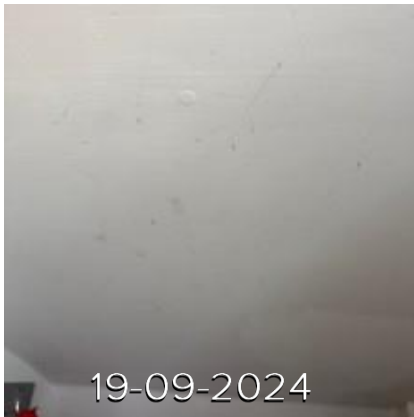
52

living room wall facing into kitchen side has a crack

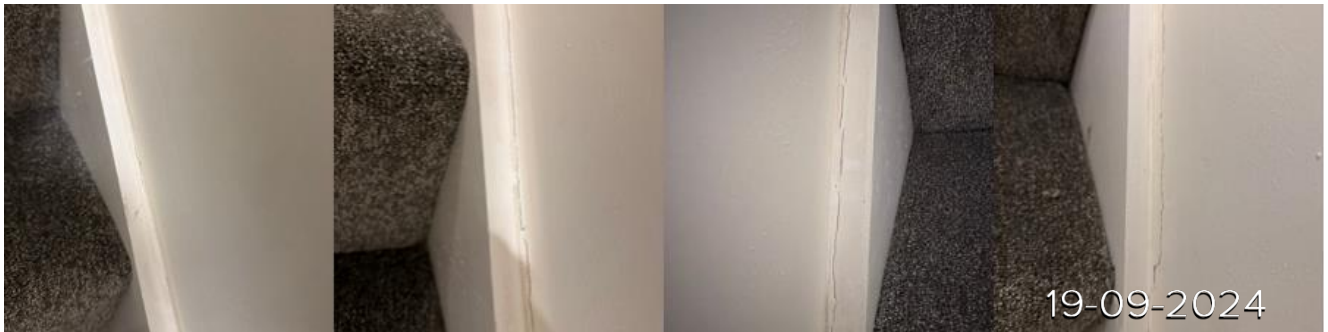
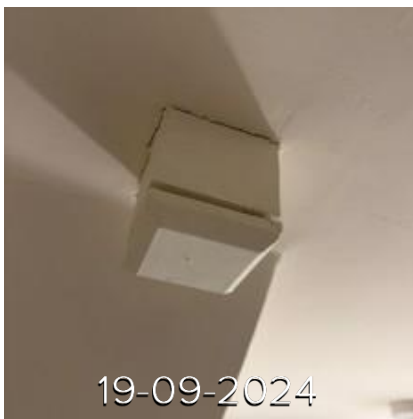
103

Cracks observed on staircase side panel.

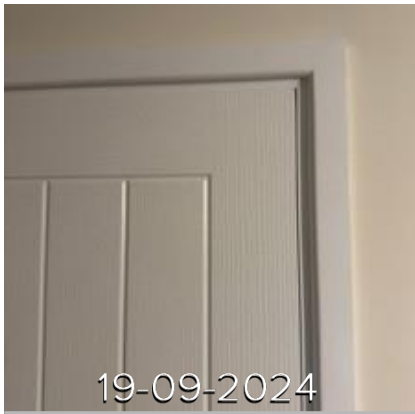
105

Upper rear bedroom door closer is missing.

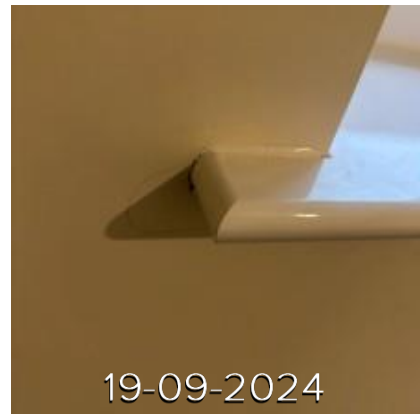
107

Crack observed on upper rear bedroom window board.

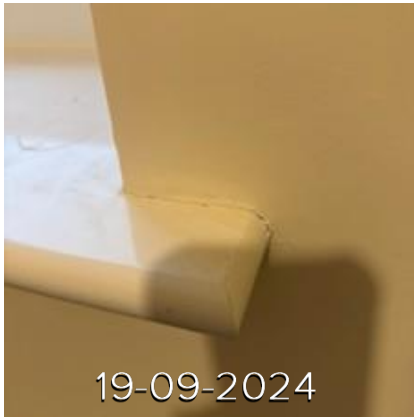
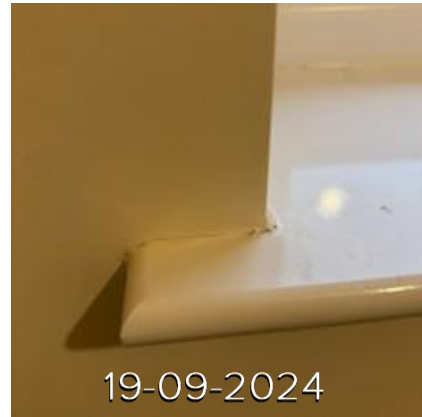
116

Crack observed on window board at entrance to second floor.

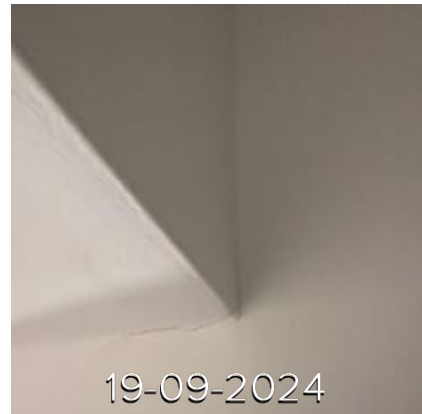
117

Crack observed at stairwell corner on entrance to second floor.

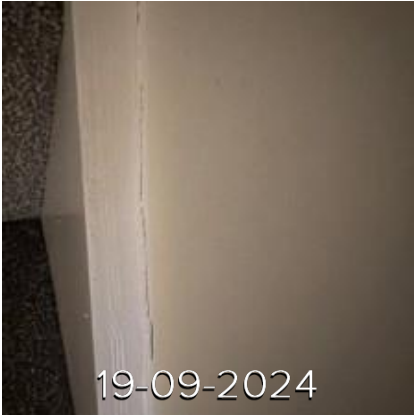
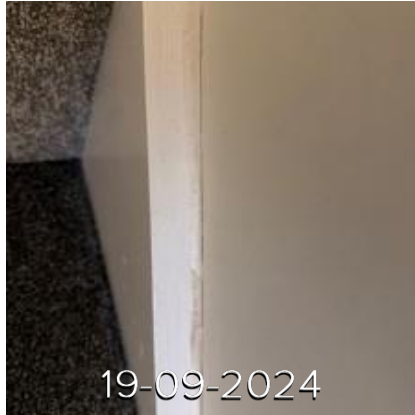
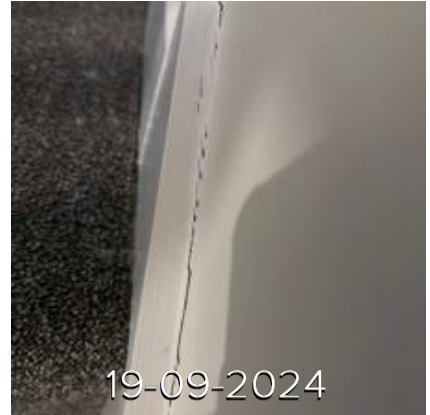
118

Crack observed on second floor staircase side.

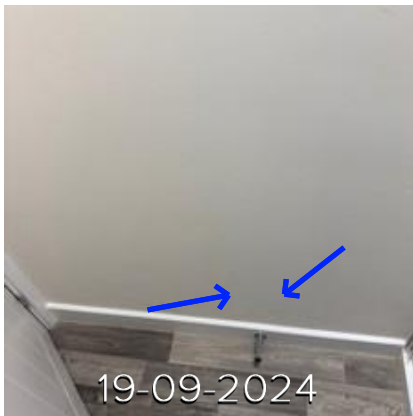
121

Crack observed on second floor bathroom wall.

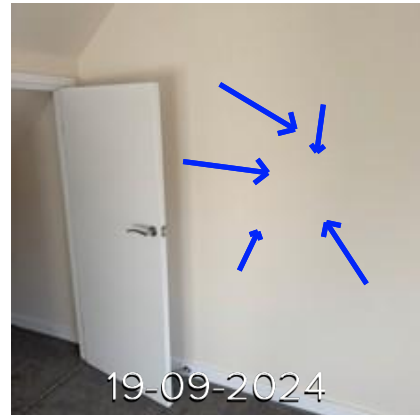
**141**

Oil mark observed on living area wall.

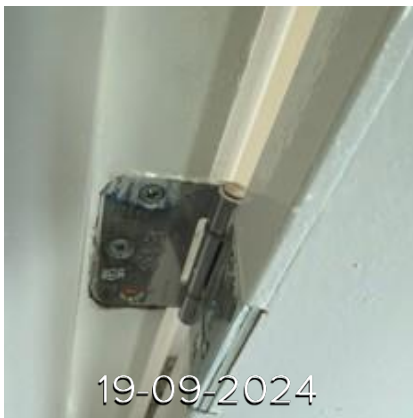
Screw missing from underside of staircase door.

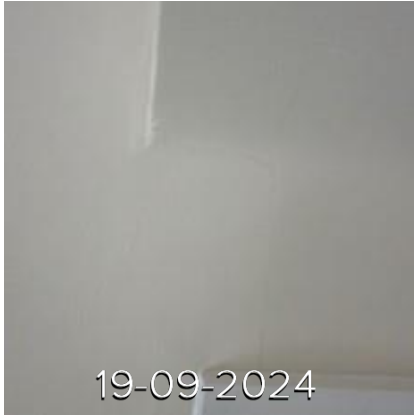
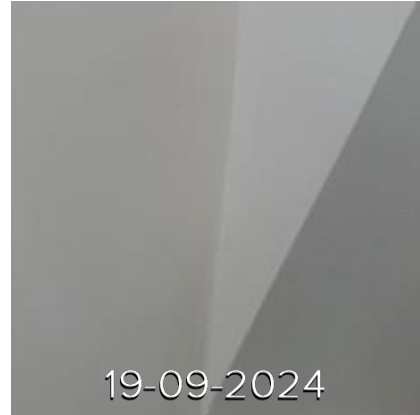
**144**

Crack observed at under-staircase wall.

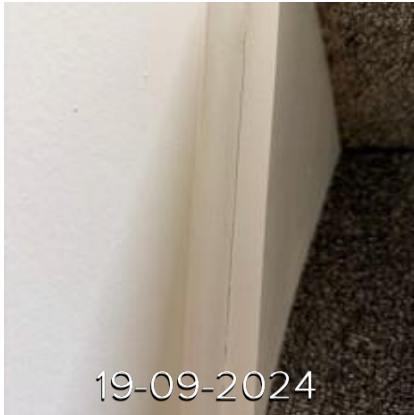
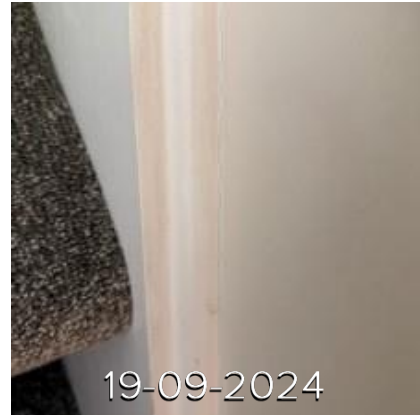
Cracks observed on staircase sideboard.

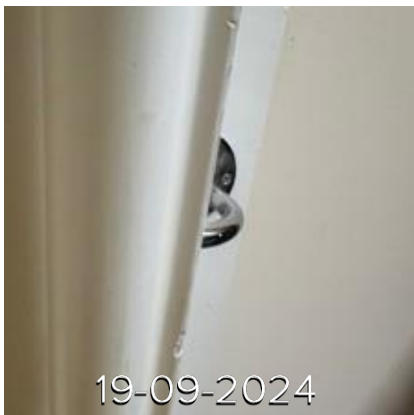
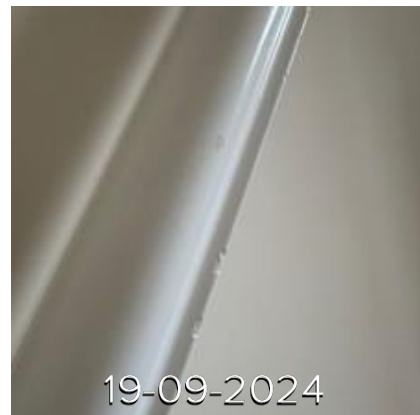
147

Damages on staircase handrail require filling and smoothing.

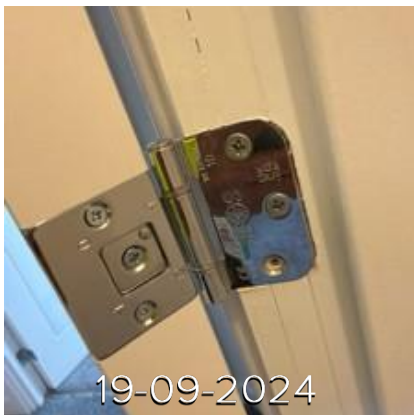
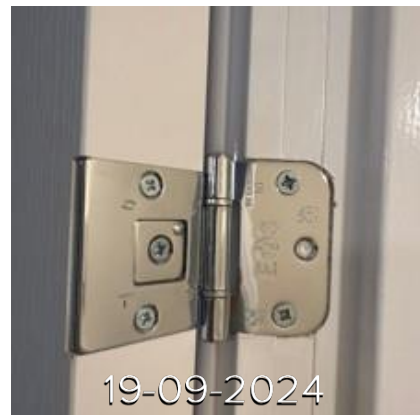
Screws missing from hallway and utility room doors.

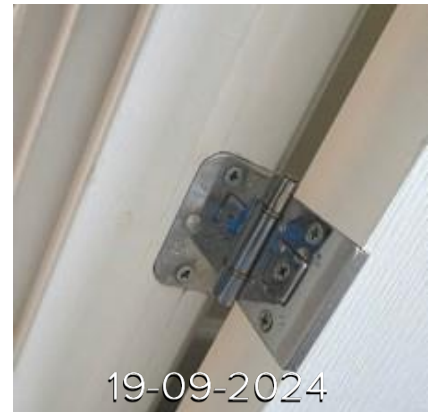
Screw missing from front left-hand side lobby door.

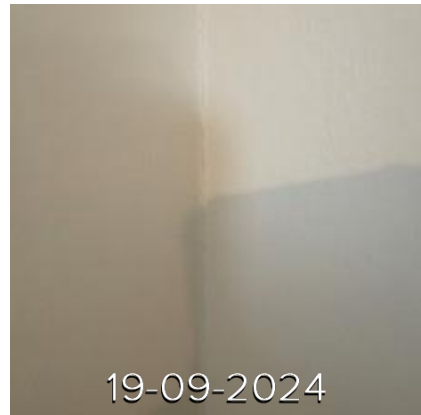
Crack observed at wall-ceiling corner on second floor.

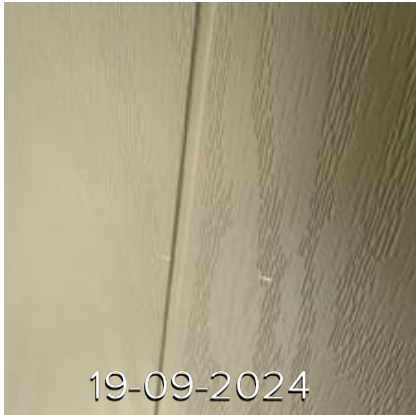
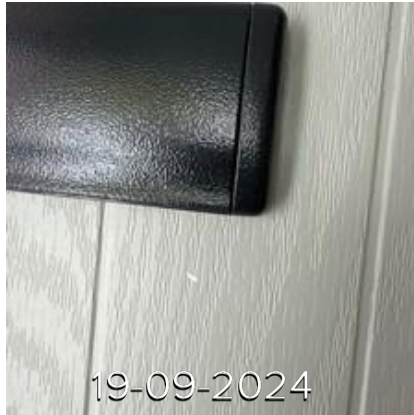
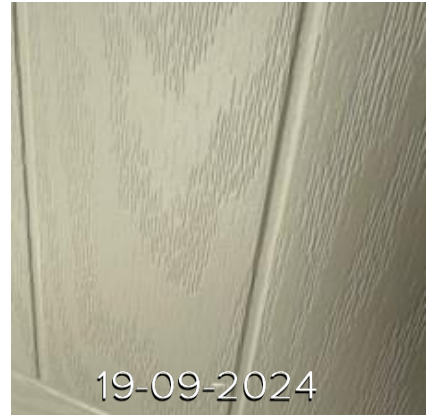
The main door has scratches that require repair or refinishing to restore its appearance.

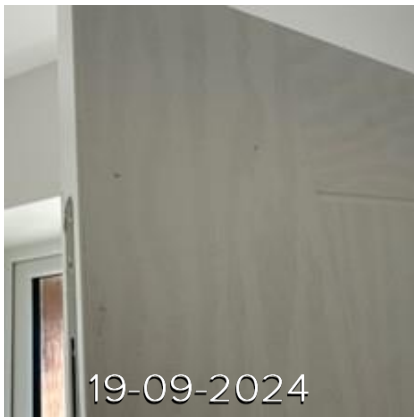
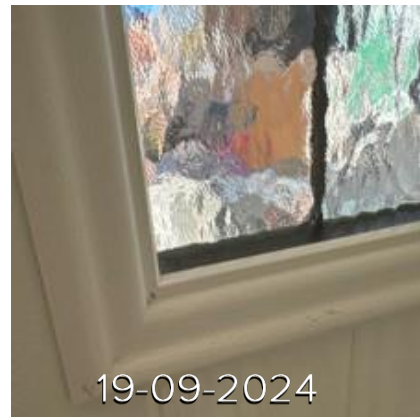
**174**

The main door has internal scratches that require repair or refinishing to restore its interior finish.

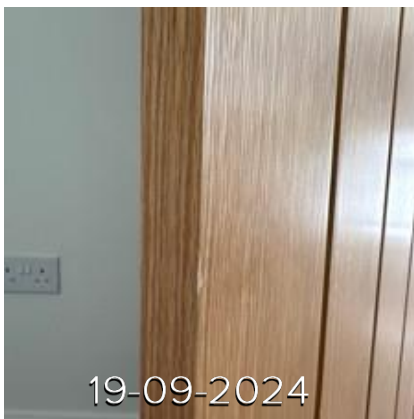
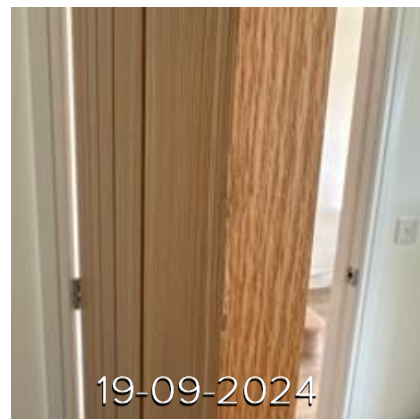
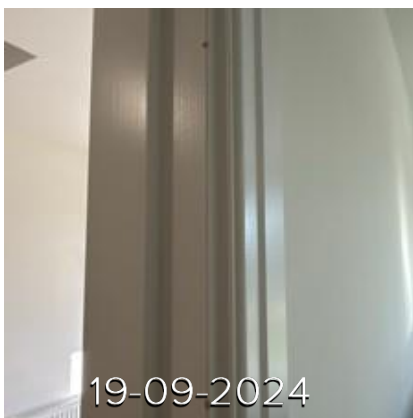
The living room door has scratches that require repair or refinishing to restore its appearance.

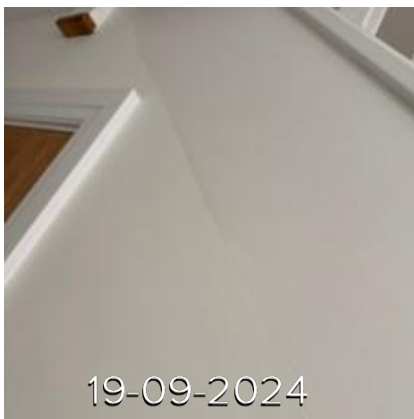
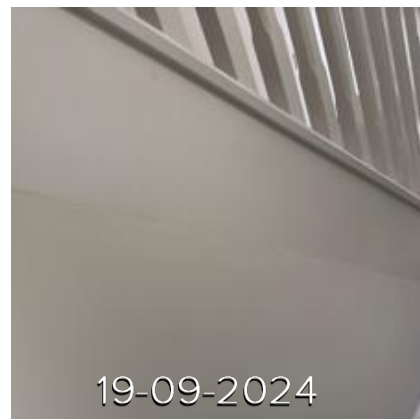
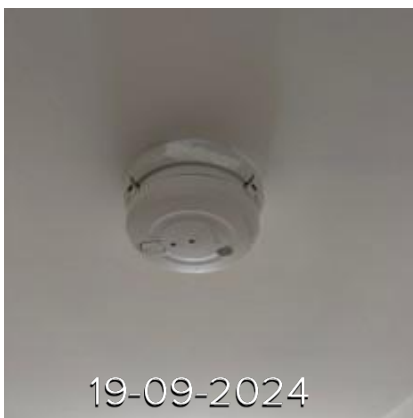
The wall under the staircase cupboard has a crack that requires repair to ensure structural integrity and a smooth finish.

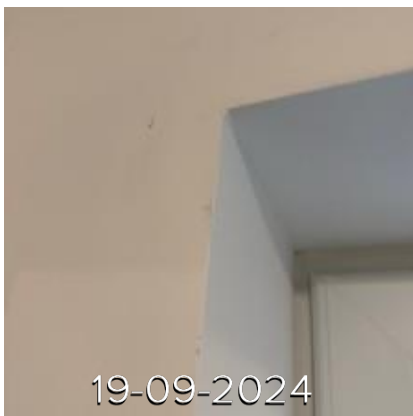
The laundry room door stopper is too short and needs adjustment or replacement to function correctly.

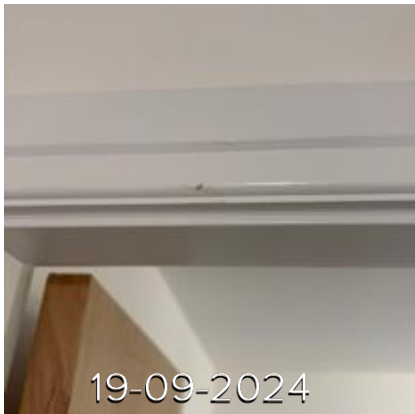
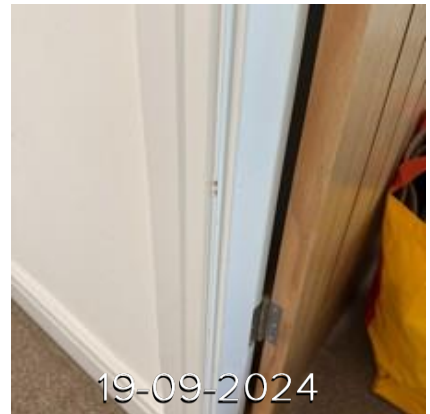
The rear left bedroom door frame has a crack that requires repair to ensure a smooth finish.

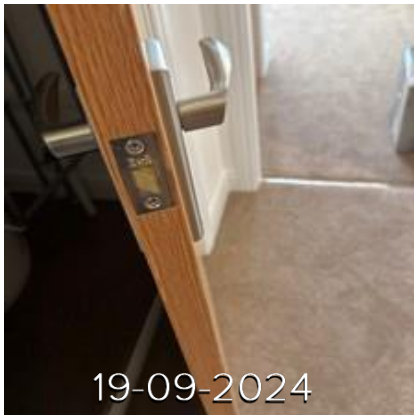
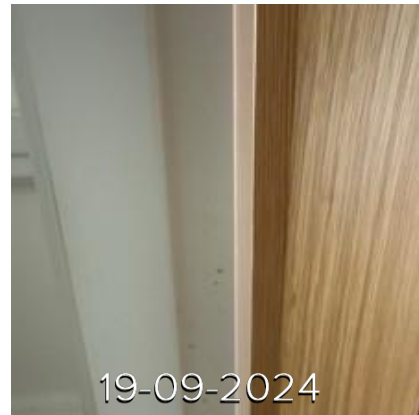
The upper plant room door has paint scratches that require repair or repainting to restore a smooth and uniform finish.

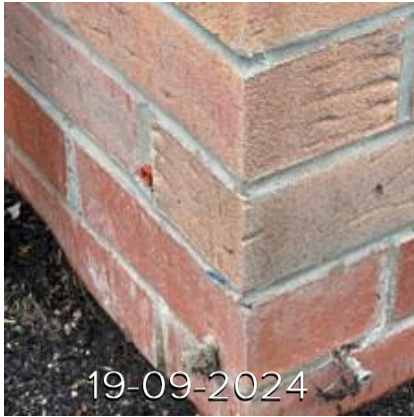
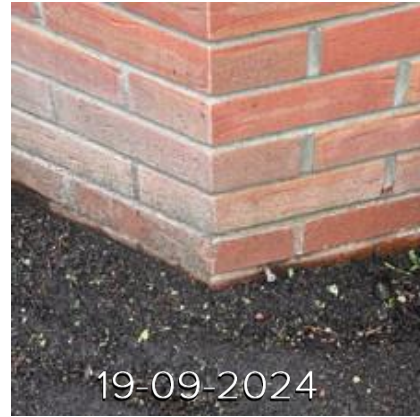
Unattended screw observed on the front wall.

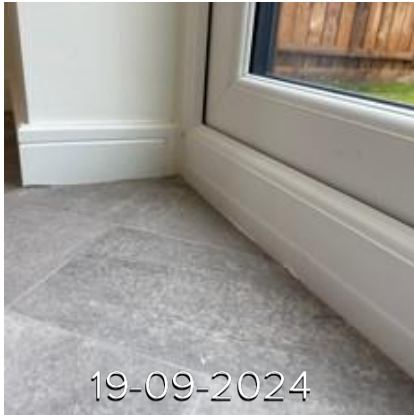
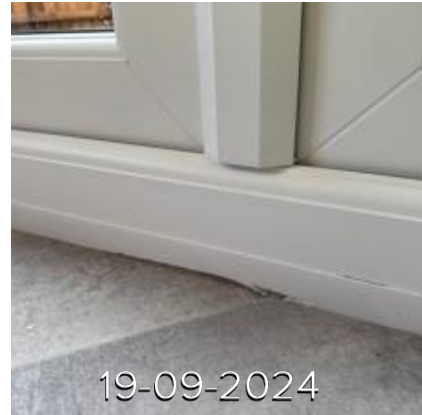
Refinishing required between French door and floor, and scratches observed on the frame.

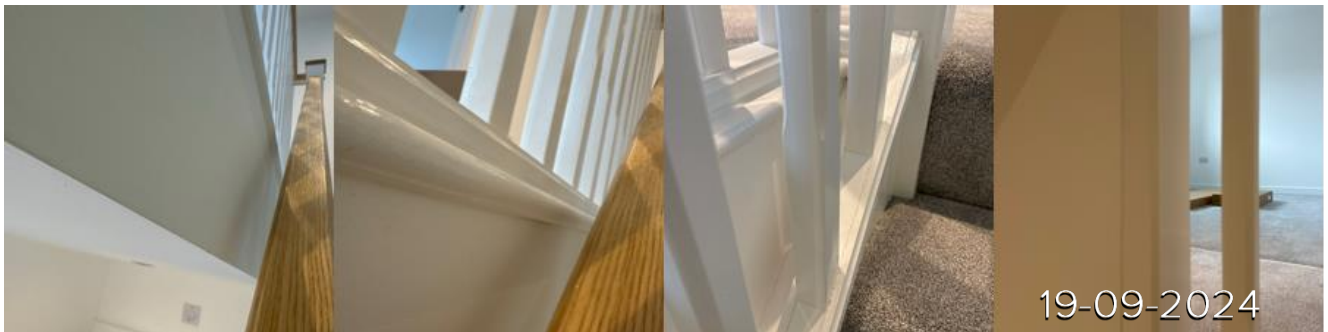
254

Paint cracks observed on staircase.

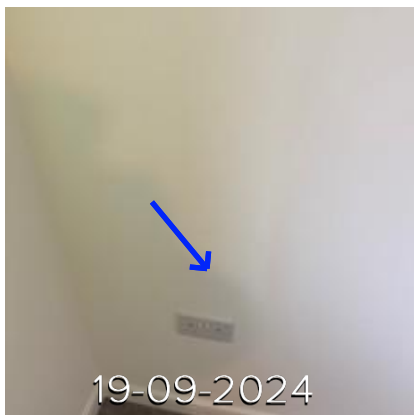
Crack observed on front bedroom wall.

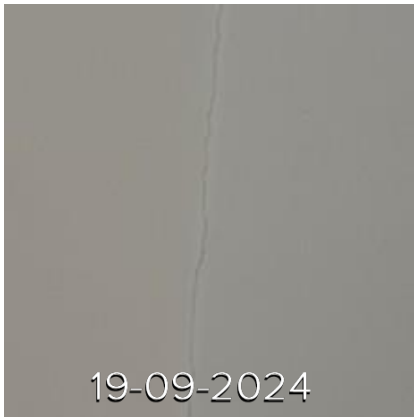
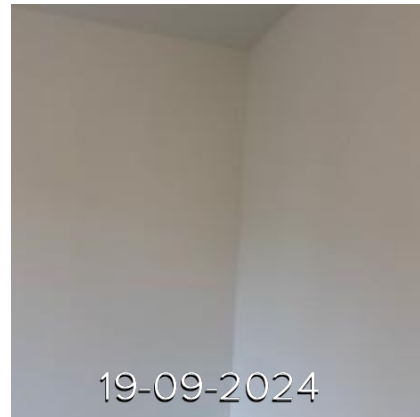
Crack observed on upper front bedroom wall.

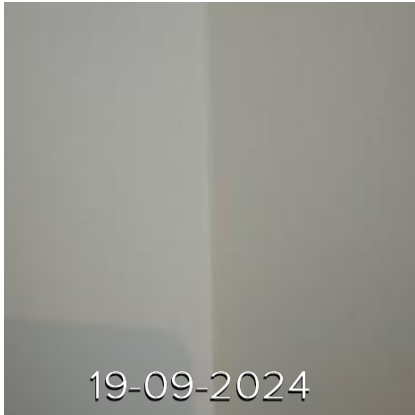
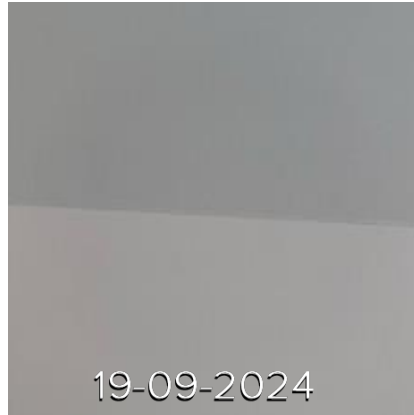
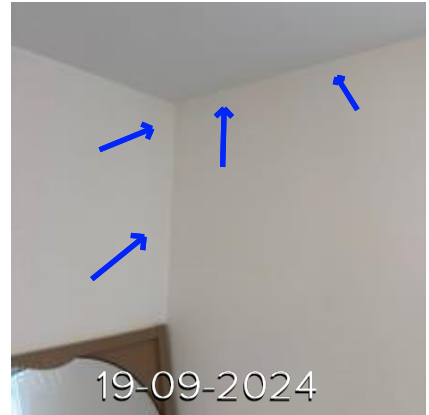
Crack observed on master bedroom wall ceiling junction.

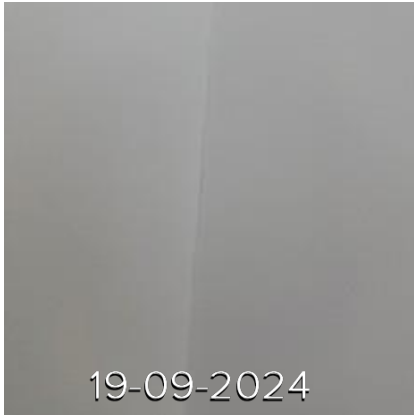
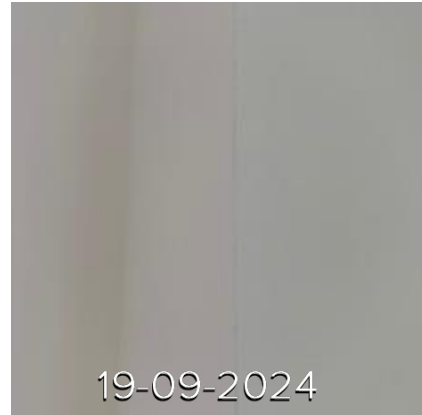
Crack observed on master bedroom wall ceiling junction.
