# 4-Point Inspection Form

Address Inspected: 2820 21st Ln, Vero Beach, FL 32960

Actual Year Built: 1982 Date Inspected: 04/30/2026

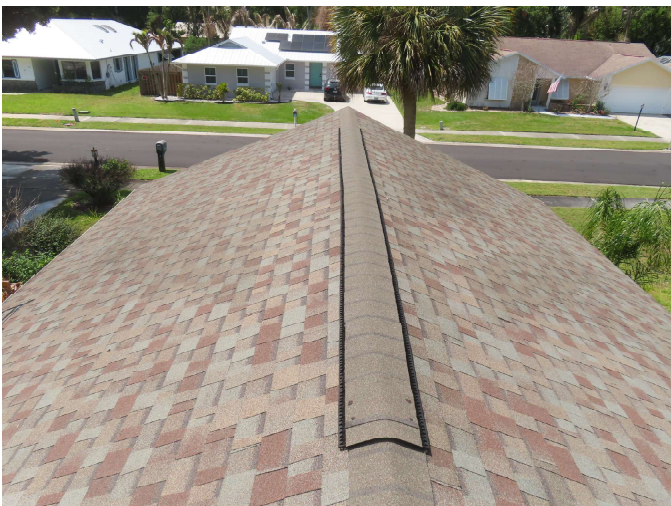
Roof

- ☒ Satisfactory  
☐ Unsatisfactory (**explain below**)

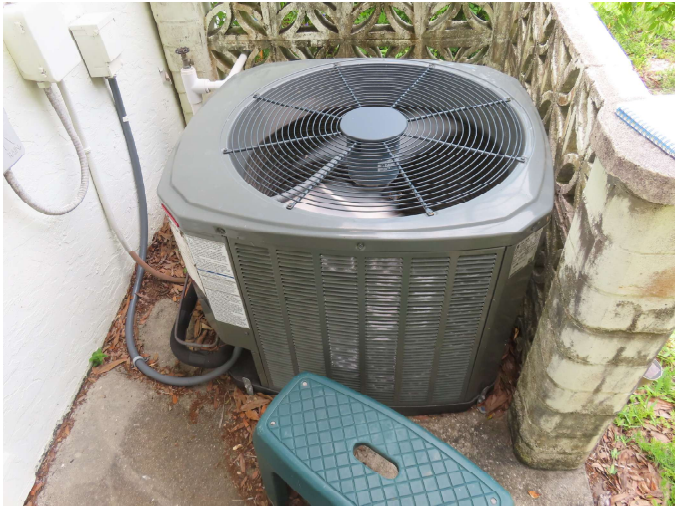
Air Conditioner

Are the heating, ventilation and air conditioning systems in good working order? ☒ Yes ☐ No (explain)

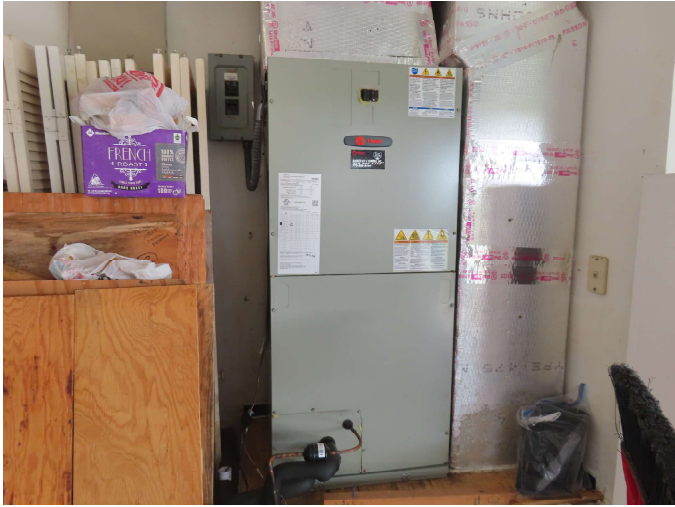
Heater/Air handler

☐ Yes ☒ No

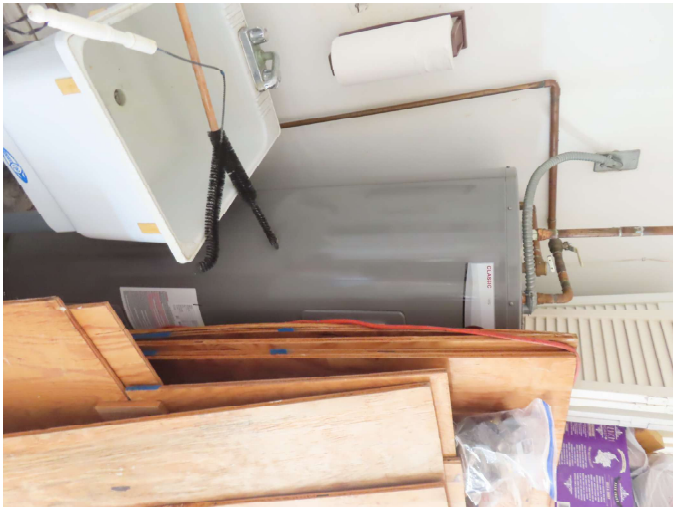
Water Heater

Is there any indication of an active leak? ☐ Yes ☒ No

Is there any indication of a prior leak? ☐ Yes ☒ No

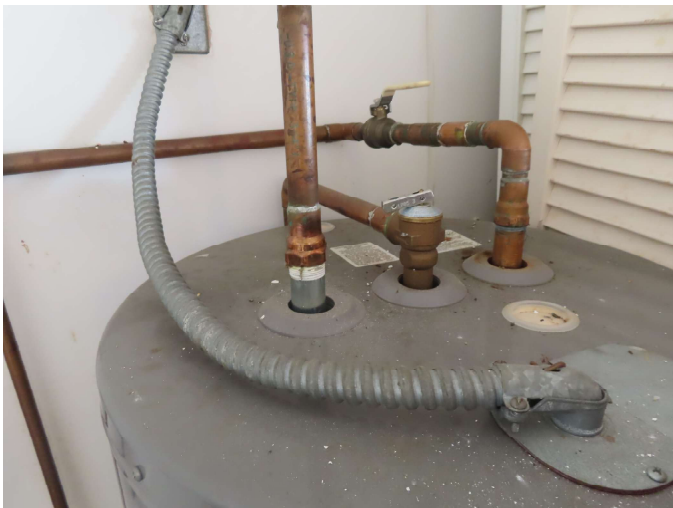
TPR Valve

Is there a temperature pressure relief valve on the water heater? ☒ Yes ☐ No

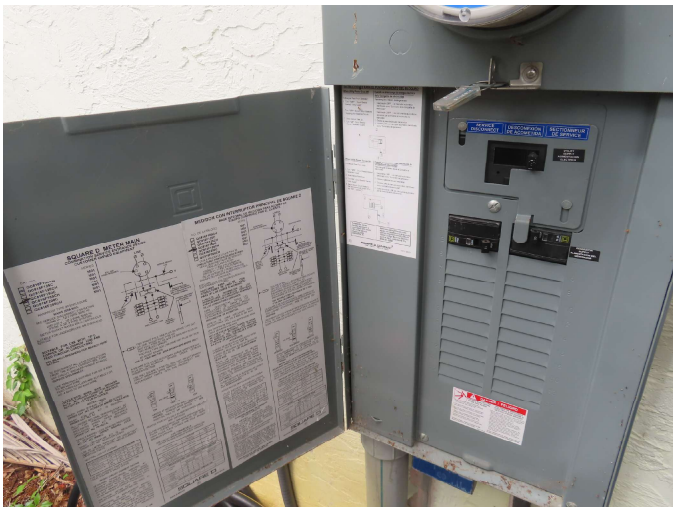
Electrical panel

**General condition of the electrical system:** ☒ Satisfactory ☐ Unsatisfactory (explain)
