DISCOVERY
RV SERVICES, LLC.

RV Inspection Report

Prepared for: Kelly Hanna

Inspection Date / RV Model:
11-04-2021 ; 2020 Keystone Alpine 3851RD

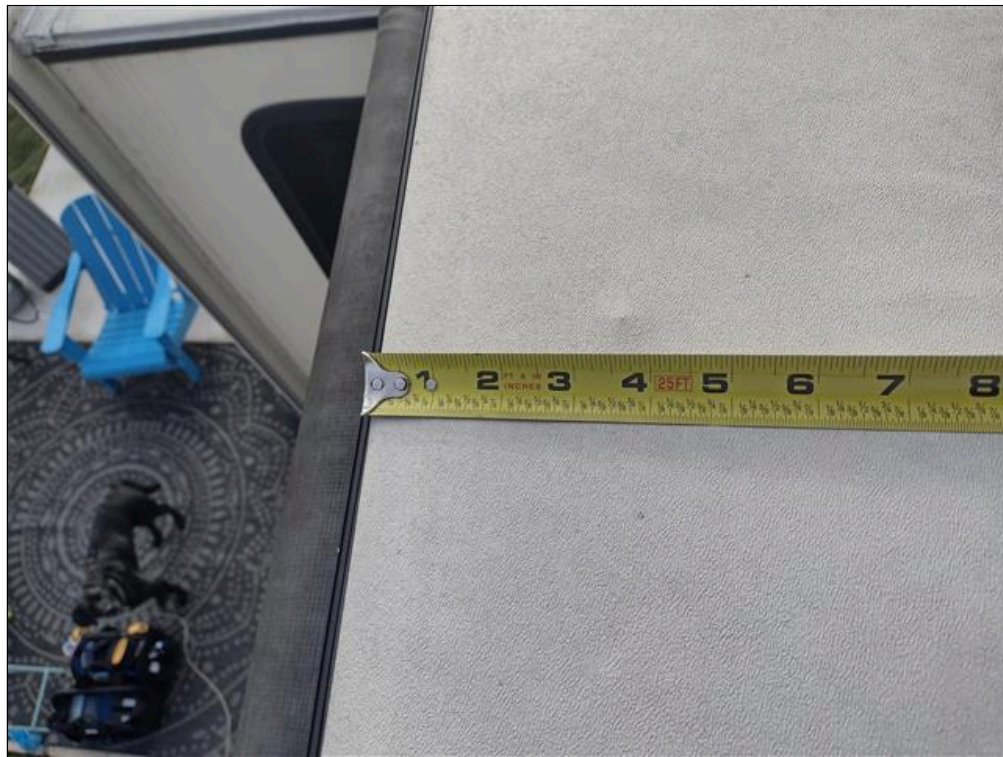
Inspector noticed two location's with unknown item's under rubber roof material which are causing elevated areas. It is recommended that these two areas be evaluated by a qualified RV technician.

First Location 4" from edge of Curbside directly above entry door.

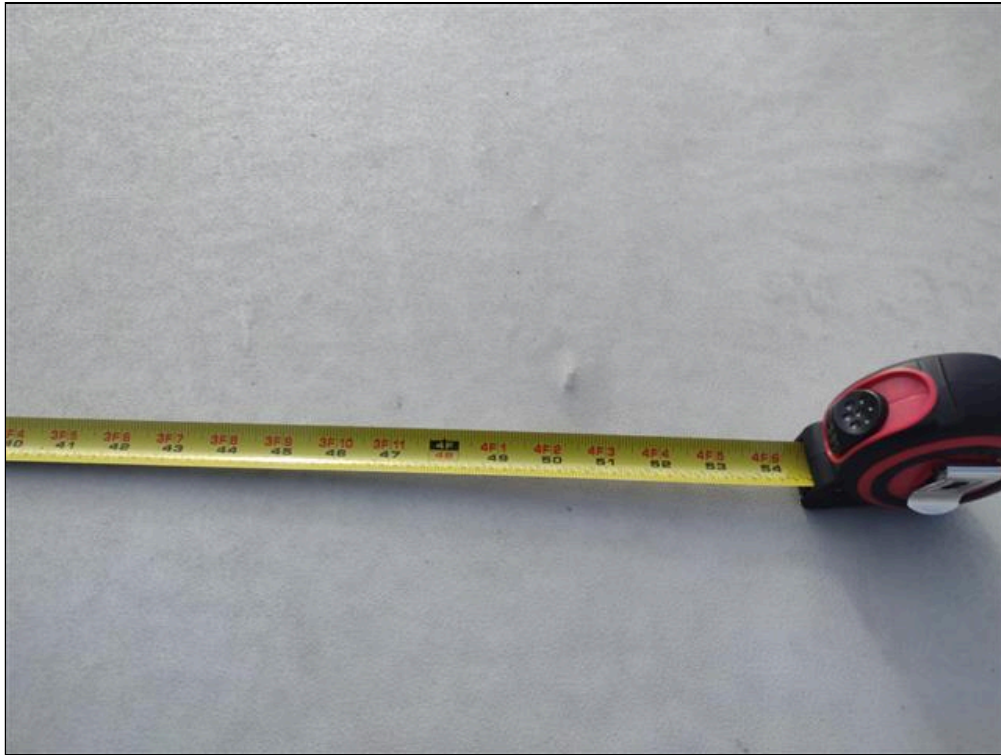
Second location 50" from Curbside edge in-line w/ centerslide

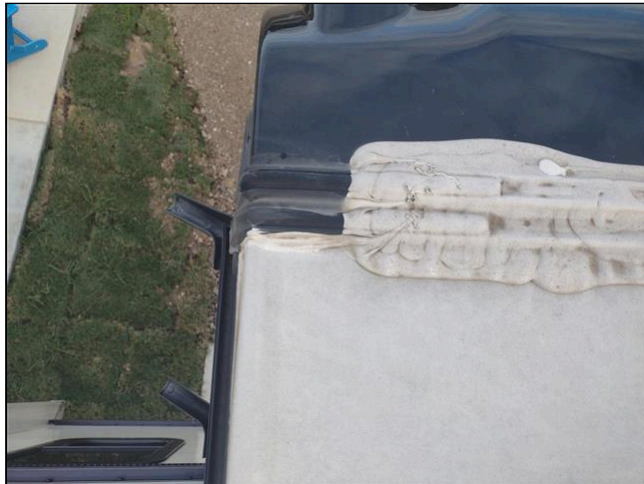
Streetside Front Cap Joint Corner

On the curbside front corner joint there is a crack in the sealant. It is recommended that this area be repaired by a qualified RV technician.

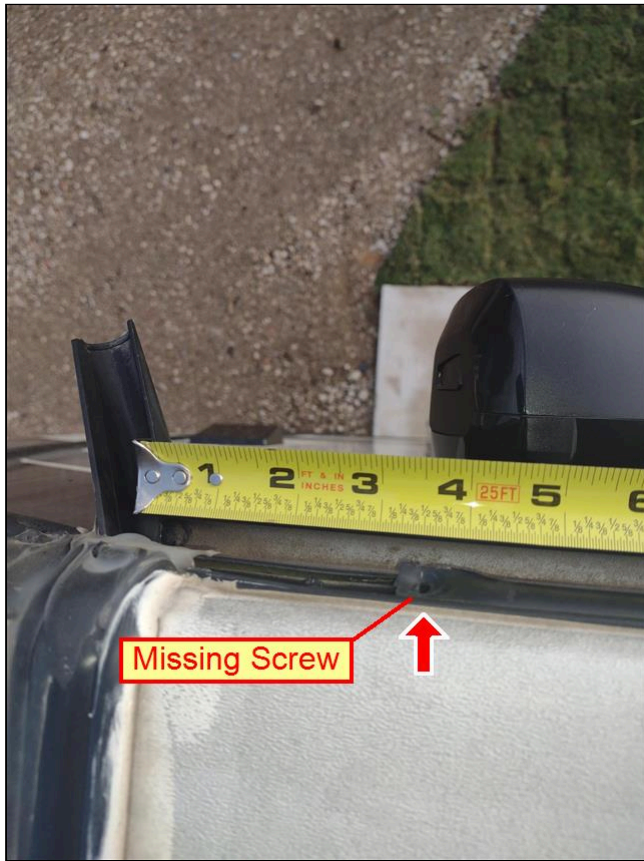
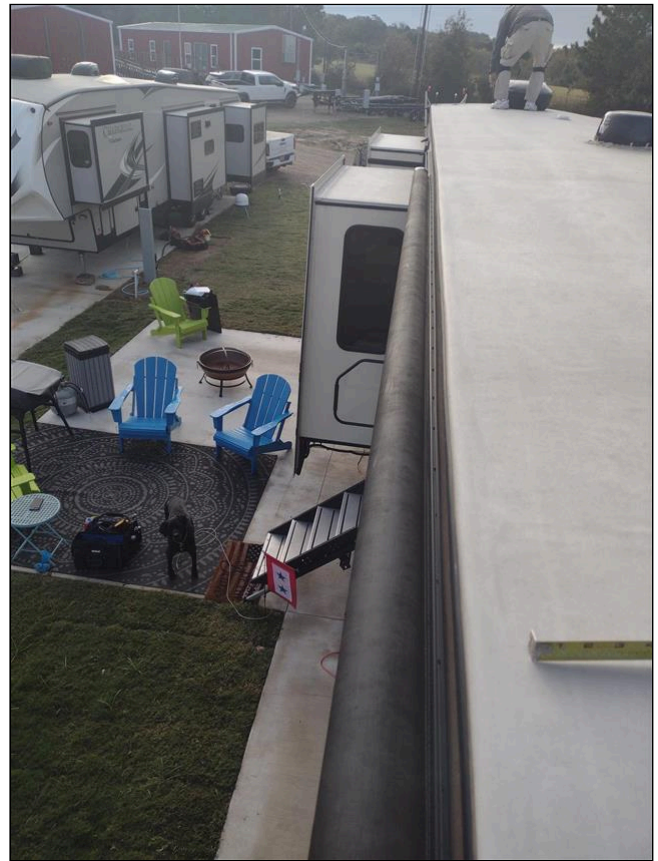
Curbside Trim Rail

On the curbside front corner of the Trim Rail there is a missing screw. It is recommended that this area be repaired by a qualified RV technician.

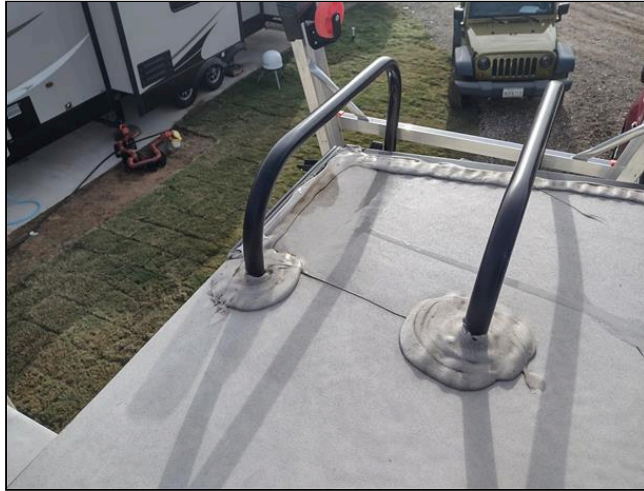
Curbside Rear Cap Seal - Standing Water

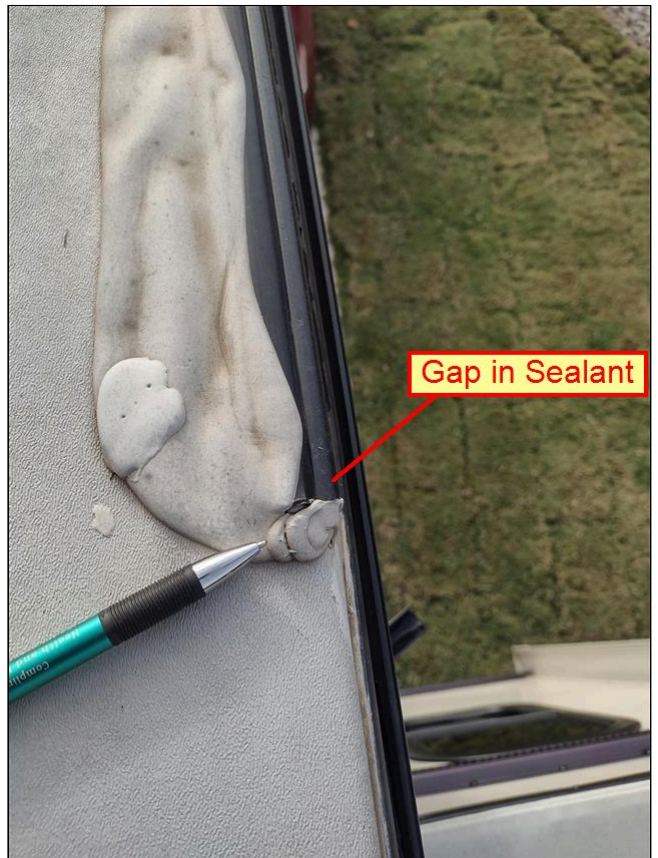
On the Streetside rear corner joint there are two cracks in the sealant. It is recommended that these areas be repaired by a qualified RV technician.

Streetside Rear Cap Seal - Gap in Sealant

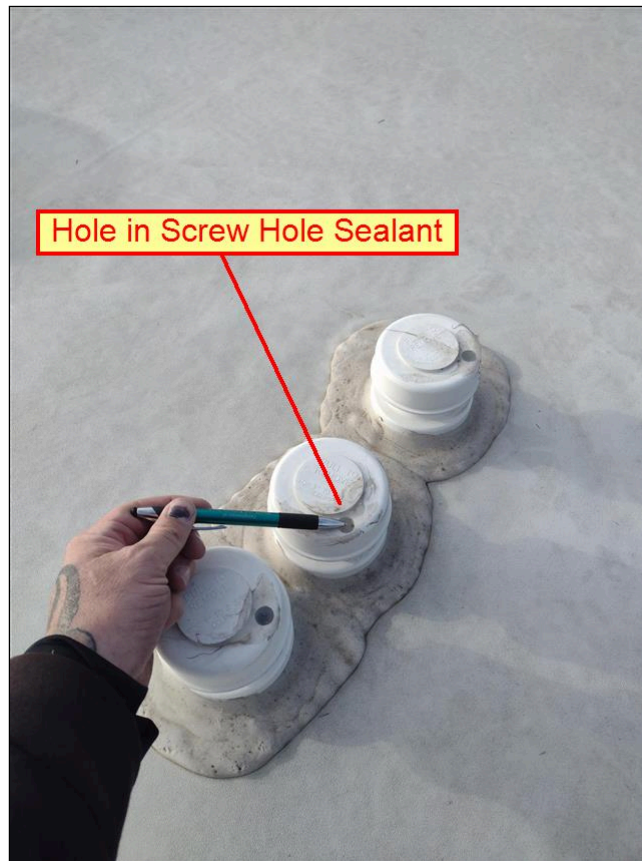
Inspector noticed that there is a hole in the cap mounting screw hole sealant. It is recommended that this area be repaired by a qualified RV technician.

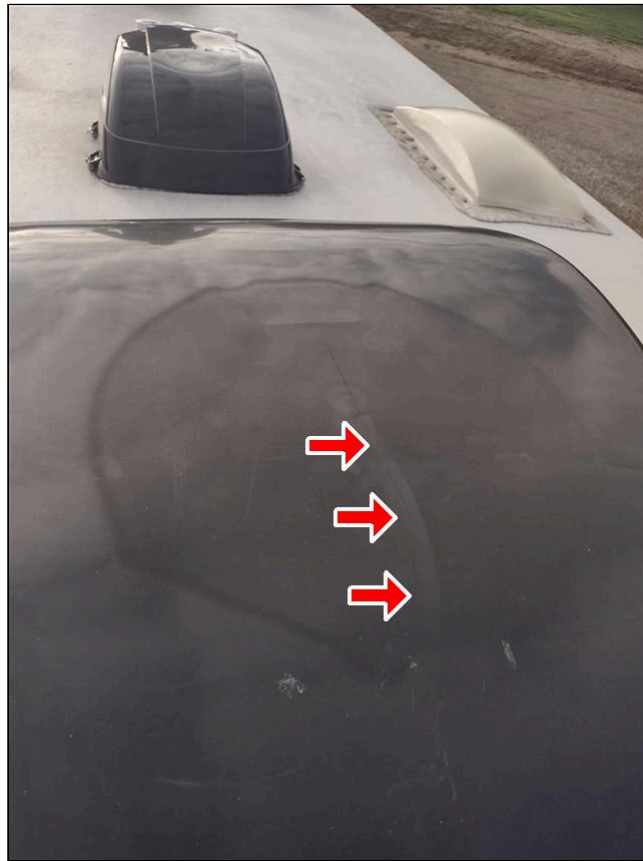
Inspector noticed that there is a scratch in the front Air Conditioner Shroud. It is recommended that this area be evaluated by a qualified RV technician.

Front Air Conditioner Shroud - Scratch

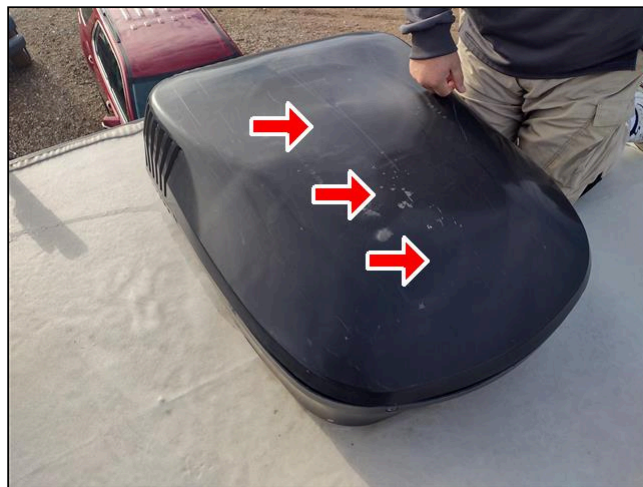
Inspector noticed that there light scratching on the Rear Air Conditioner Shroud. It is recommended that this area be evaluated by a qualified RV technician.

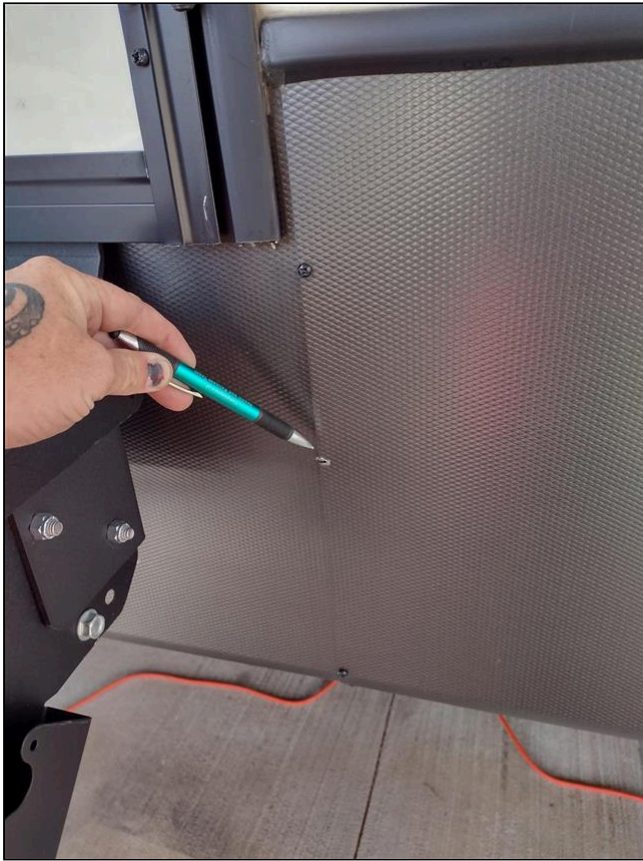
Inspector noticed a missing screw on the Curbside Metal Skirting by the Entry Door.

Missing Screw

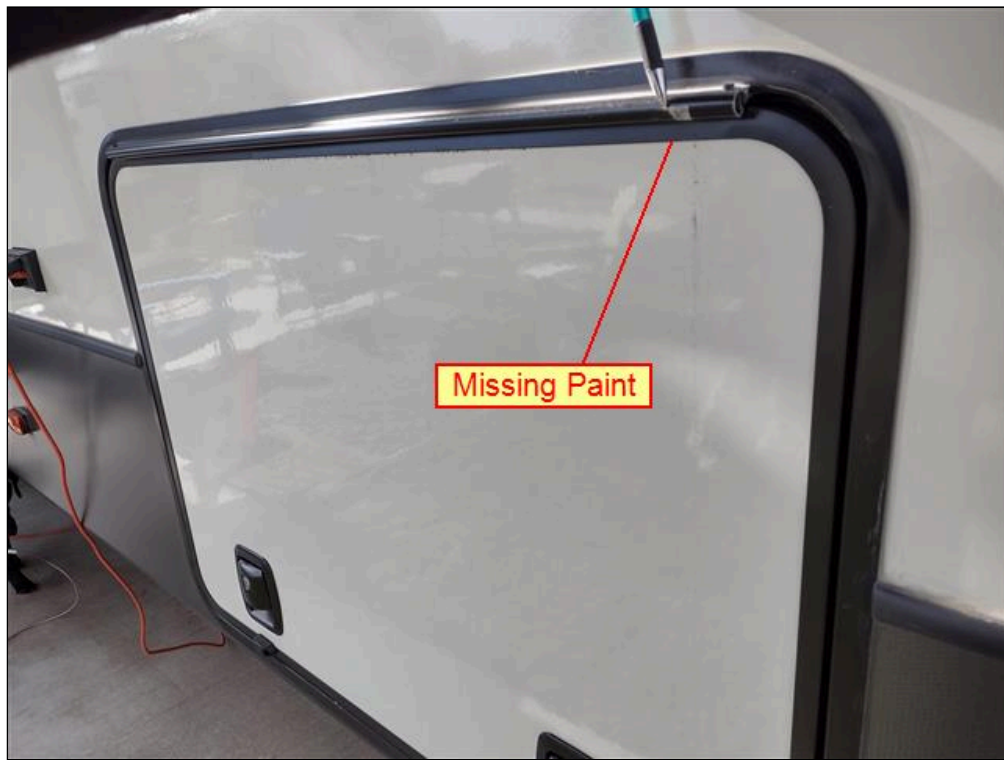
Inspector noticed missing paint on the Curbside Front Basement Access Door Hinge.

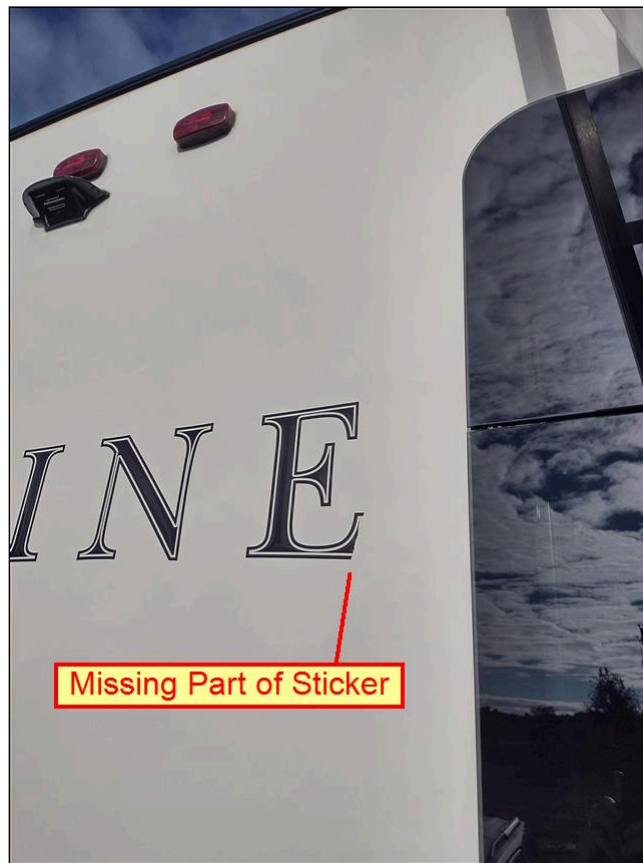
Inspector noticed the letter E in "Alpine" is missing the edge of the sticker

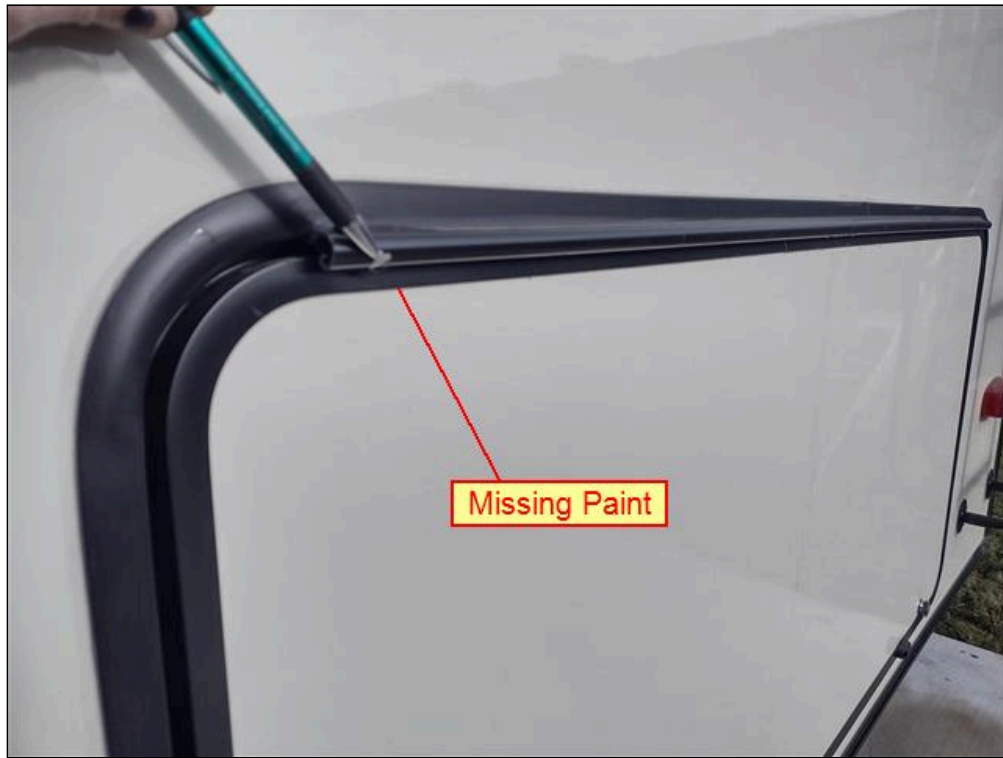
Inspector noticed missing paint on the Rear Cap Access Door Hinge.

Missing Paint on Rear Cap Access Door Hinge.

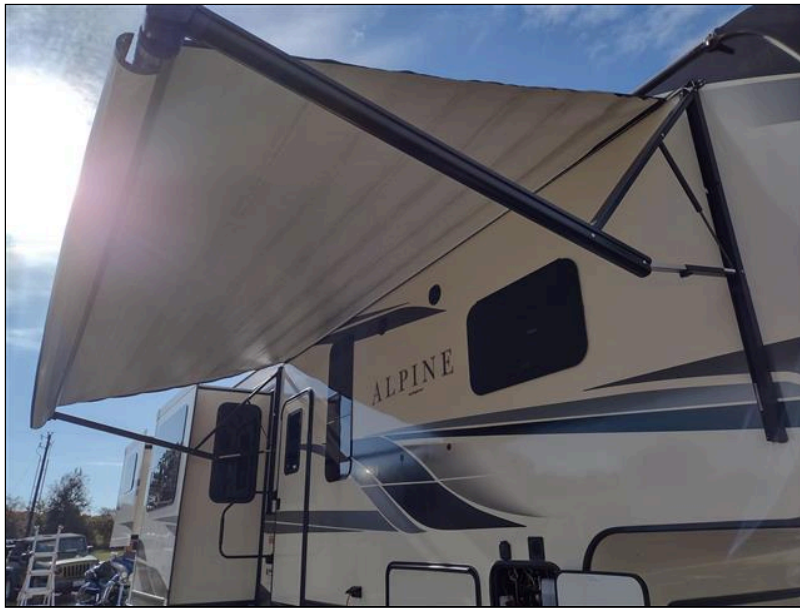
Inspector noticed Black Residue on underside of Awning. It is recommended that the awning be evaluated by a qualified RV technician.

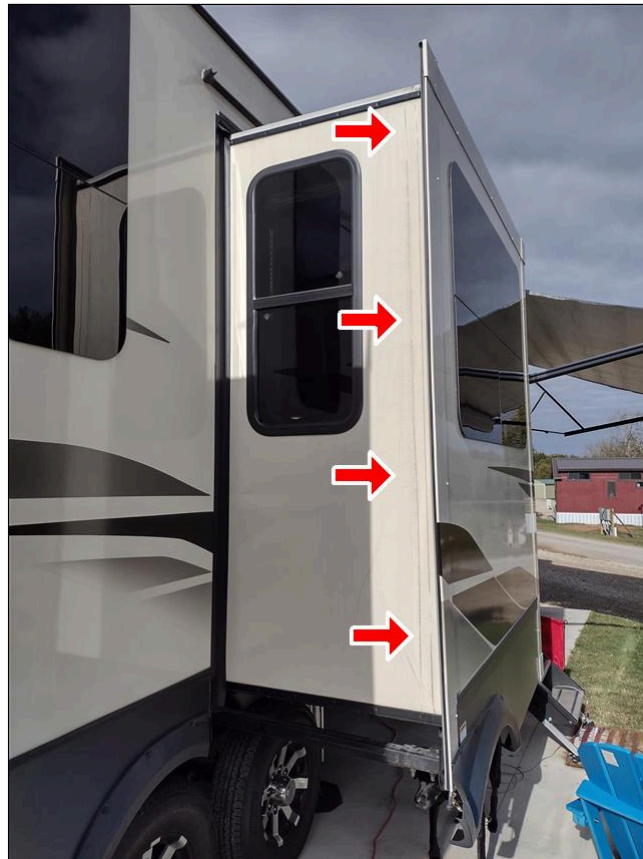
Inspector noticed a black residue on the Curbside Center Slideout Rear Wall. It is recommended that this area be evaluated by a qualified RV technician.

Curbside Center Slideout - Black Residue

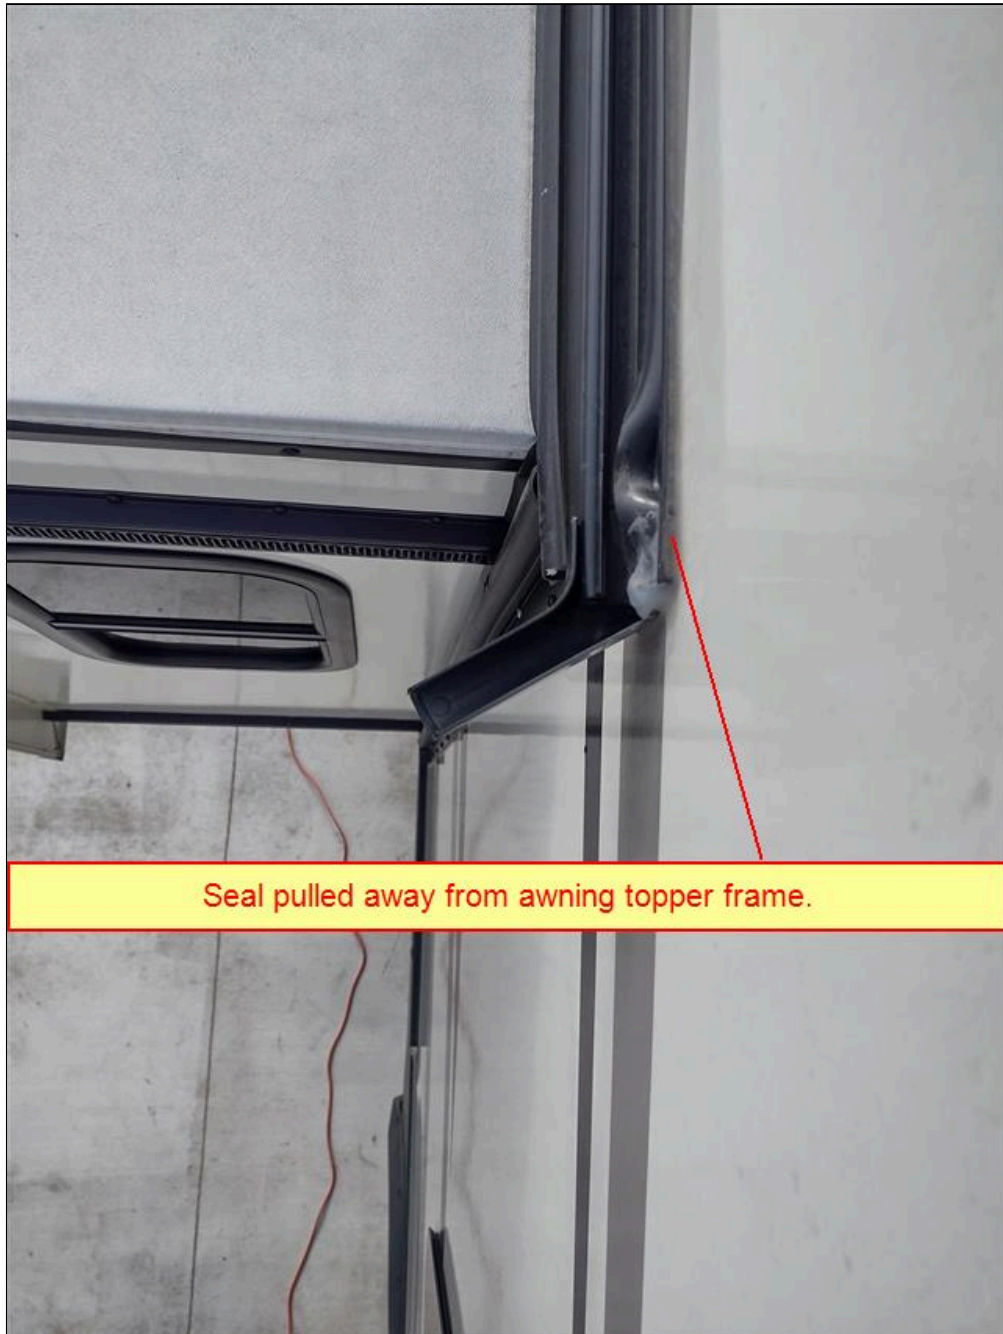
Inspector noticed rubber seal pulling away from Awning Topper Frame. It is recommended that this area be repaired by a qualified RV technician.

Curbside Center Slideout - Seal

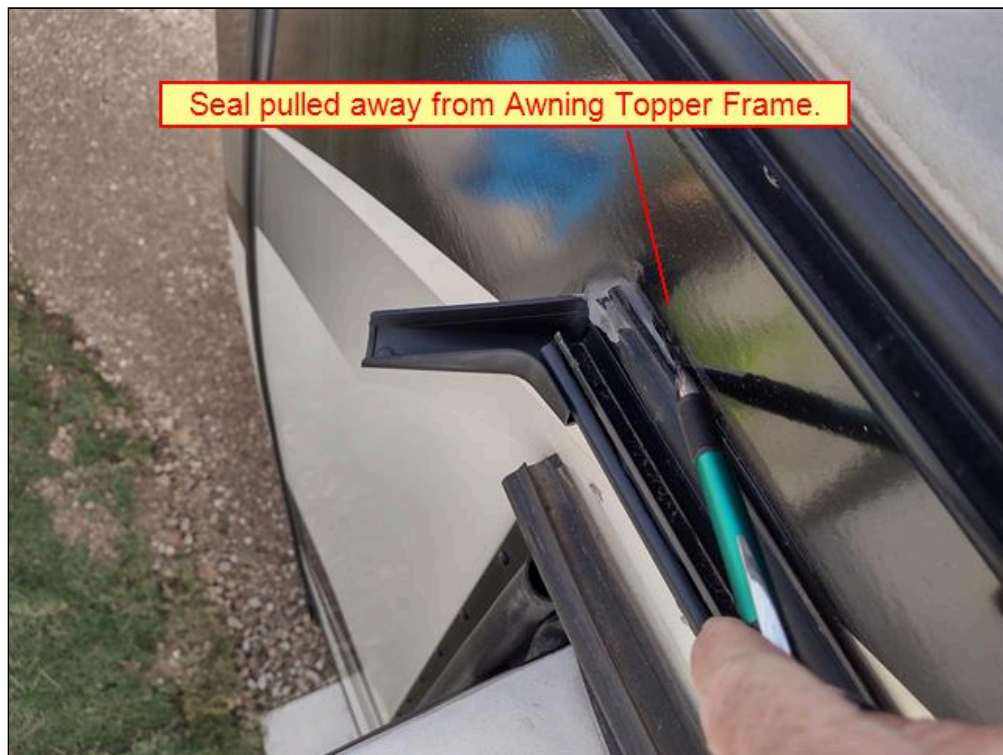
Inspector noticed rubber seal pulling away from Awning Topper Frame. It is recommended that this area be repaired by a qualified RV technician.

Streetside Front Slideout - Seal

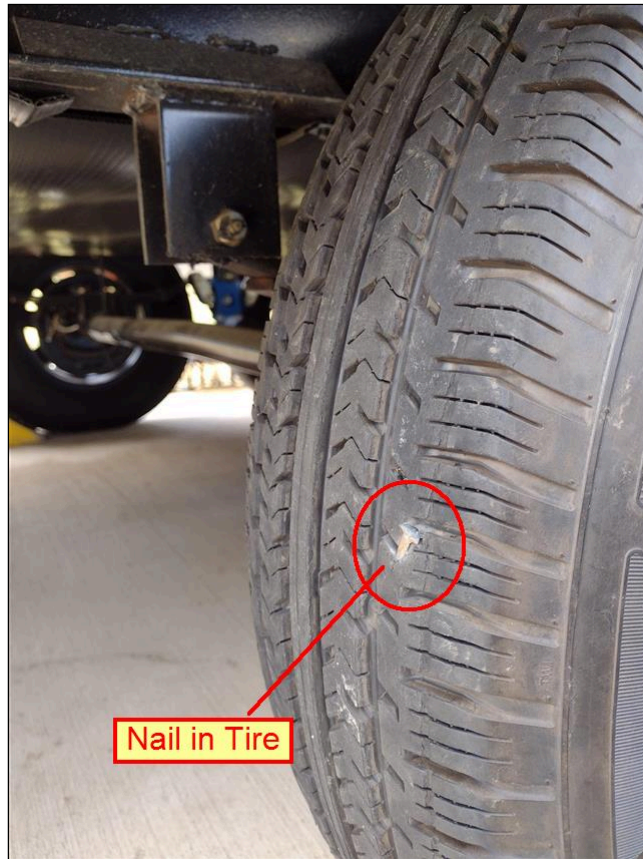
Inspector found that the Curbside Rear Tire has a plug repair and a a nail imbedded in the tire. It is recommended that a Certified RV Technician repair before

+ Inspector found that the Curbside Rear Tire has a plug repair and a a nail imbedded in the tire. It is recommended that a Certified RV Technician repair before

Curbside Rear Wheel - Nail in Tire

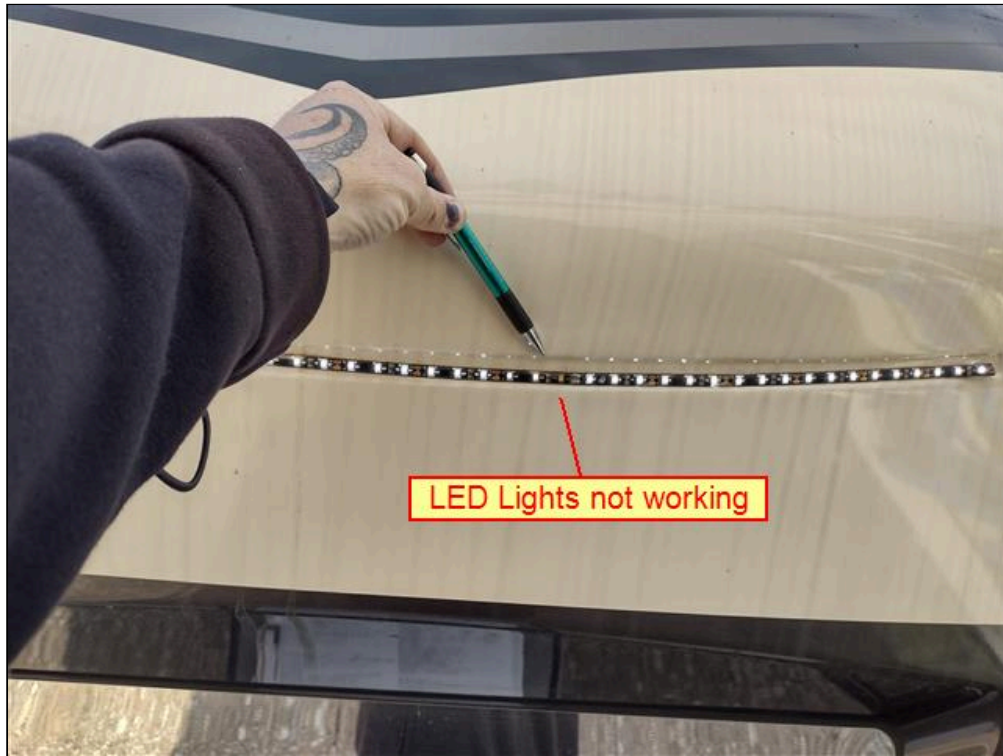
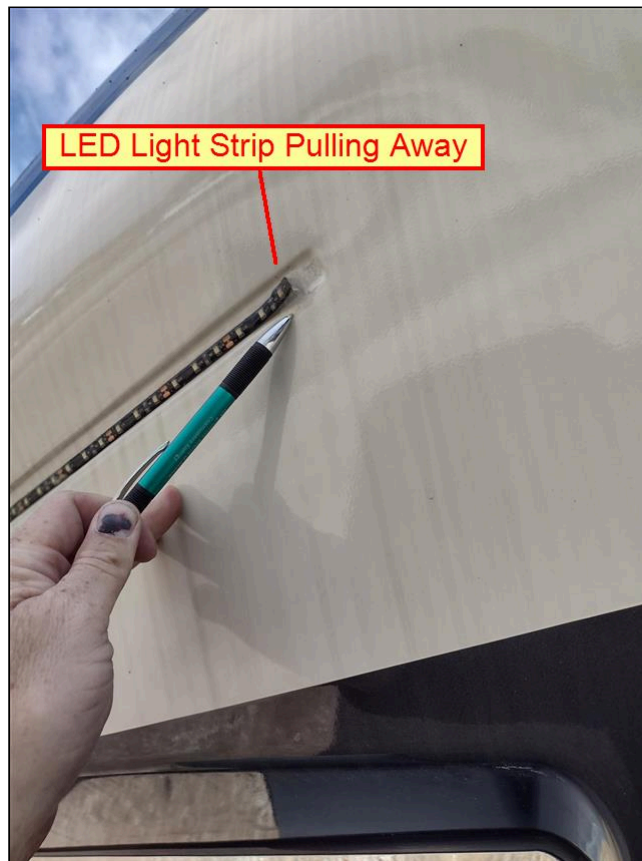
🔍 Inspector found that some of the LED Light Strip is not working as well as pulling away from the Front Cap Wall. It is recommended that these areas be repaired by a Qualified RV Technician.

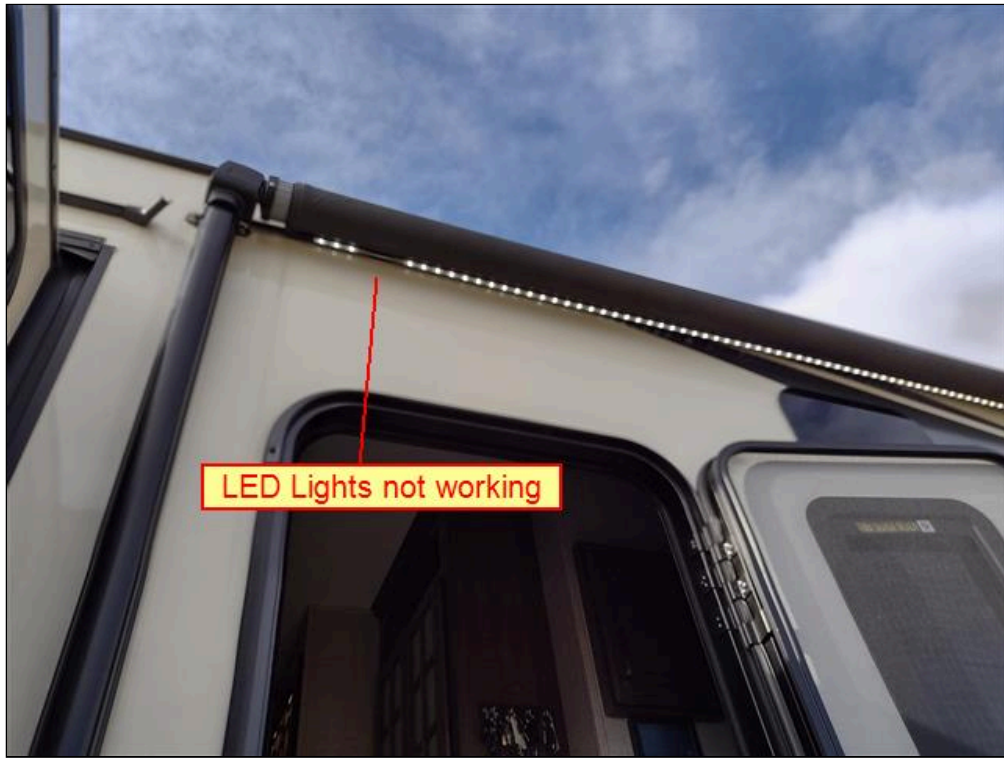
Inspector found that some of the LED Light Strip is not working under the Streetside Awning. It is recommended that these areas be repaired by a Qualified RV Technician.

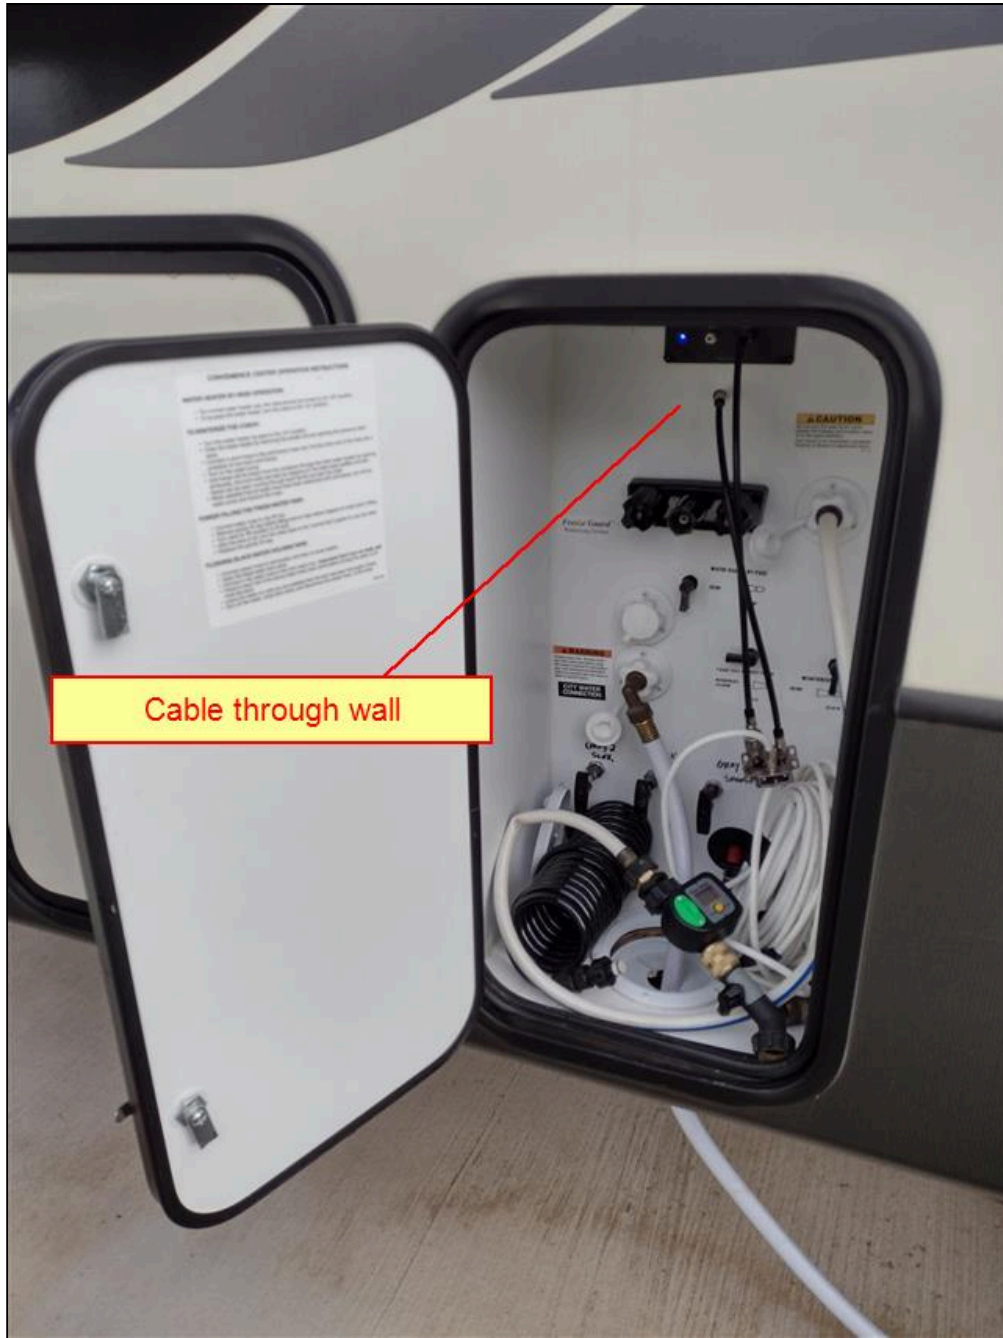
Wet Bay

Wet Bay. Inspector noticed that there is a cable installed through the wall and some black residue located on the wood in the pass-thru port. Inspector recommends these areas be evaluated by a Qualified RV Technician.

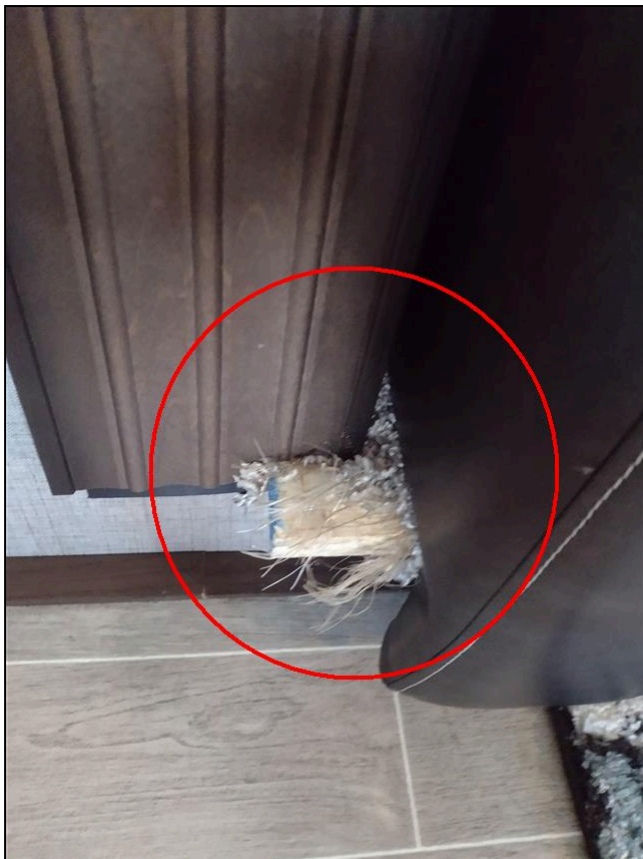
Inspector has found carpet damage at both corners of the sofa on the Streetside Slideout. Owner has stated that pet chewed it off. It is recommended to have a Qualified RV Technician evaluate damage and make repairs.

Carpet Damage Left Side of Sofa

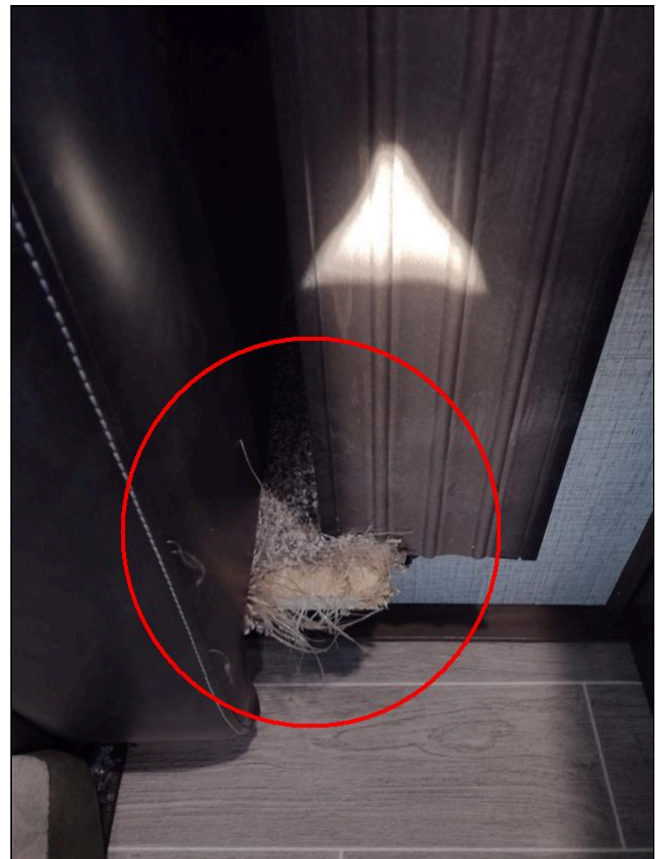
Carpet Damage Right Side of Sofa
