Condition and Valuation - Survey Report 7A1121

Vessel Name	<i>Redacted</i>	Length	29ft
Model	Bayfield 29	Beam	10.17ft
Year	1984	Draft	3.5ft
Serial #	29234	Displacement	7100 lbs
Builder	Bayfield Boat yard	Ballast	3000 lbs
Documentation #	Cert. of Registry 804494	Propulsion	Yanmar 2GMF
Date Surveyed	Nov 21 st 2021	Parties present	P. Smith
Owner	<i>Redacted</i>	<i>Address Redacted</i>

THIS IS TO CERTIFY that the undersigned Marine Surveyor inspected this vessel on land, at Whitby Yacht club, Whitby, Ontario, Canada. This survey was commissioned at the request of *Redacted* for the purpose of insurance underwriting. This report is unbiased and is subject to the condition and accessibility of the vessel at the time of the survey.

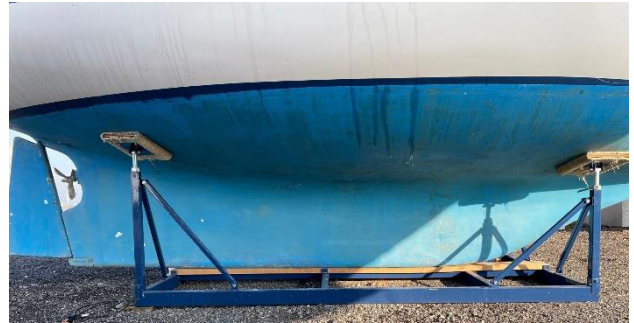
Finish and Condition: Coats of ablative bottom paint. In serviceable condition with small patches requiring touch up. (1)

Moisture Levels: Low and uniform throughout hull. (Solid hull)

Soundings: Taken at random, no structural concerns.

Keel/hull joint: The integral keel and hull joint appear sound with no evidence of grounding.

- (7) Install fire extinguishers as per transport Canada marine safety. (A4)
- (8) Install Co detector to protect accommodation areas. (A26)
- (4) Install Grounding bond between AC ground and DC ground, and install ELCI (E11)
- (3) Install Batteries in trays, strapped and terminated with less than 4 wires per post without wingnuts. Cover positive terminals to protect against inadvertent short. (E10)
- (6) Cap Diverter valve to stop inadvertent overboard discharge. (Canada Regs.)
- (5) Install Polarity detector for AC panel (E11)
- (2) Install fuel cut off at tank. (H33)
- (9) Remove transport plastic wrap and have rigging inspected by professional.
- (1) Touch up Antifouling paint

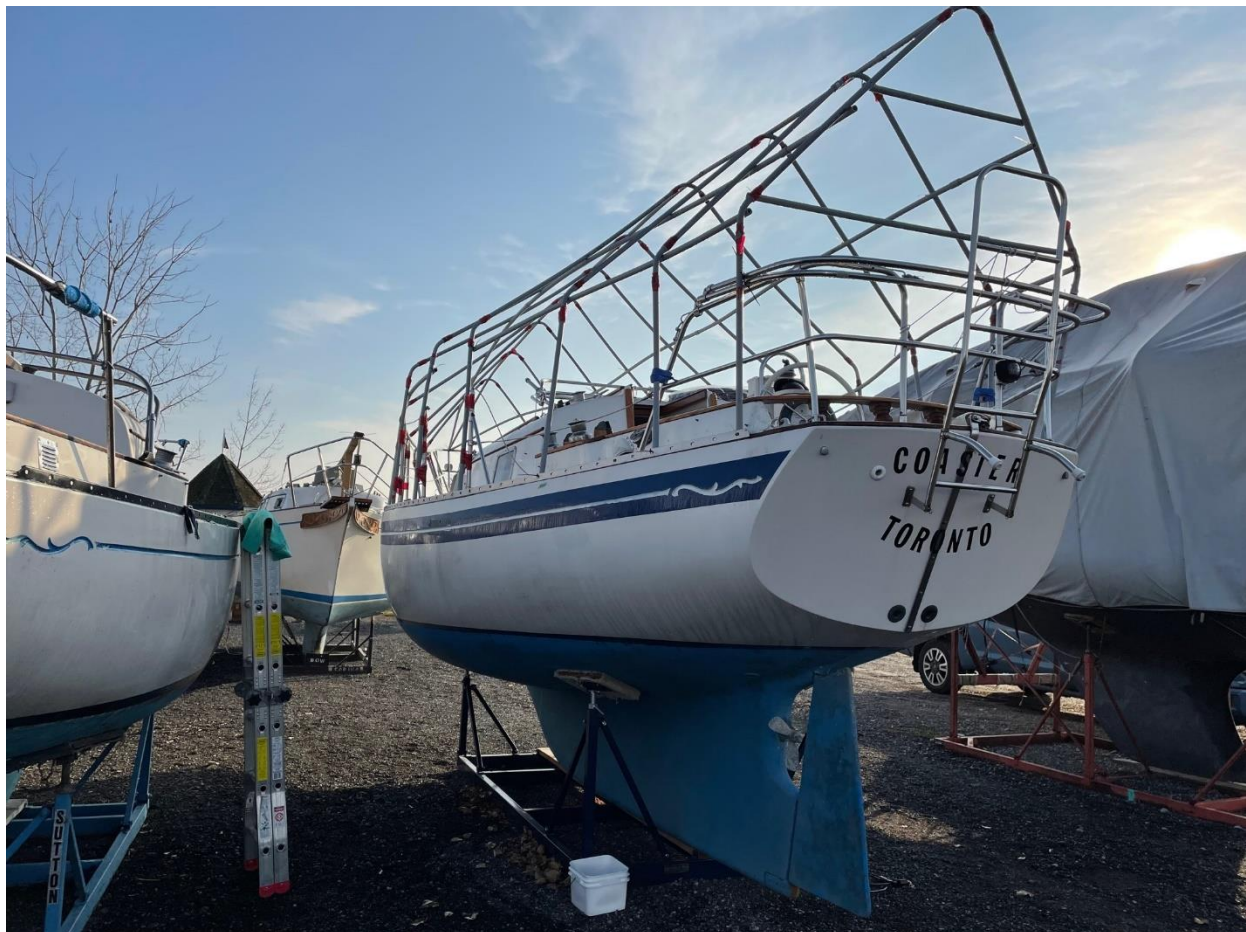
Finish and Condition: Gel coat surface is in serviceable condition showing average scuffs and abrasions for the boats age.

Moisture Levels: Low

Soundings: Taken at random with no apparent structural concerns observed.

Hull to Deck Joint: The flanged joint is secured with fasteners through an aluminium toe rail. No evidence of leaks or working of the joint were visible.

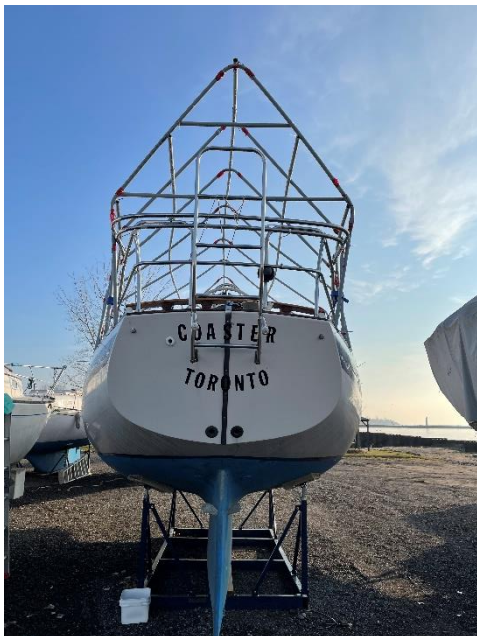
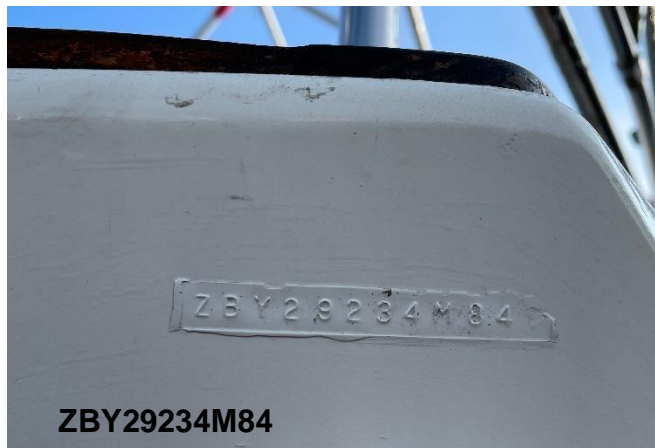
Transom

Finish and Condition: Good condition with minor scuffs and abrasions.

Moisture Levels: Low - Solid Glass structure

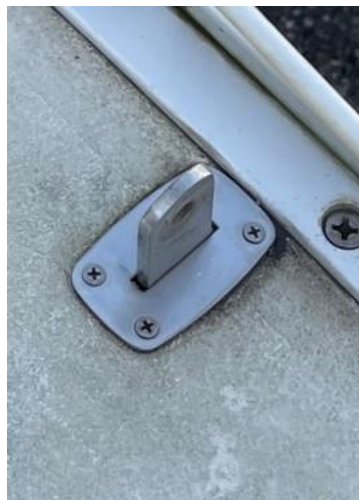
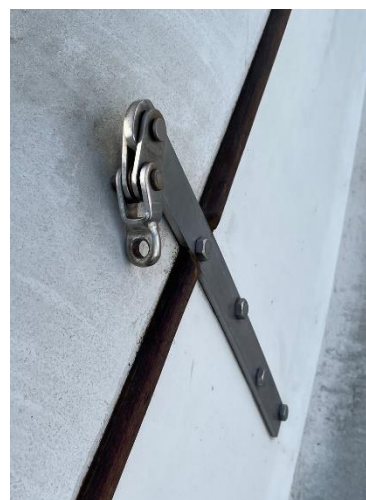
Chain Plate Load Points: Stainless steel brackets thru sealed at deck and affixed below to knees. The forestay and backstay appear to be solidly attached.

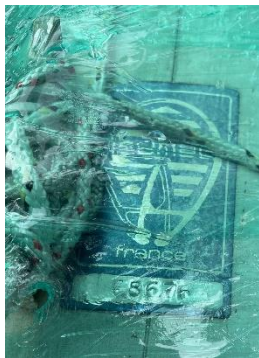
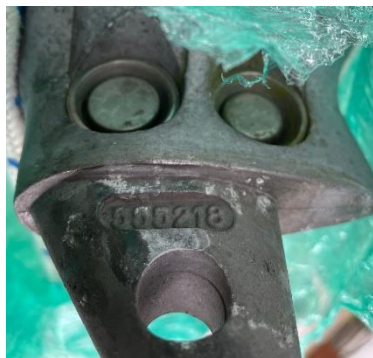
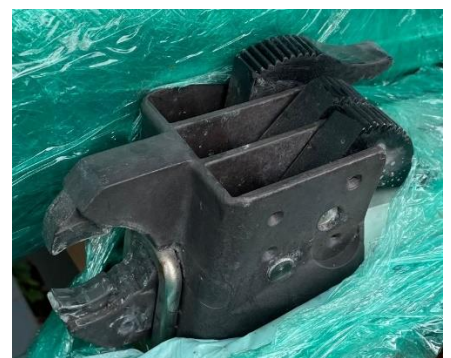
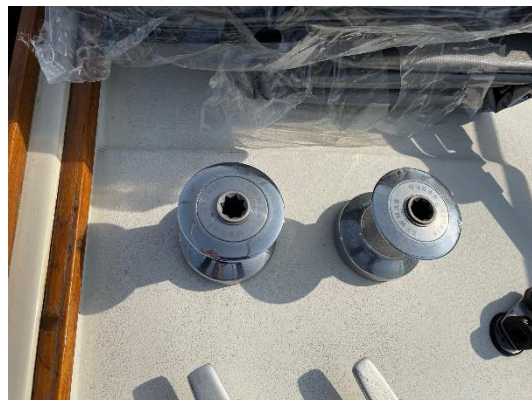
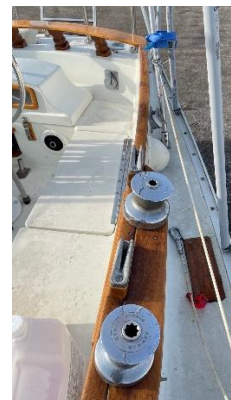
(9) – No obvious signs of damage to rigging, little to no corrosion seen on available parts. Mast found wrapped up in transport plastic, recommend removing this while in storage to help prevent corrosion build up.

Masts and Boom: Keel stepped with single spreaders. The aluminum extrusions of both the mast, boom and spreaders appear to be in serviceable condition.

Standing Rigging: Stainless steel wire stays and fittings. All appear to be in serviceable

Winches: Lewmar Primary are 25's, secondary and cabin top winches are 7's. All appear functional.

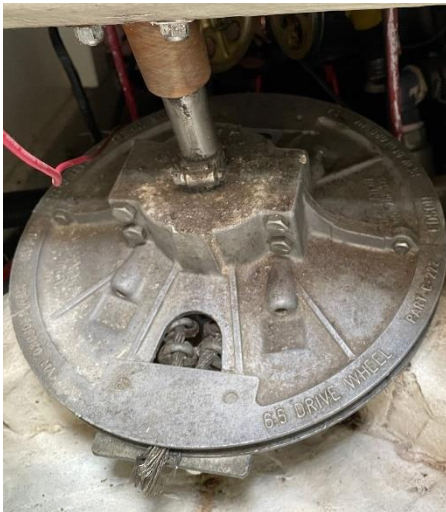
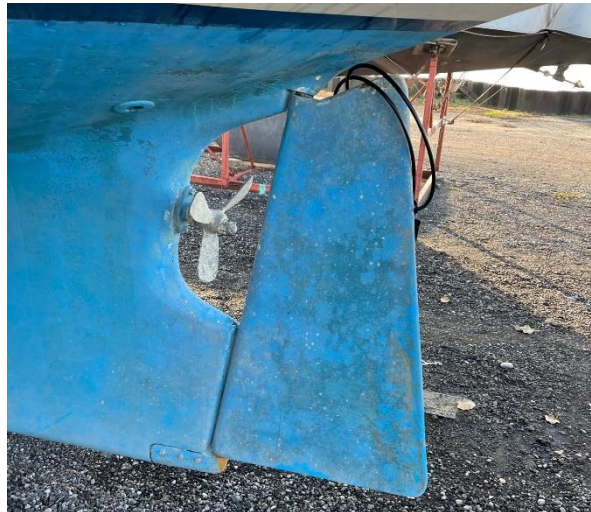
Type and Description: Pedestal Wheel cable connected and secure. Edson. Emergency steering available, emergency tiller not found during inspection.

Rudder: Fibreglass rudder is in serviceable condition showing low moisture levels with solid soundings.

Rudder Shaft and Bearings: No excessive play noted.

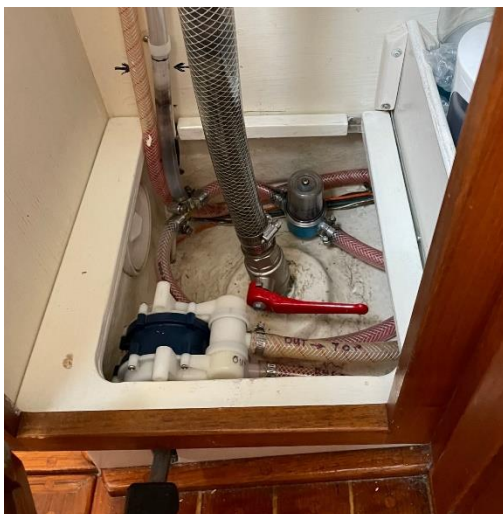
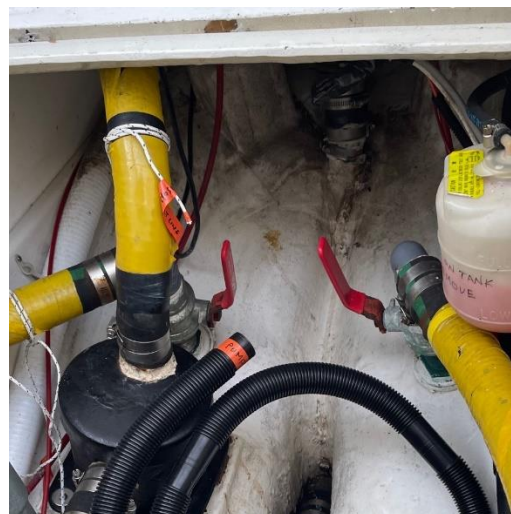
There are seven penetrations through the hull, a mixture of bronze and stainless thru hull fittings appear in good general condition. Plastic and Vinyl hoses are fitted and secured with stainless steel gear clamps and ball lever valves.

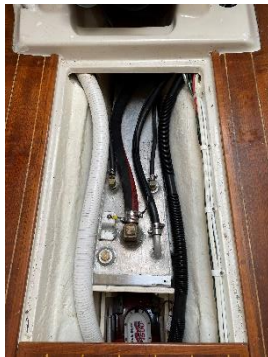
Diesel Tank: 19 Gallon Aluminum, vented overboard, no fuel cut off. (2)
Hose appears solid, double clamped.

ABYC H23 recommends Shutoff valves, installed so as to close against the fuel flow, must be fitted in the fuel supply lines, one at the tank connection and one at the engine end of the fuel line to stop fuel flow when servicing accessories.

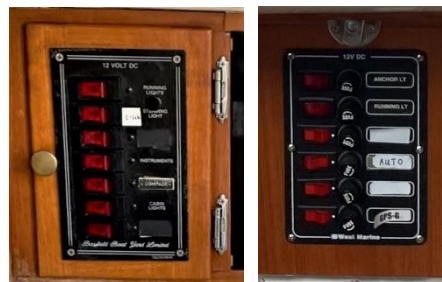
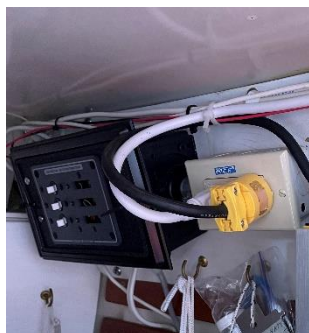
Two DC Panels with individual branch circuits & current protection by both fuse and GFCIs.

Conductors: Where accessible, were found to be stranded copper in good visual condition.

Battery Charging: Engine mounted Alternator and a hard-wired Guest 20Amp battery charger.

General Condition of Wiring and Fixtures: Would benefit from installation of an ELCI. (see 4)

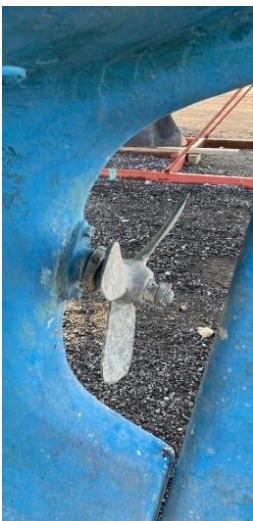
Propeller: 3 blade bronze, 3 x 9 L.H. in serviceable condition, secured to the prop shaft by a nut and cotter pin.
