## **Cracking the Code for Wind Distress at Tile Roofs, A Regional Assessment**

Todd E. Jorgenson, M.S., P.E., M. ASCE<sup>1</sup>

Bart B. Barrett, B.S., P.E., M. ASCE<sup>2</sup>

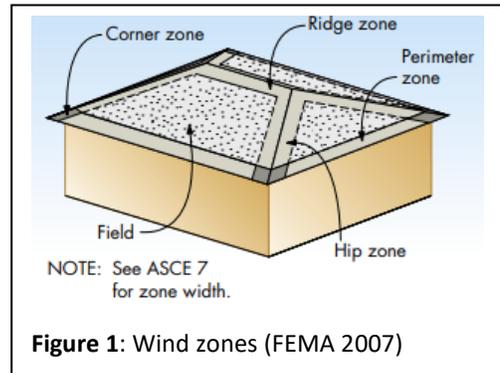
Hip and ridge tiles, often referred to as trim tiles, are located in zones of the roof where higher wind pressures are anticipated (**Figure 1**). Comparatively, field tiles are likely to experience lower wind pressures (ASCE 2016).

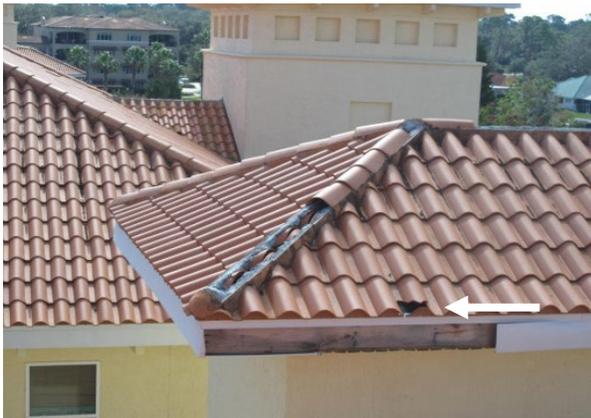
**Figure 2:** Displaced trim tiles, tile distress downslope

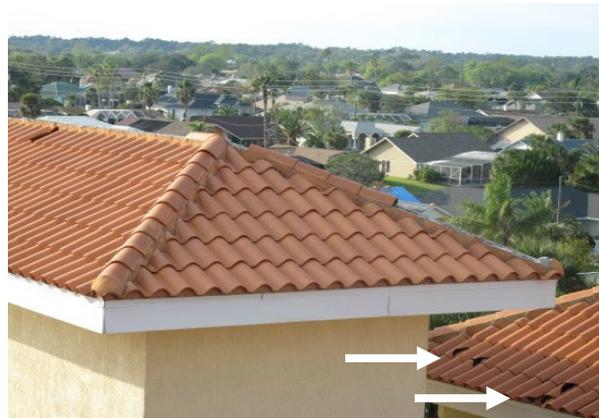
**Figure 3:** Displaced trim tiles, tile distress at lower roof

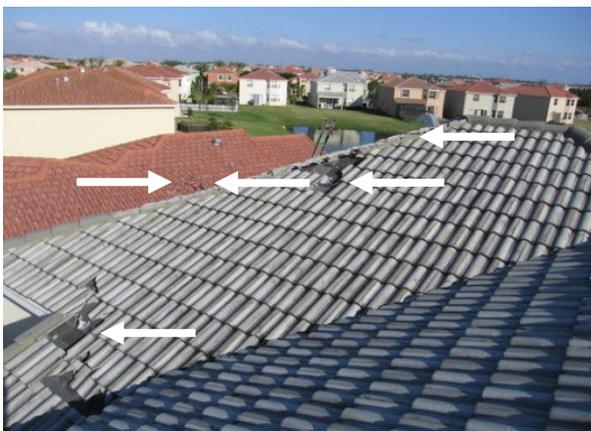
**Figure 4:** Displaced hip tiles at second-level roof, tile distress downslope and at adjacent roof

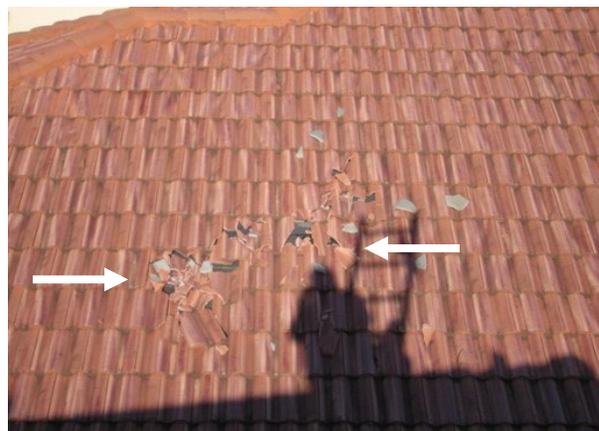
**Figure 5:** Tile distress at adjacent/neighborhood first-level roof from displaced tiles in Figure 4

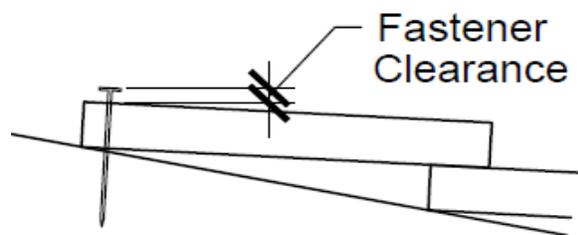
As illustrated in **Figure 6** and **Figure 7**, mechanically-fastened field tiles that engage with fasteners which transfer the load to the roof deck resist upward force once they contact the securing fastener heads (**Figure 7**). This resistance indicates that the fasteners have not withdrawn or disengaged from the roof deck due to previous uplift forces.

**Figure 6:** Field tile at rest

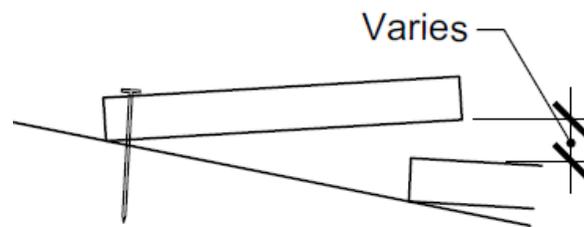
**Figure 7:** Field tile lifted to fastener resistance

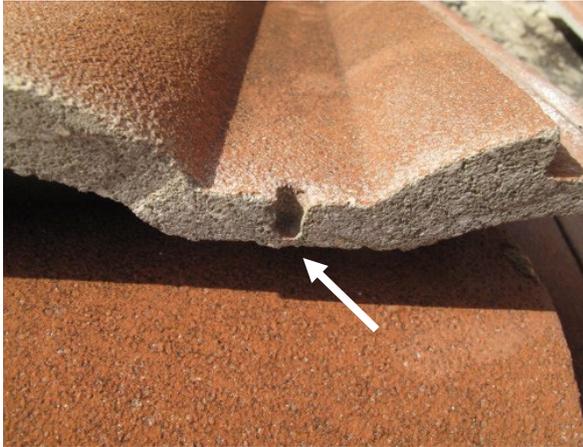
Tiles that are trimmed to accommodate valleys, hips, rise-walls, or other features of the roof may be trimmed at or downslope of the punchouts. In these conditions, the trimmed tile cannot accommodate a fastener (**Figure 8**).

**Figure 8:** No punctured punchout at a trimmed tile

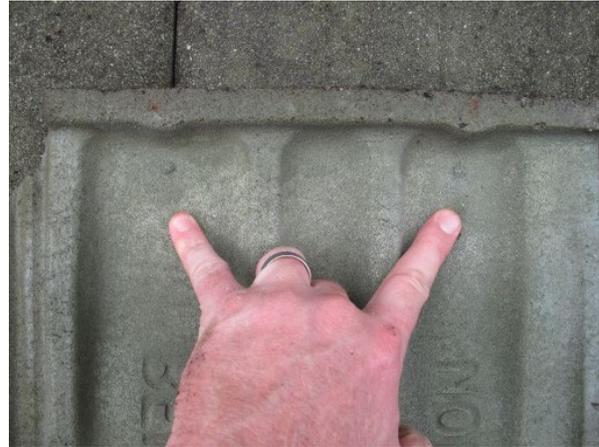
The fastener punchouts of tiles are broken by the fasteners when they are installed. Therefore, if these punchouts remain intact, it is a reliable indication that the tile was never fastened to the roof with a mechanical fastener (**Figure 9**). Remedial tiles may be differentiated by manufacturing stamps or variations in color, finish, or profile. At roofs with battens, a remedial tile often has the upslope lug removed so that the remedial tile can slide over the batten.

**Figure 9:** Field tile without punctured punchouts

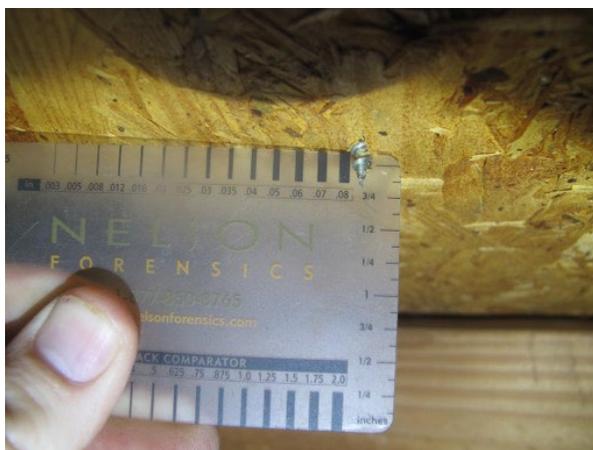
Observations of distress patterns and evaluations of tile fasteners provide insight into the conditions experienced by the roof. The fasteners may be evaluated at roof level or from the underside, inside the attic. Screw fasteners that have experienced uplift failures are expected to be accompanied with withdrawal failure of the roof sheathing between the threads. Observation of the fasteners in the attic space allows the evaluator to determine if the screw fasteners have experienced such a failure. It is the experience of these authors that the as-installed penetration of tile roof fasteners varies. As a result, the measurement of the screw penetration alone is not a good determination of uplift failure. The fasteners depicted in **Figure 10** and **Figure 11** occurred at a representative tile roof installation condition. The images are exemplary of fastener penetrations that vary from one tile to another; however, there is no distress consistent with uplift failure at the roof deck or at the fasteners.

**Figure 10:** Approximately 1/4" tile fastener penetration

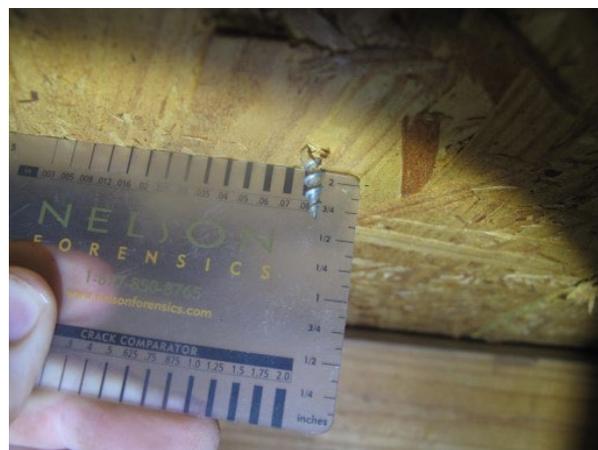
**Figure 11:** Approximately 1/2" tile fastener penetration

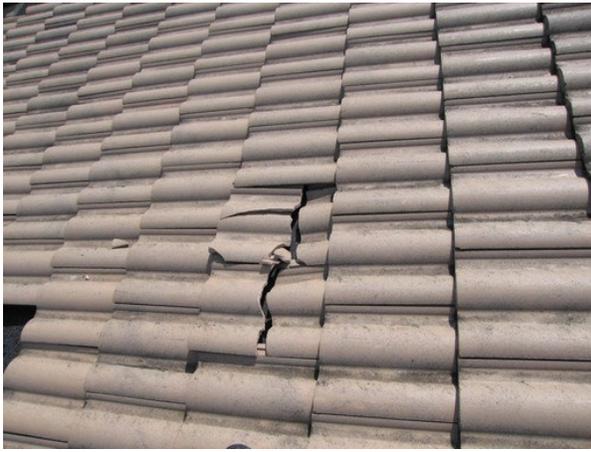
**Figure 12:** Starburst and transverse fractures at tiles fractured by roof contractor foot traffic during a site visit

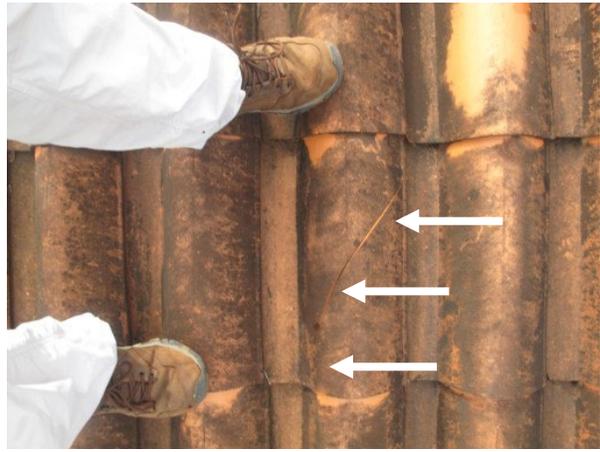
**Figure 13:** Curvilinear fracture in a clay Spanish S-style field tile observed to occur during a site visit

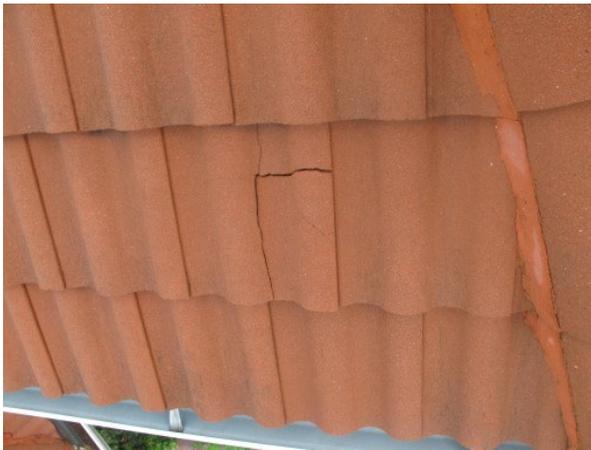
**Figure 14:** Intersecting longitudinal and transverse fractures at a concrete double S-shape field tile observed to occur during a site visit

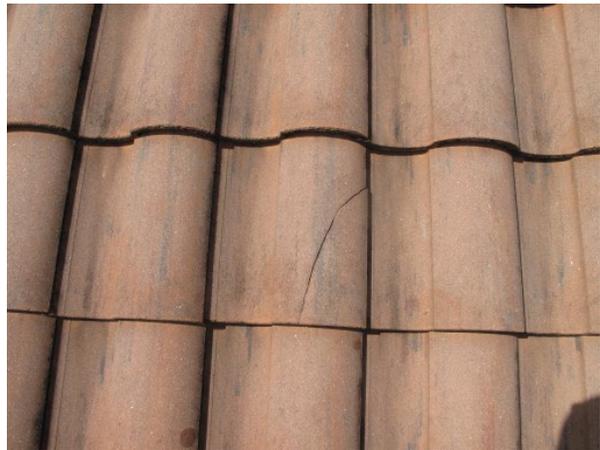
**Figure 15:** Curvilinear fracture in a concrete single S-shaped field tile observed to occur during a site visit

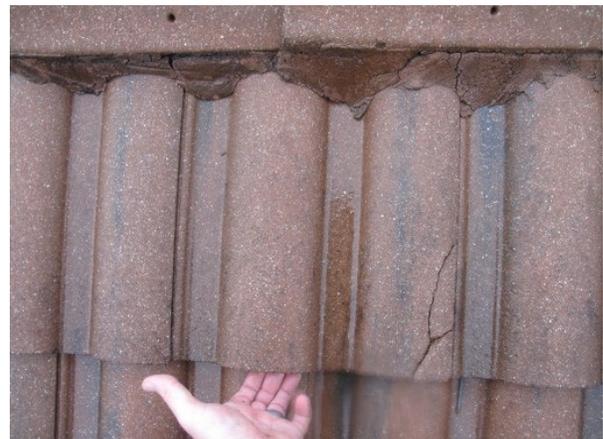
**Figure 16:** Fracture at the lower right-hand corner with vertical extension at a field tile embedded in ridge mortar lacking displacement under finger pressure

Additionally, improperly mixed or cured concrete can result in weakened sections and a higher likelihood of concrete roof tile breakage (TRI 1999). Locations of lower corner fractures, or other fractured tiles for that matter, can include field tiles embedded in hip and ridge mortar beds (**Figure 16**). These mortar beds restrain the field tiles from wind-related or other movement. The authors have also observed lower corner fractures at tiles embedded in hip or ridge mortar and at tiles installed with adhesive foam, which are adhered to the deck and are not free to move. Such instances make it clear that corner fractures can occur irrespective to the effects of wind pressures.

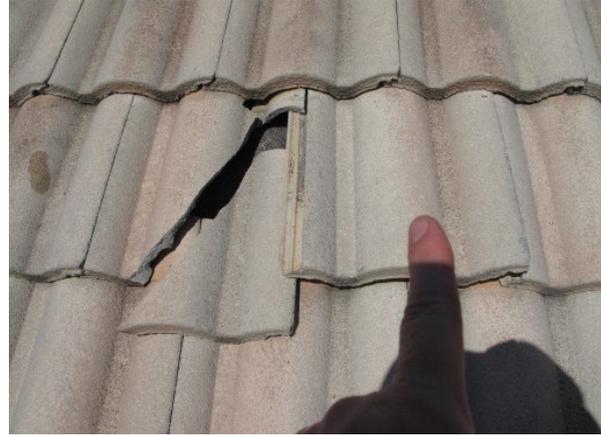
Although less common, mechanical damage, is another form of tile roofing distress. This type of distress is commonly associated with maintenance or inspection activities. A limited number of the evaluated roofs exhibited uncommon forms of distress, such as sporadic fractured tiles adjacent to tiles with withdrawn fasteners. The authors performed destructive testing on more than twenty (20) field tiles at four different condominium properties to evaluate for mechanical damage. Field tiles upwardly loaded with a load-cell hook near the middle of the leading edges generally failed with withdrawn fasteners at the loaded tiles and diagonal fracture patterns at the side overlapping tiles (**Figure 17**). This pattern of distress is not consistent with wind loading as wind pressures would act along a grouping of tiles.

**Figure 17:** Upward pressure applied to the indicated tile resulted in a withdrawn screw fastener of the loaded tile and a diagonal fracture at the adjacent overlapping tile

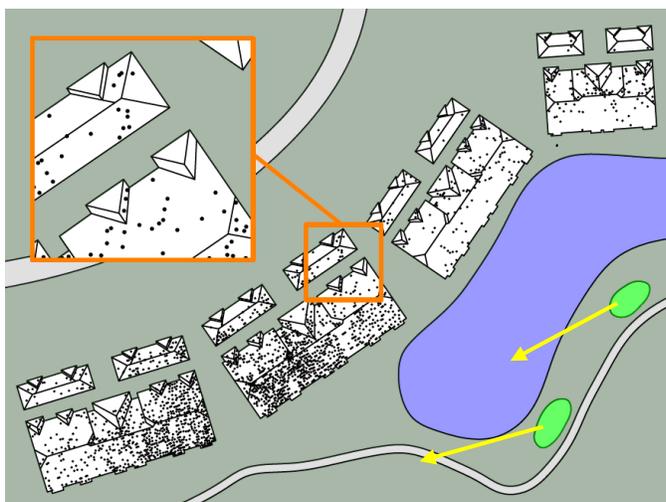
Golf course communities are common in Florida, and these communities have the added potential for roofing distress due to golf ball impacts. Multi-building complexes have been observed to exhibit a higher concentration of fractured tiles along the path between the tee box and the green (**Figure 18**). The distress pattern for golf balls commonly includes a circular fracture with fractures radiating from the center (**Figure 19**); however, this is not always the case.

**Figure 18:** Concentrations of fractured tiles consistent with golf ball impact (arrows point from tee boxes toward green)

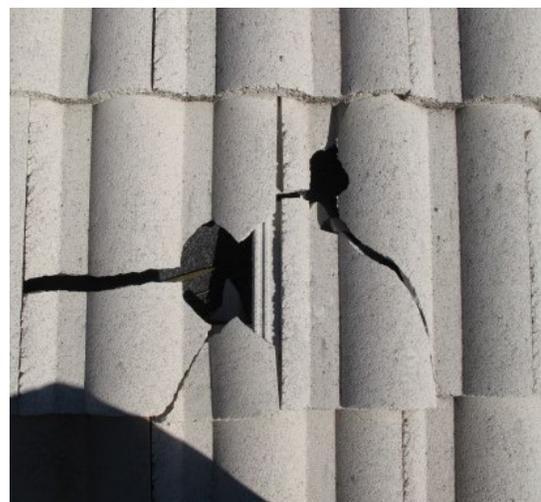
**Figure 19:** Fractured field tiles consistent with golf ball impact adjacent to a golf course fairway

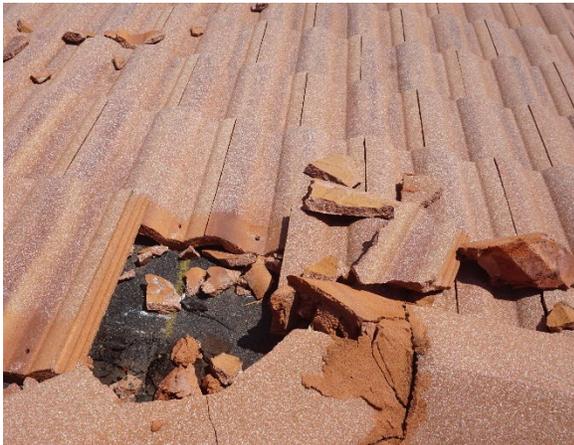
Uncommon events may also result in tile fractures such as tree limb impacts or lightning strikes. Discrete areas of displaced and fractured tiles with charred roof sheathing and melted underlayment are indicators of lightning strikes (**Figure 20** and **Figure 21**).

**Figure 20:** Fractured/displaced tiles with melted underlayment

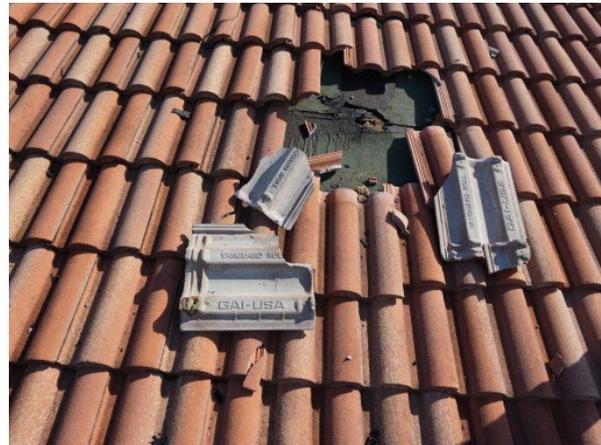
**Figure 21:** Fractured/displaced tiles with melted underlayment and charred roof sheathing
