Timing Cover Oil Leak on 2020-2024 Alfa Romeo 2.0L Engines

The AERA Technical Committee offers the following information regarding a timing cover leak on 2020-2024 Alfa Romeo 2.0L engines. Customers have reported a leak coming from the timing cover area of these engines to AERA member shops.

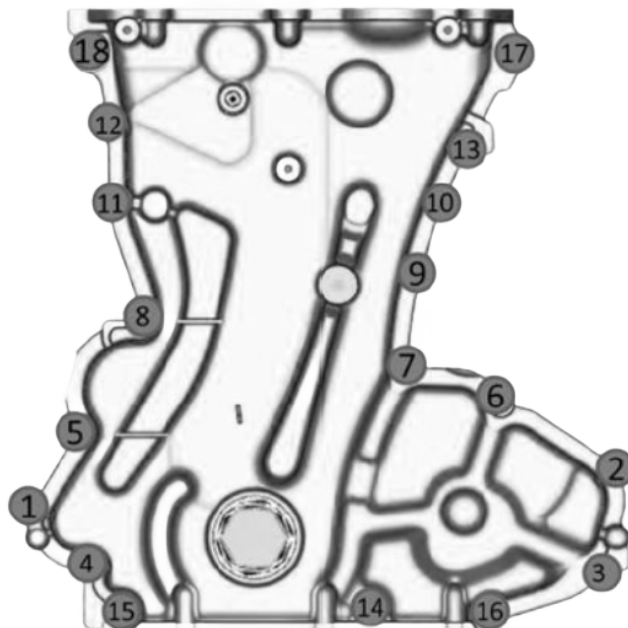
FIGURE 1: Timing Cover Torque Sequence

This leak is caused from the timing cover bolts becoming loose over time. To repair the leak, follow the procedure below.

1. Apply sealant and install the front cover.
2. Using a digital torque wrench (recommended), mark each bolt, making sure that the mark is on the bolt head and the valve cover, and loosen the bolts one at a time. Then return the bolt back to the mark made earlier. Record the torque value at this mark as it should be 6.3-8.1 FT/LBS. To properly torque the bolt, follow the sequence supplied in Figure 1.

3. If the torque value is found to be below the 6.3 FT/LBS limit, proceed as follows. Using a digital torque wrench (recommended), loosen the bolts, and tighten to a torque of 3.7 FT/LBS + 40°. The torque value now should read between 6.3-8.1 FT/LBS. A mechanical torque wrench can also be used by applying a torque of 7.4 FT/LBS.

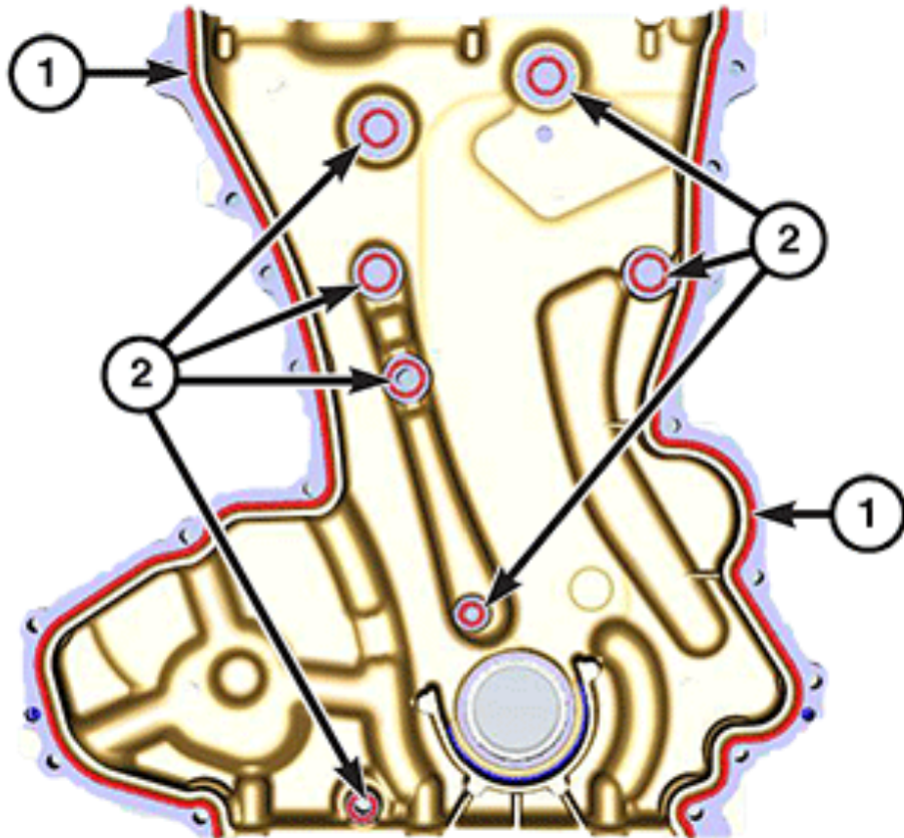
Figure 2: Sealer Locations and Bead Size
1. 3 to 4 mm diameter bead of sealer
2. 2 to 3 mm diameter bead of sealer

4. Clean off any residual oil and check for leaks after running the engine for 10 minutes.
5. If leaks are still present, remove the cover and remove all the sealers from the cover.

6. Apply new sealer, shown in Figure 2 and torque to 7.4 FT/LBS rechecking for leaks.
