**Analysis of Brownfield Cleanup  
Alternatives – Asbestos  
Abatement of Buildings**

**Former Phillips Lionite Wood  
Products Facility, Phillips,  
Wisconsin**

February 19, 2026

**ANALYSIS OF BROWNFIELD CLEANUP ALTERNATIVES - ASBESTOS ABATEMENT OF BUILDINGS: FORMER PHILLIPS LIONITE WOOD PRODUCTS FACILITY, 115 DEPOT ROAD, PHILLIPS, WISCONSIN**

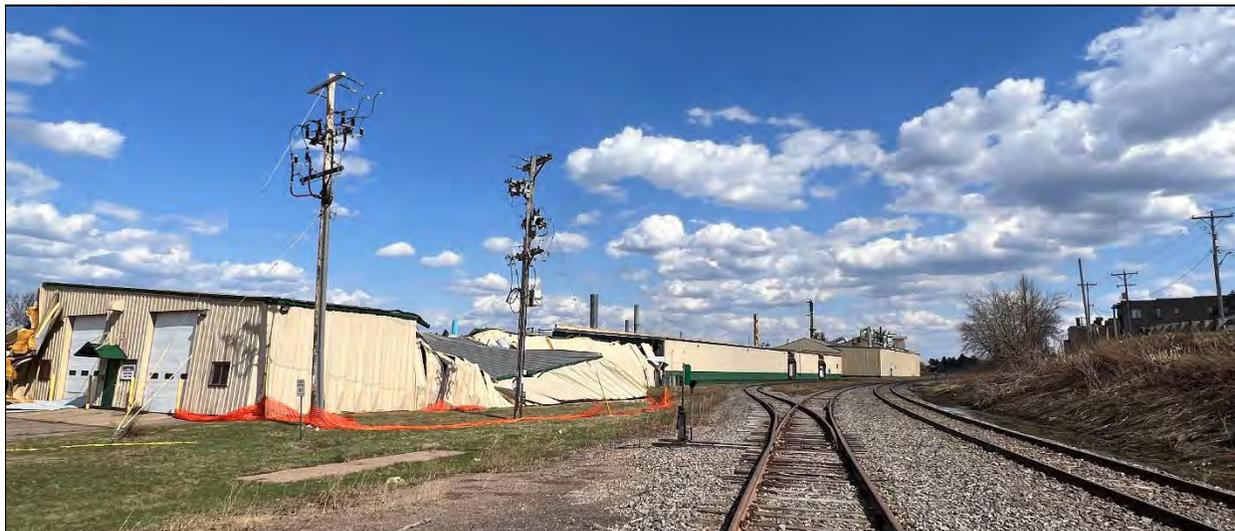
View facing southeast from Depot Road of north end of plant with Loading Dock building in foreground (5/4/2023).

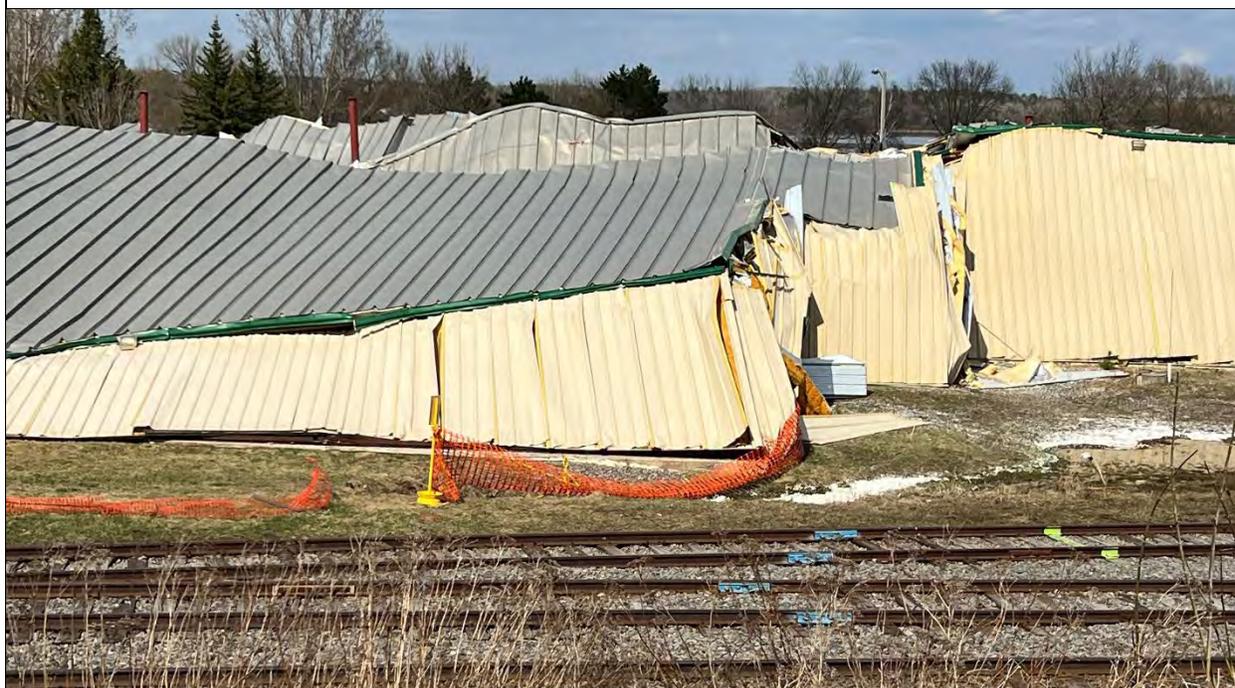
View facing east of partially collapsed Loading Dock building and New North Warehouse (5/4/2023).

The collapsed New North Warehouse and Loading Dock buildings were removed by a contractor hired by the City of Phillips in the Spring of 2024. The City assumed legal responsibility for appropriate abatement and disposal of hazardous materials associated with these buildings.

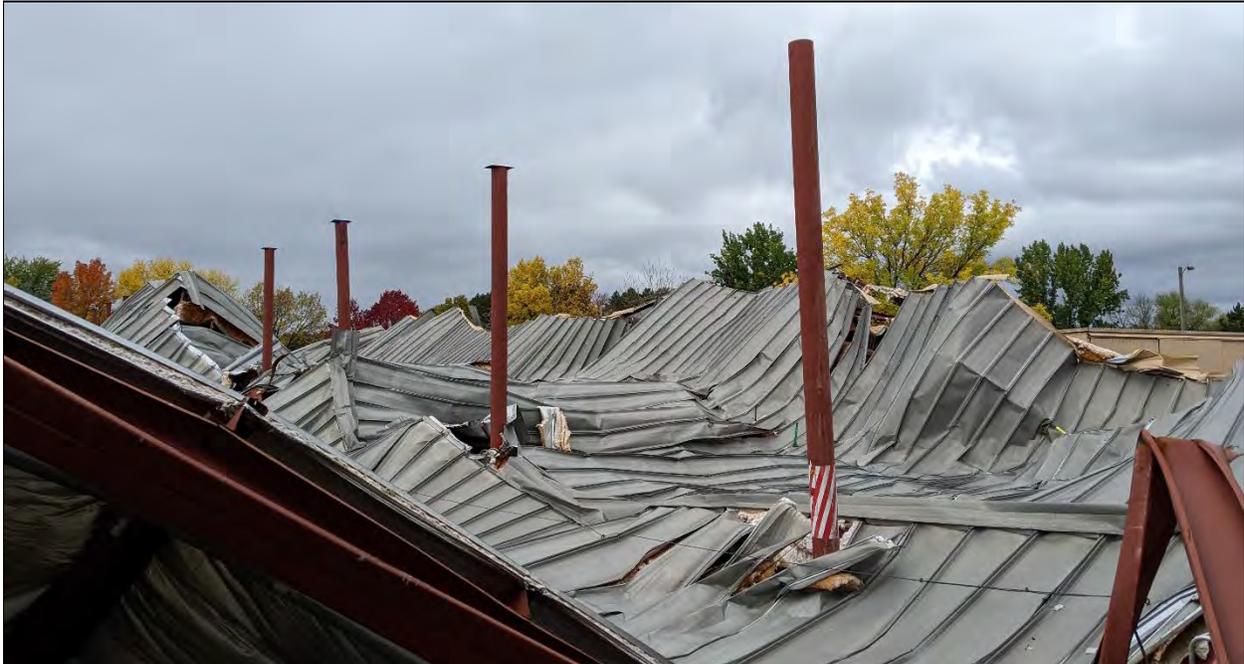
View of collapsed roof on New North Warehouse (9/28/2023).

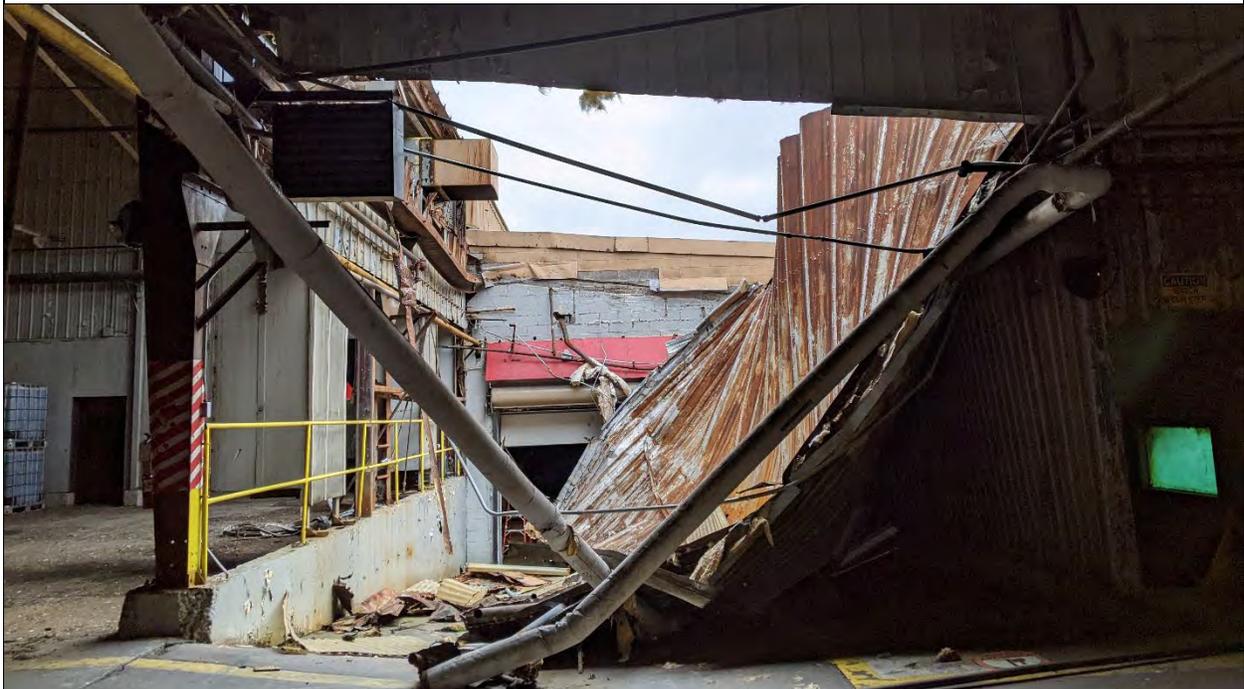
View of collapsed roof in loading dock area Building 13 (9/28/2023).

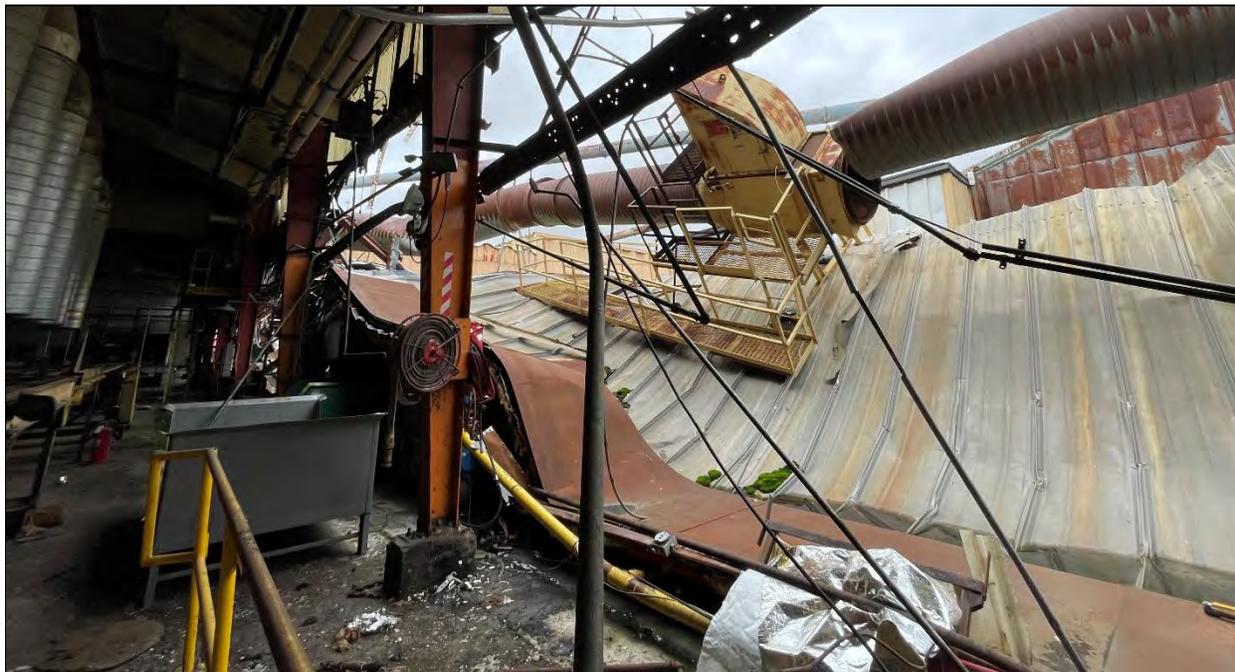
View of collapsed roof in former maintenance building (9/28/2023).

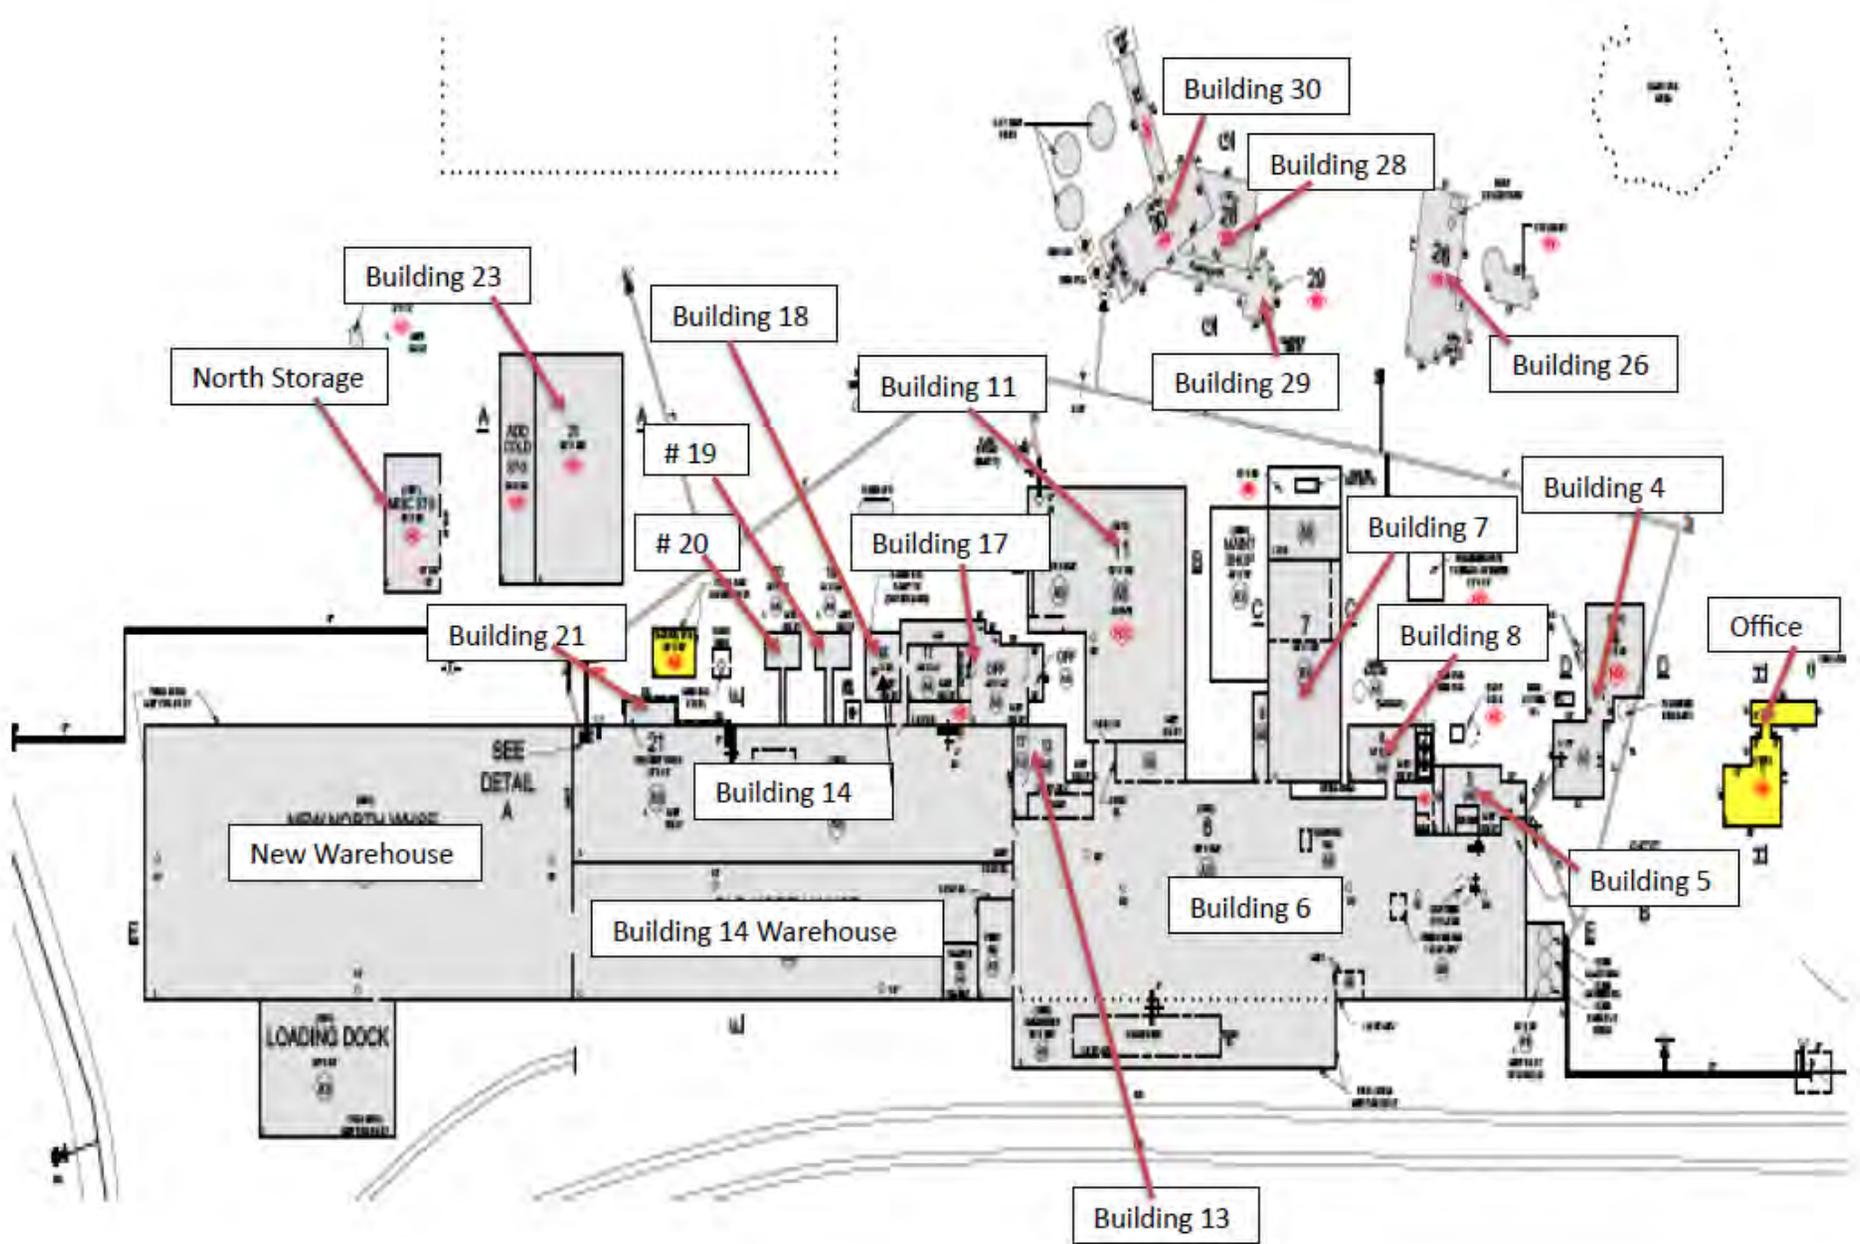
General Area  
with Multiple  
ACM Pipe  
Locations

General ACM Pipe Locations
