Learning from failures I

STEP lecture E27

To describe some structural failures caused by snow, wind or landslide.

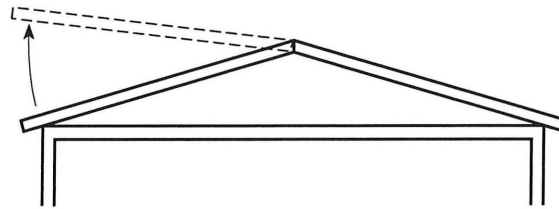
Figure 1 Typical sketch of a timber roof structure on a concrete slab; (a) concrete.

There were quite a lot of two or three storey houses that lost their roofs. On the upper concrete slab a timber frame system was built with vertical posts 50 x 100 *mm* and rafters 50 x 100 *mm* to 50 x 150 *mm*. The spacing of posts and frames was dependent on the house and rafter dimensions, however the frame spacing was very often 1,2 *m*. A typical sketch of the structure is shown in Figure 1.

All of the examined damage had either insufficient or non-existent anchorage of the timber structure to the concrete slab. In many cases the roof structure was attached at the eaves, but none of the posts was fixed in any way. This means that when the storm succeeded in breaking the anchorage at the eaves the whole roof was free to blow off. Then the wind force could also influence the roof plate with pressure from below, see Figure 2.

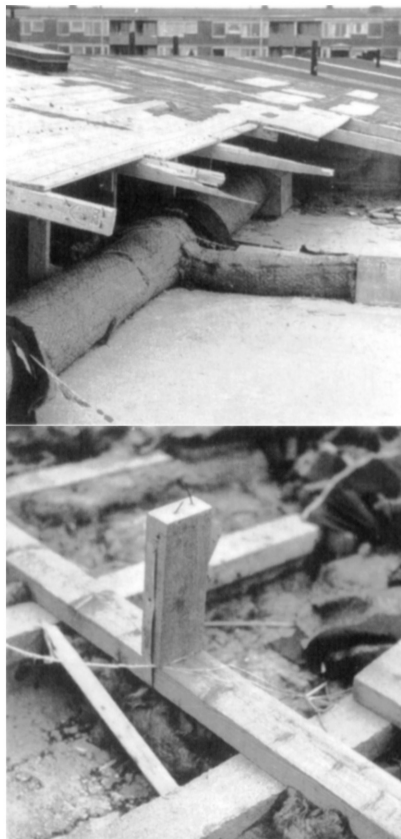
Figure 3/4 Damage examples. Fixing of post to the roof slab. Note the wrong position of the steel strap (left). Part of the roof is lying on the leeward side of the damaged building (right).

Different types of anchorage were used. The most common was thin steel straps, cast in the slab and nailed to the timber structure. In other cases a horizontal 50 x 100 mm timber was bolted to the concrete slab, to which the timber structure was fixed with just a few nails. However, many of the anchorages showed very poor workmanship and could not be expected to resist the wind forces. In Figures 3 to 6 some examples of damage are shown.

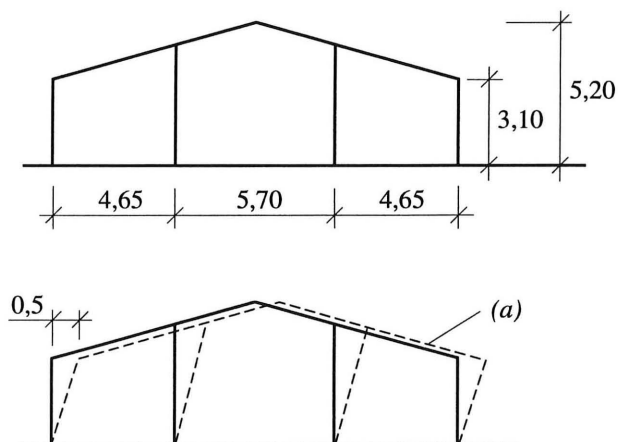
A temporary timber building was totally destroyed during the storm. The building was $30 \times 15 \text{ m}$ in plan and $5,2 \text{ m}$ high at the ridge. The frame system can be seen in Figure 7. All the joints in the structure were bolted. Unfortunately the size of the timber used is unknown but the rafters were approximately $50 \times 150 \text{ mm}$. The purlins were fixed to the frame rafters with a supporting wood block. Each block was nailed with three nails to the rafter. The purlin, however, was only nailed with one nail to the block. Because of this the whole roof blew off. The frames were sway deformed with a maximum deflection of $0,5 \text{ m}$. If the roof had not been removed, the frames would have probably been broken instead.

Figure 7 The frame structure and the deformation of the frame; (a) deformed frame.

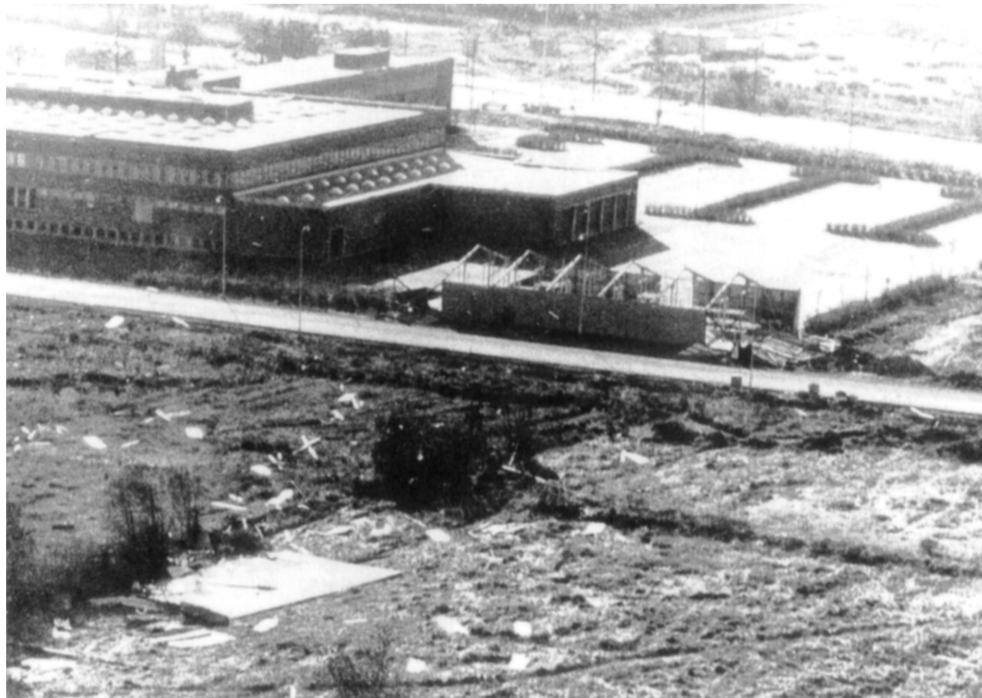
Figure 8 View of the damaged building. A blown-off roof section can be seen to the left.

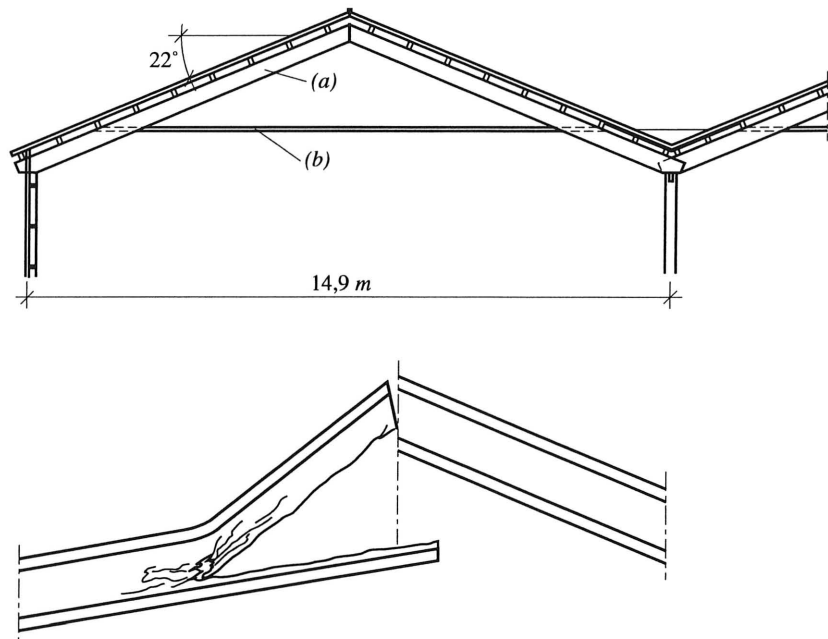
Bad gluing of wooden structures had caused failures in glulam beams and plywood webbed I-beams. The glulam beams were of an I-type where the gluing of the flanges to the web was badly done. Due to the thickness of the flanges it was probably impossible to achieve proper pressure along the whole gluelines during manufacture. One of the basic conditions for successful gluing is that the glued surfaces are plane enough to come in close contact and that the applied pressure is sufficiently high. Especially in the case of nail-gluing it is necessary to use planed surfaces. The plywood beams failed due to badly planed flanges resulting in bad glue joints.

Figure 9 Failure in a glued laminated timber structure due to bad gluing. Section (top) and sketch of the failure (bottom); (a) glulam, (b) tension bar.

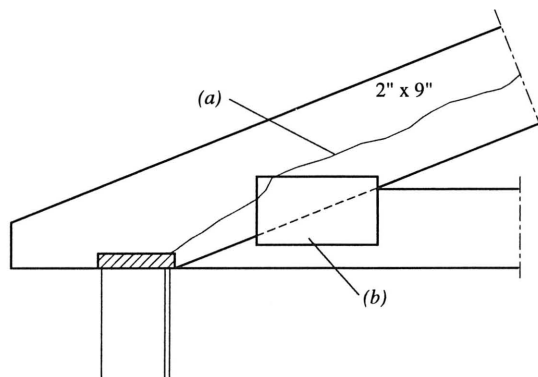
Timber connections with nail plates (punched metal plates) are sensitive to misplacement of the nail plates since the plate size is often small. Collapses of roof trusses were found to be due to undersized nail plates at the supports. These small plates were placed so that cracks could develop in the rafter leading to a collapse. When nail plates are used it is necessary not only to determine the minimum size of the plate from strength considerations but also to take into consideration the possibility of crack development. A similar failure occurred in a glued laminated beam with a notch at the support.

Figure 10 Joint with a nail plate that is too small; (a) failure surface, (b) nail plate.

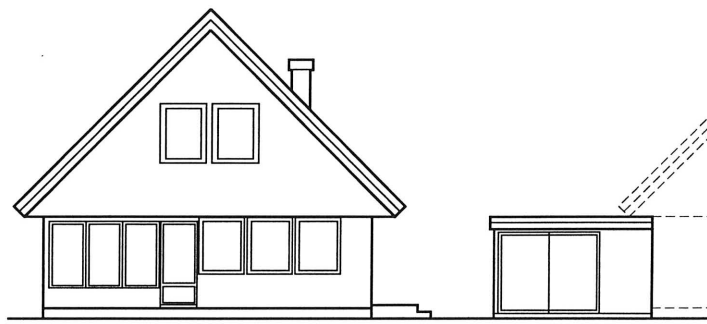
Figure 11 Typical placing of a carport next to the neighbour's house.

The design of carports usually means rather limited resistance to withstand horizontal loads. In some observed cases the carports were built next to the neighbour's house to which, due to legal difficulties, they could not be attached. Sliding snow from that house caused horizontal forces in the carports resulting in permanent horizontal sway. Methods to prevent this kind of damage probably have to concentrate on preventing the snow from sliding, since it is difficult to stiffen a carport, due to its function.

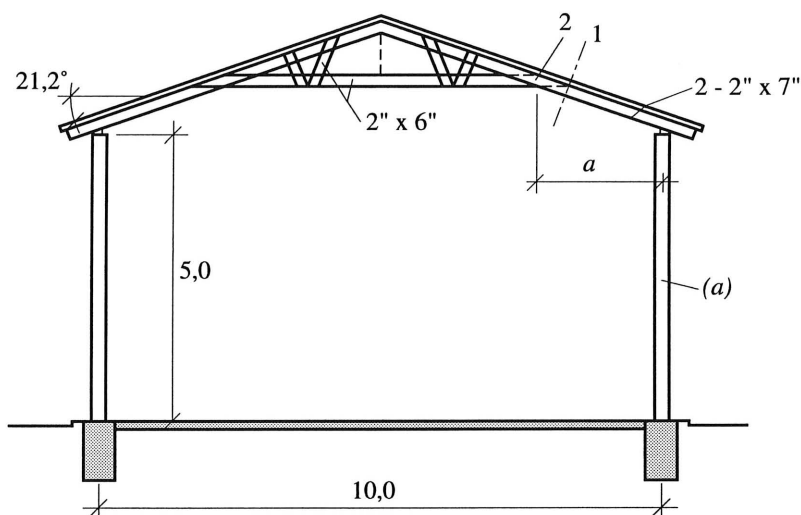
Figure 12 Section through a timber store house; (a) round timber pole.

Figure 12 shows one type of roof truss that is easily "overloaded". The moment distribution is very much dependent on the distance a in the figure. The failure is often a pure bending in section 1 or in the joint 2. In the case shown the bending stress in section 1 was calculated to 66 N/mm^2 .

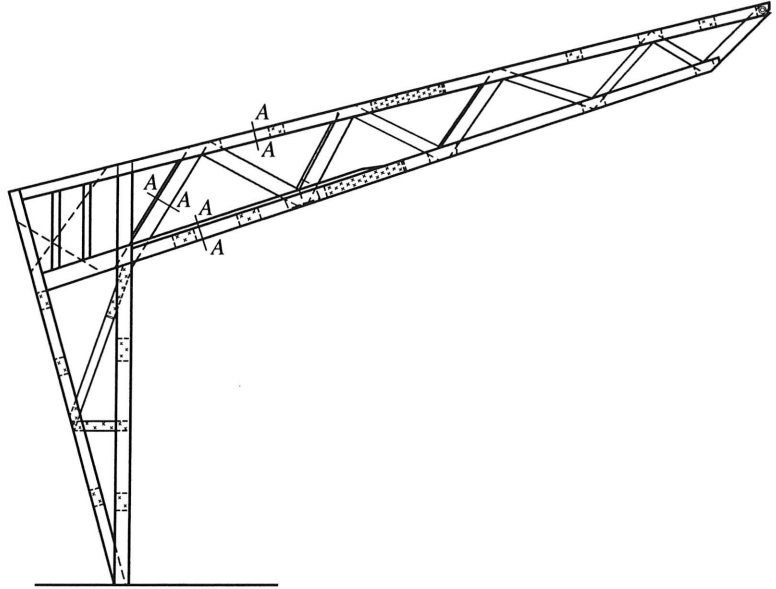
Figure 13 One half of a three-hinged truss frame, spanning 15,5 m, with joints at A-A.

The primary structure of a cold store house was a three-hinged wooden truss frame. After about 20 years of service the building was moved to another place. A drawing of one half of the truss is shown in Figure 13. The flanges of the truss-beam were made of $50 \times 125 \text{ mm}$ sections. The contractor cut the frames in the sections A-A (Figure 13) when the building was moved to its new place. In these joints lap splices of $50 \times 125 \text{ mm}$ were nailed with just a few nails to each part. The length of the lap splices was about one metre.

The whole building collapsed due to failure in the joints A-A. This was probably a progressive failure starting from one frame. At failure the snow load was

estimated at $1,1 \text{ kN/m}^2$ based on in-situ measurements. According to the Swedish Building Code the joint in the tension flange should have been nailed with about 130 nails. The estimated number of nails actually used in the joint corresponded to an allowable load of $0,2 \text{ kN/m}^2$ which is less than the dead load of $0,3 \text{ kN/m}^2$.

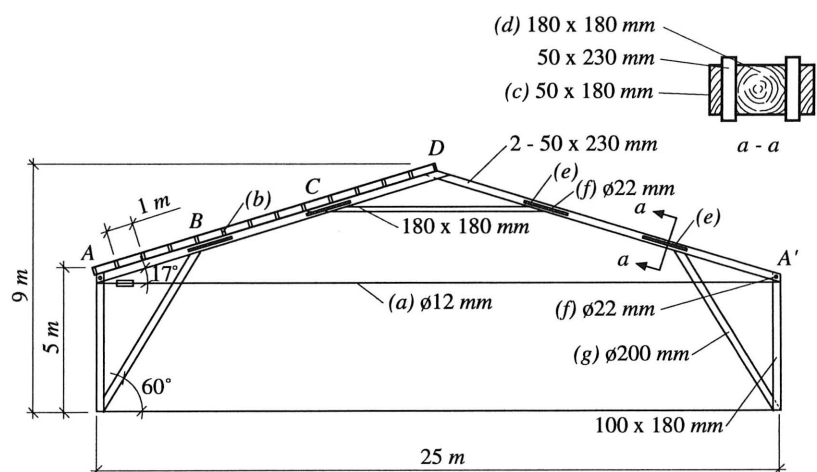
Figure 14 Timber frame structure with a steel tension rod. (a) steel cable, (b) purlins, (c) cover plate, (d) distance piece, (e) splice, (f) bolt, (g) round timber.

The structure in Figure 14 probably collapsed due to the fact that the deformation in the steel wire tie rod was neglected. The failure occurred between joints B and C. The load on the structure was a combination of wet snow and wind forces. The snow load was approximately 1 kN/m^2 unevenly distributed on the roof. Stresses calculated for this load and wind load at a wind speed of 15 m/s gave a bending stress of 20 N/mm^2 if the deformation in the steel wire was considered and 4 N/mm^2 if not.

Hence it may be concluded that it is vital that the theoretical model in the calculations is correct in order to avoid a disastrous failure.

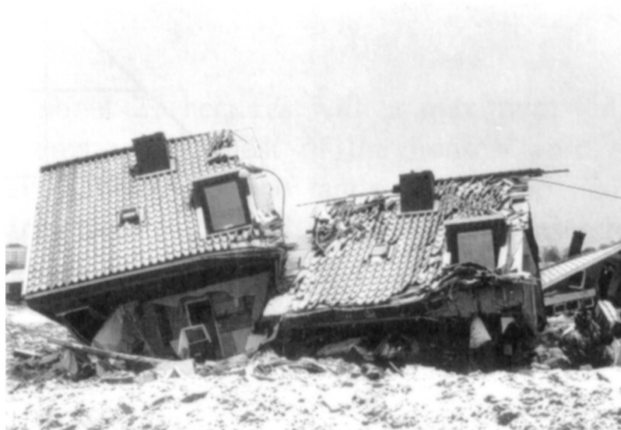
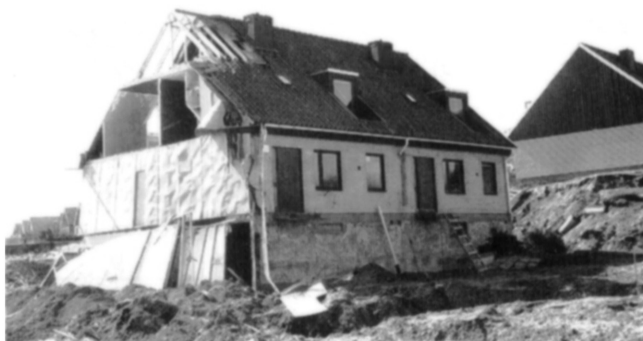
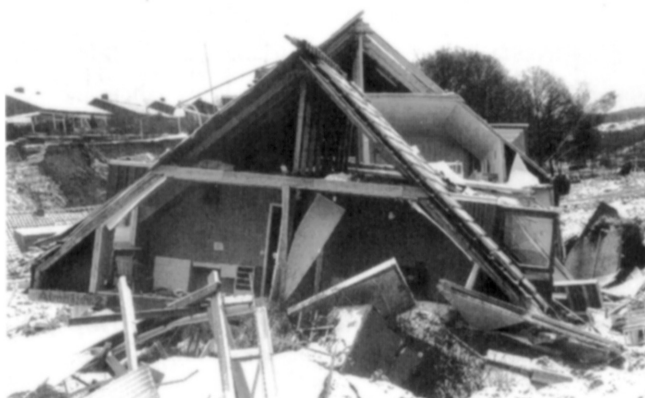
The main reason for the severe damage to these houses was that the concrete walls in the basement broke down. The walls had very little or no reinforcement and they split at the corners. Then the concrete slab slid off the walls and broke. The basement walls were intact in only two of 29 houses. After the concrete slab was broken, the timber frame superstructure was exposed to loads which exceeded the design loads many times.

In most of the houses the "roof triangle" was not damaged. Also the "non load carrying walls" acted as load carrying to a great extent. As a matter of fact, the bathroom on the second floor seemed to be the most secure room in the whole building. Figures 16 and 17 show the frame system, the roof triangle and a sketch of possible damage development. In Figures 18 and 19 some details are shown.

Figure 18/19/20 Details of damaged houses at Almhöjdsvägen.

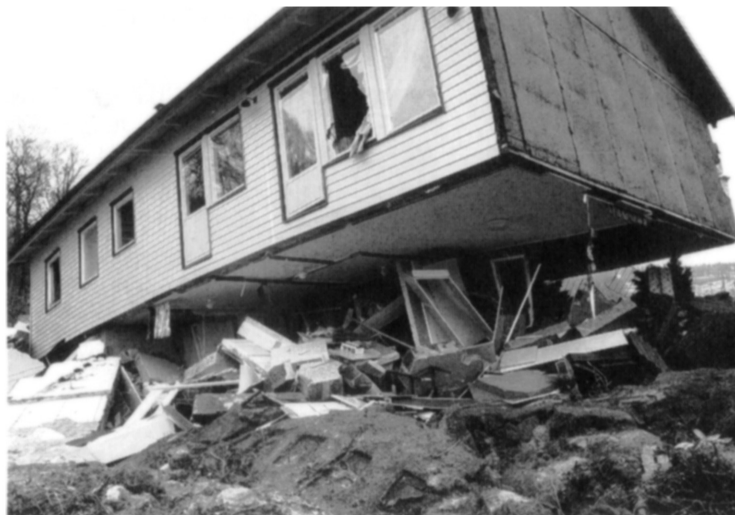
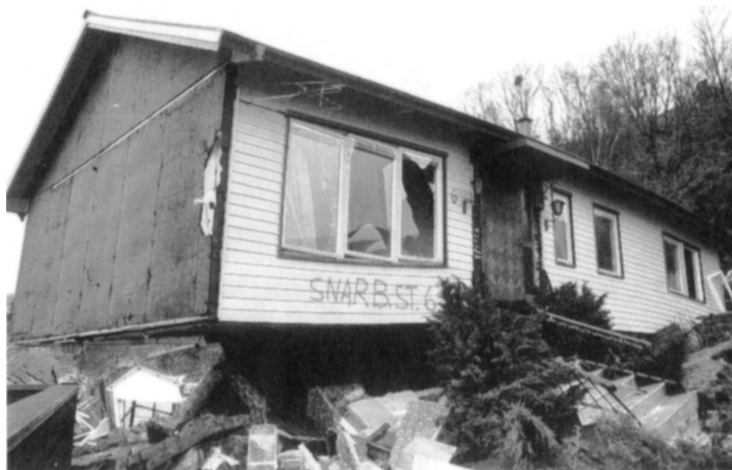
This house was very interesting. Although it had lost approximately 75% of its supporting basement walls, it did not break down, although it showed some deformation and a few broken windows. This is an excellent example of "box-function". A box with 4 stiffened walls (the inner walls act as stiffeners) and an intact top and bottom is rather stiff and safe. This was proved many times in the slide area. Figure 25/26 shows the building, resting on "nearly nothing".

Figure 25/26 The house rests only on the centre walls and cantilevers in all four directions. Notice the shear deformation in the window openings.
