Learning from failures II

STEP lecture E28

J.P. Biger

Bureau Veritas

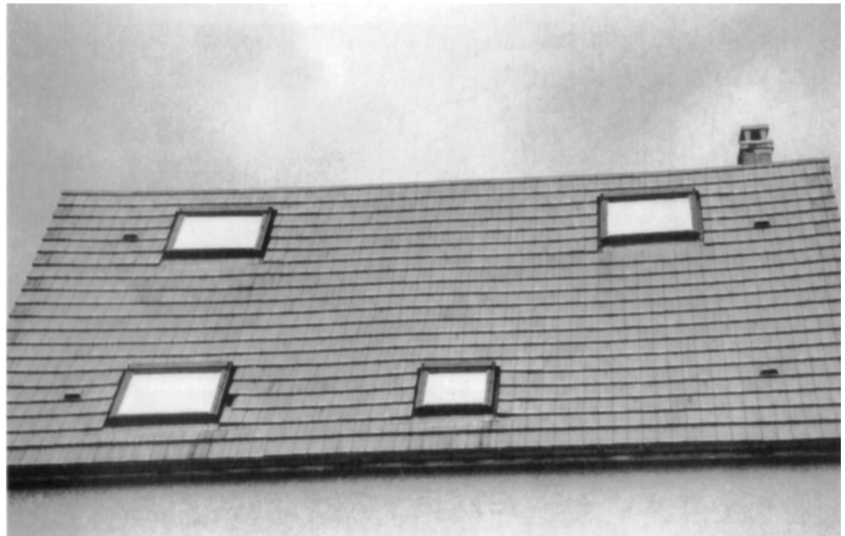
Figure 1 Roof deformation.

The carpentry supporting the roof in Figure 1 is of a classical type: rafters, purlins, supported by gable walls and a central truss. The ridge beam of the roof shown in Figure 1 has become concave, and rows of tiles have slipped to the bottom of the roof planes.

This very common situation is the result of the absence or inadequacy of blocking of rafters at the base of the planes, allowing the purlins placed obliquely to become deformed by transverse bending.

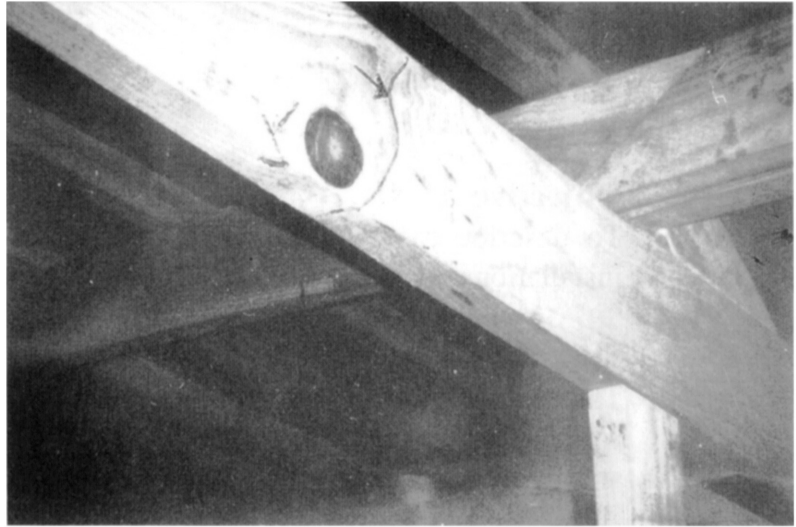
The trussed rafter shown in Figure 2 has broken because of the presence of a large-sized knot. The timber was obviously not graded properly.

Figure 2 Fracture caused by a knot.

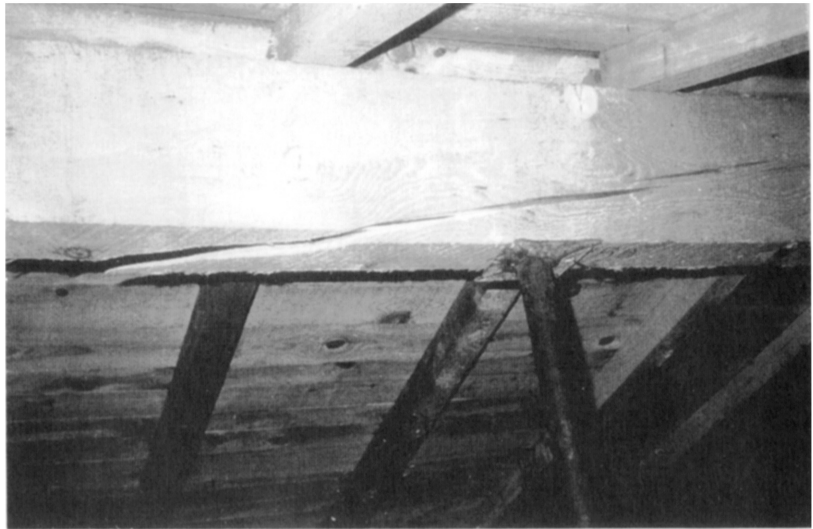
The ridge purlin shown in Figure 3 has broken because of the steep slope of the grain of the timber, which causes local transverse stresses, resulting in breakage. The timber was obviously not graded carefully enough.

Figure 3 Fracture caused by the slope of the grain.

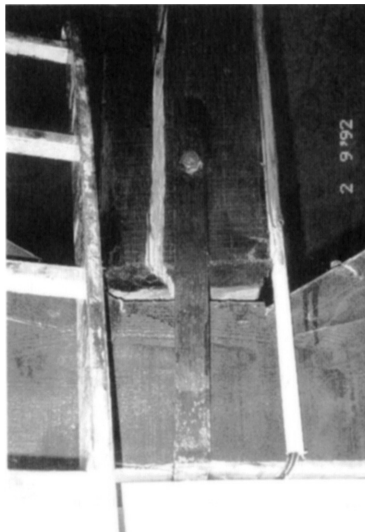
The opening of the assembly of a king post on the tie bar of a traditional truss is shown on Figure 4. It may be seen that the king post is cracked more or less on the plan of the bolt, and that the metal suspender is embedded in the bottom of the tie bar. The fracture process is in progress.

Figure 4 Assembly of king post on tie bar.

This case involves a design error in the assembly of the central diagonals, which are blocked on the tie bar with the result that the metal suspender and bolt are overloaded. A good design would tie the diagonals to the king post.

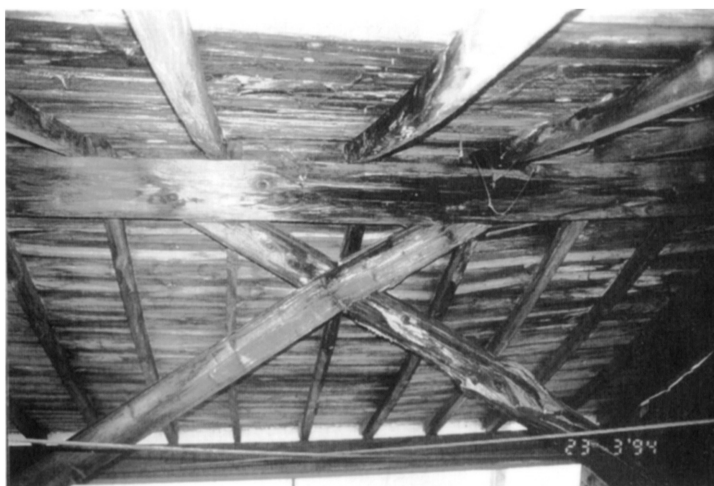
Figure 5 *Serious damage by fungus.*

The structure shown in Figure 5 is about fifty years old. Infiltrations of water caused by gaps in the waterproofing of the roof created conditions favourable to the growth of fungus. This structure is very seriously damaged at places where infiltrations took place. Proper maintenance of the roofing is needed to avoid, or reduce, the risk of fungus attack on the supporting timber structure.

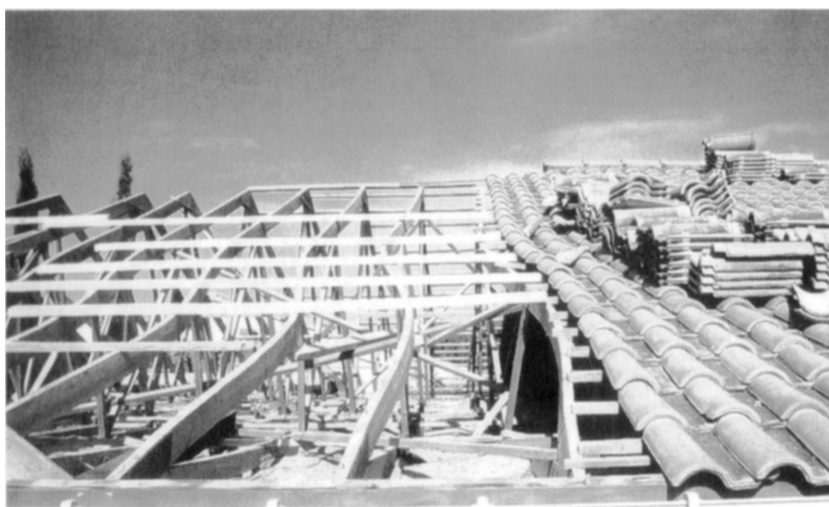
Figure 6 *Buckling of trussed rafters.*

Cases of buckling of trussed rafters, as shown in Figure 6, are rather common. They are caused by over estimation of the transverse rigidity of the framework, resulting from the idea that the length of transverse buckling for trussed rafters would be equal to the distance between batten lines. This idea is an illusion because the lateral restraint given by the tile battens and the bracing is not sufficiently rigid. The numerous nailed joints which are involved may slip and drag, as shown on Figure 7.

The design of continuous bracing bars under the roof planes, with girtrails and torsional blocking of truss bases, as well as the adoption of reasonable design buckling lengths, are essential precautions needed to prevent the risk of lateral buckling of trussed rafters.

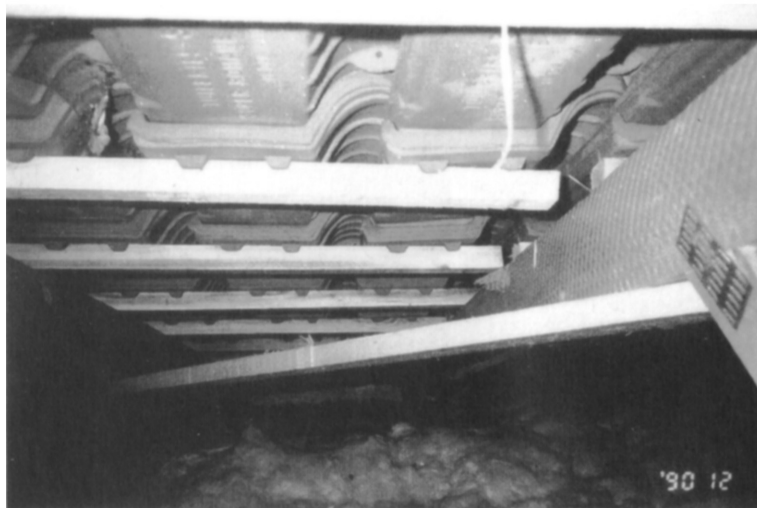
Figure 7 *Slipping and dragging of batten nailing.*

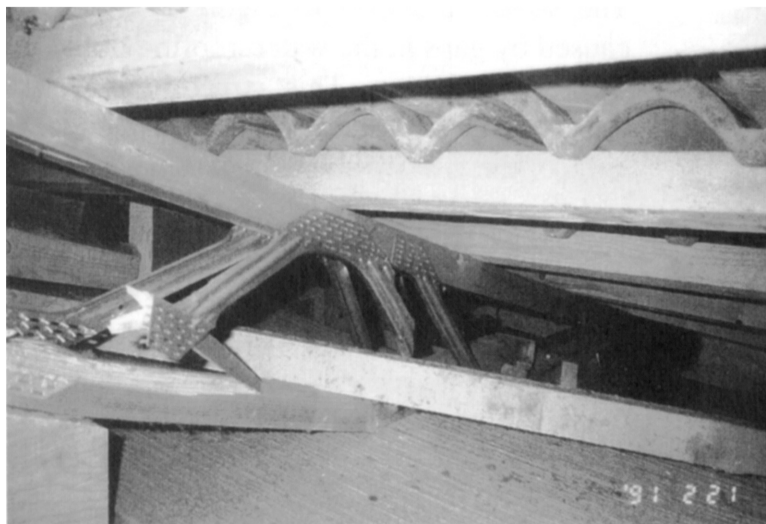
Figure 8 *Failure of timber girder.*

The broken girder shown in Figure 8 is used as a rafter. The end of its lower flange has broken, and its metal diagonals have torn away. The support of this girder is not properly designed: offsetting the supporting point from the triangulation node causes a secondary moment, which has resulted in the failure. Attention must be paid in the design of supports with respect to the calculation hypothesis in order to avoid secondary moments.

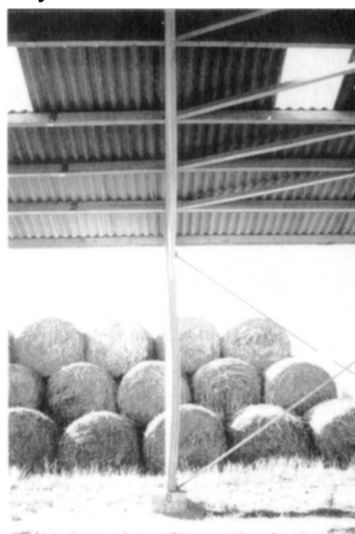
Figure 9 *Warping of LVL frame.*

The frame shown in Figure 9 consists of two thicknesses of 36 mm LVL, side by side for the crossbeam and forming a coffer for the columns. Warping is due to insufficient lateral and torsional stiffness, caused here by a loose nailing of the LVL sheets together. The specification of adequate nail densities in the design documents is necessary to avoid this instability.

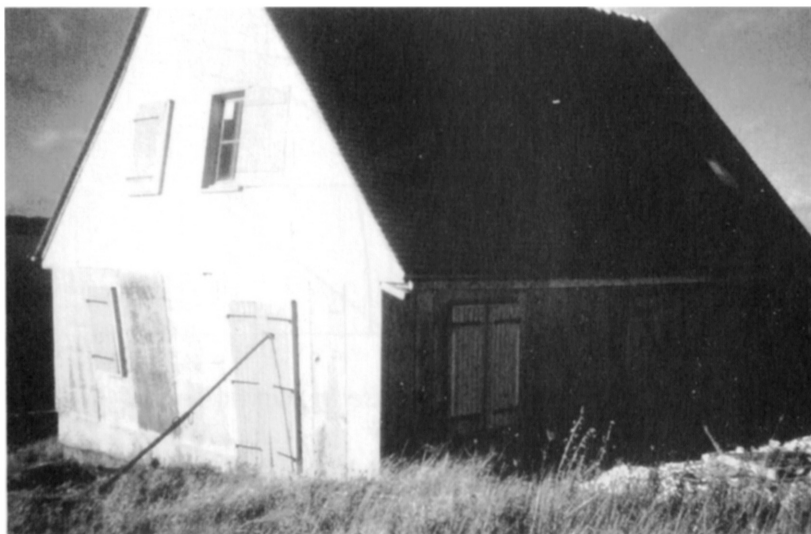
Figure 10 Instability of timber frame walls.

The timber frame house shown in Figure 10 is supported by props. The ground floor walls slope outwards, probably because the connections between floor and walls are absent or inadequate. Design, fabrication and erection should be done by professionals, preferably.

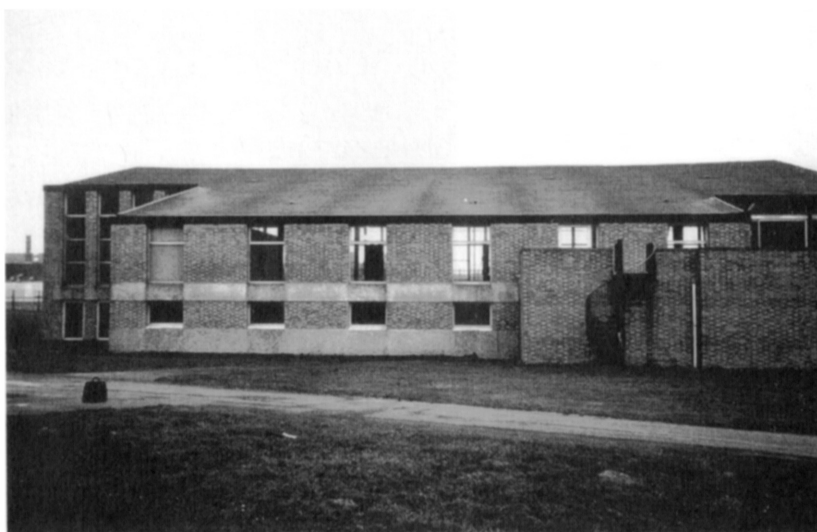
Figure 11 Ridge deformation.

The ridge of this sports centre (Figure 11) has subsided about 300 mm, following an increase in the curvature of the flanks of the frames that form the main structure. This increase in curvature is not caused by any extra load on the frames, nor by creeping, but results from the transverse shrinkage as the wood dries out.

Shrinkage moves the soffit and back of the curved flanks of the arches closer together, while their respective lengths remain approximately the same, which

means an increase in their curvature, and consequently subsidence of the key point as indicated in Figure 12. Control of drying conditions with regard to the service condition, and anticipation of the possible deformation will prevent this problem.

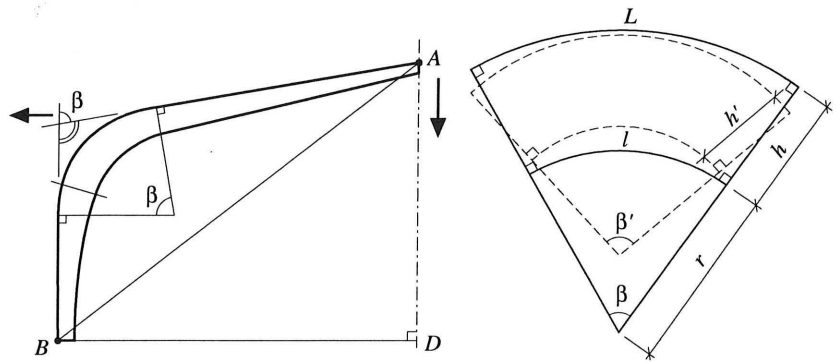
Figure 12 Increase in curvature and deflection due to shrinkage.

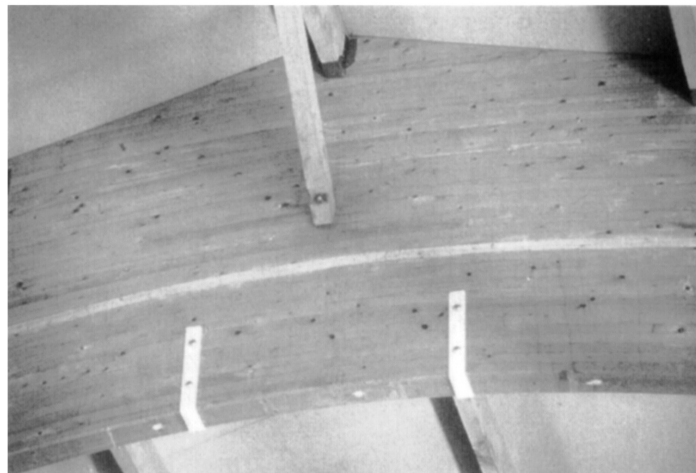
Curved beams are subject to transverse tensile stresses accompanying bending forces. This is a cause of serious cracking. Many cases have been recorded of cracking similar to the case shown in Figure 13. They are generally the result of over-optimism in the transverse tensile strength. Consideration of the influence of curvature on the transverse tensile stress (see STEP lecture B8) as well as the influence of service conditions on shrinkage and surface cracking is needed in the design of curved tapered beams. The use of reinforcements made of glued in bolts or glass fibre is recommended (see STEP lecture E4).

Figure 13 Cracking of tapered curved beam.

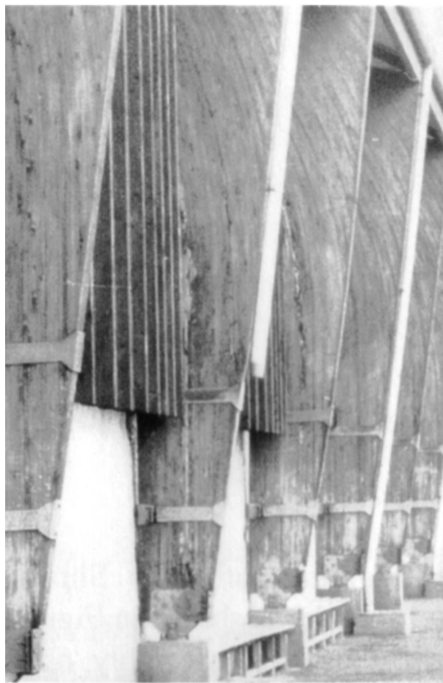
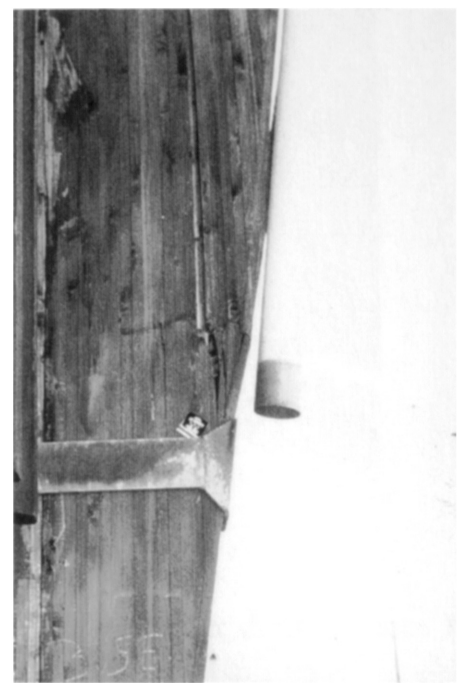
Another case of cracking caused by transverse tensile stresses is shown on Figure 14 and 15. These steeply tapered glulam columns are situated outside. Their exposure to climatic changes helps cracking. A good design would need a smooth taper, and inside location, which is, in most cases, an architectural concern.

Figure 14 External uprights with cut-off strips.

Figure 15 Detail view of cracking.

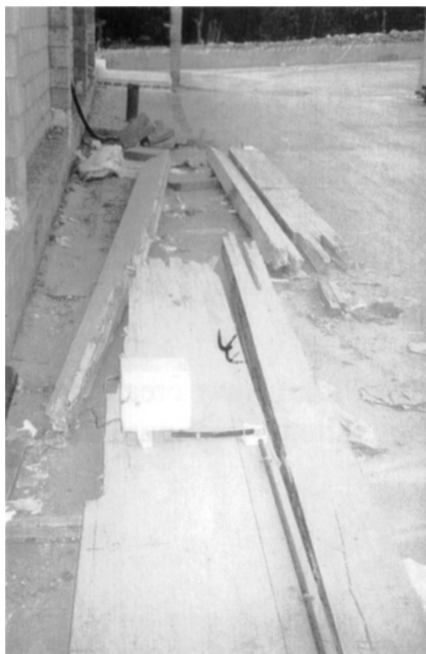
Waterponding may occur on flat roofs. It is responsible for many cases of collapse, the beam in Figure 16 is one example. Beam deflection under water ponding loads increases beam loading. In case of insufficient beam stiffness, this process leads to instability, gluing defects (Figure 17) and finger jointing defects (Figure 18) may reduce the stiffness and the resistance of beams, increasing dangerously their susceptibility to water ponding loads. Special care is needed for beam design in the case of flat roofs, the stability under water ponding loads must be checked. Prevention of gluing and finger jointing defects needs quality control in the manufacturing process.

Figure 16 Beam collapse.

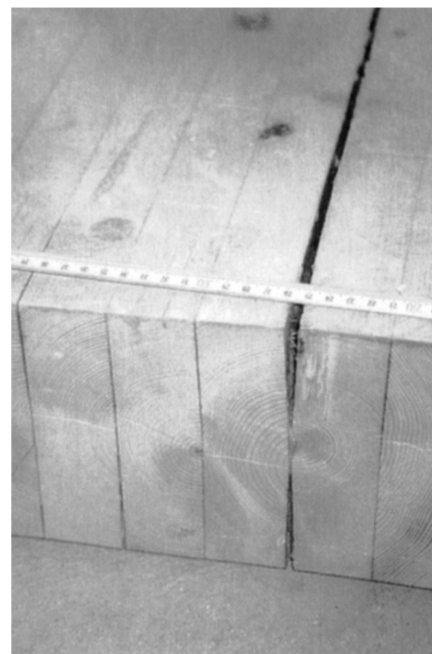
Figure 17 Defective gluing.

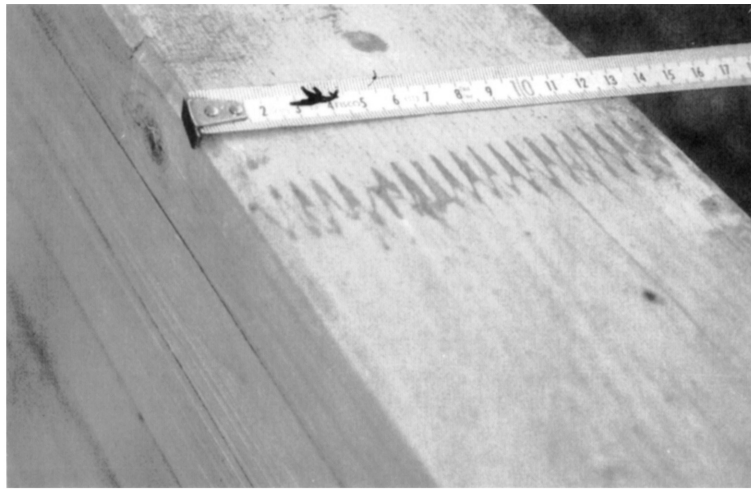
Figure 18 Finger jointing defects.

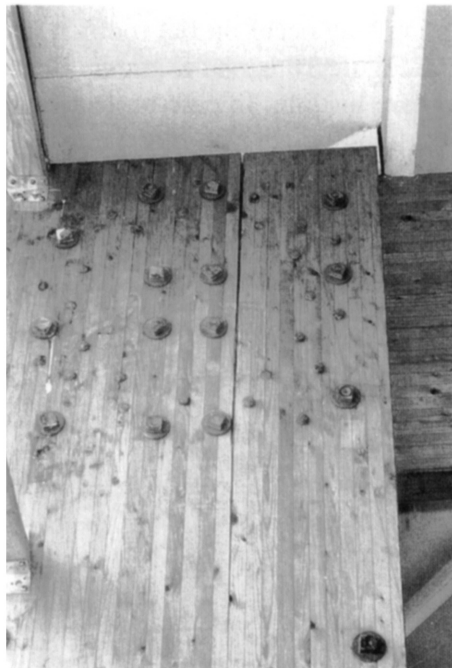
Joints play an important part in glulam pathology. Shrinkage of beams and columns at frame corners often result in cracks as shown in Figure 19. This can be prevented by adequate drying of the glulam prior to assembly, associated with gluing process control. The designer must bear in mind that the risk increases with the depth of beams and columns. Reduction of design stresses may be recommended in particular cases.

Figure 19 Cracked frame corner.

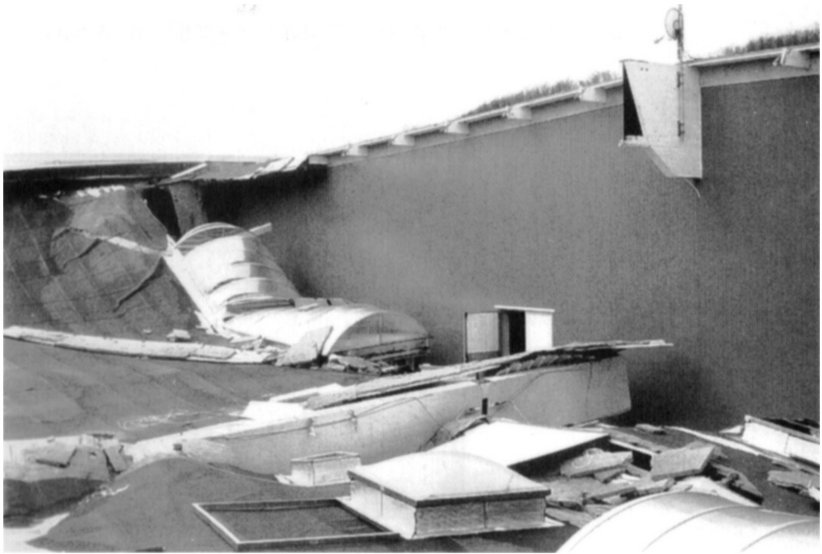
Insufficient rotational capacity of joints may create problems for glulam structures. This is the cause of the collapse shown in Figure 20.

Figure 20 Failure of cantilever joint.

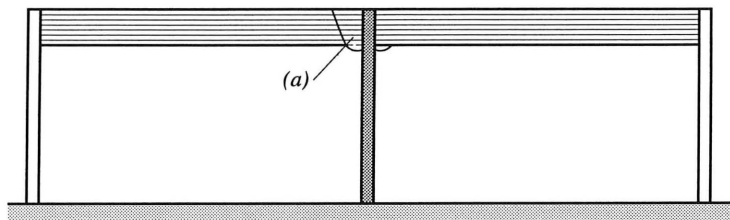
The beam had two bays, a cantilever joint was located at a short distance from the central support, see Figure 21.

Figure 21 Two bays beam and cantilever joint (a).

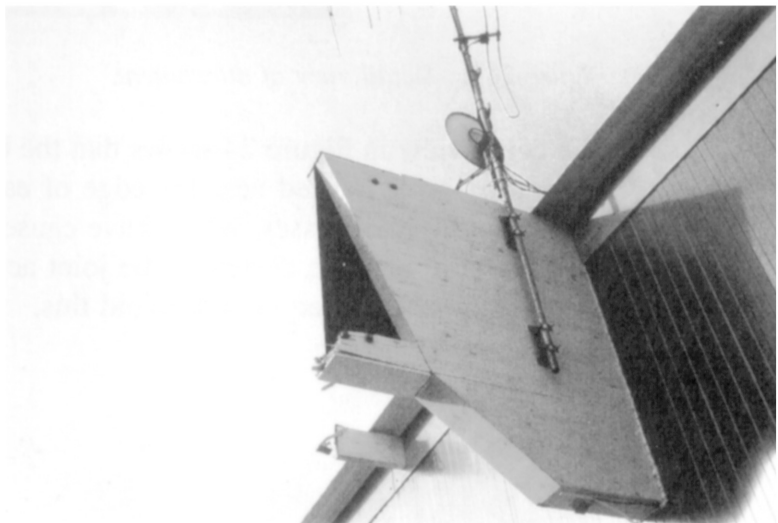
The design of the cantilever joint shoe shown on Figure 22 does not allow the rotational possibility required by the position of the joint, which is different from the zero moment point.

Figure 22 Detail view of cantilever joint.

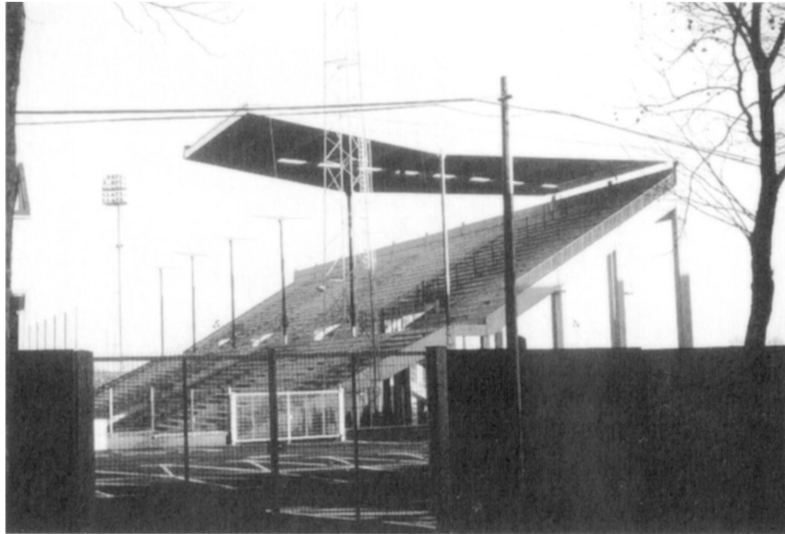
The canopy of the stadium stand shown in Figure 23 has been almost entirely carried away by an ordinary gust of wind.

Figure 23 Attachment failure.

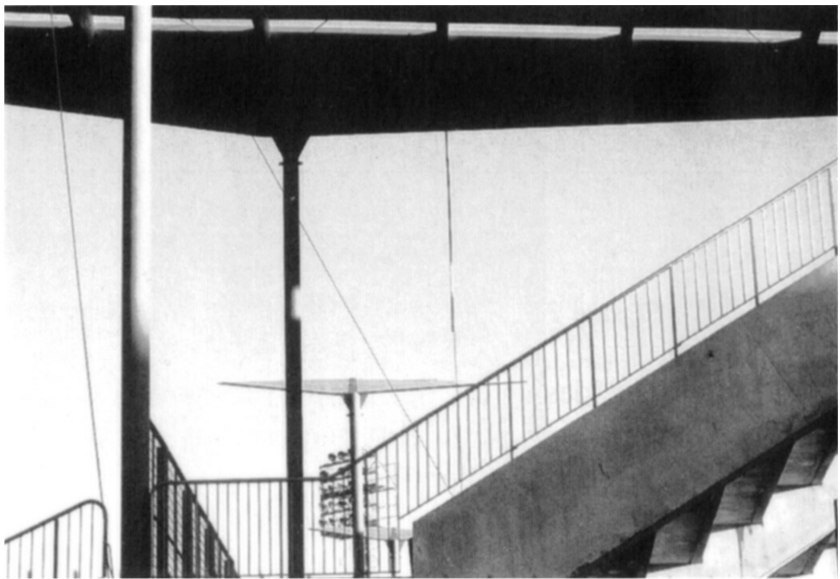
Figure 24 Detail view of attachment.

The detail view in Figure 24 shows that the beams were attached to the tops of the column by bolts located near the edge of each beam. This arrangement generates transverse tensile stresses, which have caused cracks to cut the beams at the level of the upper bolt. The design of the joint according to the provisions described in STEP lecture C2 is required to avoid this.
