# INSPECTION REPORT

For the Property at:  
**123 MAIN ST**  
BLUFFTON, SC 29910

Prepared for: MR. SMITH  
Inspection Date: Saturday, June 25, 2022  
Prepared by: Charles Mullins

Report No. 1010

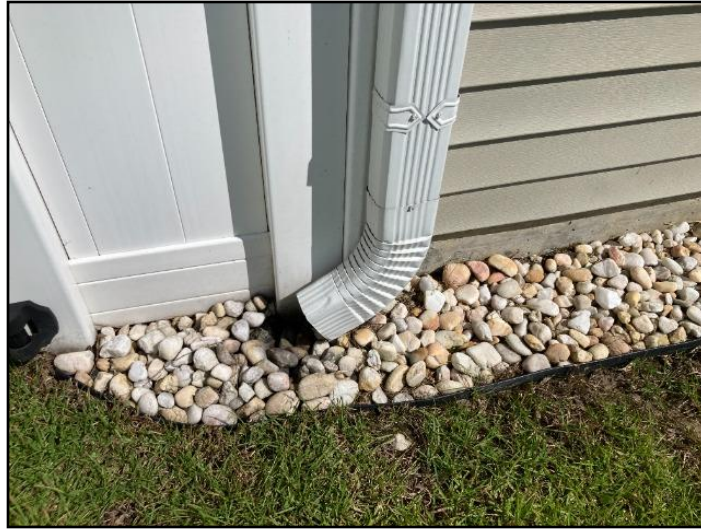
The downspout should be extended so the gutters will drain 6' away from the foundation.

**Implication(s):** Chance of water damage to structure, finishes and contents

1. Discharge too close to building

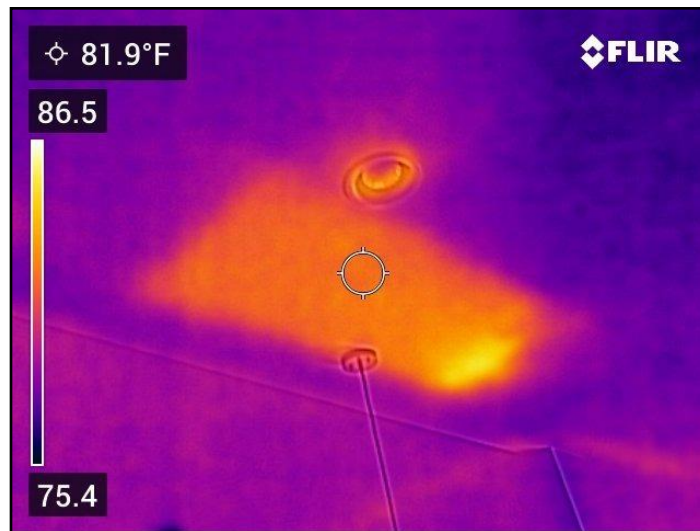
There appears to be an area above the kitchen with missing insulation. There is plywood in the attic above that area so it is hidden.

**Implication(s):** Increased heating and cooling costs | Reduced comfort

2. *Gaps or voids*

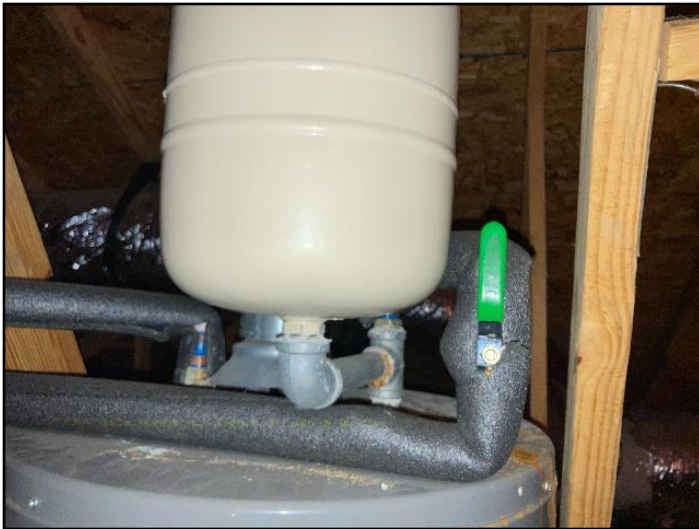
The galvanized fitting where the expansion tank connects to the water heater water supply has been dripping for some time. This should be repaired as soon as possible to avoid a major leak in the attic.

3. Rust

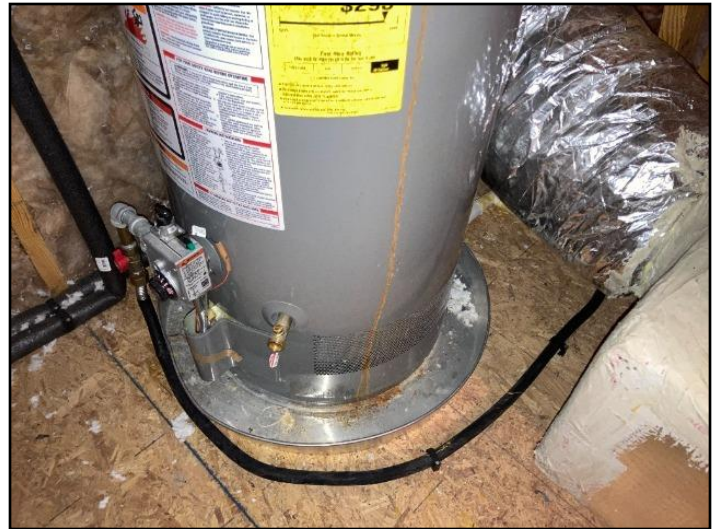
4. Rust

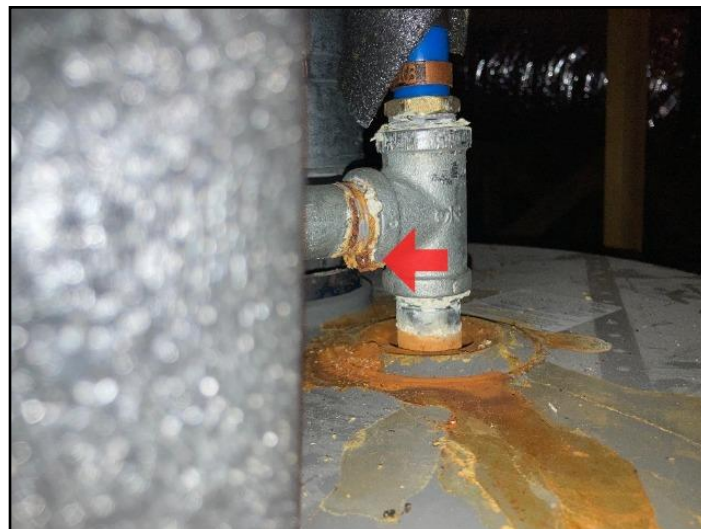
5. Rust

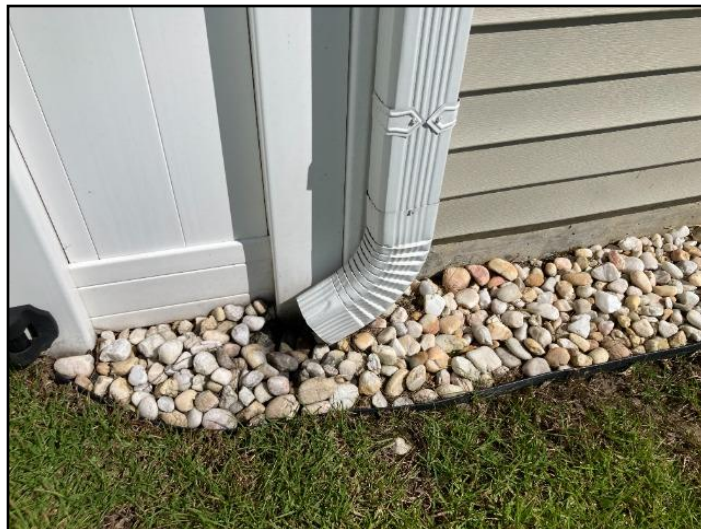
The downspout should be extended so the gutters will drain 6' away from the foundation.

**Implication(s):** Chance of water damage to structure, finishes and contents

7. Discharge too close to building

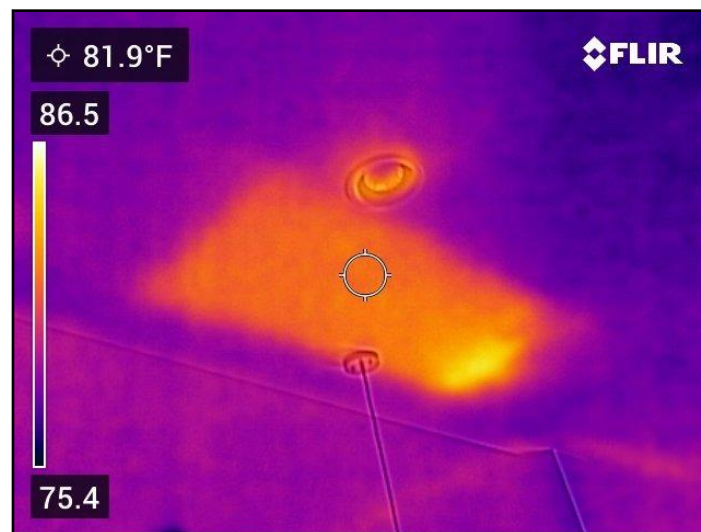
There appears to be an area above the kitchen with missing insulation. There is plywood in the attic above that area so it is hidden.

**Implication(s):** Increased heating and cooling costs | Reduced comfort

14. Gaps or voids

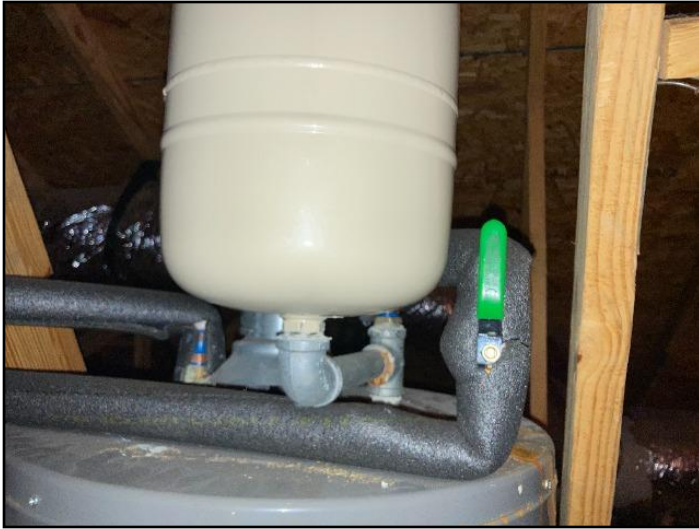
The galvanized fitting where the expansion tank connects to the water heater water supply has been dripping for some time. This should be repaired as soon as possible to avoid a major leak in the attic.

16. Rust
