BUILDING RESTORATION CORPORATION

November 13, 2023

**Our Lady of the Lake Catholic Church
2023 Masonry Repairs and Maintenance Budget**

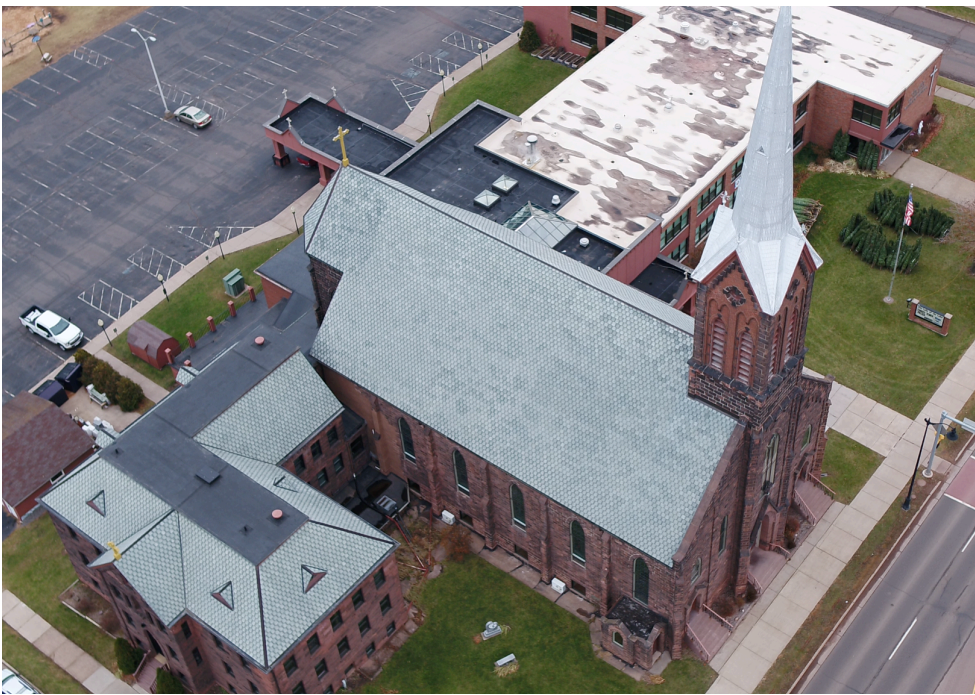
Masonry repair and maintenance is needed on all of the Our Lady of the Lake campus buildings. Cutting and tuckpointing of deteriorated mortar joints, patching and replacement of damaged stone and bricks, removal and replacement of caulking sealant, and other related work is outlined in this report and the attached budget estimate.

In addition to the age of the church building, the proximity to the busy highway with constant vibration from heavy trucks and seasonal exposure to de-icing chemicals has contributed to an accelerated rate of deterioration.

It appears that some of the de-icing chemical deterioration may have come from chemicals applied to the steps and sidewalks to make them safe to use during the winter conditions.

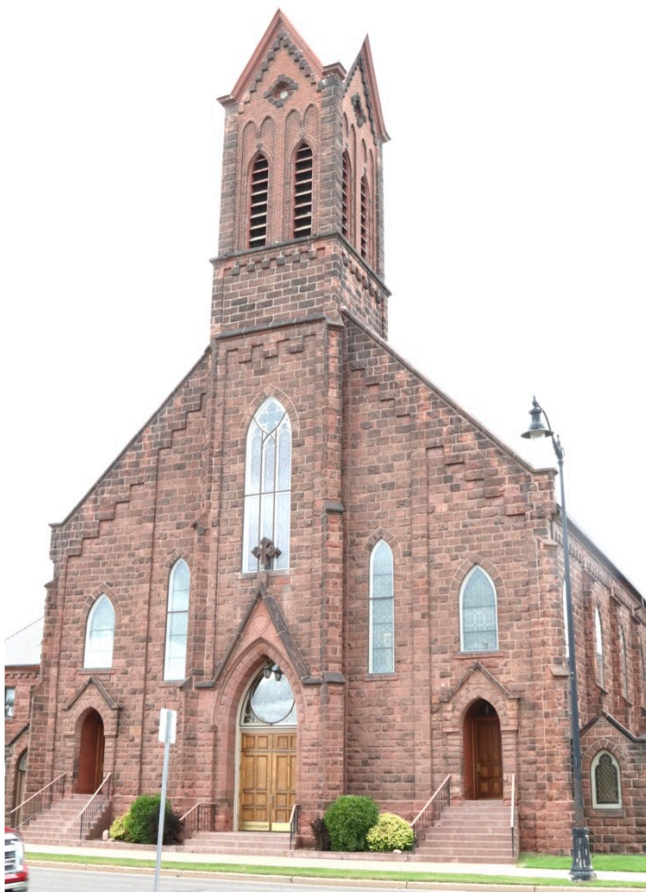
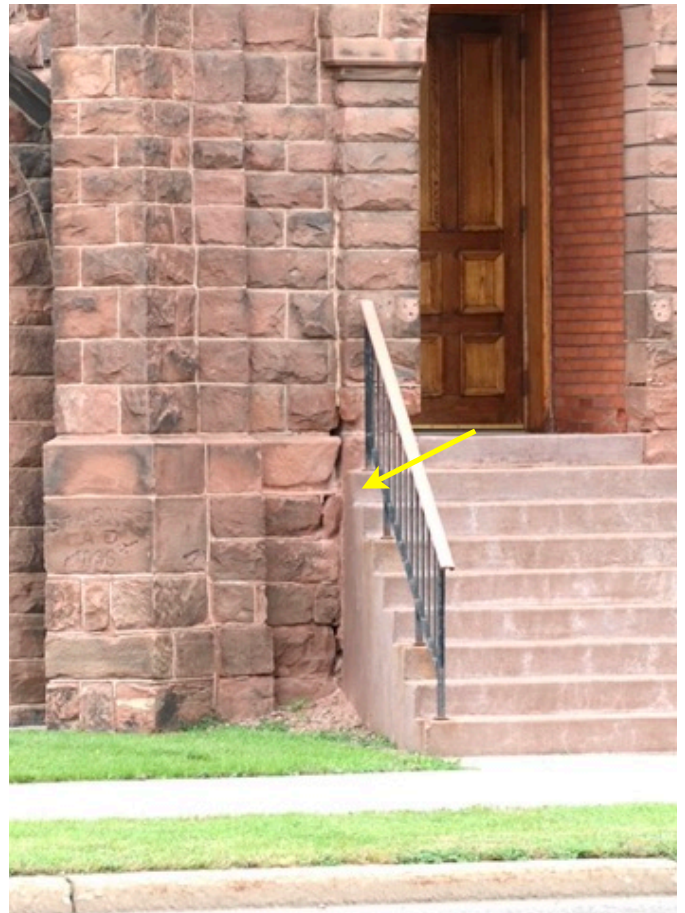
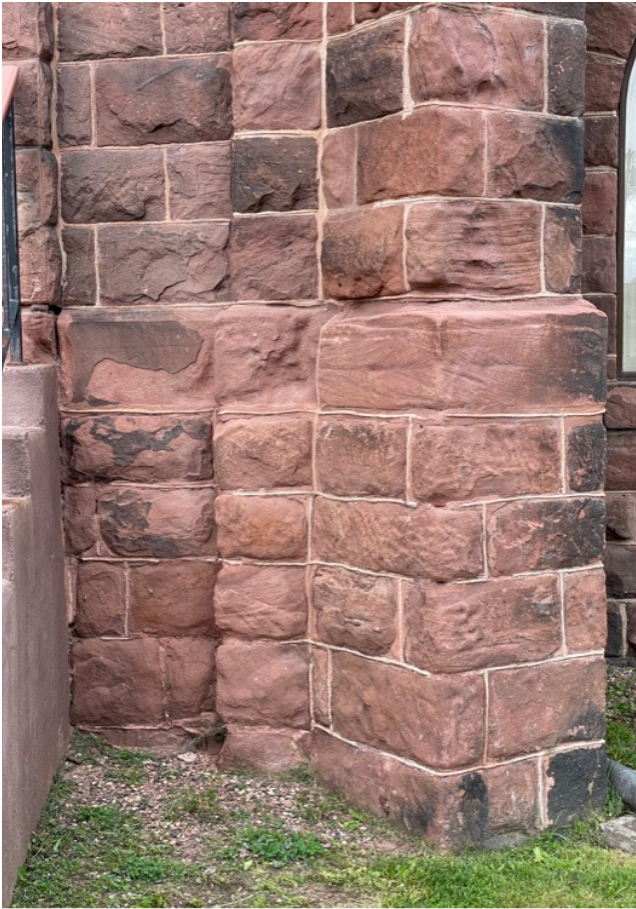
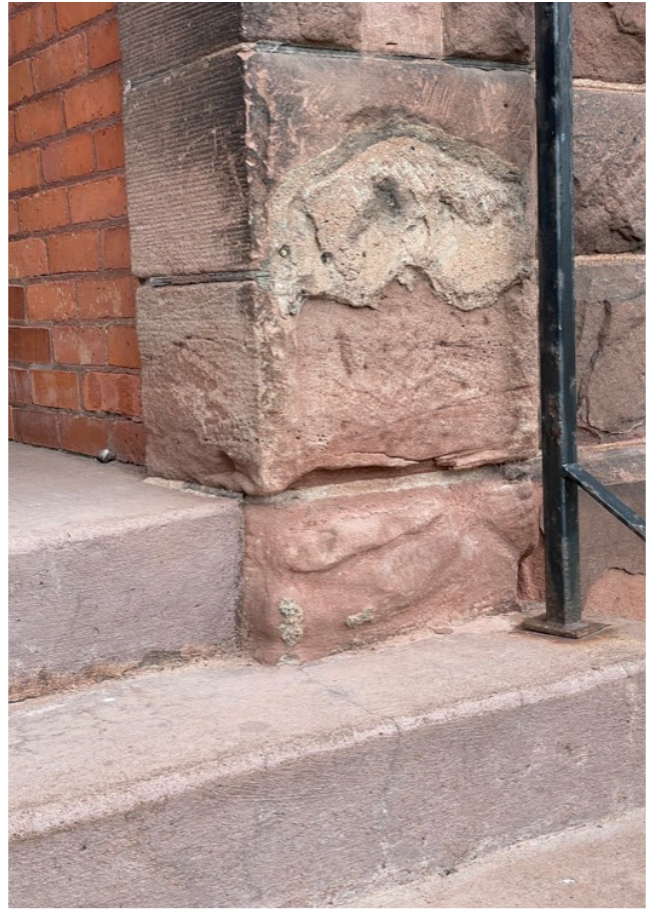
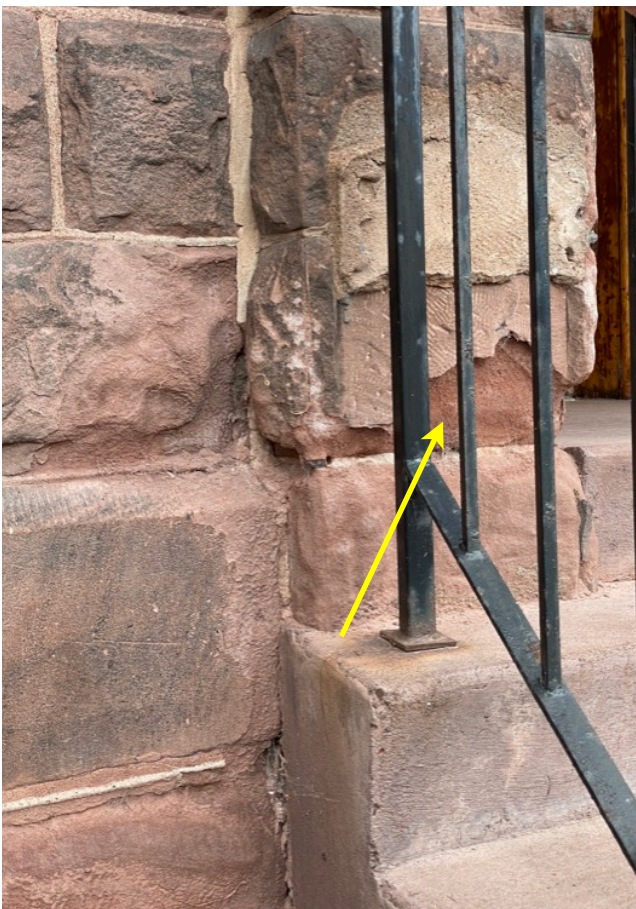
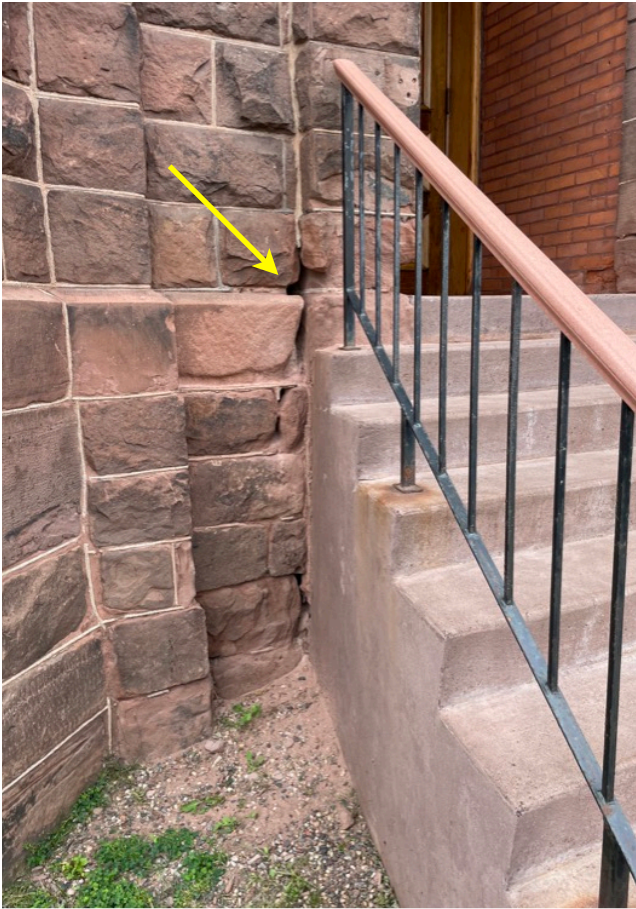
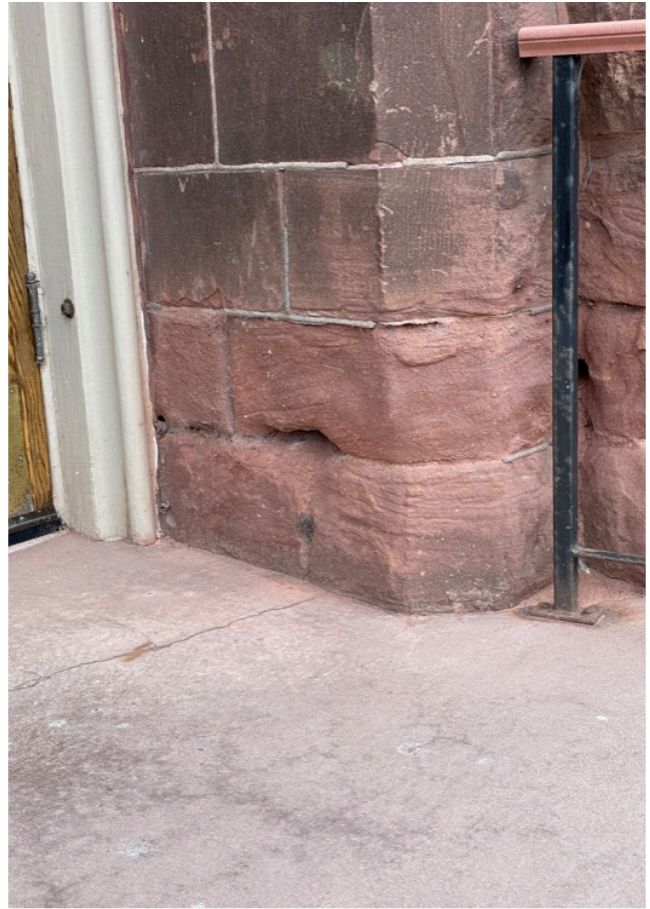
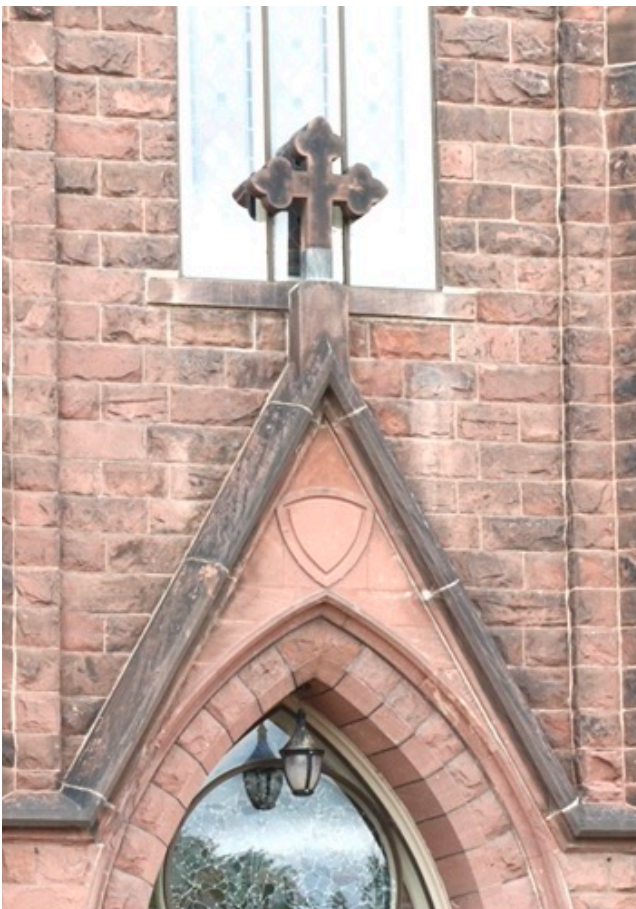
Examples of different types and degrees of stone damage are shown in these photos. Conditions run from weathering away of the stone surfaces to deep cracking and loss of portions of the stones. Recommended repairs depend on the individual stone conditions. In some cases, cutting back and replacing the surrounding mortar is a reasonable response. In other cases, entire stones may need to be replaced because the existing ones are too badly damaged to be repaired.

Unfortunately, Bayfield Brownstone like that used in the construction of the church is no longer being quarried, so finding repair stone that will match well with the building is difficult. There are a number of high quality stone patching materials available for repair of smaller cracks and spalls.

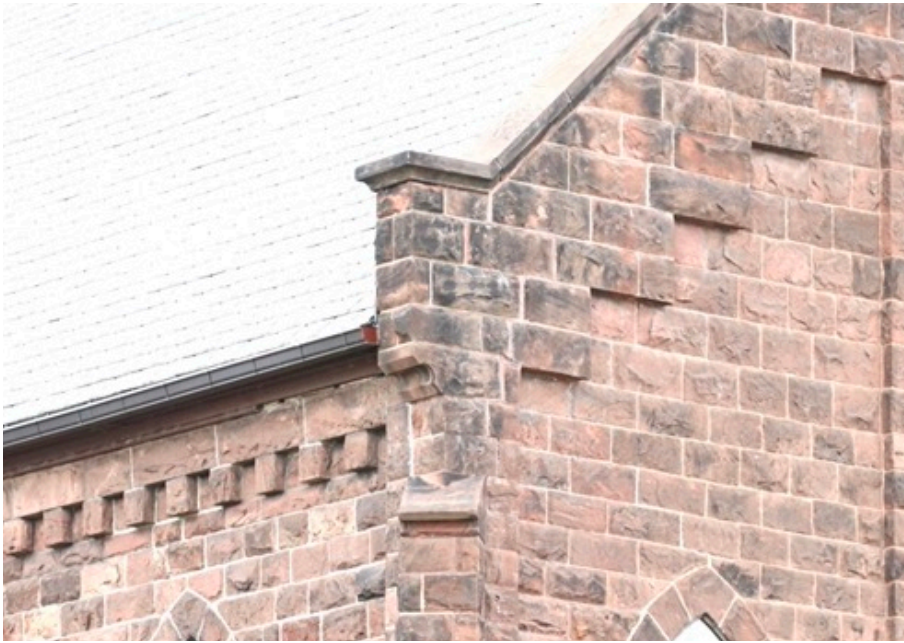
In 2015, loose stones were reset and anchored on both ends of the main gable wall. The stones appear to be stable as there are no signs of shifting or cracking of the masonry on either corner.

The intent of the 2015 project was a temporary stabilization with more comprehensive repairs to follow once finances allowed. In order to save money at the time, some damaged stone was left in place, and the mortar joints were not finished with the raised, beaded profile.

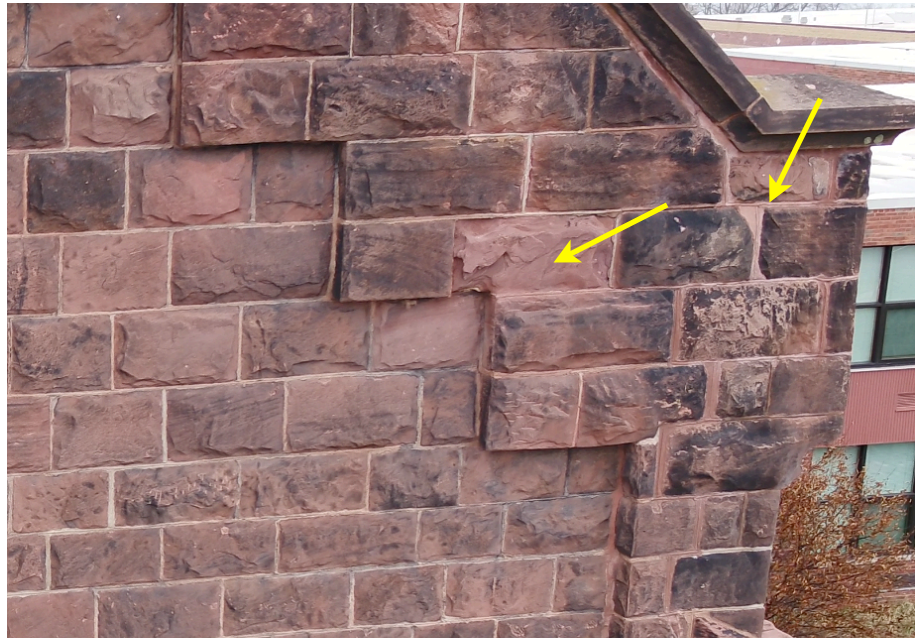
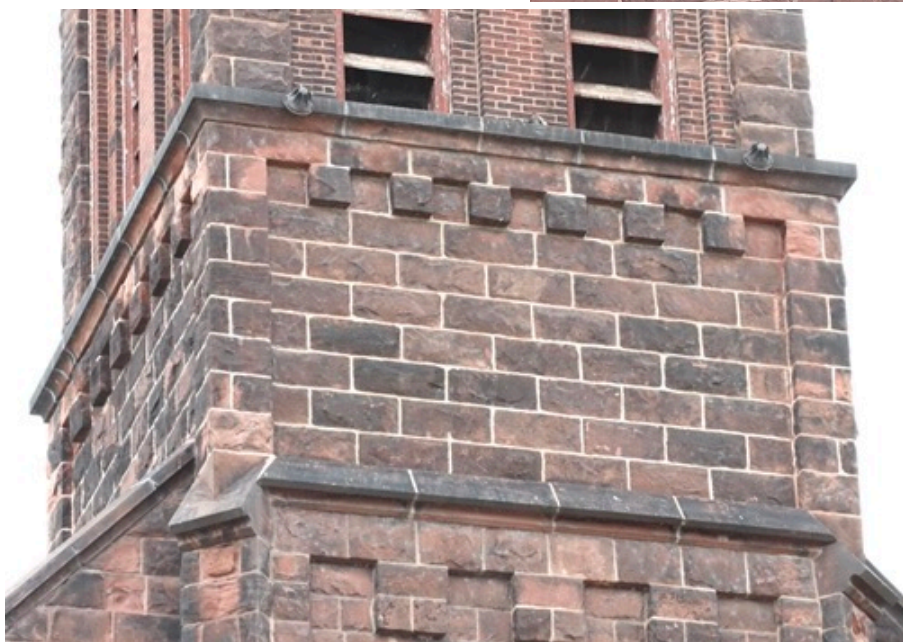
A noticeable feature of the church is that the stone exterior is badly soiled. Costs for chemical cleaning of the building are included in the attached budget estimate.

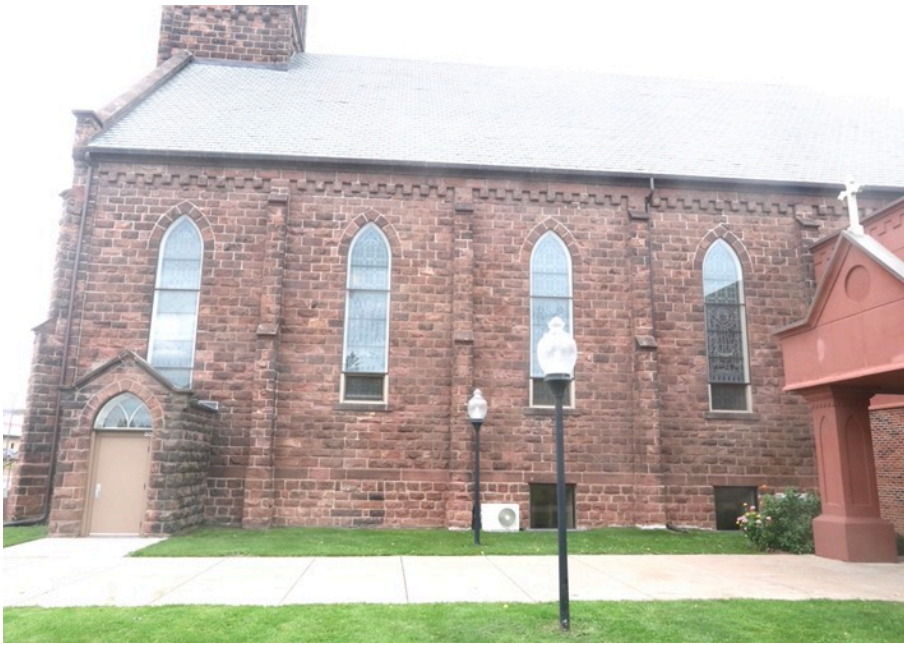
The east side of the church is also included in the attached budget estimate. We are recommending that 100% of the mortar joints be cut and tuckpointed as part of the work, but it is not possible to accurately predict the quantity of stone repair and replacement that will be needed until the work is under way. The estimate includes unit prices for this type of work item where the actual quantity can vary.

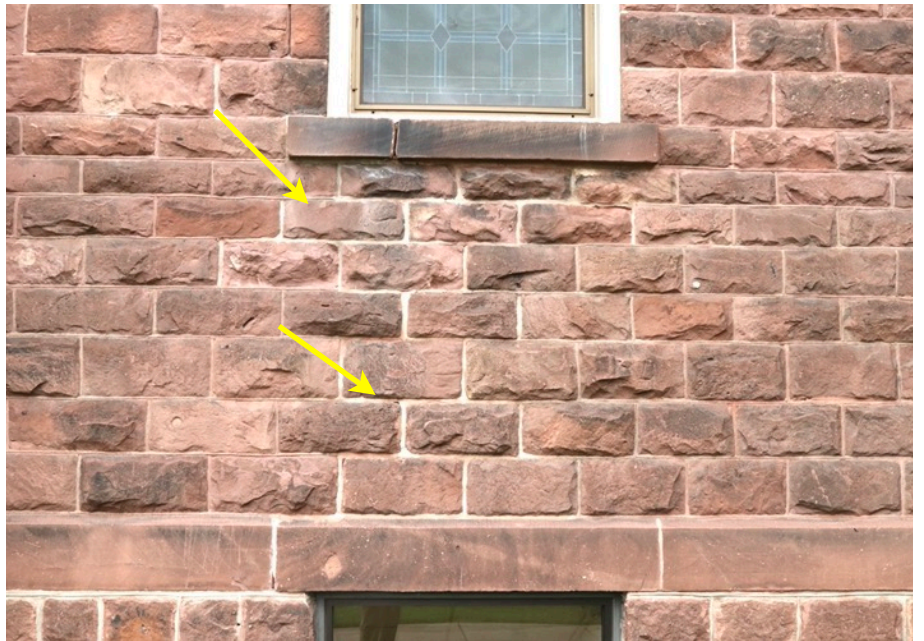
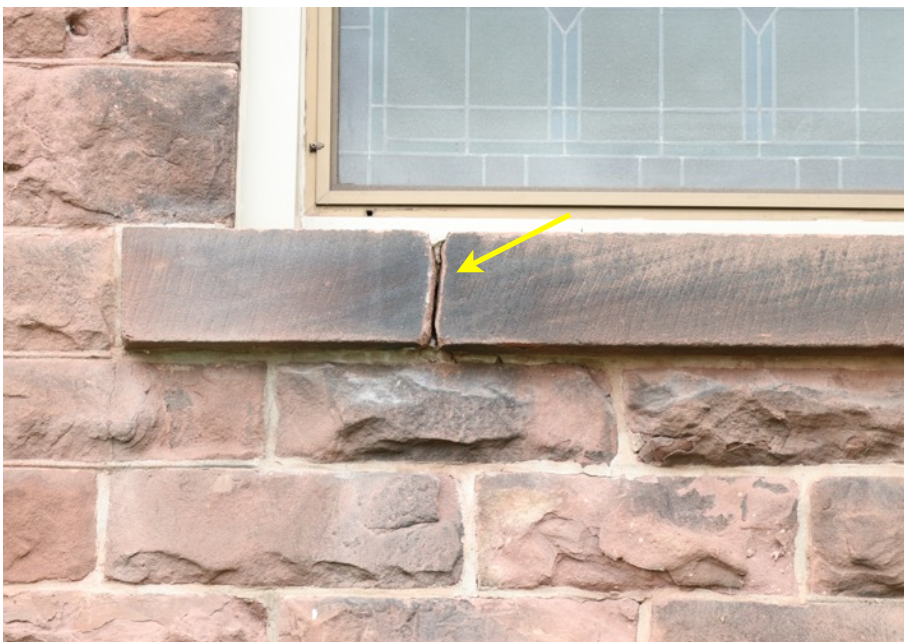
Movement in the building structure over time can lead to cracks in the mortar joints, and eventually in some of the individual stones. In this area it appears that a weakness in the structure between the upper and lower windows allowed a running crack to develop. The crack extended up into the sill of the upper window, and has created a path for water to continue to leak into the wall.

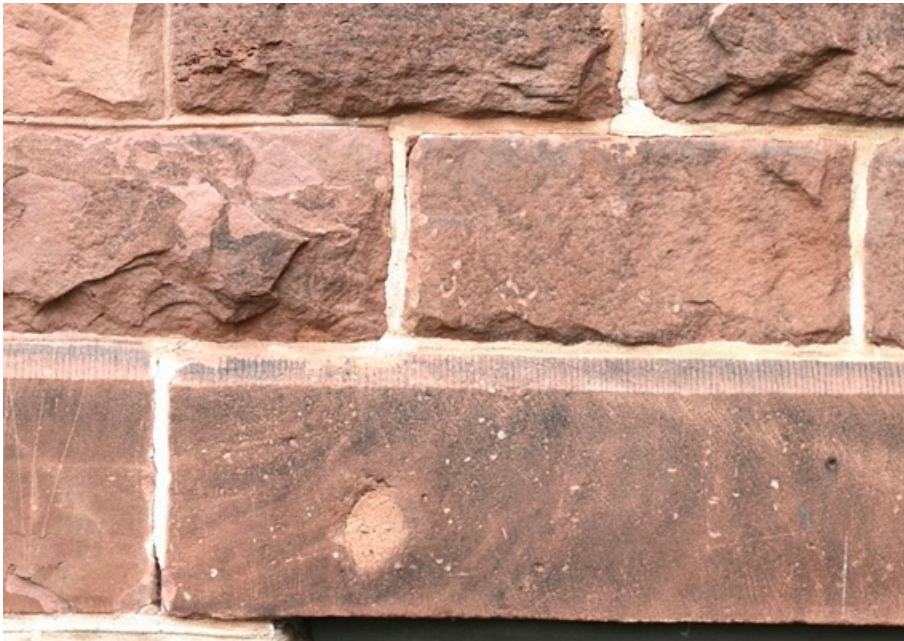
This close-up shows the opening in the sill stone. When the original mortar cracking was noticed, if the repair had been done properly it is unlikely that the crack would have spread to the point where the sill was cracked.

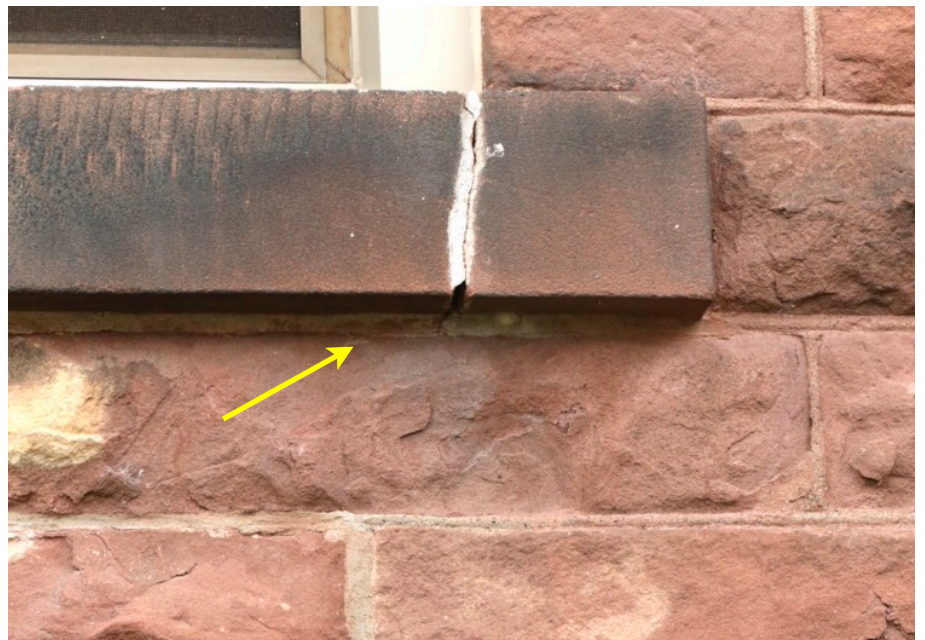
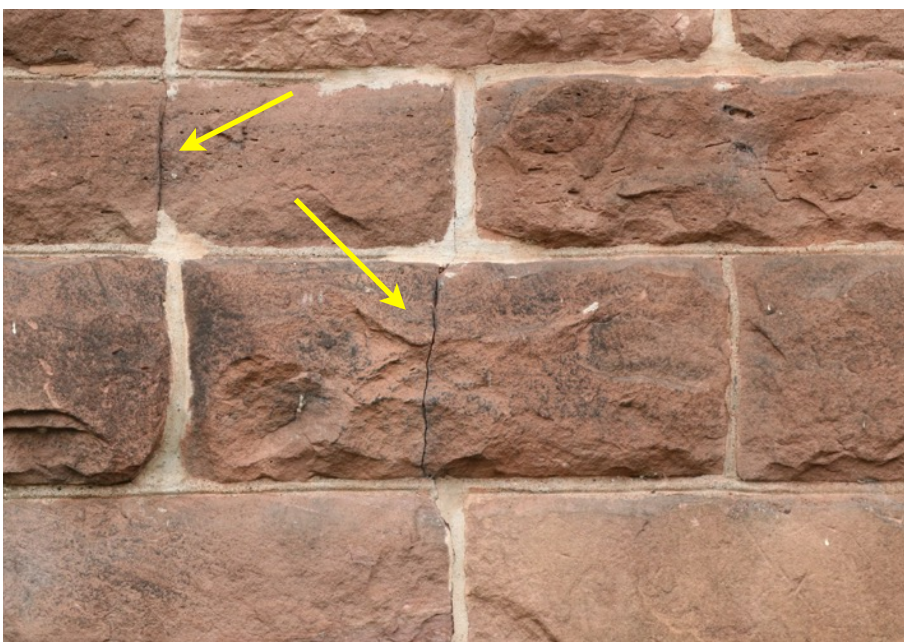
There are many examples of poor quality work on the building. Not only does the mixture of mortar colors and joint profiles look bad, it is obvious that this type of work is bad because the “repairs” have failed so quickly.

A more detailed examination of this cracked window sill will be needed to determine the most appropriate repair. Regardless of the repair chosen for this individual stone, unless the wall below is also properly repaired, the sill repair will not be durable.

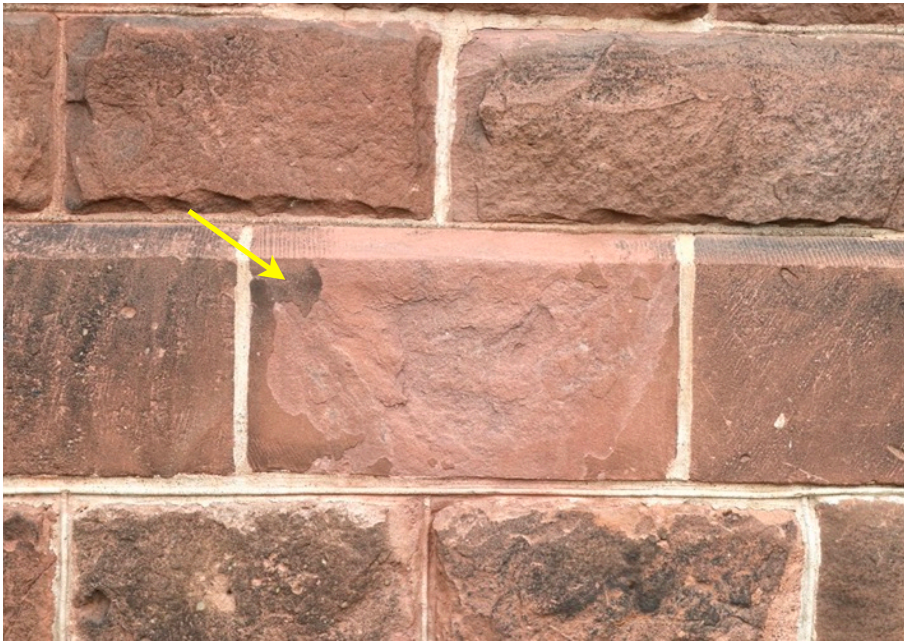
Narrow stone cracks like those pictured here can often be repaired using a combination of epoxy injection and surface patching.

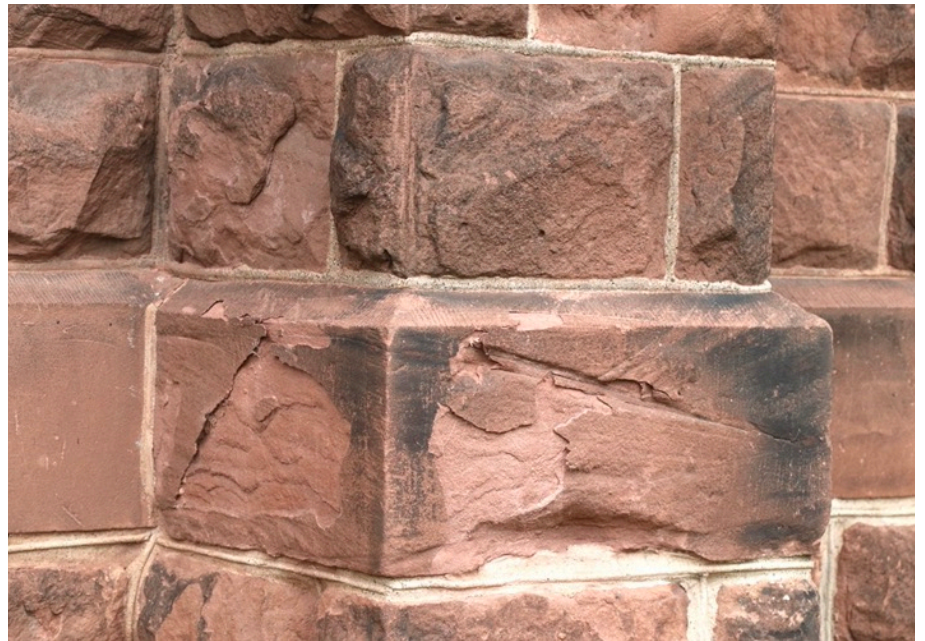
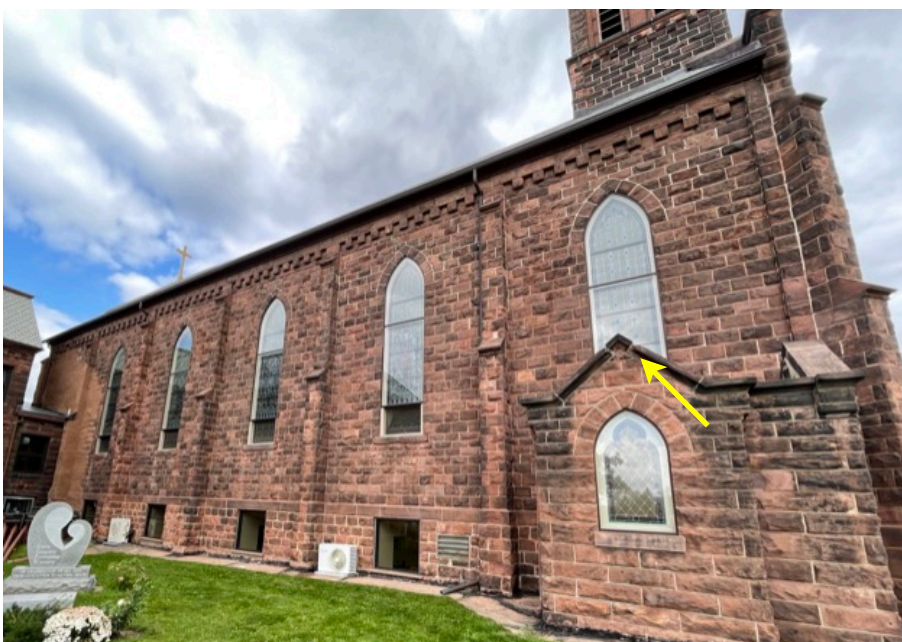
The condition where outer layers of a stone flake off is known as “spalling”. When the depth of the spalling is not too severe, it is sometimes possible to remove the stone and recarve the surface profile before reinstalling it. This is an especially useful option when working with historic stone that is no longer available from any quarries.

This is an example of a stone that may not be a good candidate for a patch based repair because so much of the surface area has been lost. Further examination will be needed to determine how deeply the “softness” extends into the body of the stone as part of the decision on the best repair option.

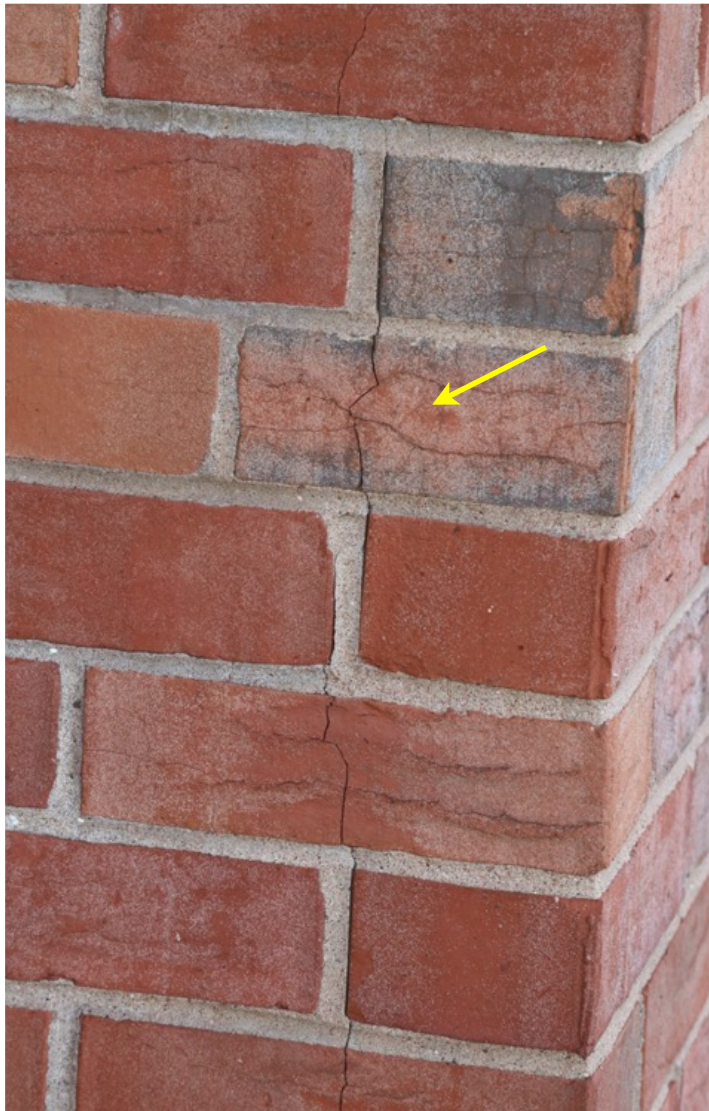
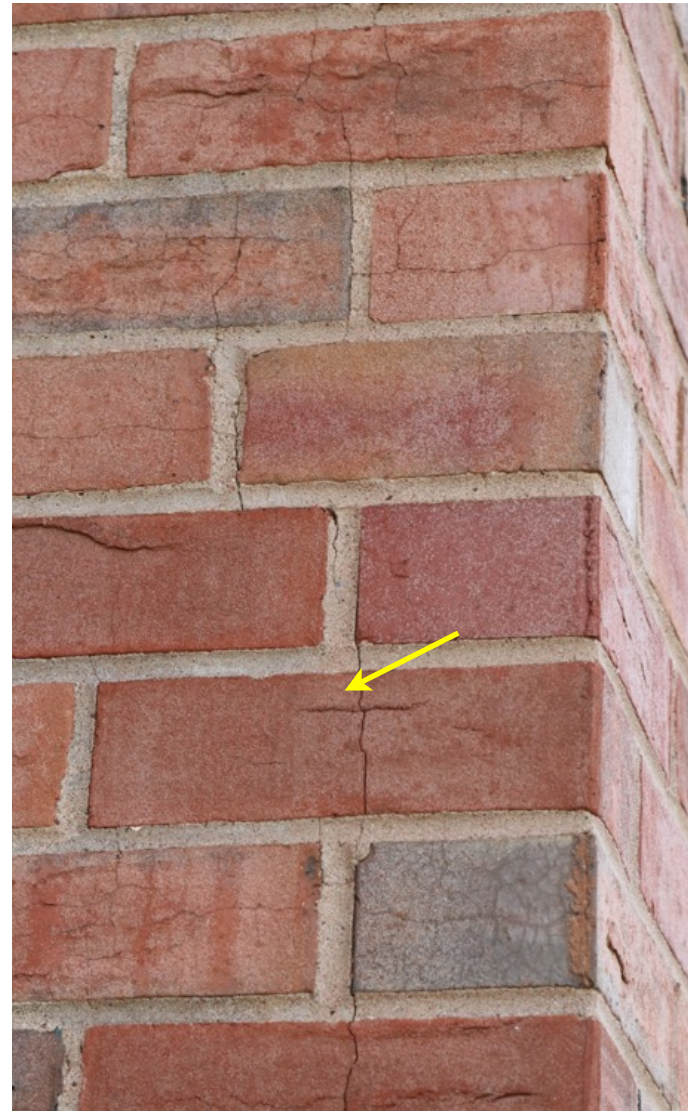
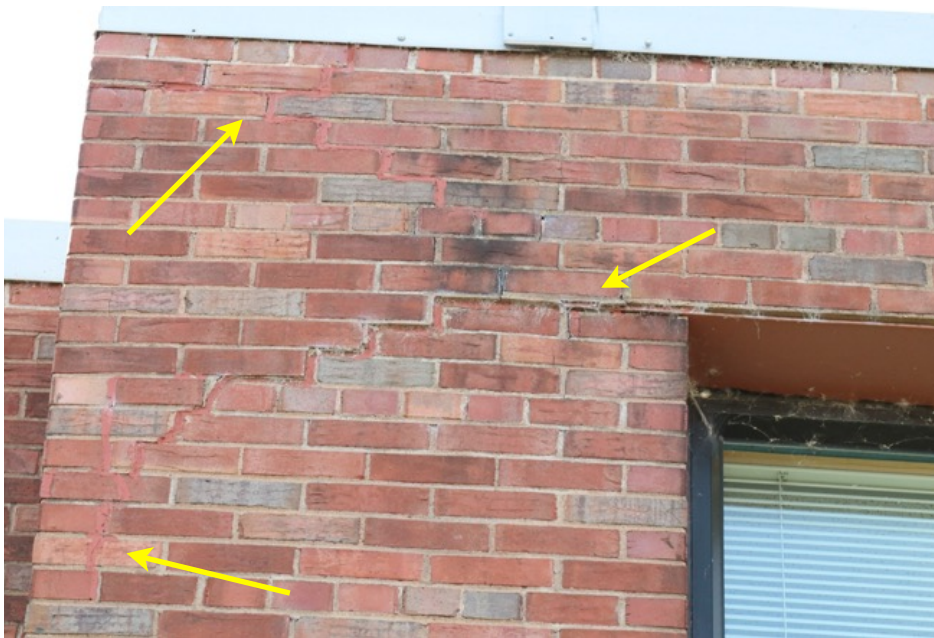
A large number of cracked brick are visible on the school. The close up photos below are from the area highlighted in the top photo. The running vertical crack is consistent with a brick expansion pressure build up. In this case, the expanding brick on the east elevation are causing this crack around the corner.

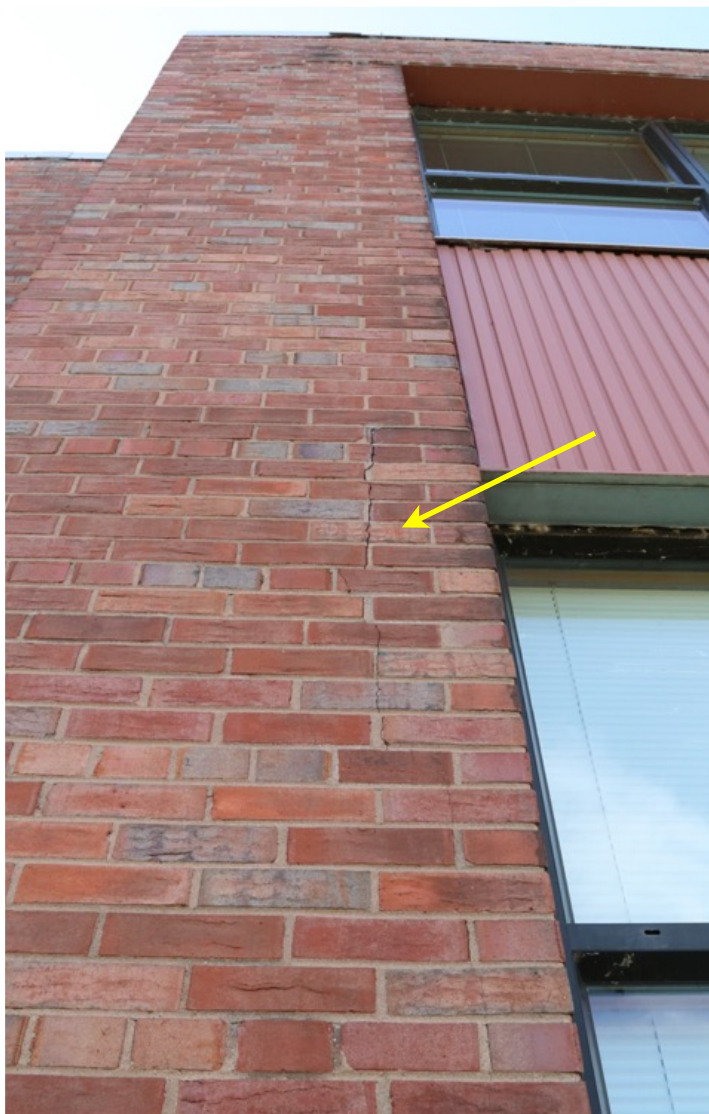
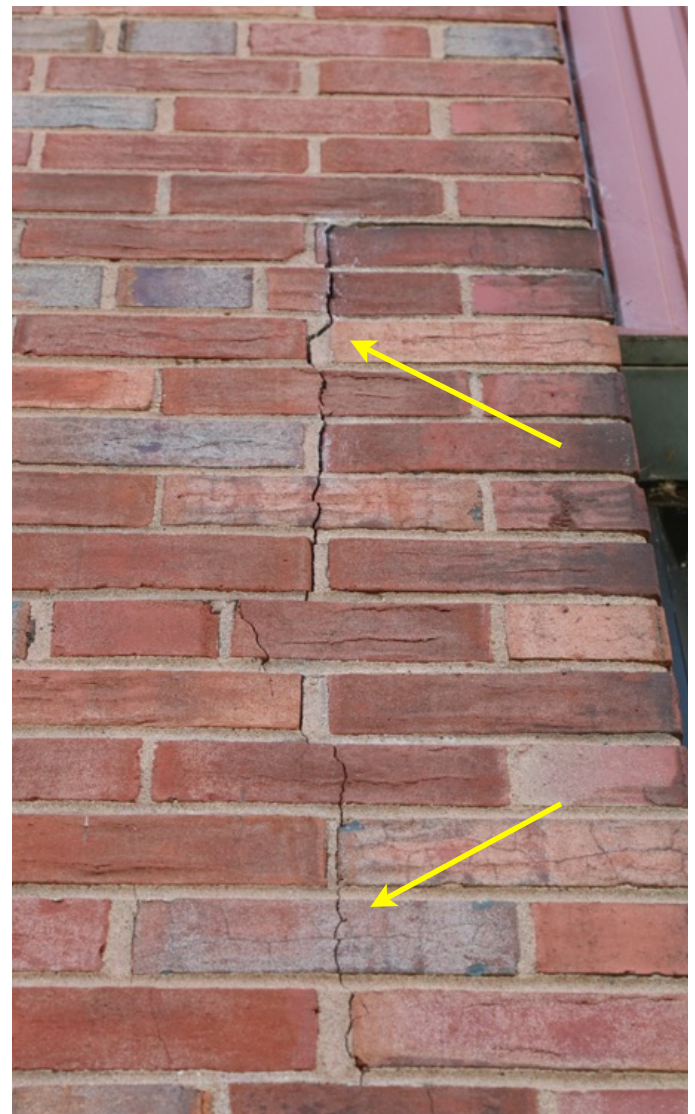
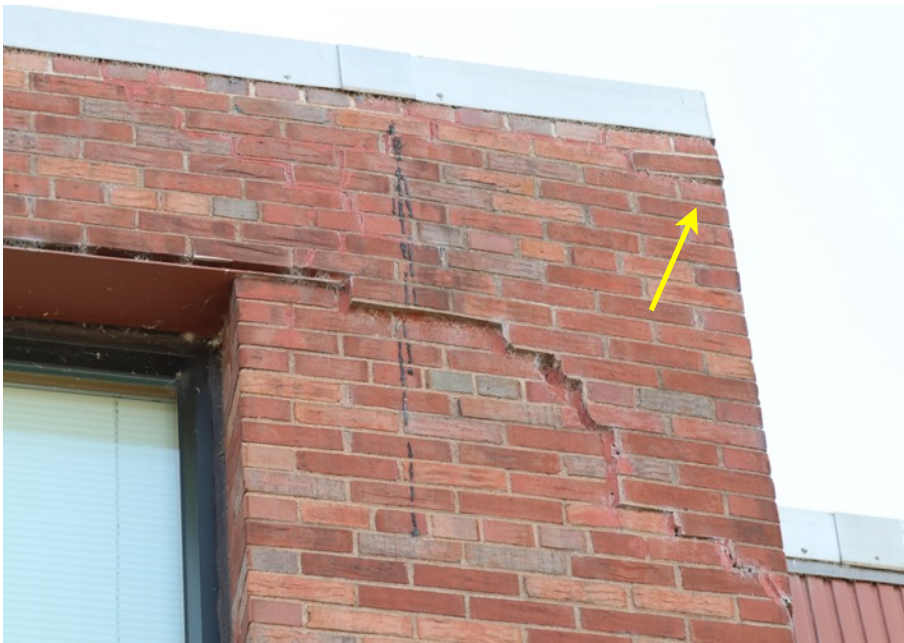
The cracking highlighted here is likely caused by the pressure from the build up of flaking pack rust on the window lintel. Close observation of this lintel showed that it has bowed down in the center. As a result, the ends of the lintel are lifting the brick to the left of the opening. The pressure is severe enough to break the bond of the mortar joints creating a typical “stair step” cracking pattern.

Further investigation will be required to determine the cause of the vertical cracking highlighted in the photos below. That investigation should include an examination of the roof cap that is immediately in line with the cracking. Finding and correcting underlying causes of damage during the course of a repair will result in a more durable repair.

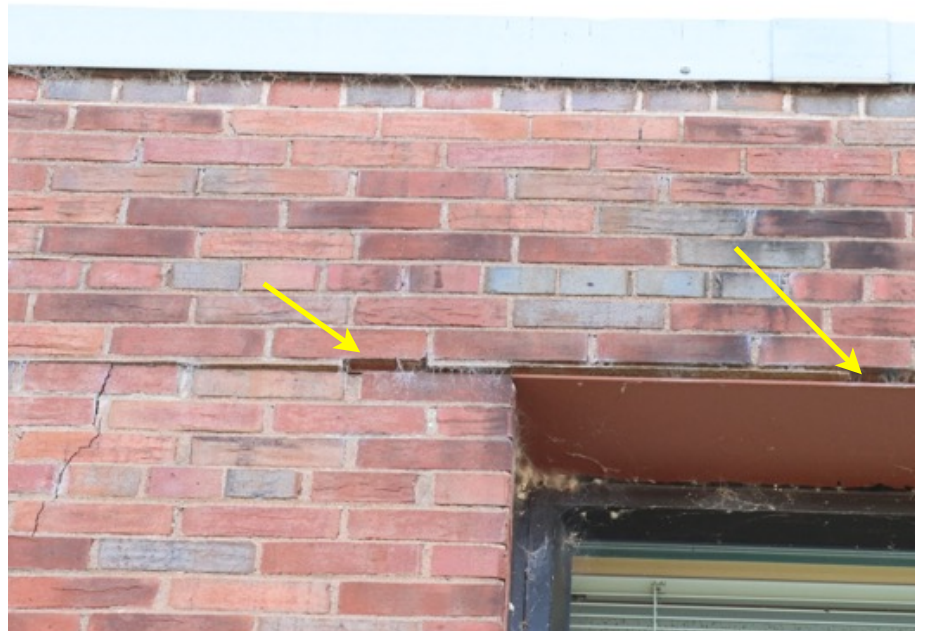
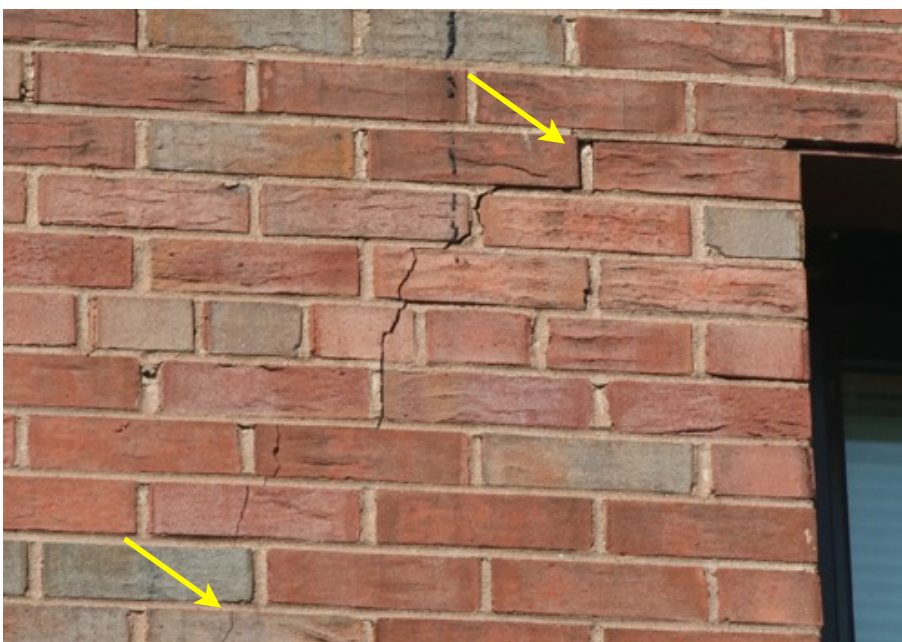
In addition to the stair step cracking pattern seen at several other windows on the building, there are displaced bricks at the top of the highlighted corner.

Based on the mortar being pushed out of the joint cavity at this location, the pack rust build up on the steel lintel must have gotten pretty thick at this location.

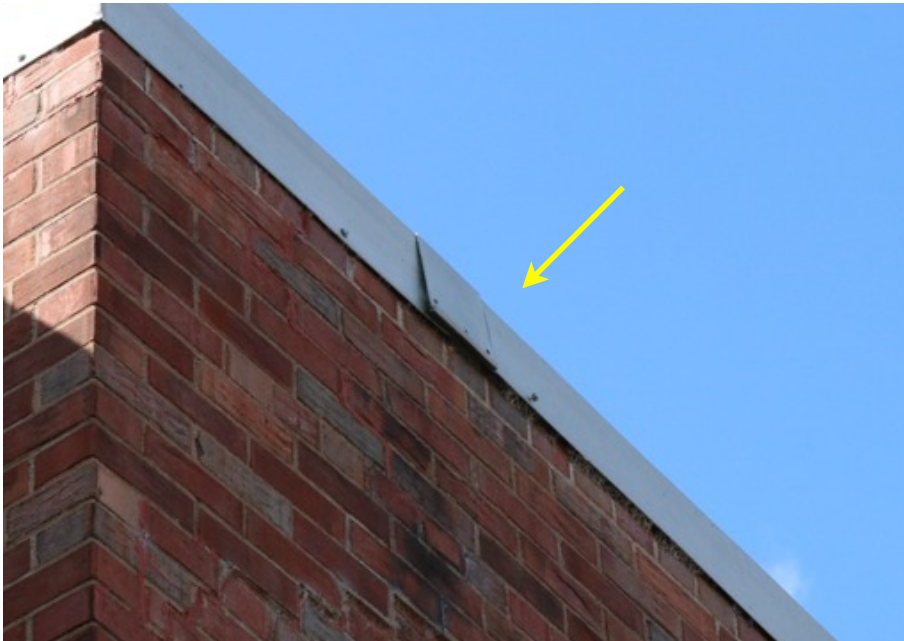
During the course of repairing this crack, a number of brick will be removed from the wall. This will provide an opportunity to see the construction detail and some of the interior wall conditions.

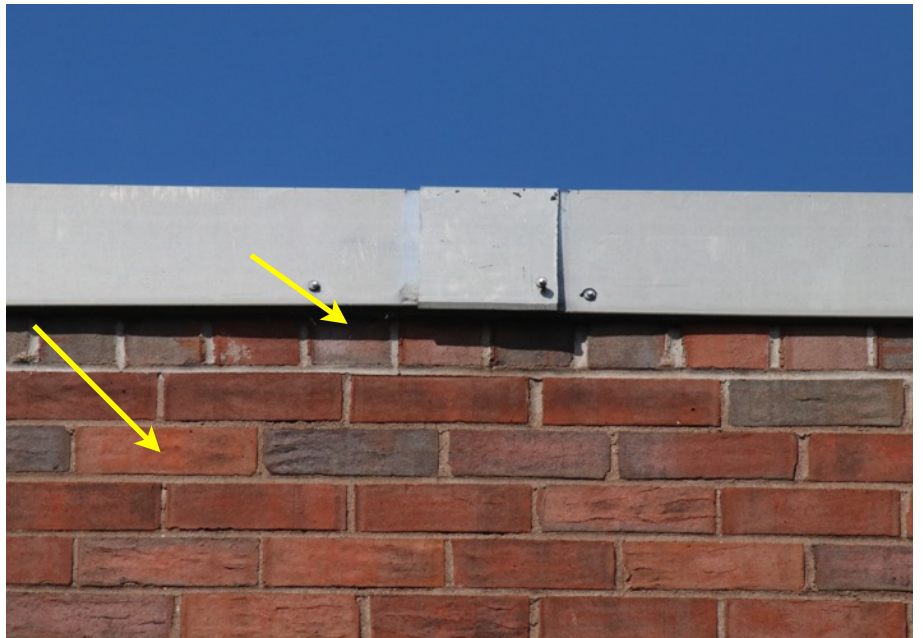
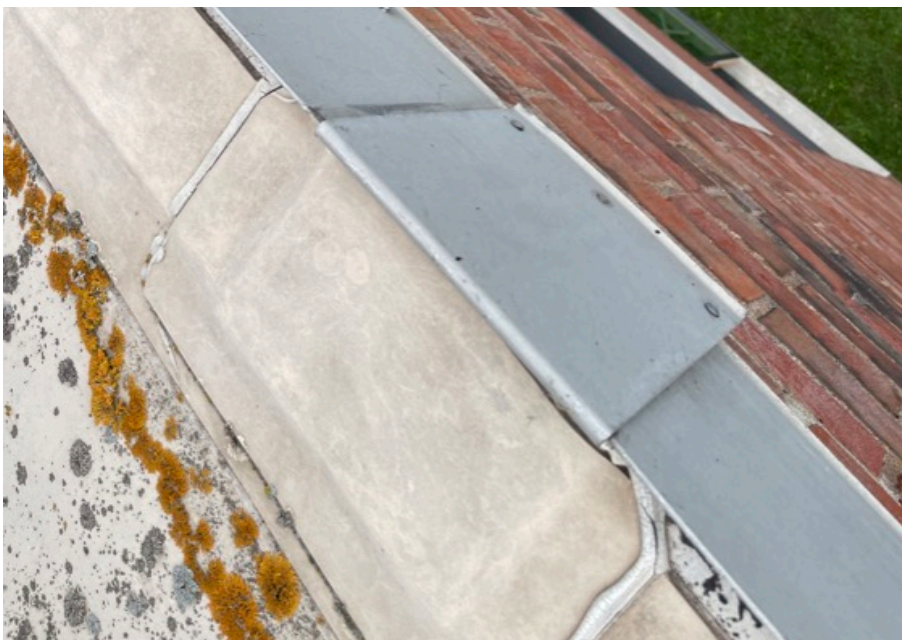
Several conditions observed in the roof perimeter cap system are likely having an impact on the masonry wall below. One of the most obvious conditions is that several of the cover plates between cap sections are coming loose.

There is a large gap between the roof perimeter cap and the face of the brick masonry. If wind driven rain is able to get into this gap, it is likely that some of the moisture will infiltrate into the top of the masonry wall. Any loose cover plates only create a bigger gap for potential water entry.

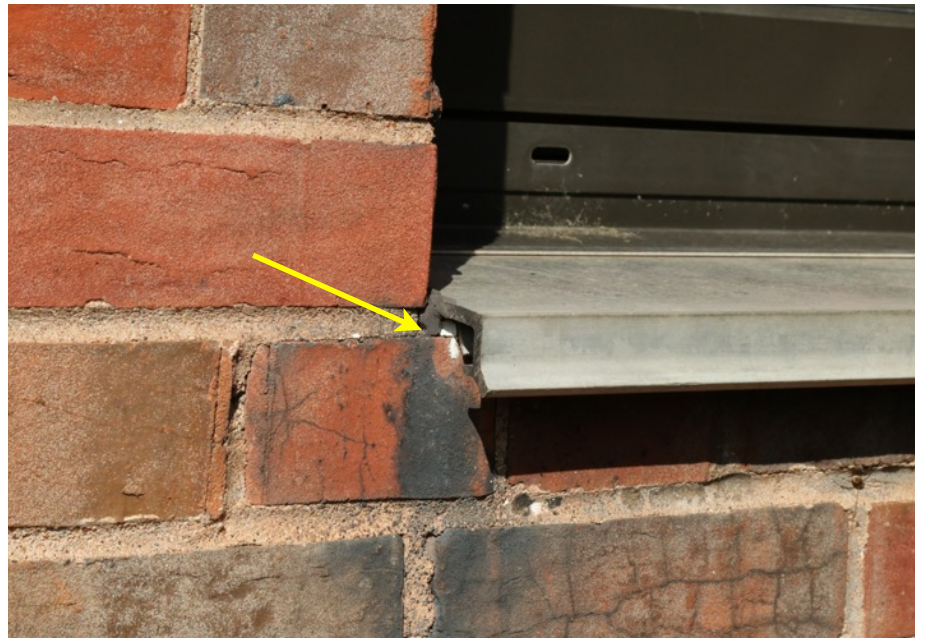
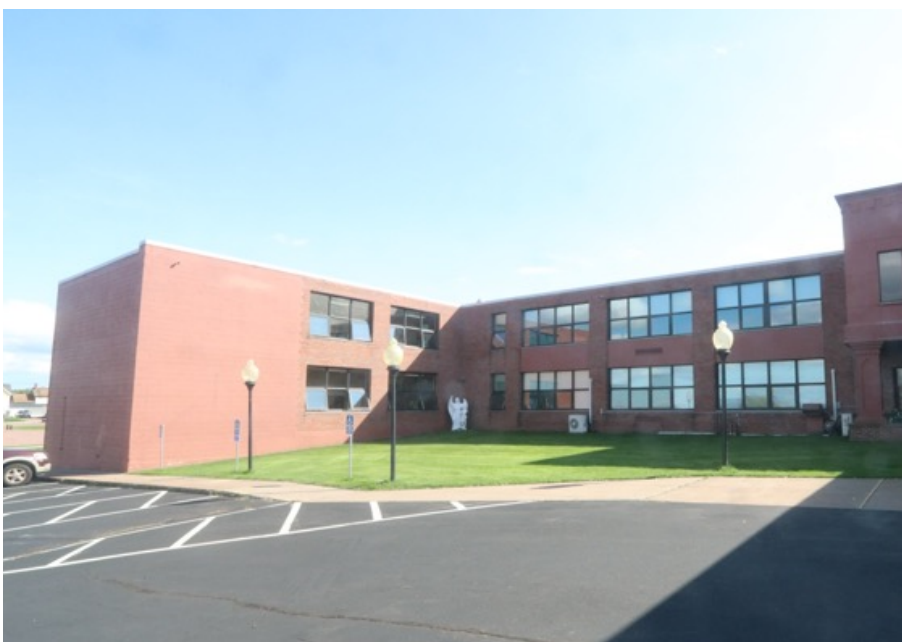
The window perimeter caulking sealant shown here is cracking and no longer providing protection against water infiltration. Also, the staining on the grey aluminum sill suggests that the sill is pitched back towards the building allowing water to pool at the joint with the window frame.

The construction detail of the joint where the sills meet the masonry wall below is such that water can easily get under and behind the sill. Consideration should be given to installing a water tight gasket or sealant joint at all of the similar sills on the building.
