BUILDING RESTORATION CORPORATION

November 13, 2023

**Our Lady of the Lake Catholic Church
2023 Masonry Repairs and Maintenance Budget**

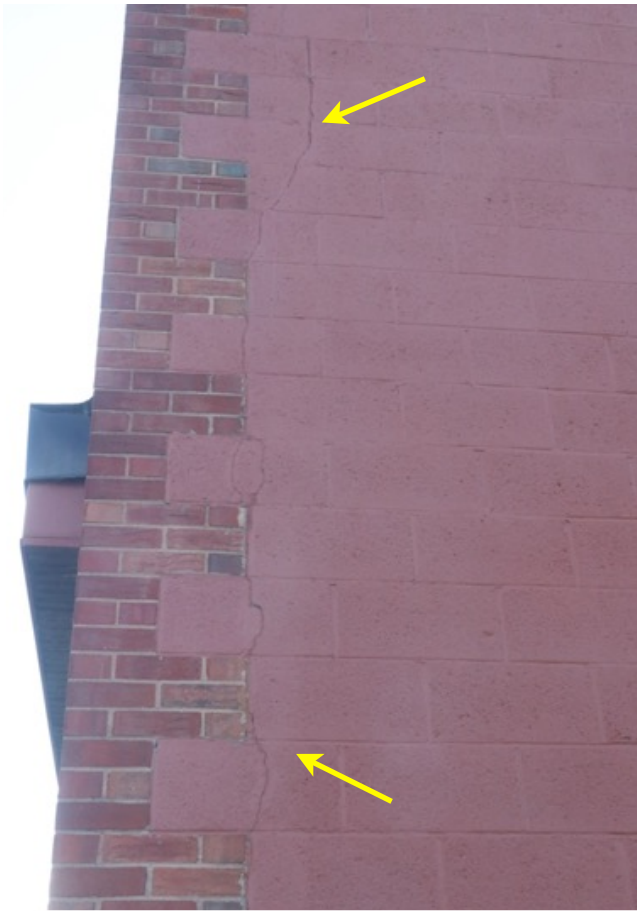
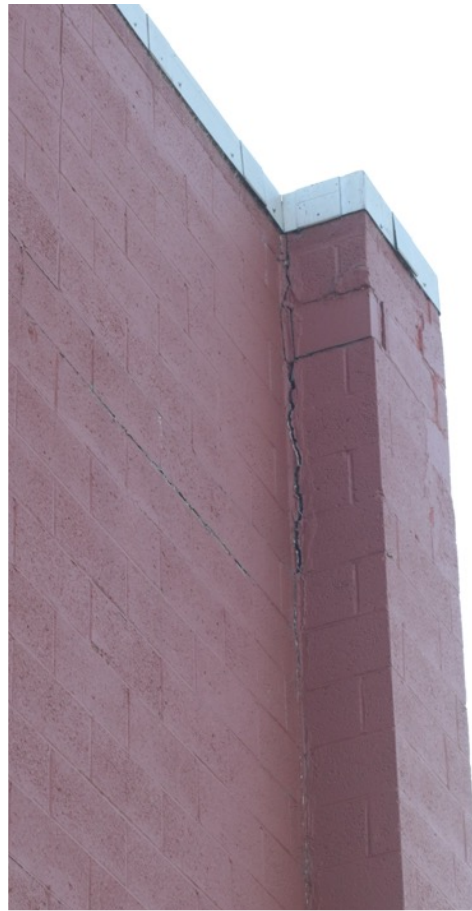
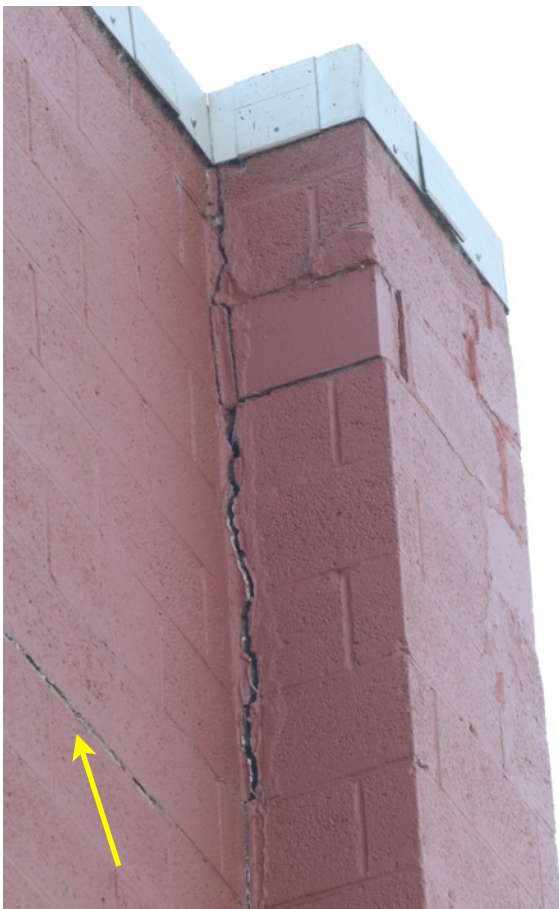
The north elevation of the school is shown here. The conditions are generally similar to the other school building elevations with the exception of the two concrete block walls.

Vertical cracking in the block wall sections of the building appears to be related to the lack of flexible control joints. The severe deterioration visible at the upper corner is typical of the damage caused by repeated cycles of freezing and thawing when the masonry is saturated. The full repair of this condition will likely require some work at the connection between the roofing and the masonry.

The horizontal crack highlighted in the photo to the left will need further investigation to determine the cause and appropriate repair, but it is consistent with rust expansion of block reinforcing “ladder” ties.
