# An automobile ownership retrospective

By MMOCC Member Steve Hall

1965 Corvair Monza Coupe

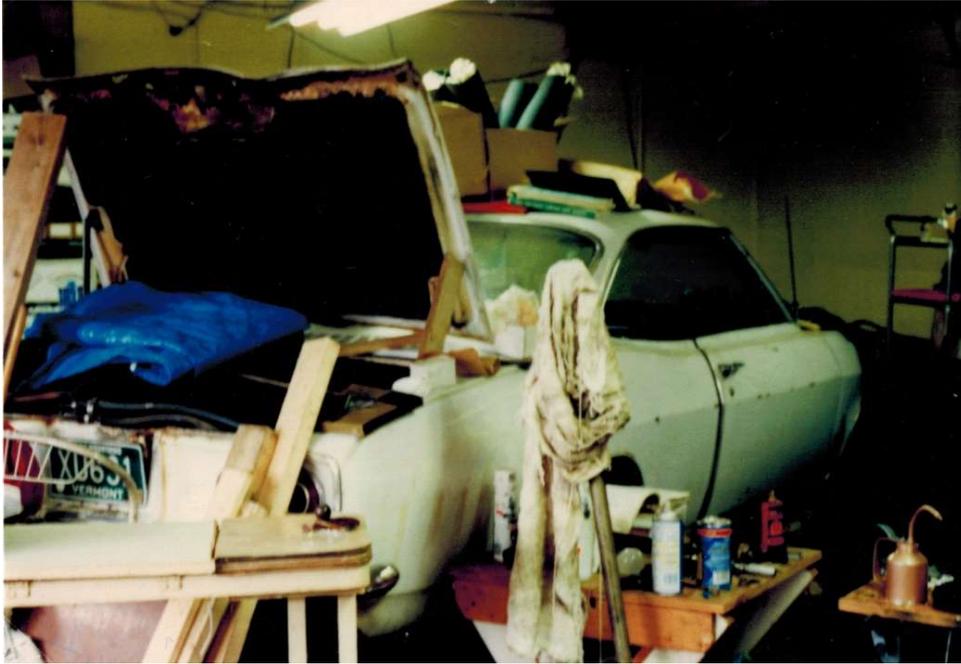
Corvair after bringing it home from the salvage yard in 1988 (engine lid required replacement)

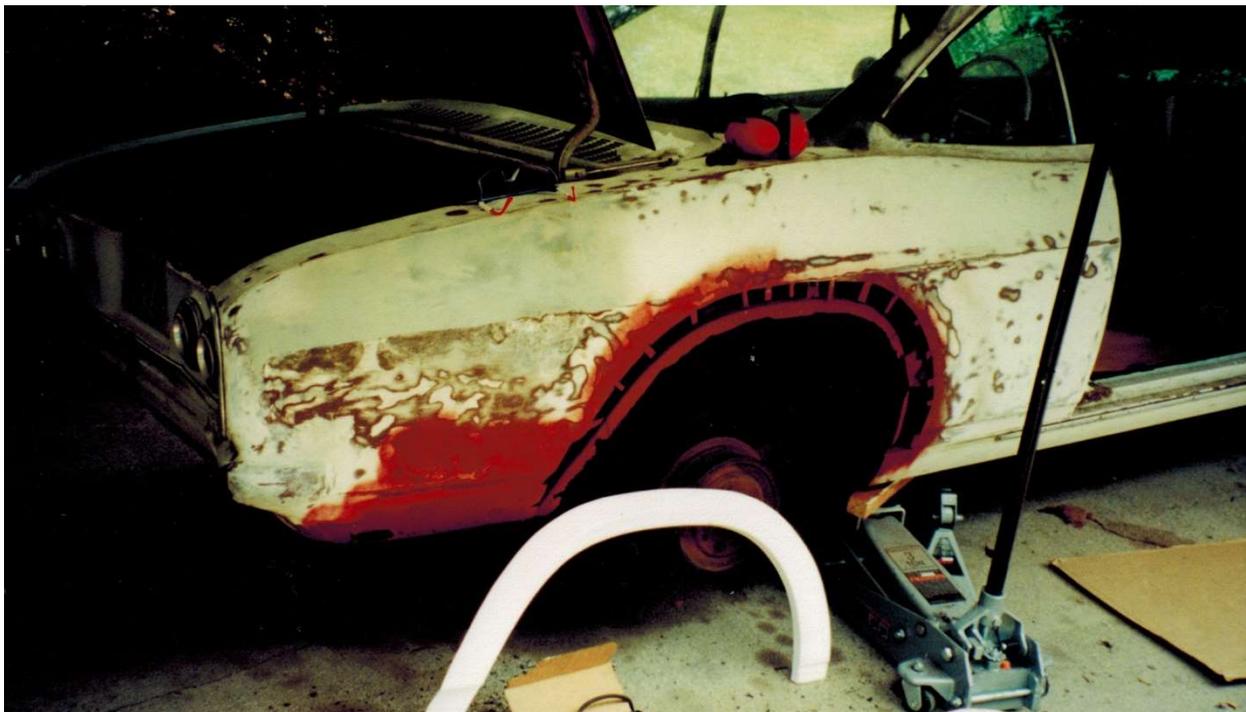
In 1993 I went to a shop to have the 1965 Monza state inspected and a ball joint was bad and rust had opened up in the rear wheel well and would not pass inspection. In New Hampshire there can't be any holes in the body panel skins what so ever to pass inspection. I was busy with school and moved on to another daily driver. The car sat for a number of years and when I started it one day a valve stuck on one head and bent a push rod. I decided it was time to rejuvenate the car. I met my wife Jamie in late 1999 and relocated to Jefferson City, MO in 2000. Jamie and I towed the vehicle out together on a trailer attached to the U-haul truck. Soon after we were married, my son Darby and daughter Josie were born, so the 'restoration' of the Corvair progressed very slowly over a number of years. I finally pushed myself to finish the car in 2012.

Wheel well area with rust cut away in 2001

Let me first start by saying I 'hate' doing bodywork and I'm not the best at it. However, doing the bodywork myself saves a significant amount of money that... guess what... goes into other car projects! I'm also not very diligent about documenting my work on my vehicles since I'm using them for my own pleasure rather than preparing them for resale. The only reason I have some of the restoration photos for this article is that when Jamie and I got back from our honeymoon in 2001 there were several camera shots left on the roll of film in our camera (remember the days of camera film ASA rating, shutter speed and F-stop settings?) and needed to use them up so we could get the film roll developed. The Corvair was manufactured of unit body construction, which is good for strength and stability, but most unit body vehicles of this era and others suffer from the propensity to rust where the body panels are spot welded together with layers of overlapping steel panels. This has the unfortunate consequence of trapping any water and moisture that makes its way onto a car floor, rocker panel, wheel well or countless other locations in the body. Although, my 1965 Corvair appears to have spent its early life in Florida, it spent enough years in New England to require attention to areas of the body. The most significant area of rust was the rear wheel wells where the inner and outer body panels are spot welded together. Basically it all rusted away around the edges. In the late 1990s I repaired the left side wheel well area by welding metal to make the repair. The issue with that method was there are many compound angles in the wheel well and I had to 'excessively' skim coat the repair and it took hours of work. In the early 2000's I took a different approach to the right side rear wheel well. I purchased a fiberglass piece from Clark's Corvair Parts. I cut out all the bad metal and bent recessed 'tabs' roughly evenly spaced over the radius of the wheel well to act as a support for the fiberglass piece. I pop riveted the fiberglass molding to hold it in place while adding layers of fiberglass to it and the

wheel well. This method took significantly less time and looks, to the discerning eye, quite a bit better than the other side. Note to restorers- If you use the pop rivet method to align the panel you should drill out the pop rivets when you finish the fiberglass overlay and fill the holes. This will help prevent future flexing of the rivet/panel spot, paint chipping, and corrosion later.
