January 29, 2018

RE: 146 Santa Fe Ave
Lawson, MO 64062

Confidential Inspection Report

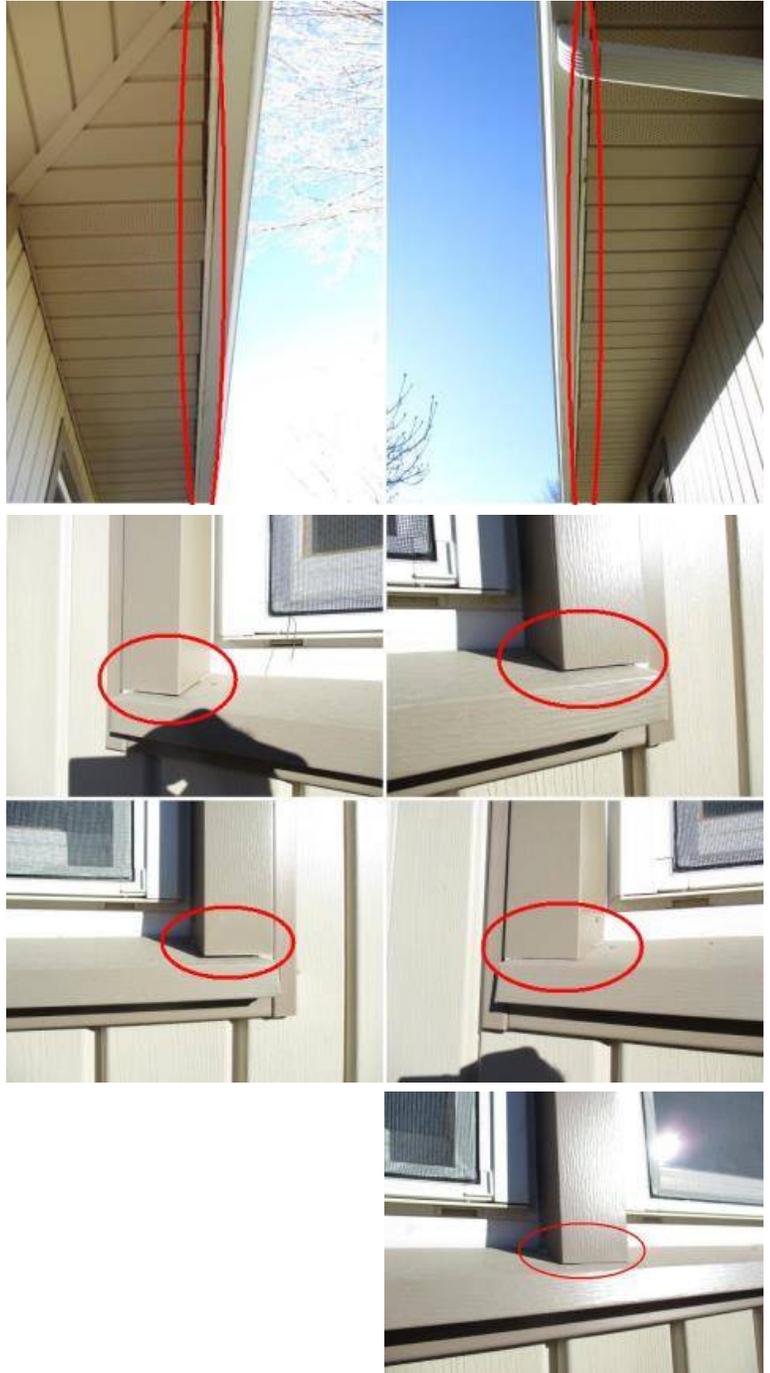
2.3 MATERIAL AND CONDITION:

The exterior trim was wood, and metal wrapped wood. **The caulk at the joints at the metal covering around the exterior trim around the windows was missing. Caulking these joints is recommended. The inside soffit channel trim was missing off back side of fascia. Repair is recommended.**

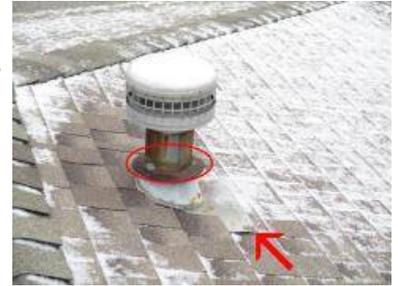
2.5 CONDITION:

Raised flashing viewed at roof. The storm collar sealant was missing. A storm collar is a necessary flashing around chimney flue piping to prevent water entry. Replacement of sealant recommended. Consult qualified roofing contractor for further evaluations and necessary repairs.

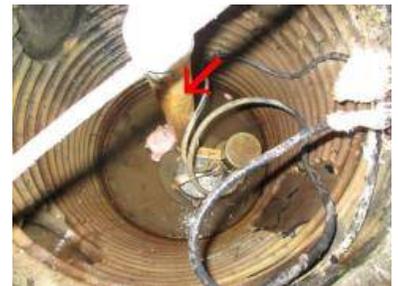
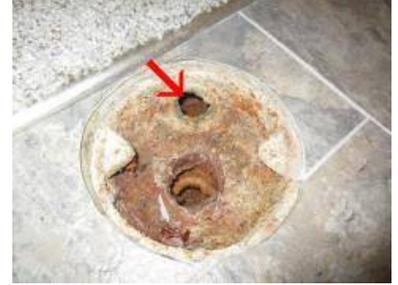
3.3 FLOOR DRAIN & SUMP PUMP: TYPE AND CONDITION:

The basement floor drain clean-out plug was missing. It is recommended that a clean-out plug be installed to prevent potentially volatile and unhealthful sewage gas from escaping into the interior of the home.

No check valve was installed on the discharge pipe of the sump pump. Installation of a check valve is recommended to prevent water re-entry into the sump pit when the pump stops. Hole viewed in drain pipe at top of pit area. Recommend repair. Contact a qualified plumber for further evaluation and repair or improvement as necessary.

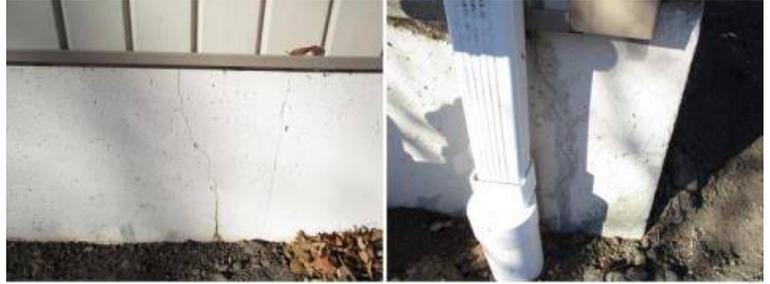
3.4 WALLS: TYPE AND CONDITION

The basement foundation walls were poured concrete. Some of the foundation wall(s) was/were concealed and could not be fully inspected. **The S side wall has moved. Bowing/cracking is evident. This condition is caused by exterior ground pressure due to improper terracing. Wall restraints were installed and appear to be functioning. It is recommended that the condition be periodically monitored. If any worsening of the condition is detected, contact a professional engineer for further evaluation. Recommend obtaining all documentation on repair work done.**

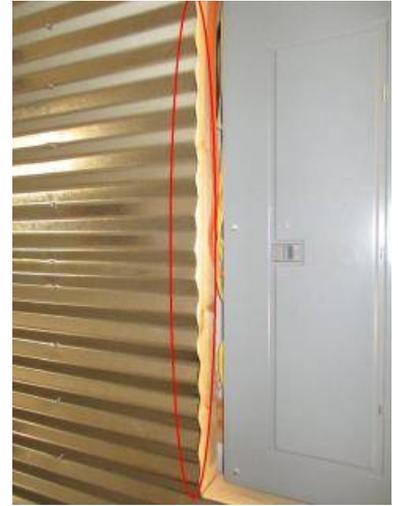
3.12 OTHER OBSERVATIONS:

The S side wall was covered over with sheet metal. Sharp edges viewed at various areas. This condition presents a safety hazard. Repair or improvement is recommended for safety purposes.

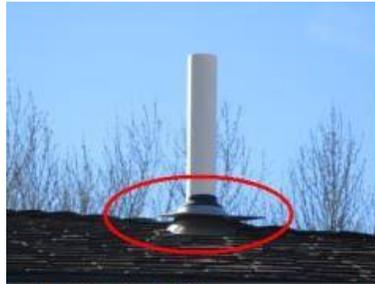
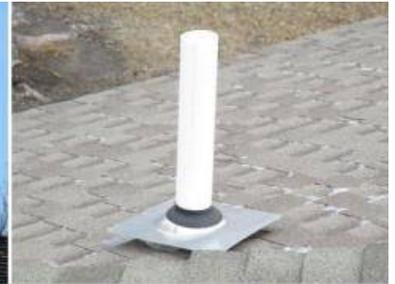
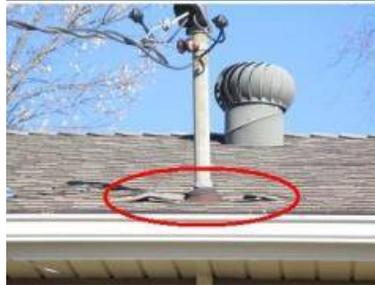
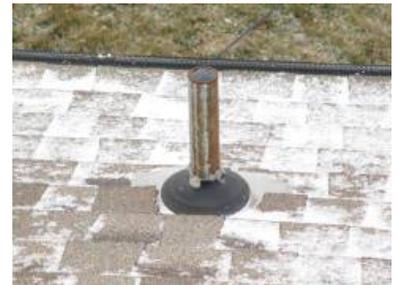
4.10 TYPE & CONDITION:

Metal and rubber roof flashings were present. Most of the roof flashings appear to be serviceable. However, some areas require attention as follows: **The N side rubber boot flashing that provides watershed from around plumbing vent stack through roof was improperly installed. Replacement/repair is recommended.**

Raised flashing was viewed at electrical mast roof flashing. Repair is recommended. Consult a qualified roofing contractor for further evaluation and repair or improvement as necessary.

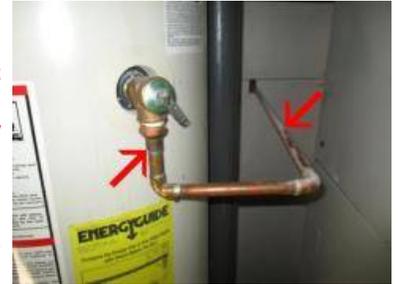
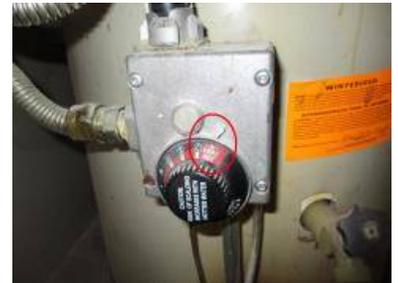
5.9 CONDITION:

The water heater has exceeded the end of its average economic life. Short remaining life should be anticipated.

The temperature setting at the water heater was set in a high range. Check the manufacturers' instructions for proper setting of the water heater for safety purposes. Thermostat on water heater is set at the hottest setting. This usually indicates the demand for continual hot water is not being satisfied.

Consult a qualified plumber for further evaluation and repair or improvement, as necessary.

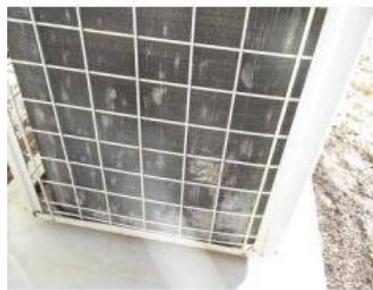
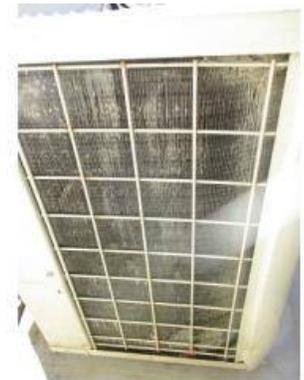
6.15 SYSTEM CONDITION:

The cooling system could not be operated due to the low outdoor temperature. Operation of the outdoor compressor/condenser unit when the temperature is below 65 degrees Fahrenheit could result in system damage. Have the cooling system evaluated by the appropriate professional when the conditions are favorable.

The cooling system has exceeded the end of its average expected economic life. Short remaining life should be expected.

The fins over the coils of the outdoor condensing unit were bent. Dirt, and or bent fins can block air flow and reduce cooling performance or cause damage to the system. Combing of the fins is recommended. Exercise care during cleaning so that the delicate fins are not bent or damaged.

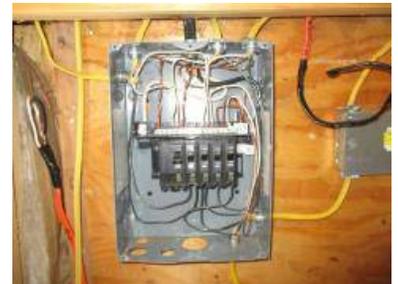
7.5 SUB PANEL: TYPE & CONDITIONS:

Circuit breakers were present in the sub panel box. **The neutral and ground wires were not separated in the electrical sub-panel box. These wires should be separated in all locations, other than the main panel box to conform to the electrical construction standards. Open unused wire slots viewed. Seal as needed. Consult an electrician for further evaluation and repair or improvement, as necessary.**

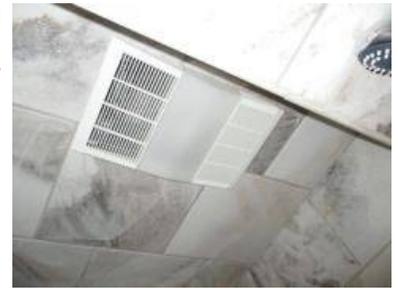
7.10 CONDITION:

Noted: The light/fan in lower level bathroom was not rated for wet use, and improper clearance over shower. This condition presents a safety hazard. Repair or improvement is recommended for safety purposes. Consult a qualified electrician for further evaluation and repair or improvement as necessary.

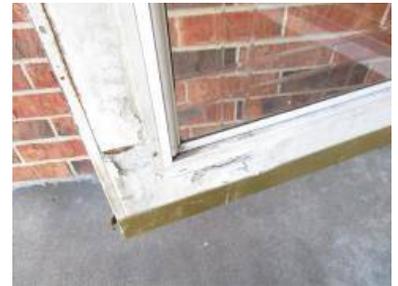
8.1 MAIN ENTRY DOOR:

The main entry door was steel. **The front door does not properly latch. Adjustment to striker plate at door jamb is necessary. The storm door was damaged. Repair is recommended.**

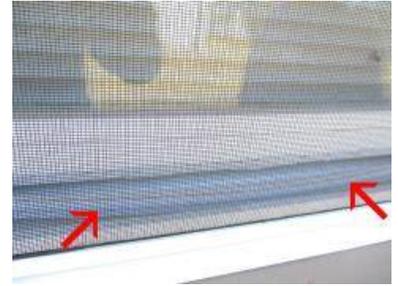
8.5 CONDITION:

Loose torn weather seal viewed on N side window off garage. Repair or improvement is recommended as good maintenance.

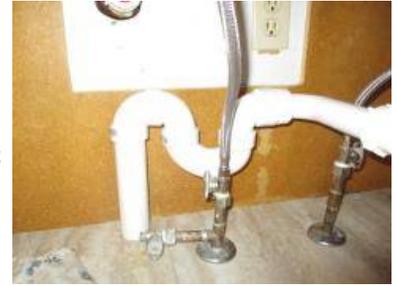
9.1 TYPE & CONDITION:

A stainless steel sink was present. **It was observed that an S-trap was present under the sink in the kitchen.** Generally, the use of S-traps is no longer acceptable in the waste plumbing system under modern standards. The S-trap configuration does not provide adequate venting of the waste pipes for pressure equalization and may be siphoned clear. Siphoning removes the required water seal to prevent entry of volatile and potentially unhealthful sewer gases. **Consider the installation of a P-trap with a drain waste vent pipe to conform to modern standards.**

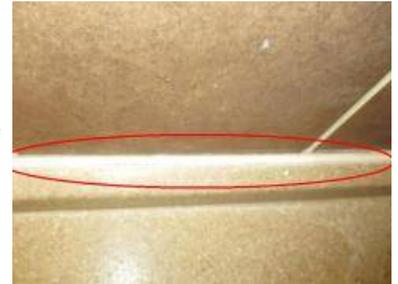
The shower basin appears to be serviceable. Gaps and cracks were present at the grout joints of the tile work at the tub/shower surround. Minor repair by re-grouting or caulking is recommended as good maintenance.

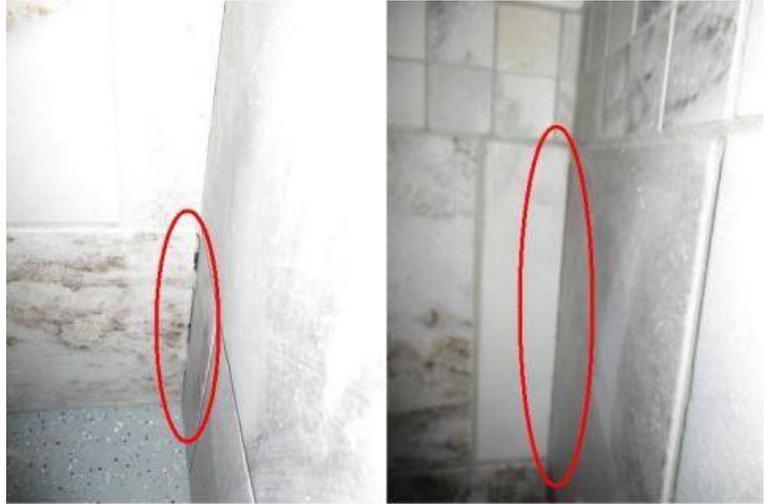
11.18 BATHTUB, SHOWER & WALLS:

The shower basin appears to be serviceable. **Gaps and cracks were present at the grout joints of the tile work at the tub/shower surround. Minor repair by re-grouting or caulking is recommended.**

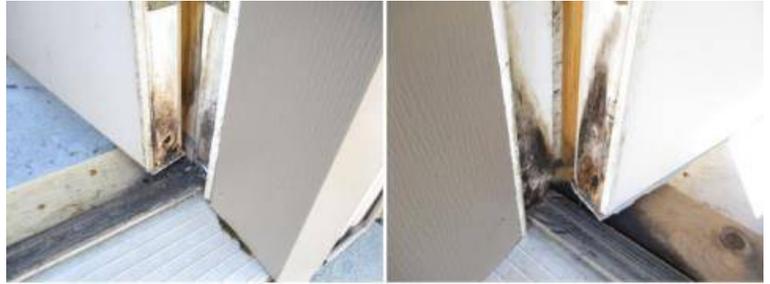
12.6

Low wood core decay was viewed on both N side detached garage side doors. Recommend replace.

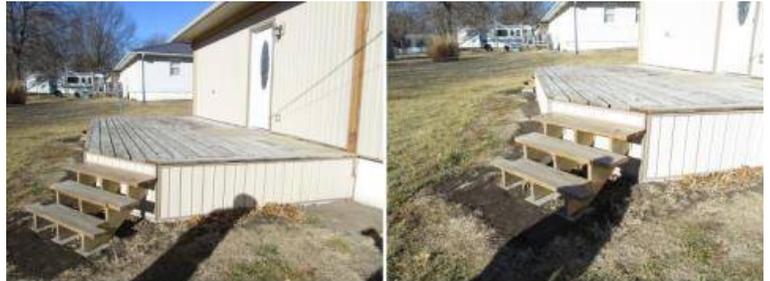
13.4 TYPE & CONDITION:

The deck was wood. **The handrail was missing off deck and stairs. This condition presents a safety hazard. Installation recommended for safety. Consult a qualified carpenter or general contractor for further evaluation and repair or improvement as necessary.**
