STAR BRITE

PROPERTY INSPECTION REPORT PREPARED FOR

724 WILLOW COURT, ARLINGTON, TX 76003

August 18, 2018

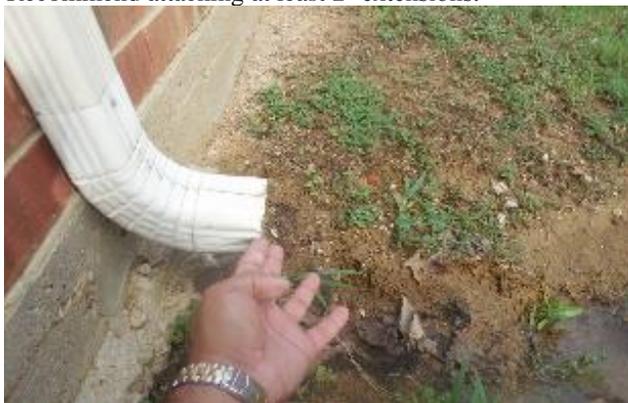
- ✳ (D) Downspouts terminated too close to the foundation which could be harmful to the foundation. This will allow excessive water to drain under the concrete footing which may eventually cause damage to the foundation. Water ponding here is also a conducive condition for termite infestation. Recommend attaching at least 2' extensions.

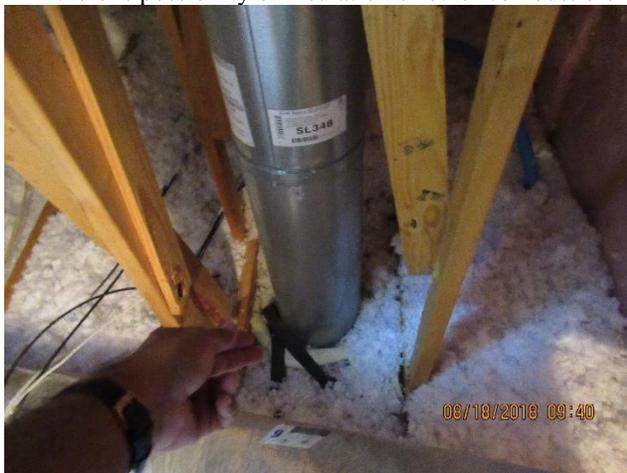
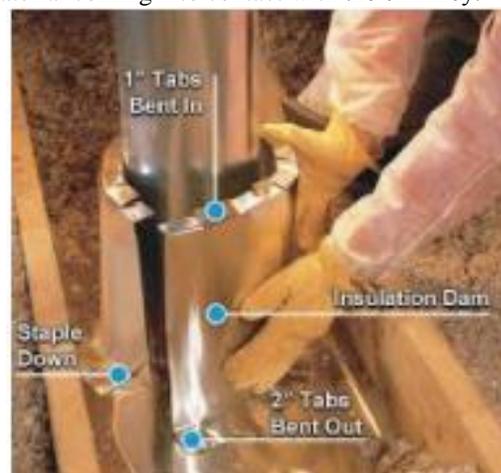
- (D) The insulation was pushed up against and touching the metal chimney flue in the attic. This is a fire hazard. Recommend separating and pushing back the insulation. A sheet metal or metal screen "collar" around the chimney will help keep the insulation away. See sample photo on right.
- Note from the manufacturers: "Warning! Risk of Fire! You must install an attic insulation shield where there is possibility of insulation or other combustible material coming into contact with the chimney."

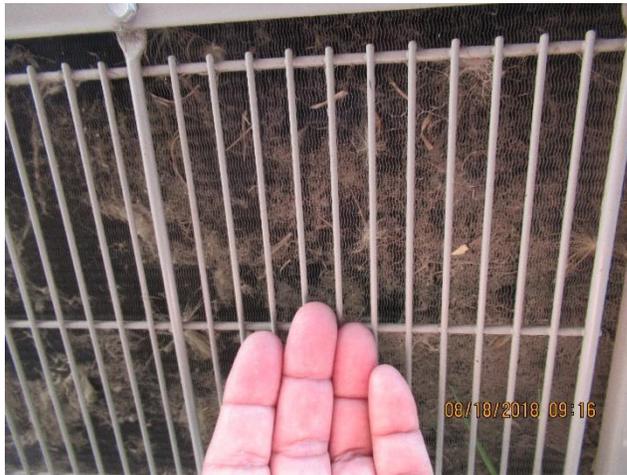
- (D) The unit’s aluminum cooling fins were dirty and clogged. This will make it work inefficiently. The fan motor will also be overheating as well. Recommend cleaning.

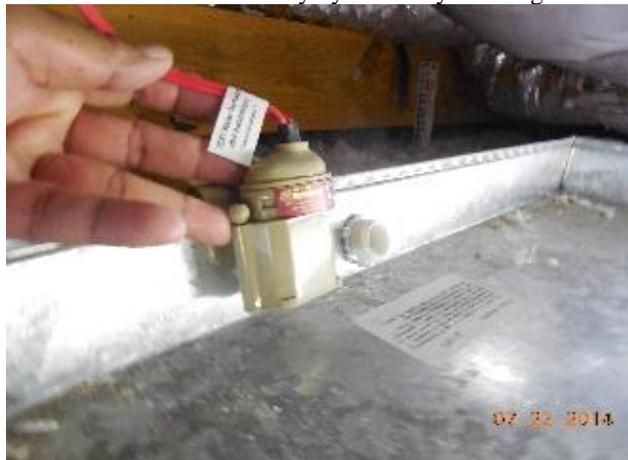
- ✱ **(D) Missing Water Level Sensors:** For air handlers in the attic, it is recommend to install a water level sensor (wired to the thermostat) inside the emergency drain pan or the secondary drain line. It will shut the unit off if the water in the secondary pan gets too high because of a clogged drain line. This switch will help with the possibility of water overflow going down to the ceiling below. This is manufacturer recommended and necessary by most city building codes. See sample photo.

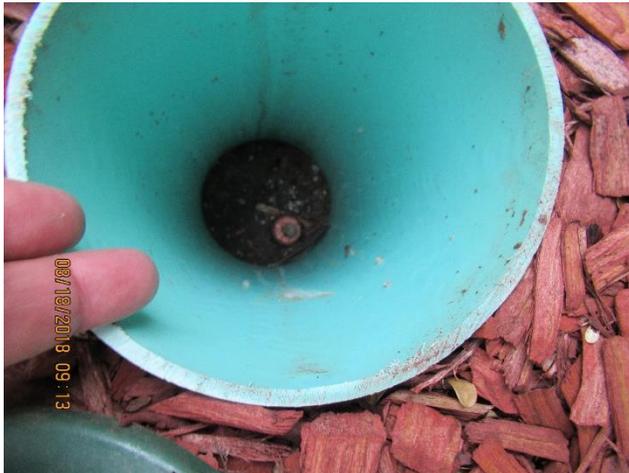
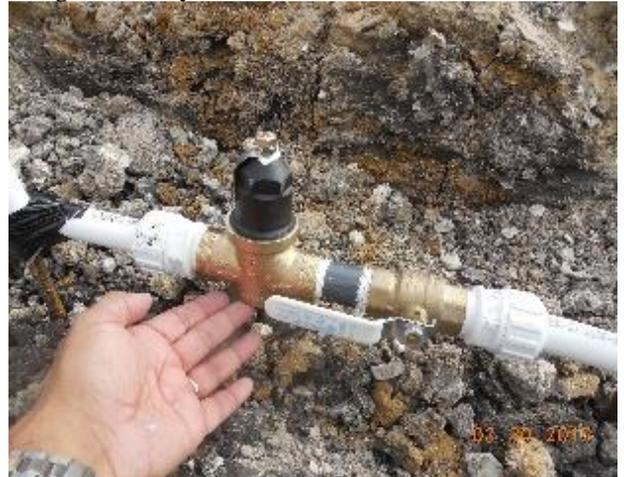
- Note: The left sink faucet in the master bathroom had low flow. A plumber should check it out.
- (D) A pressure adjusting valve was installed in plumbing system. This valve is found inside a valve box in the ground. The soil was too high and too close to the metal valve. This will cause premature corrosion and failure of the valve. The soil should be lowered to at least 12 inches below the valve and layered with gravel. The valve itself should be cleaned and sprayed with a rust-inhibitive lubricant. A handyman or contractor can do this but preferably a qualified plumber should do it. These valves are installed in-line with the incoming water supply line from the city to adjust for water pressure that may have been too high. The valve has a nut at the top which is turned to adjust the flow of water and is pre-set for a specific water pressure. The common type of valve is the cartridge type which can be changed out instead of replacing the entire valve.

See sample photo on the right of valve before being covered by a box.

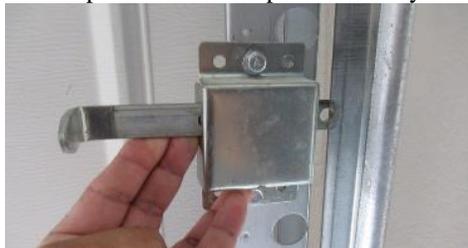
- ✱ (D) The lock should be disabled by inserting a bolt through the handle so it will not slide or totally removing it. Leaving the lock operable and forgetting that it is in use when opening the door will place undue pressure on the opener and may cause damage to it.

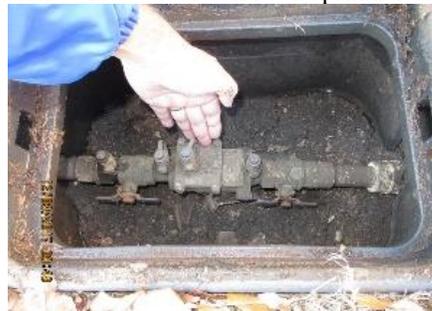
- ✱ **(D)** The backflow preventer was not found. It is usually installed in the ground with a green-covered plastic lid by the front yard next to the water meter. Sometimes it is installed next to the house. This backflow device is required installation by every city. This device is meant to keep out possibly contaminated lawn sprinkler water from mixing with the drinking water. It must be accessible. Ask seller to locate it or call lawn sprinkler tech. See sample photo below.
