OVERVIEW

IET was retained by the builder to determine the cause of excessive sweating of HVAC ducting equipment and components in a \$3 million home. The residence had been occupied less than one month. It also was showing elevated humidity conditions in the second story of the home. Mold growth was starting in both home and attic.

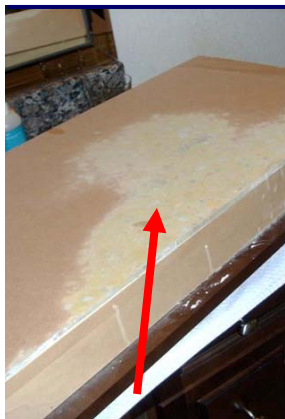
Mold growth on back of medicine cabinet, third floor bathroom

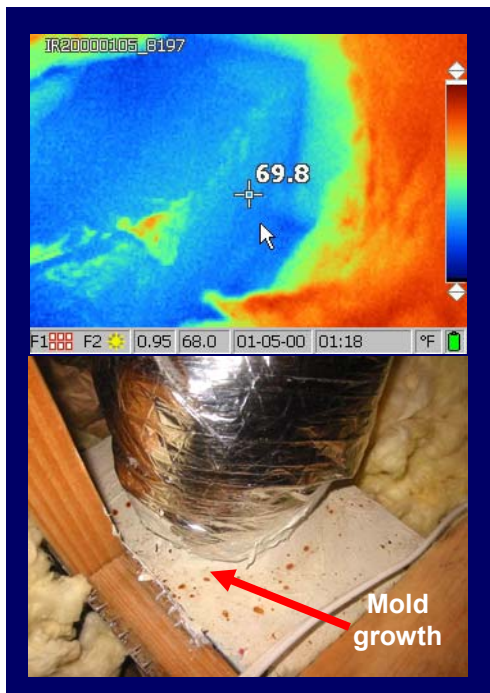
Results: Energy-efficiency measures taken during construction had contributed to the development of “cold attic syndrome,” where air conditioning ducts in a ventilated but cool attic in a hot/humid climate are prone to excessive condensation. Various building design features had contributed to significant negative pressure and infiltration of exterior humid air into the occupied space, resulting in excessive humidity in the home and in interior wall cavities.

Visible light and thermal images of duct boot with condensation and mold growth

Recommendations: Seal attic from outside air. Install dehumidifier in attic to control humidity. Install separate ventilation air dehumidifier to ensure positive pressure in the occupied space and help control interior humidity.

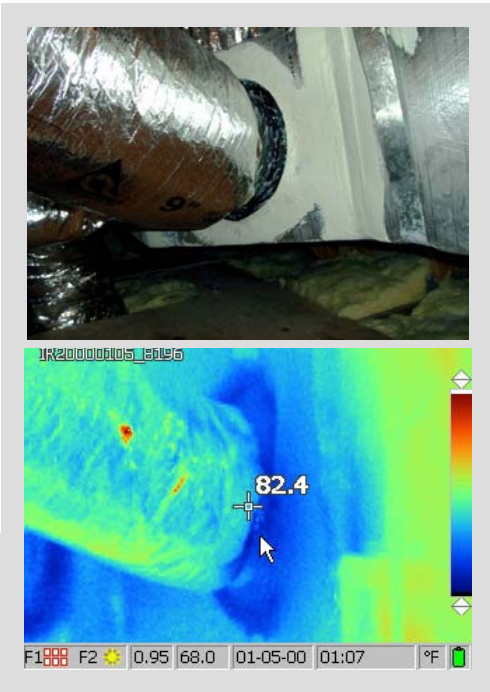
Visible light and thermal images of flex duct to plenum attachment
