InSight Inspections NW, LLC

Inspection Report

**1234 ABCD Street
Seattle, Washington 98111**

Inspection Date January 21, 2018
Inspector Yuriy Nyzhnykevych
lyst4u@yahoo.com
State of Washington license # 1663

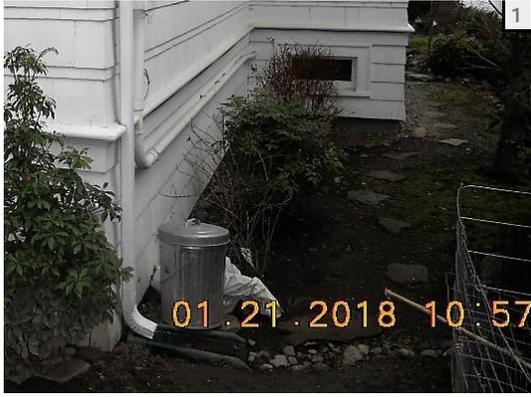
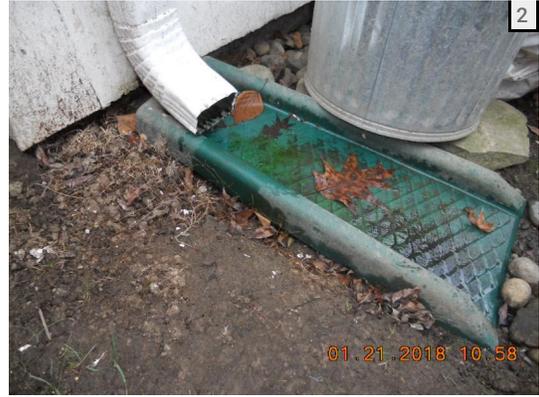
Downspouts are not properly extended

Location	Exterior: Ground View
Impact	This condition may allow roof water runoff to accumulate near the foundation, which could lead to moisture-related damage
Suggested Action	The discharge from the above-ground downspouts should be routed away from the dwelling - about 6 feet. This will ensure that the water removed away from the dwelling's foundation

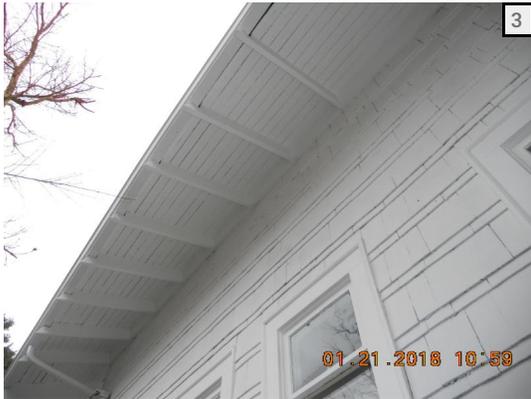
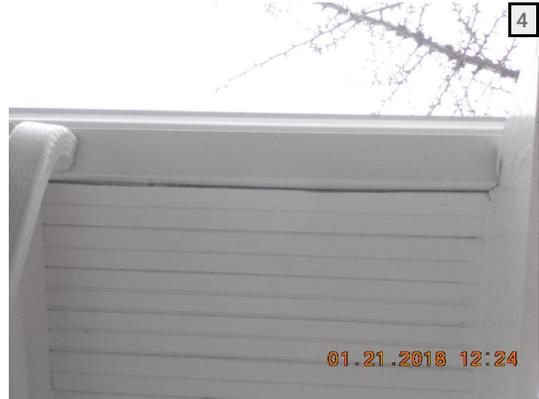
✓ Eave

In satisfactory condition at the time of inspection

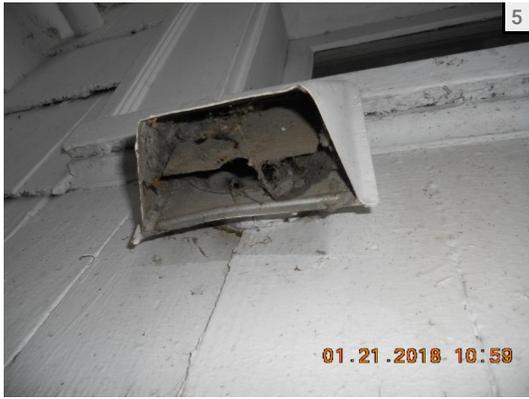
! Exhaust Vent

Appears obstructed with debris preventing moisture elimination

Location	Exterior: Ground View
Impact	Decrease in removal of moisture and odor
Suggested Action	Recommend cleaning of lint and debris. If the vent is being used, clear the vent passage and install a birdcage style vent cover. If the vent is not in use then eliminate the exhaust passage and block off and seal the opening

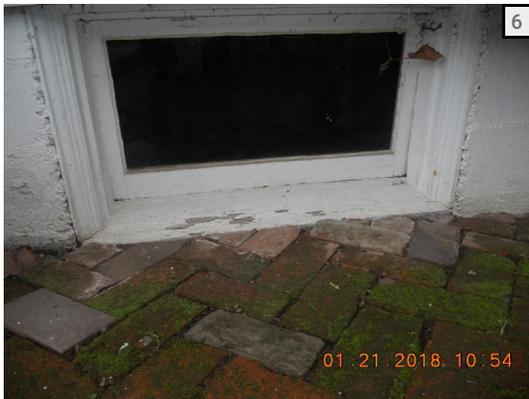
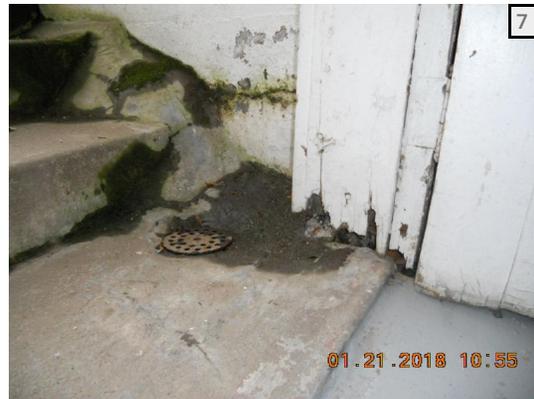
! Exterior Trim

Wood frame and trim have paint peeling as a result of water accumulation

Location	Exterior: Ground View
Impact	May further damage wood, accumulate water and increase the risk of water penetration into the basement
Suggested Action	Clean all affected surfaces, prime and apply two coats of paint

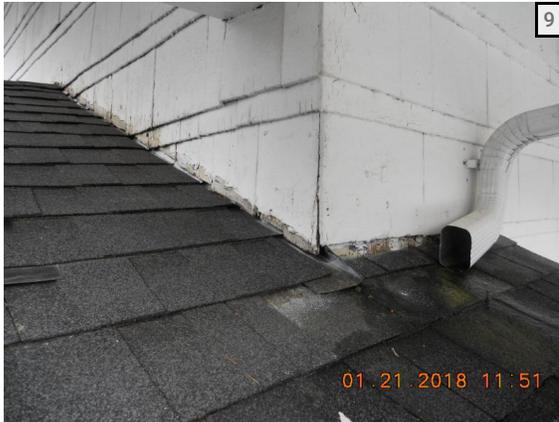
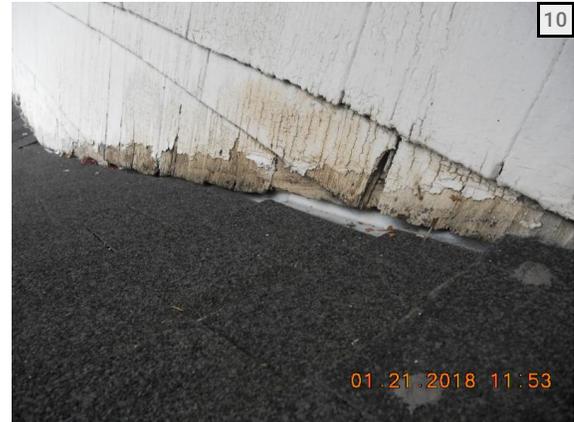
Siding is too close to roofing material. Wood and paint are damaged from water and moisture getting into the siding during rain

Location Exterior: Roof View
Impact Excess moisture in siding leads to damage of wood fibers and/or rot
Suggested Action Recommend crating a gap about 1-2" (where practical) between the siding and the roofing material and replacing any damaged trim and siding materials.

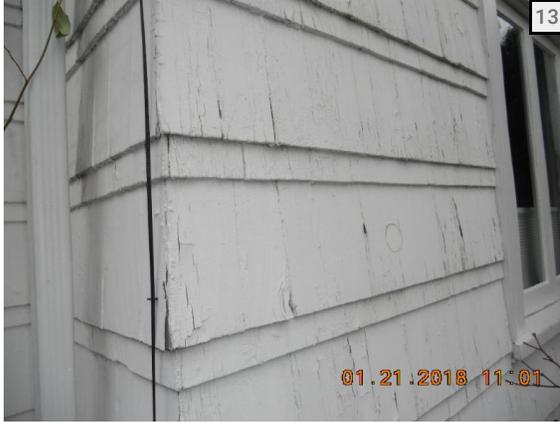
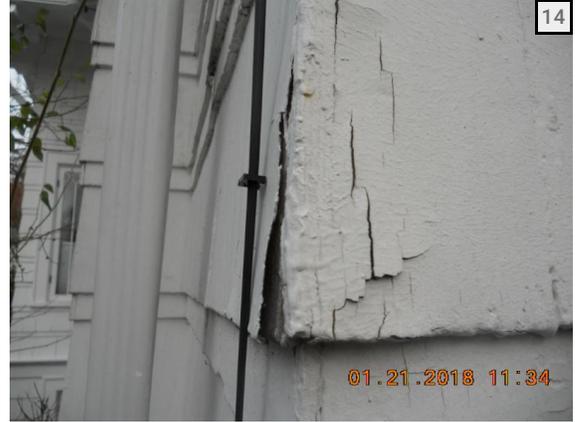
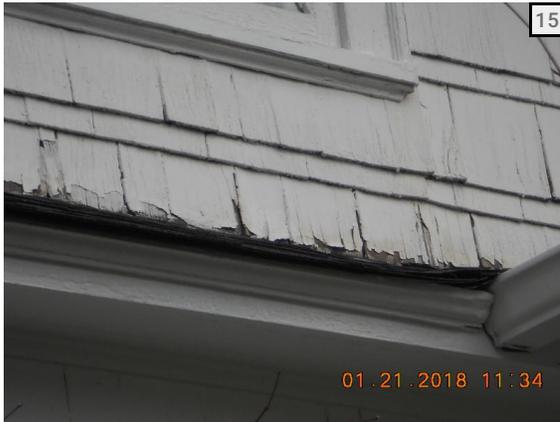
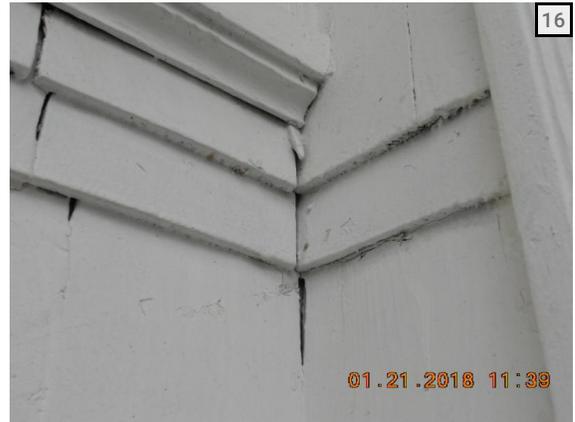
All exterior painted wood siding and trim should be annually examined with the objective to have them properly sealed, re-caulked and re-painted as needed.

Location Exterior: Ground View

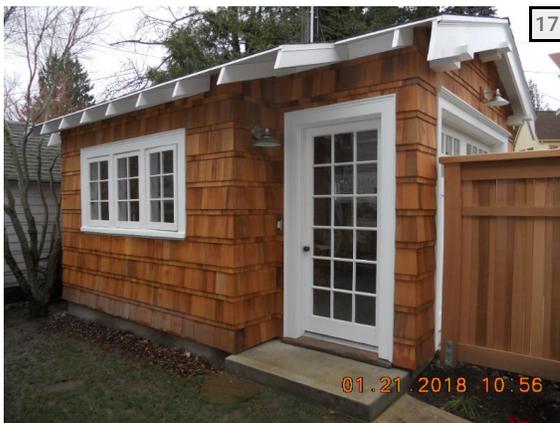
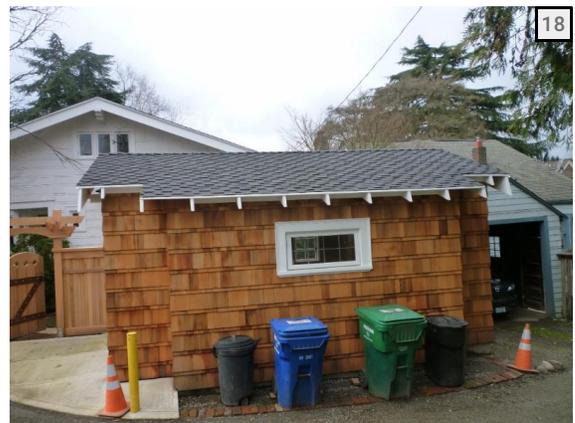
The Garage structure looks great but I recommend that you waterproof the siding to extend its useful life.

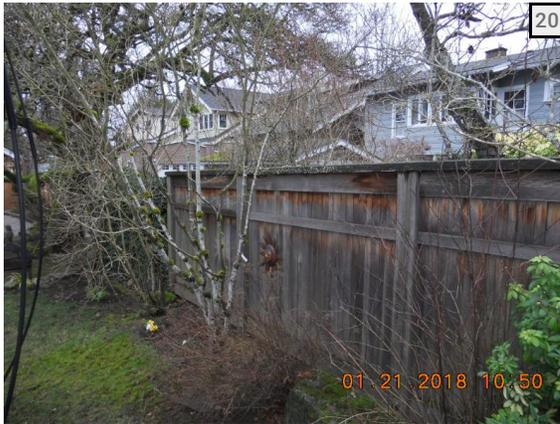
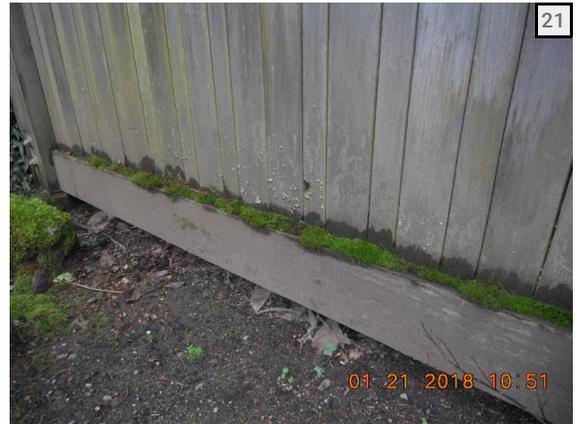
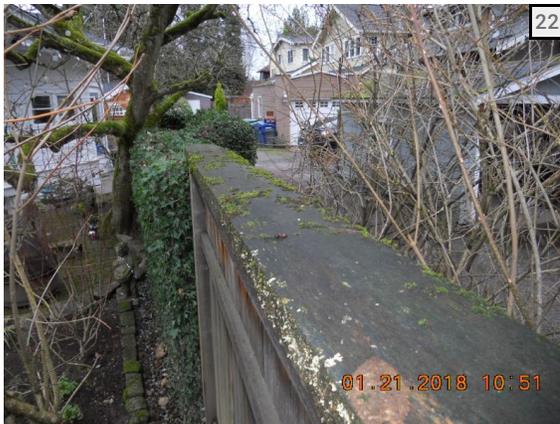
The fence on the SW, W, and NE sides of the property shows signs of typical for the PNW aging.

Location	Exterior: Ground View
Impact	Premature discoloration, damage to wood
Suggested Action	I recommend cleaning the fence from stains, and from moss and algae. After the boards are cleaned and dry, protect your fence with a waterproof sealer. Consider a product that contains a fungicide which will help prevent the return of mold and mildew. Using the cedar sealer will also help preserve cedar's natural color. In addition, warps and cracks are less likely in a treated fence.
Other Information	With proper care, a cedar fence can last as long as 30 years.

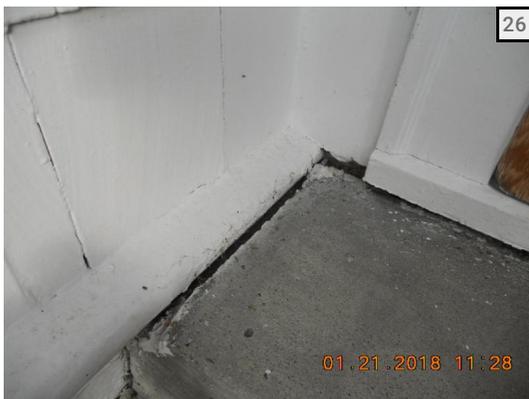
Gap between concrete porch and building

Location	Exterior: Ground View
Impact	Gaps provide an environment for moisture intrusion with the possibility of expansion during the winter months. The water that is allowed to run into this opening if not sealed can create hydrostatic pressure against the foundation/basement wall. This pressure can result in added moisture to the wall and create a wet environment in the basement.
Suggested Action	This and any concrete slab to foundation gap should be filled with a good quality urethane sealant. The gaps that are wider than 1/8" inch may need a foam backer rod stuffed down into them to keep the urethane from running down and under the slab. This backer rod, (where needed) is shoved down into the crack as far down as the crack is wide.
Other Information	A gap that develops between the slab and the foundation wall is a common occurrence.

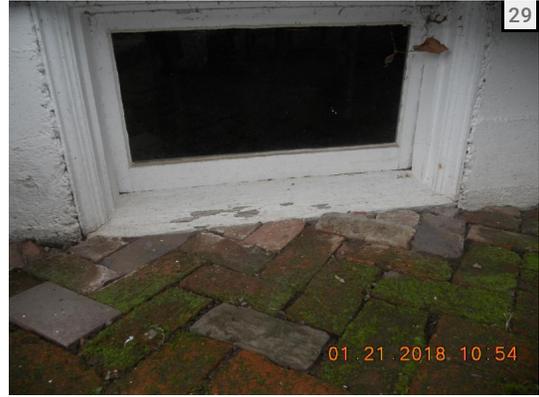
Brick patio/walkway near SE exterior wall slopes towards the house

Location	Exterior: Ground View
Impact	Accumulation of water and retention of moisture near the foundation increases the risk of moisture intrusion
Suggested Action	Monitor the area for moisture buildup. Should it repeatedly occur, and cause moisture buildup in the basement, re-grading the area may be necessary to achieve a slope away from the home

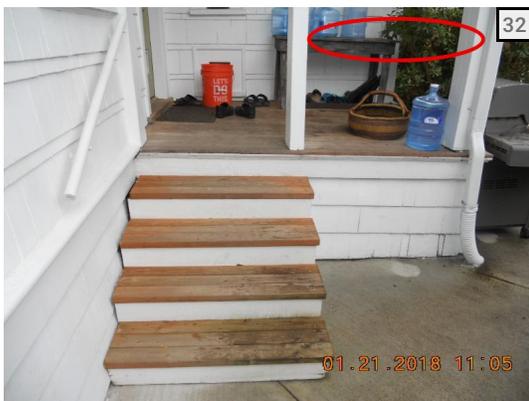
Railing on porch is missing

Location	Exterior: Ground View
Impact	A missing railing could cause a person to fall
Suggested Action	Install a handrail around porch
Other Information	If porch floor is 30 inches or higher from the ground, a porch railing is required.

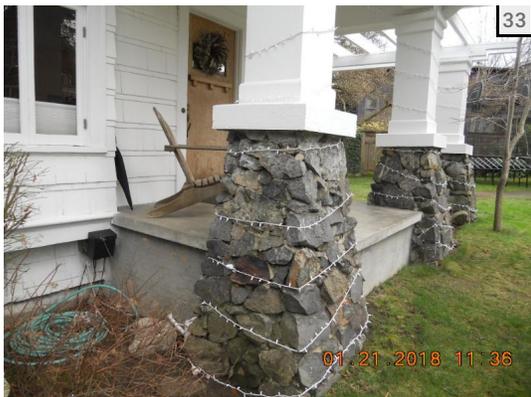
⊖ Porch, front

Railing on porch is missing

Location	Exterior: Ground View
Impact	A missing railing could cause a person to fall
Suggested Action	Install a handrail around porch
Other Information	If porch floor is 30 inches or higher from the ground, a porch railing is required.

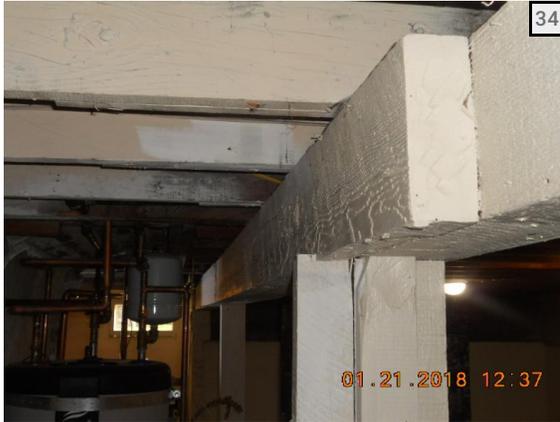
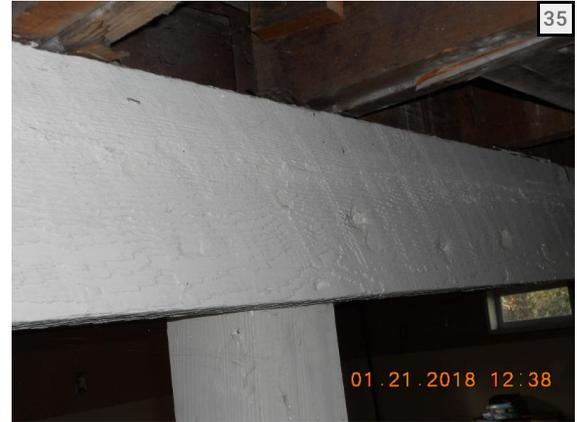
New and existing beams are not connected with bolts, only nails. It appears that the amount and placement of nails is not sufficient.

Location Basement
Suggested Action Have reviewed and repaired as needed by a qualified carpenter

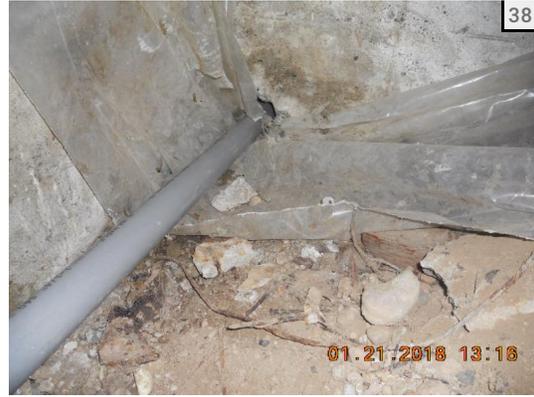
A penetration in the foundation wall for a water pipe not sealed.

Location Crawl Space
Impact Risk of water intrusion into the crawl space.
Suggested Action The penetration should be sealed with hydraulic cement available at most hardware stores.

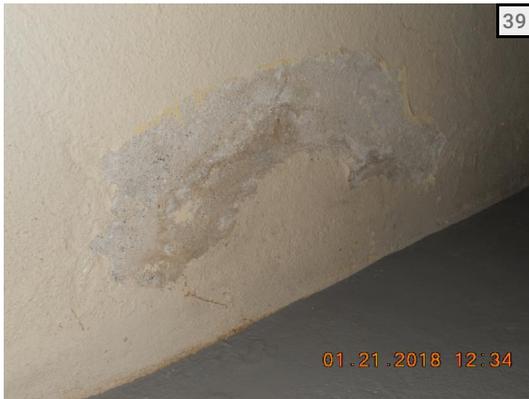
Spalling and crumbling concrete noted on interior side of foundation wall

Location	Basement
Impact	It is usually due to excessive moisture accumulated near or at the concrete surface. If left unrepaired, spalls can accelerate surface deterioration.
Suggested Action	Have repaired by a concrete contractor; **installing gutters and diverting water away from the house will help resolve this problem
Other Information	Spalling appears as circular or oval depressions on surfaces or as elongated cavities along joints

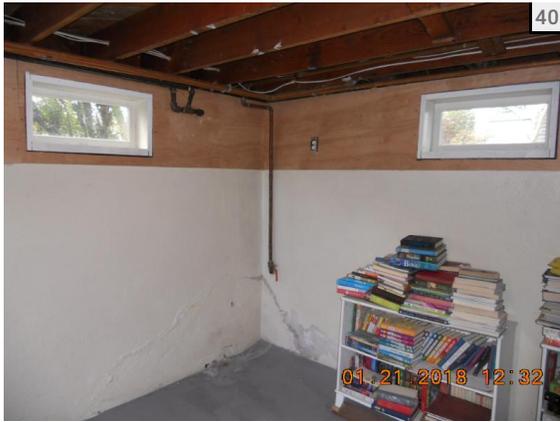
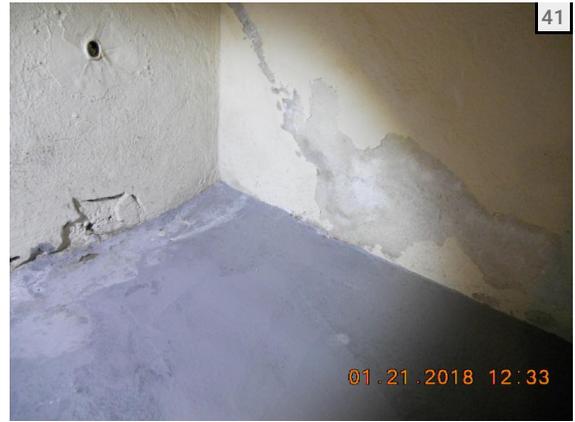
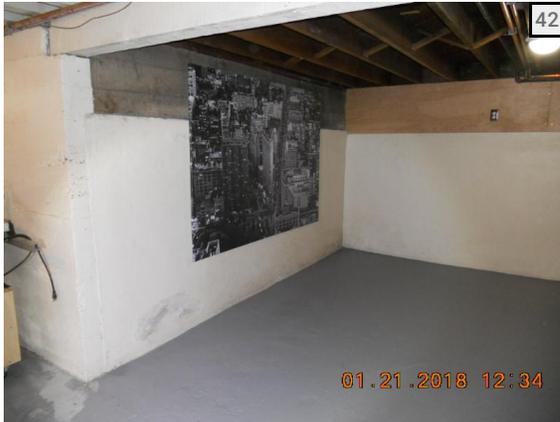
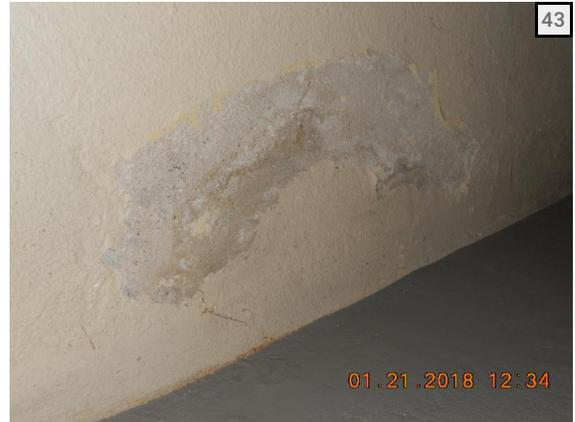
Exhibits hairline diagonal cracking

Location	Basement
Impact	The cracking may worsen allowing moisture intrusion
Suggested Action	Monitor for further cracking. If the cracks widen have repaired by a licensed waterproofing contractor

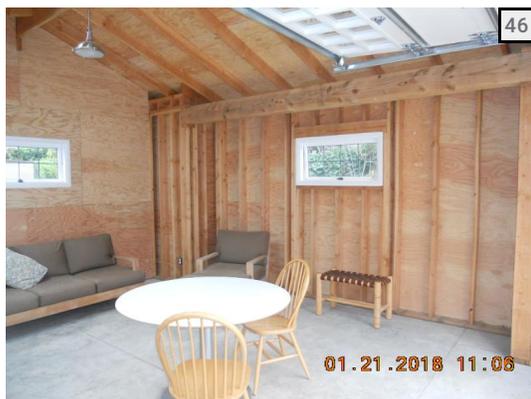
New slab, contains expansion joints. No deficiencies noted.

Location	Detached Garage
Impact	Expansions joint material will deteriorate over time and create a void which could become a location for insects to enter the home
Suggested Action	Monitor the expansion joint annually to ensure it is properly sealed. When caulking is necessary, use a weather-resistant expandable joint caulk

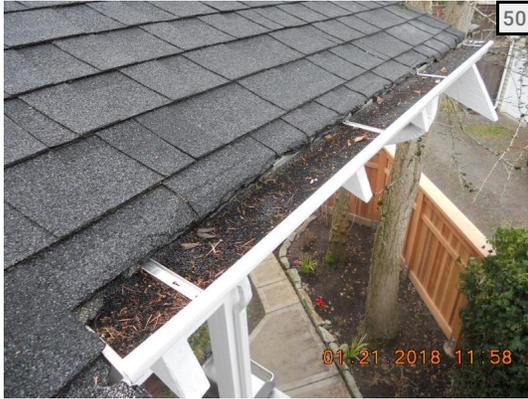
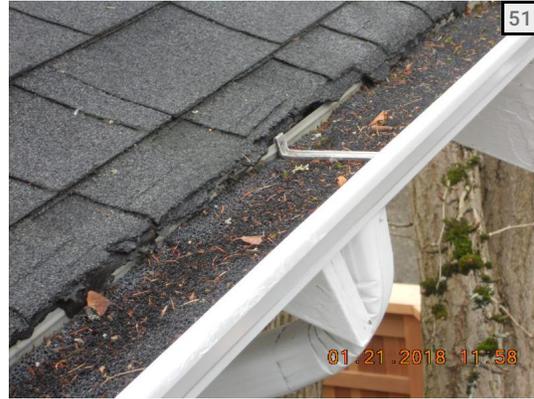
Cracked or broken asphalt tabs

Location Exterior: Roof View
Impact Any breach in the roof material will expose the underlying wood to the elements and may cause roof leaking
Suggested Action Have the damaged tabs replaced by a qualified roofing professional

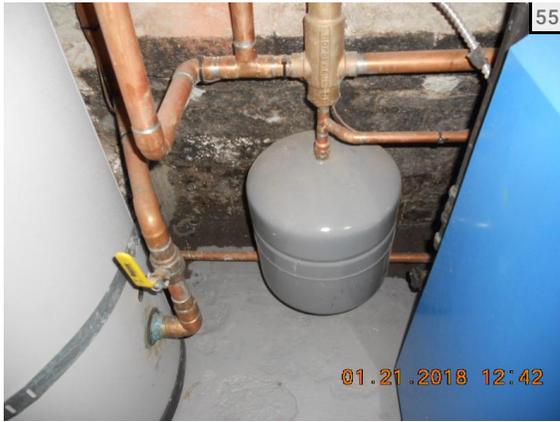
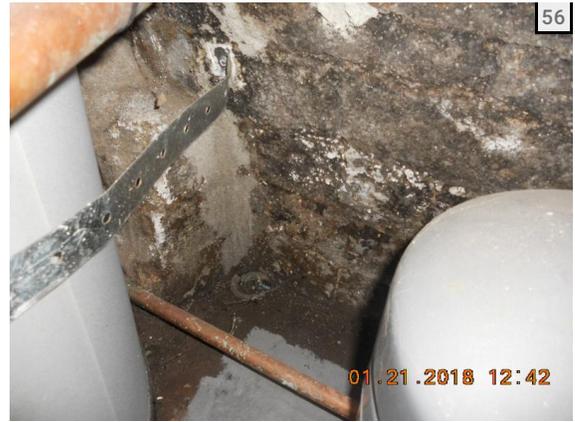
Impact Efflorescence is the dissolved salts deposited on the surface of a porous material (such as concrete or brick) that are visible after the evaporation of the water in which it was transported. The moisture that creates efflorescence often comes from water in the structure. Efflorescence alone does not pose a major problem, but it can be an indication of moisture intrusion, which may compromise the structural material.

Suggested Action To clean: A strong brush can be used to simply scrub the efflorescence off; An acid, such as diluted muriatic acid, can be used to dissolve efflorescence. Water should be applied first so that the acid does not discolor the brick. Following application, baking soda can be used to neutralize the acid and prevent any additional damage to the masonry. Muriatic acid is toxic, and contact with skin or eyes should be avoided.

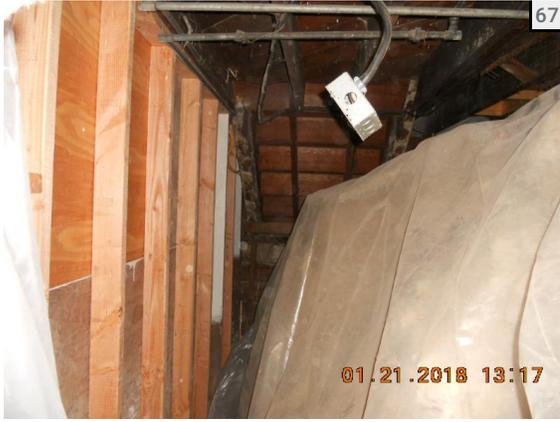
No deficiencies noted. Recommend securing suspended j-box to the floor joist above.

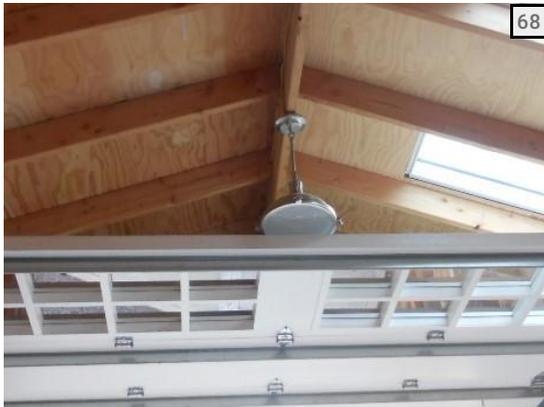
✘ Light Fixture

When opening, the garage door slightly bumps into one of the ceiling light fixtures.

Location	Detached Garage
Impact	Damage to the light fixture and/or garage door
Suggested Action	Decrease the distance between the light fixture and ceiling

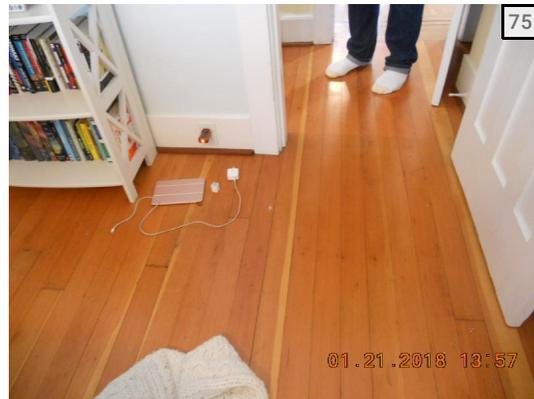
Outlet

Reverse polarity at the outlet near the door

Location	Main Bedroom
Impact	Reversed polarity at outlets is a shock hazard, but it's usually an easy repair.
Suggested Action	Have this repaired by a licensed electrician

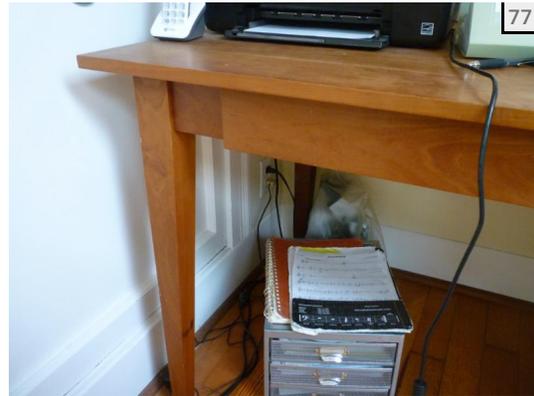
Reverse polarity in outlet under the printer table

Location	Office/Library
Impact	Reversed polarity at outlets is a shock hazard, but it's usually an easy repair
Suggested Action	Have this repaired by a licensed electrician

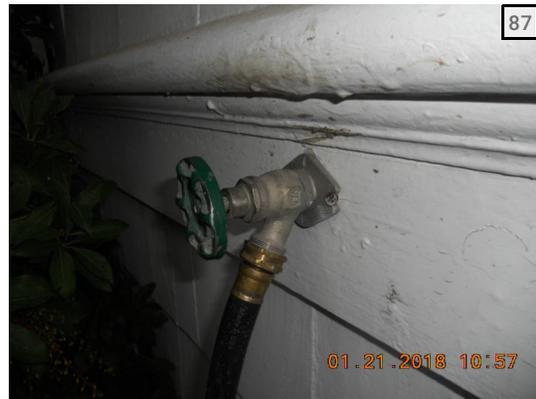
No anti siphon devices were observed.

Location	Exterior: Ground View
Impact	These backflow prevention devices are vacuum breakers that prevent contaminated water from entering the potable water system.

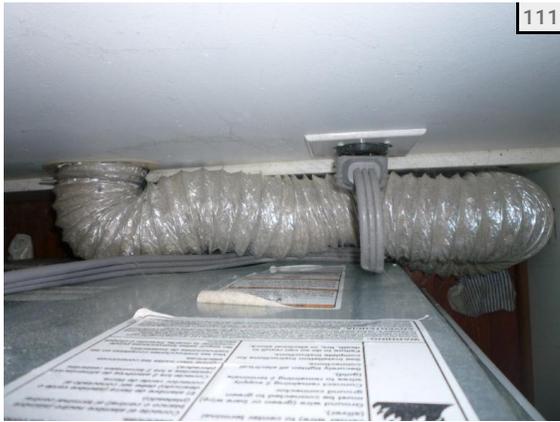
Recommend that such ducts be replaced with a rigid or corrugated semi-rigid metal duct, and by a qualified contractor if necessary

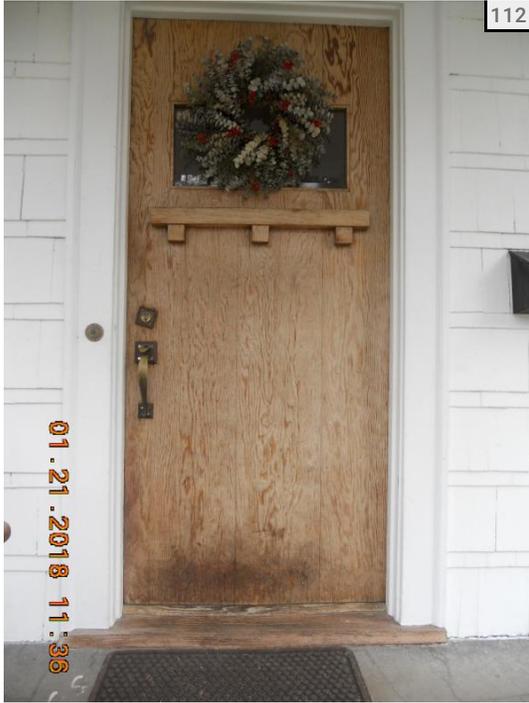
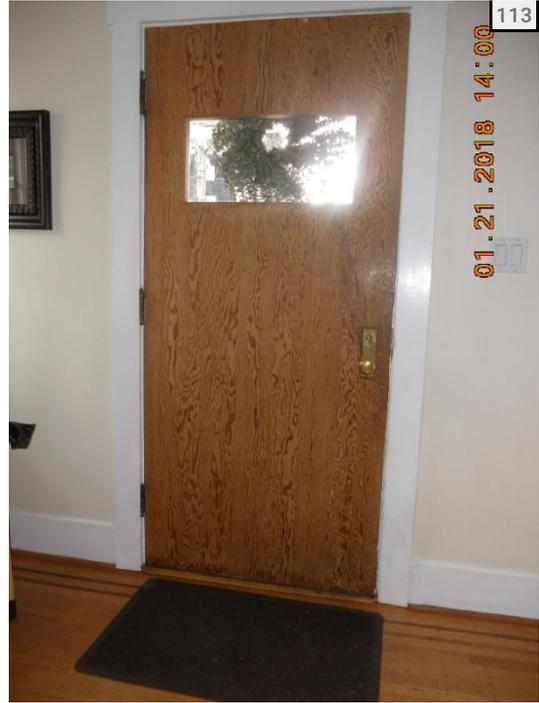
The Main Entry Door, (both sides), shows signs of weathering and wear.

Location	Exterior: Ground View
Impact	Cosmetic, appearance
Suggested Action	It would benefit from a good cleaning with mild detergent, and sealing with a good quality waterproofing coating/sealer.

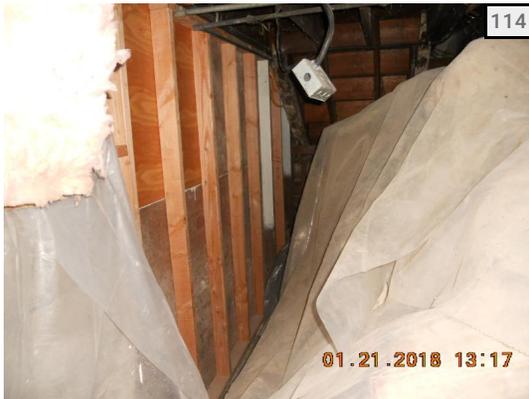
! Floor

Clear plastic is used, with plastic sheets not completely covering the ground.

Location	Crawl Space
Impact	Moisture build up
Suggested Action	Replace clear plastic with black 6 mil vapor barrier cover, seal all seams.

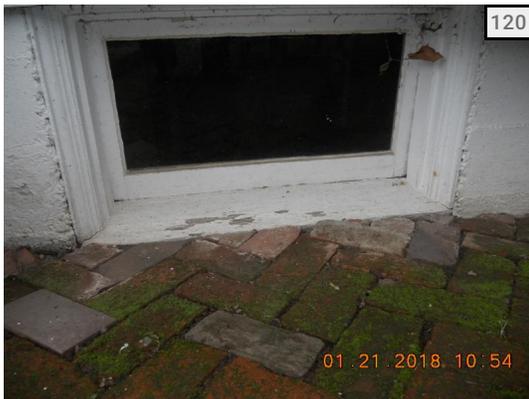
Paint or stain is peeling, weathered or faded

Location Exterior: Ground View
Impact This makes the frame at risk of premature aging due to exposure to the elements
Suggested Action Reseal or restain the window frames
