## **Entry Sign Lighting & Electrical Component Updates - Oct 2025**

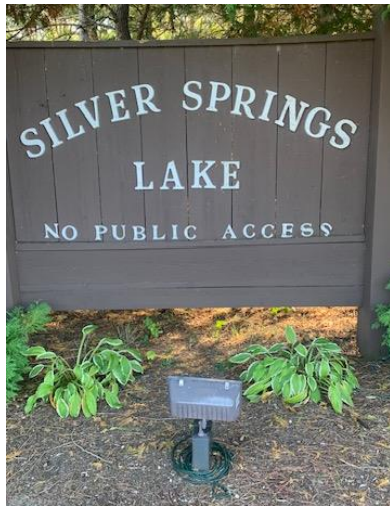
Old West SSL Entry Light:

The floodlight on the East Silver Spring Drive Entry Sign burned out. An electrical inspection by Troy Zernach (Zernach Electric) also found a weak photocell and a rusty non-weatherproof-rated GFCI receptacle outlet. Repairs costs including service calls to update floodlights and the other electrical components in both signs, were within our General Maintenance Budget. Both signs now have new Photocells, LED Floodlights and Weatherproof GFCI Receptacles.
