“Can Tilting Pad Bearings Whirl?”

Talmadge D. Ward Jr.
Duke Energy Florida

Piedmont Chapter Vibration Institute Meeting
May 17, 2019 - Lake Junaluska N.C.

Intermittent Fluid Film Instability was observed on a GE 7A6 80 MW generator with tilting pad bearings which caused high vibration and sub-synchronous frequencies. Direct shaft vibration as measured by proximeter probes was above 10 mils. Cause was determined to be a combination of excessing bearing clearance, excessive pad pre-load and misalignment.

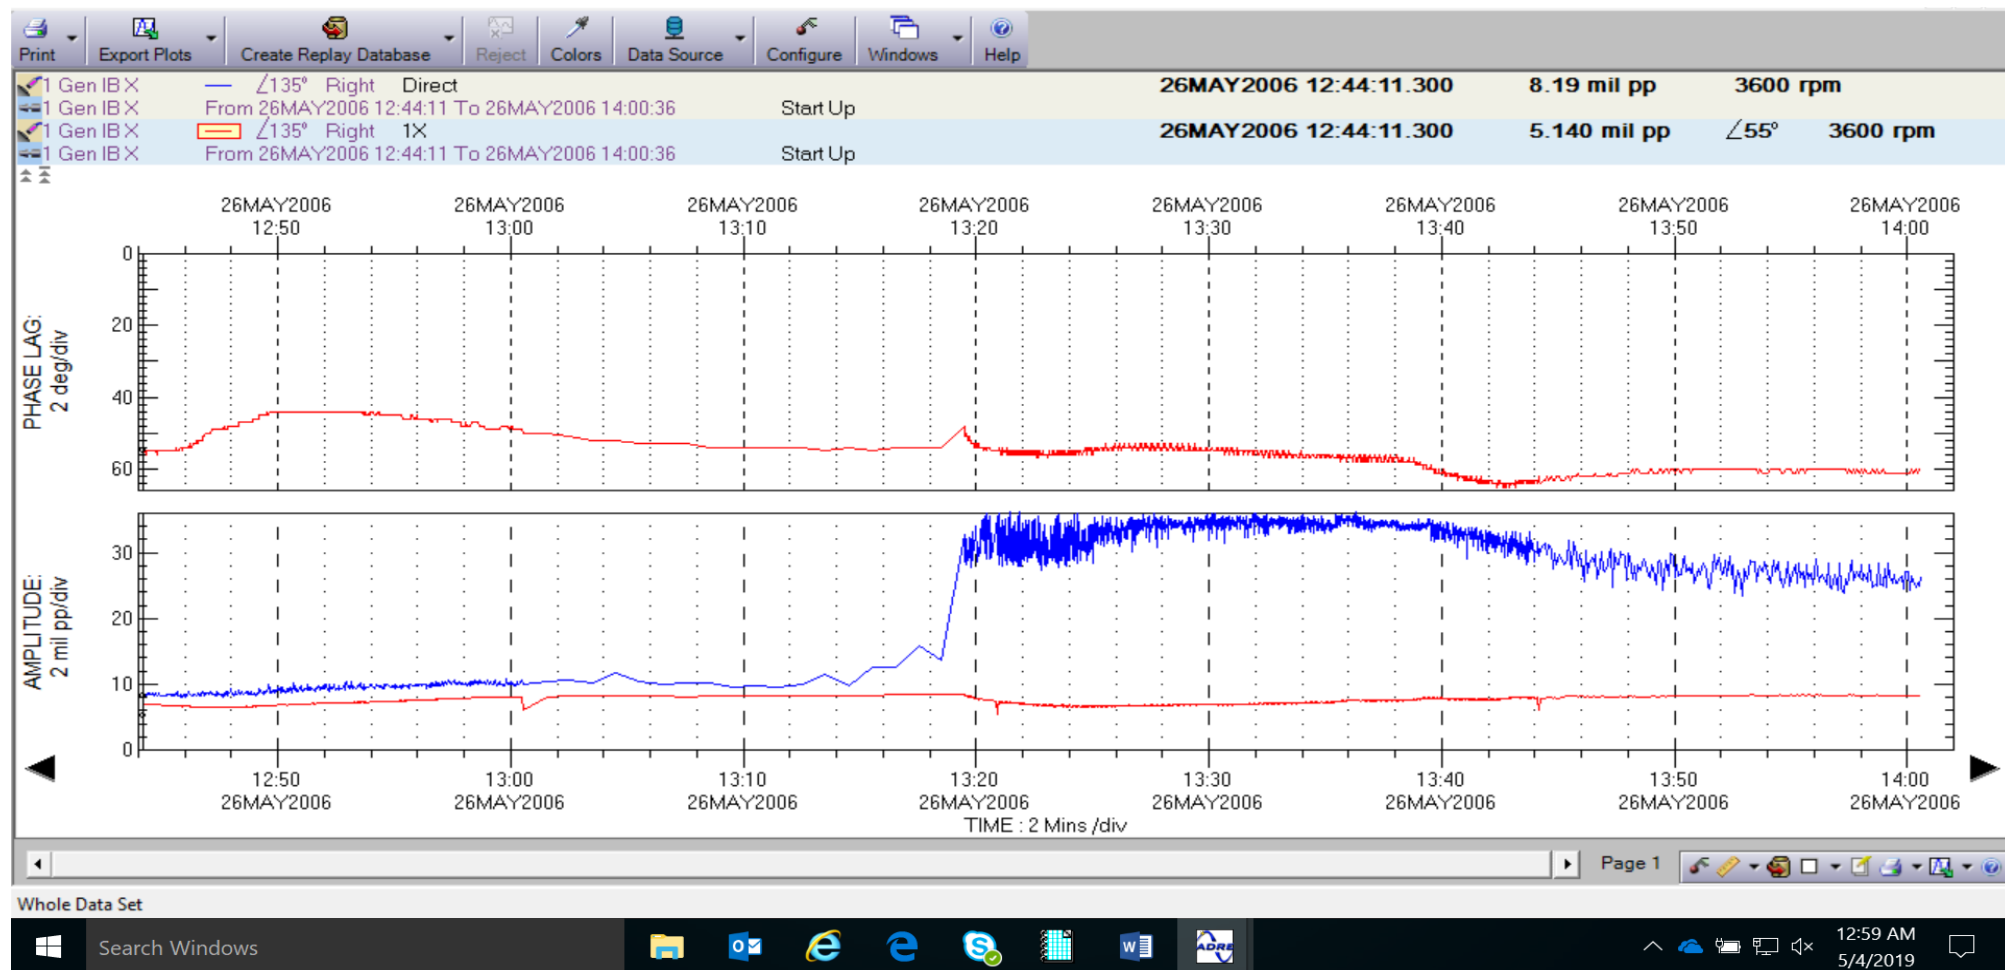
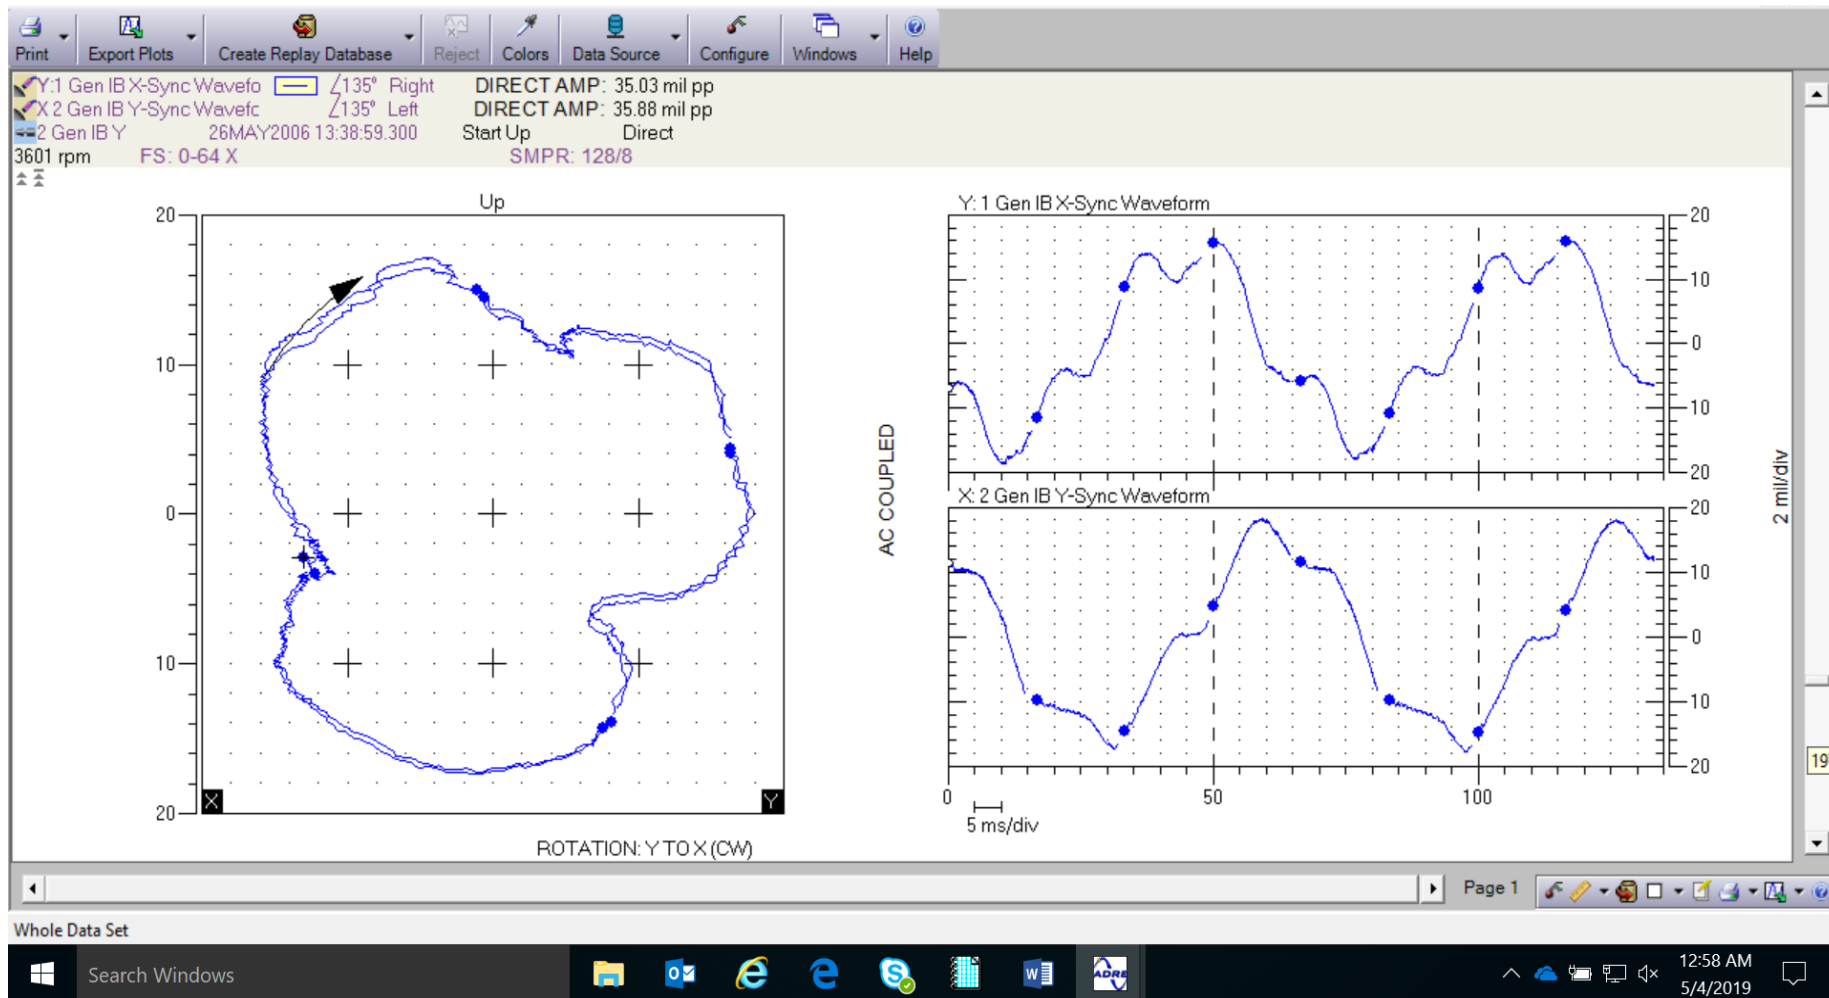
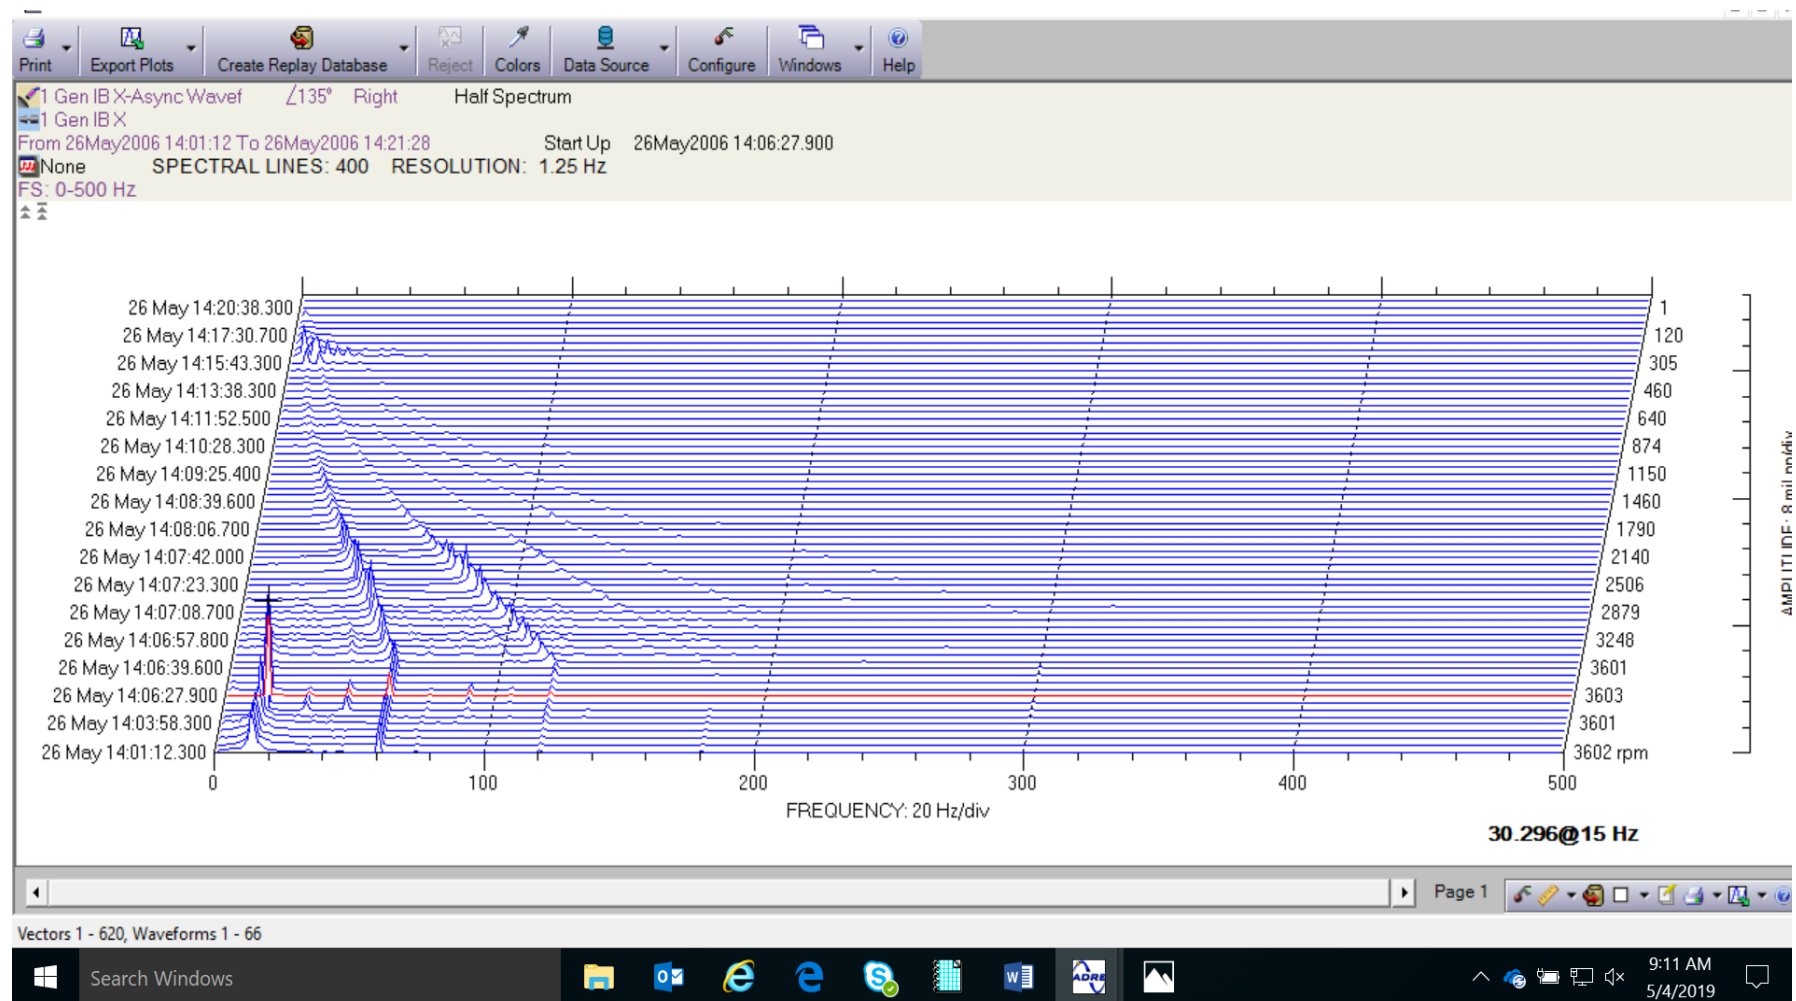
Example of Elliptical Bearing Whirl GE 7EA with misalignment

35 mils

Shook the control room 250 ft. away.

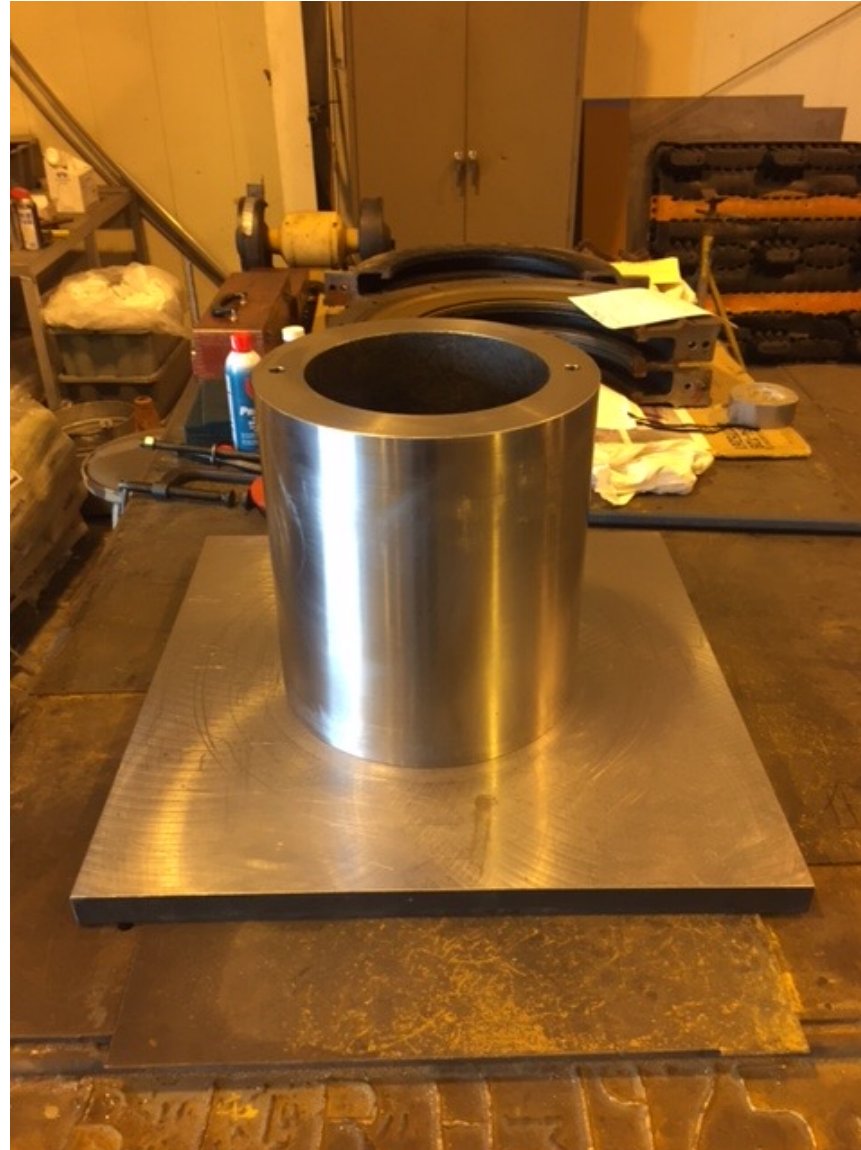
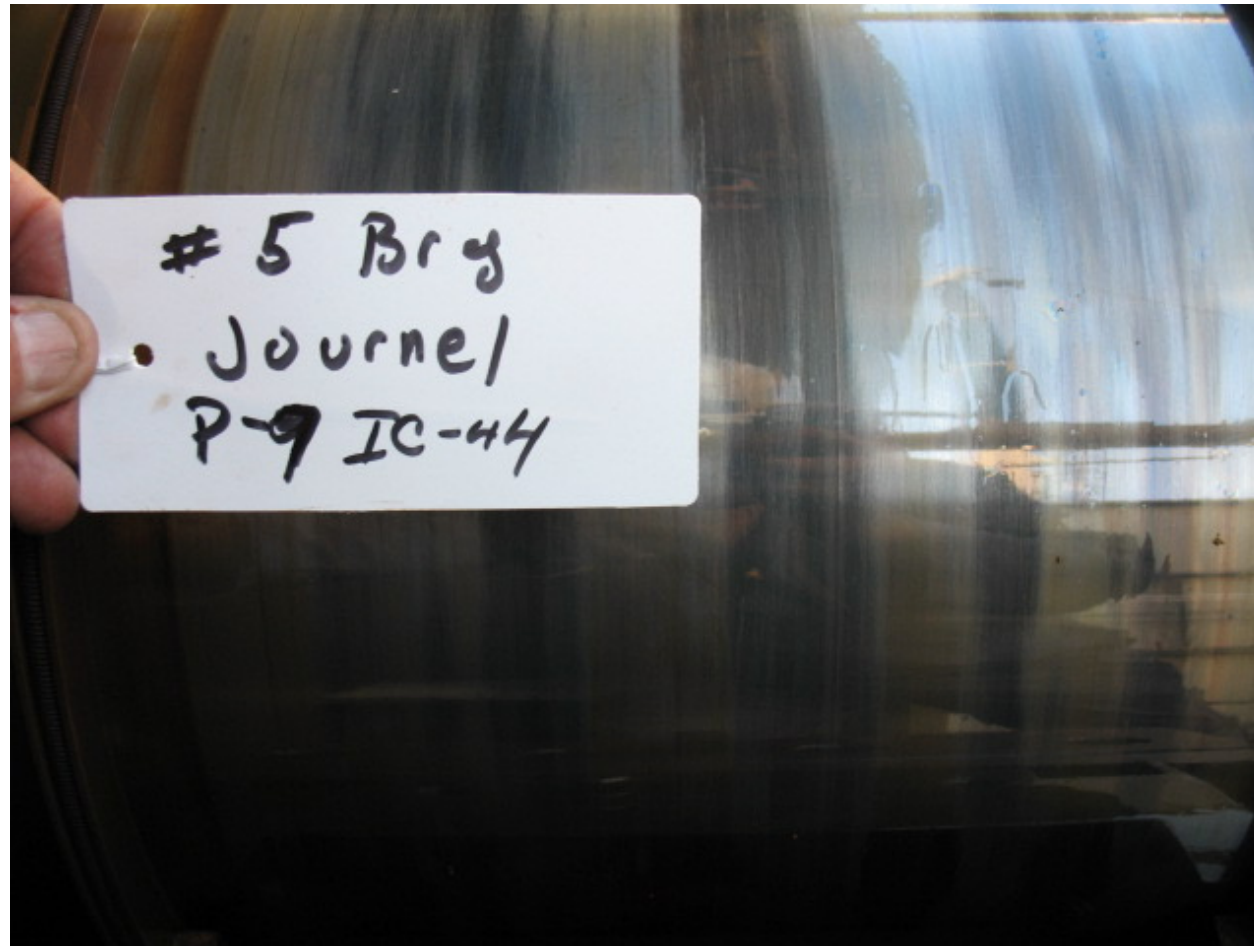
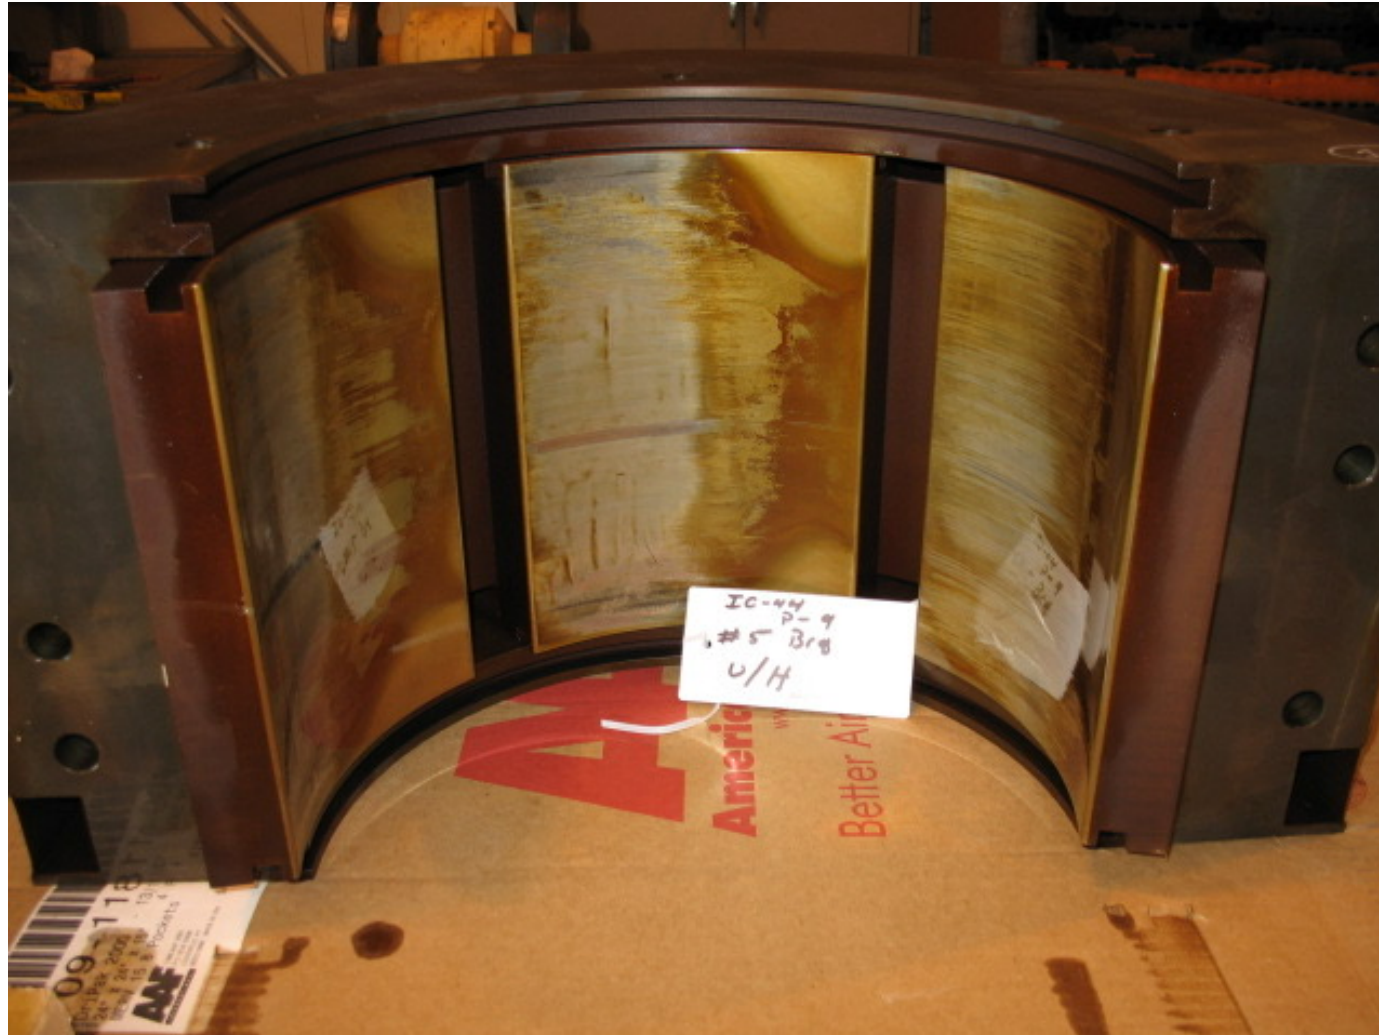
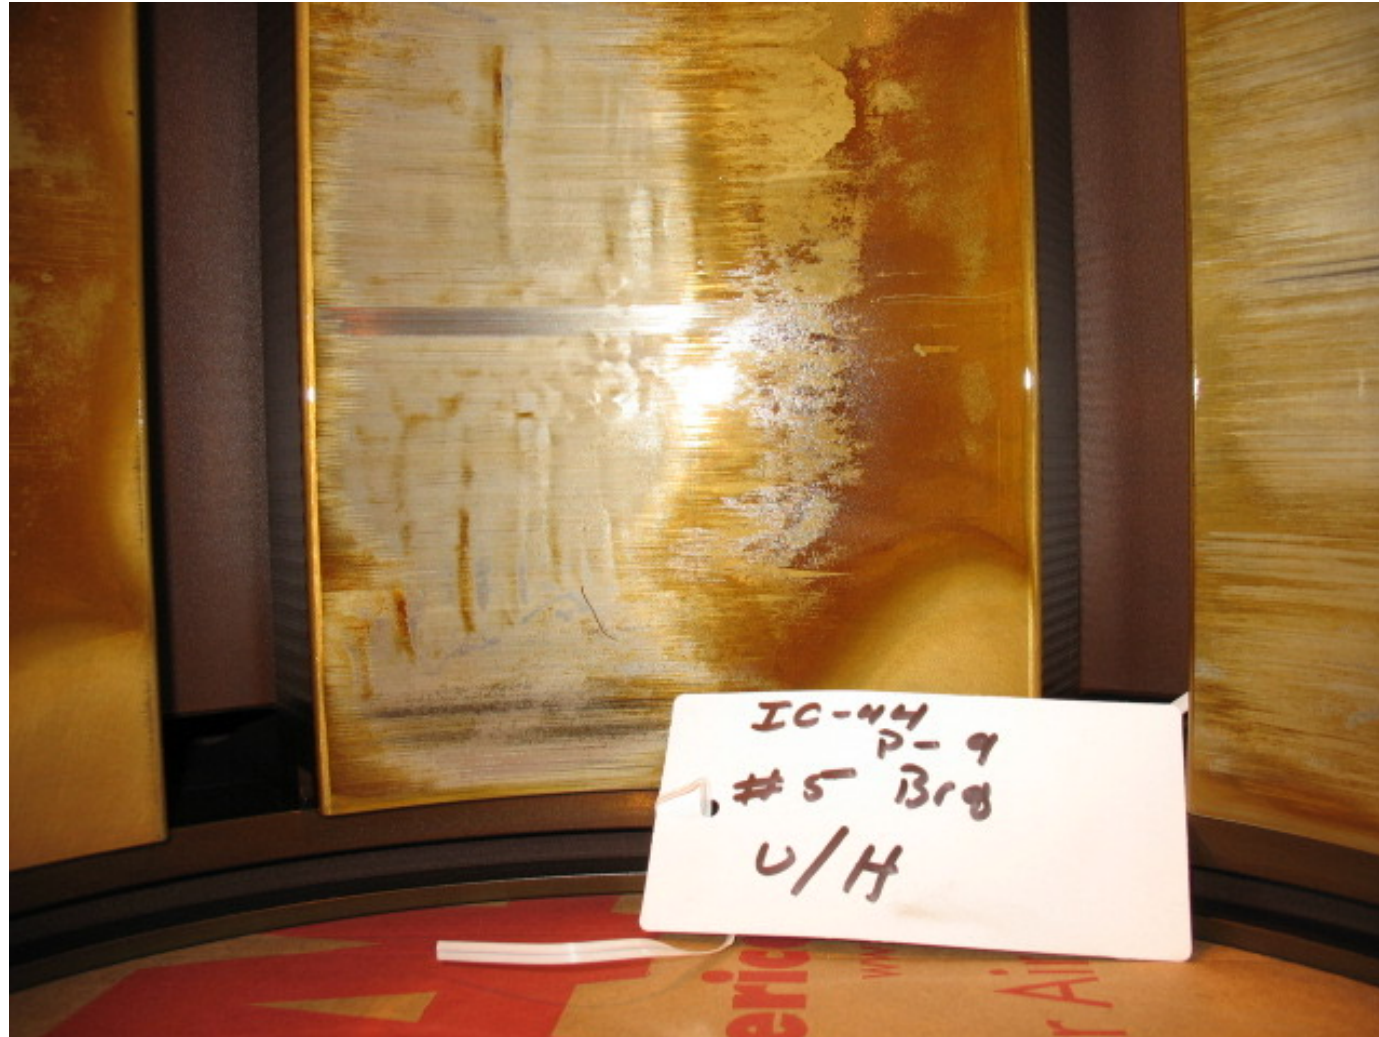
Alignment - The Turbine to Generator alignment was found out of spec by 122 mils with the generator high and 132 to the right with the coupling faces open 6 mils at the bottom. Final alignment was Gen 6 mils high and “Fair” on horizontal and 11 mils open at the top.

Bearings - Radial clearances were checked using a Bearing Mandrel and found to be 28 mils instead of 21 mils, oversized by 7 mils. The “Preload” was also out of spec.

All parameters were restored to within GE specification and the unit reassembled for testing
