ELECTRIC MOTORS

OPERATION AND VIBRATION CASE HISTORIES

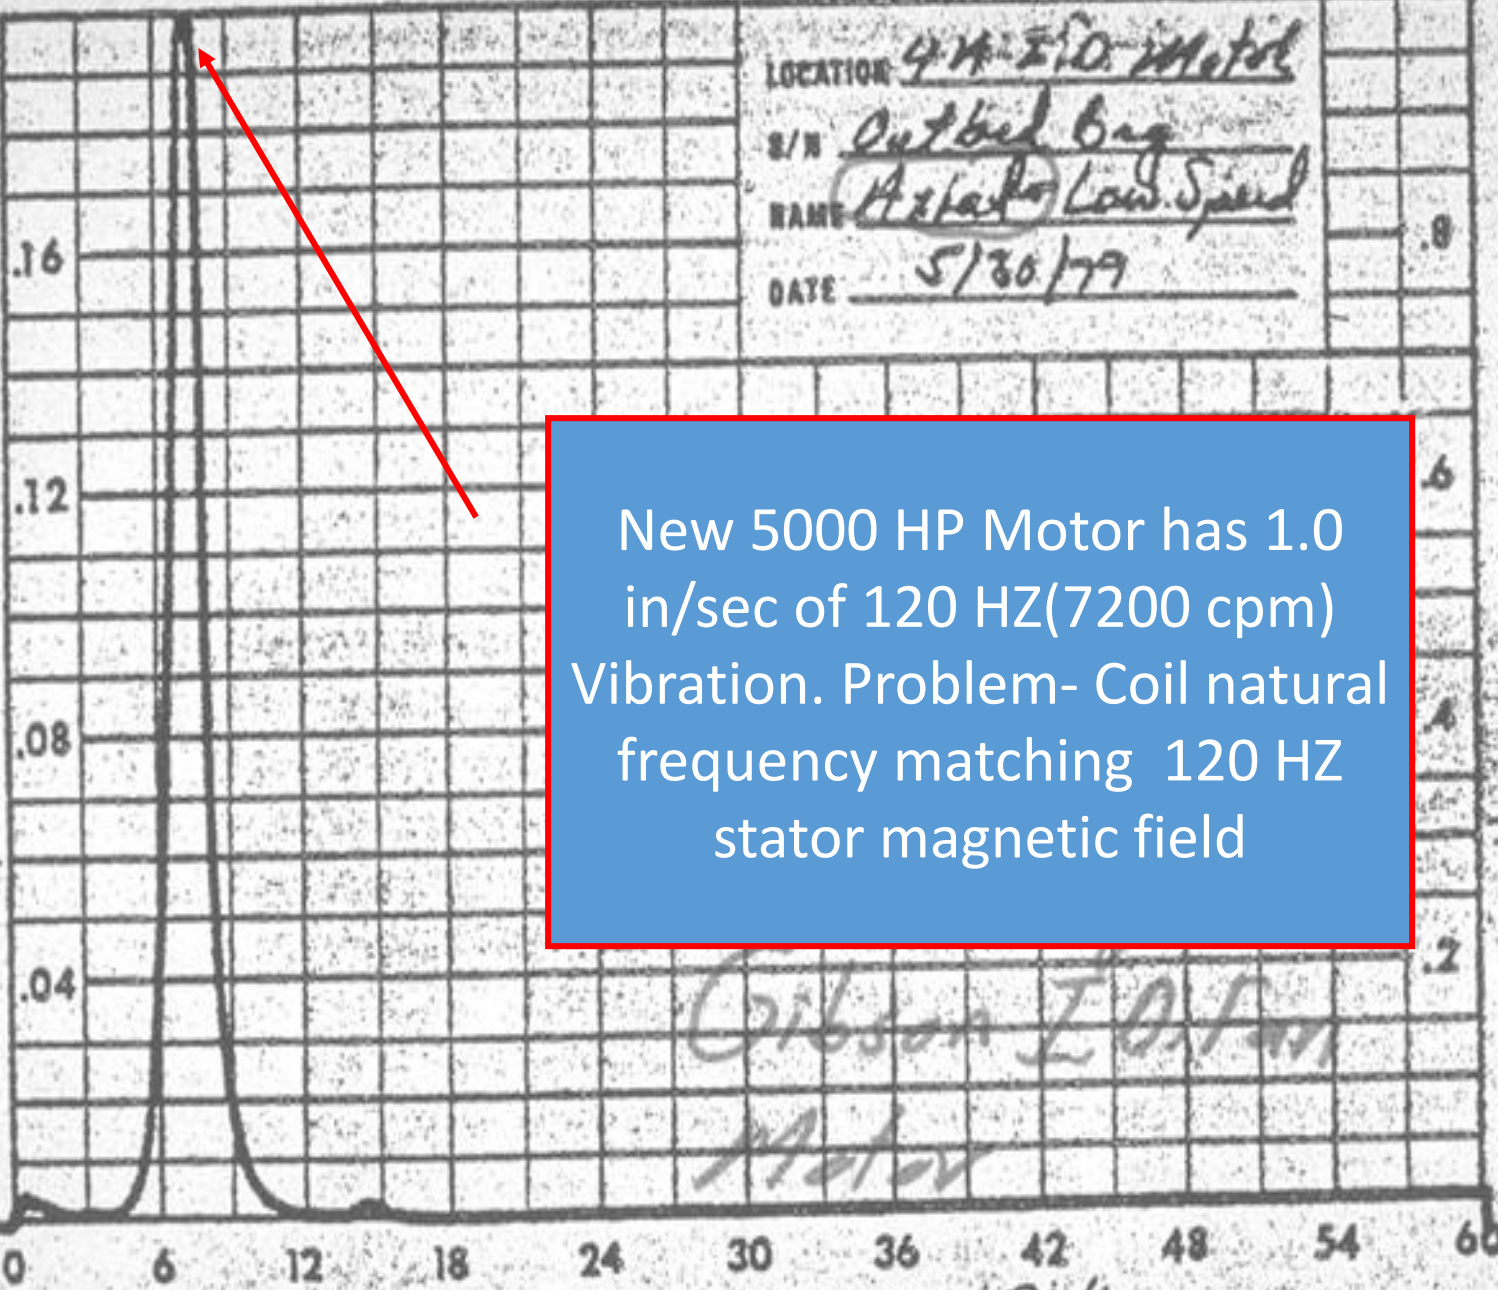
New 5000 HP Motor has 1.0 in/sec of 120 HZ(7200 cpm) Vibration. Problem- Coil natural frequency matching 120 HZ stator magnetic field

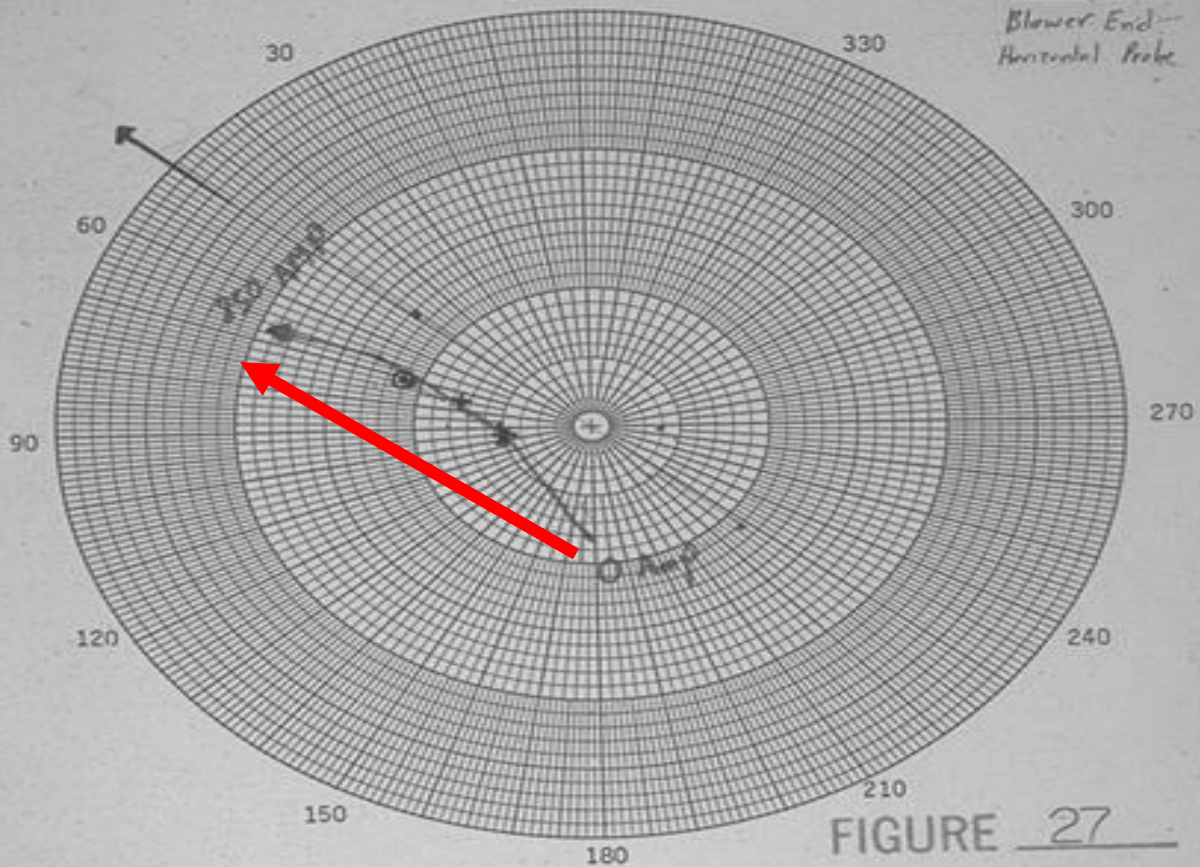
FIGURE 27

Case 1- LARGE MOTOR IN VENEZUELA WITH THERMAL LOAD BASED UNBALANCE SENSITIVITY

- RECEIVED CALL THAT STATED “ THE MOTOR IT DOES NOT RUN ANY GOOD ANY MORE SINCE WE BALANCED IT”

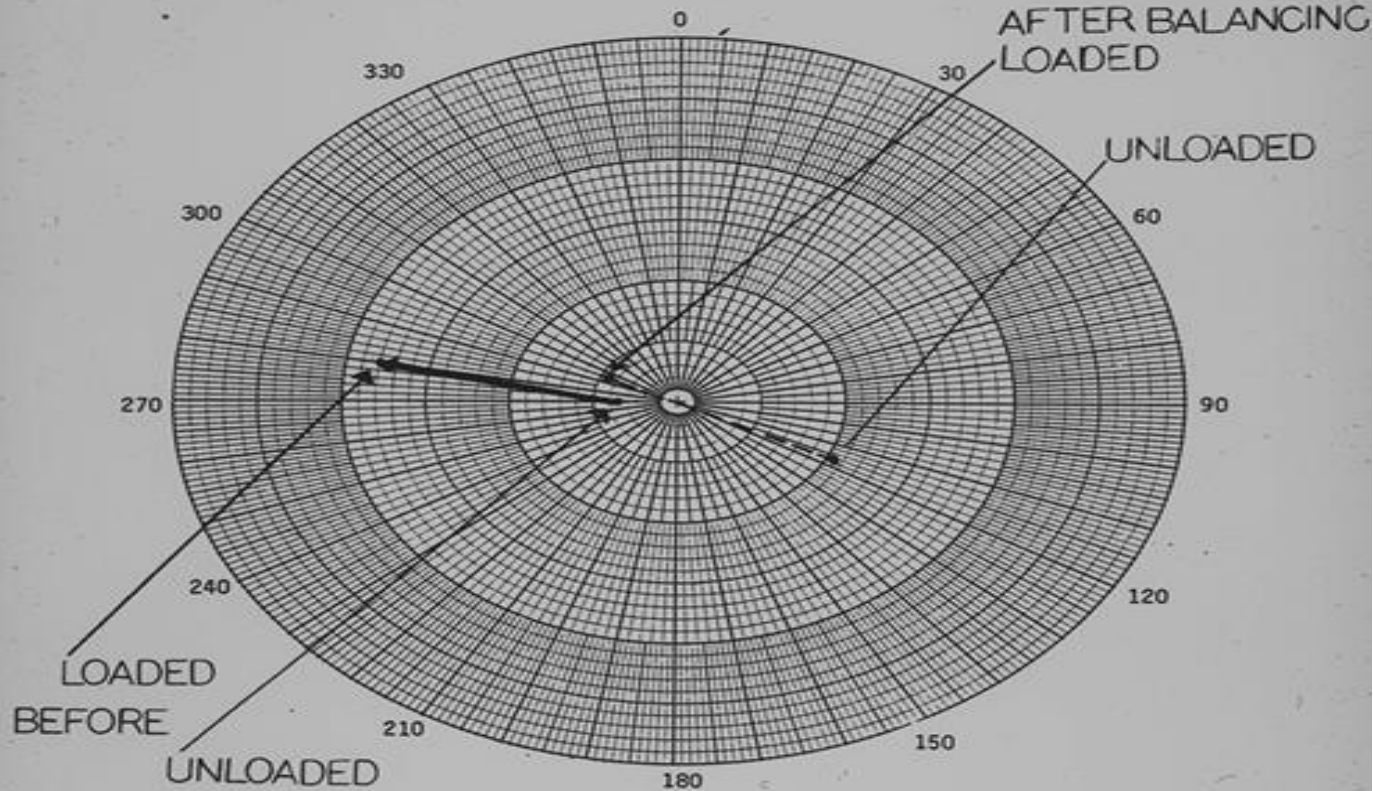
THERMAL SENSITIVE MOTOR

Notes: 5.6 MIL THERMAL CHANGE

- Examination of rotor showed what looked to be damage to rotor laminations. Motor shop had dropped rotor, but did not think there was any significant damage.
- Shorted laminations cause a hot spot which causes the rotor to bow.
- Solution was to install proximity probes and compromise balance the rotor at full load. Balance solution was extremely non-linear. Had to put in only half what balance solution calculated.
- Motor operated like this for the next 8 years until it was finally sent out for its normal repair cycle.
- I hope whoever got this rotor did not take out the compromise balance weights because if they did, someone is going to say “ **The motor it does not run well anymore ever since we balanced it**”. See **case history 1**.

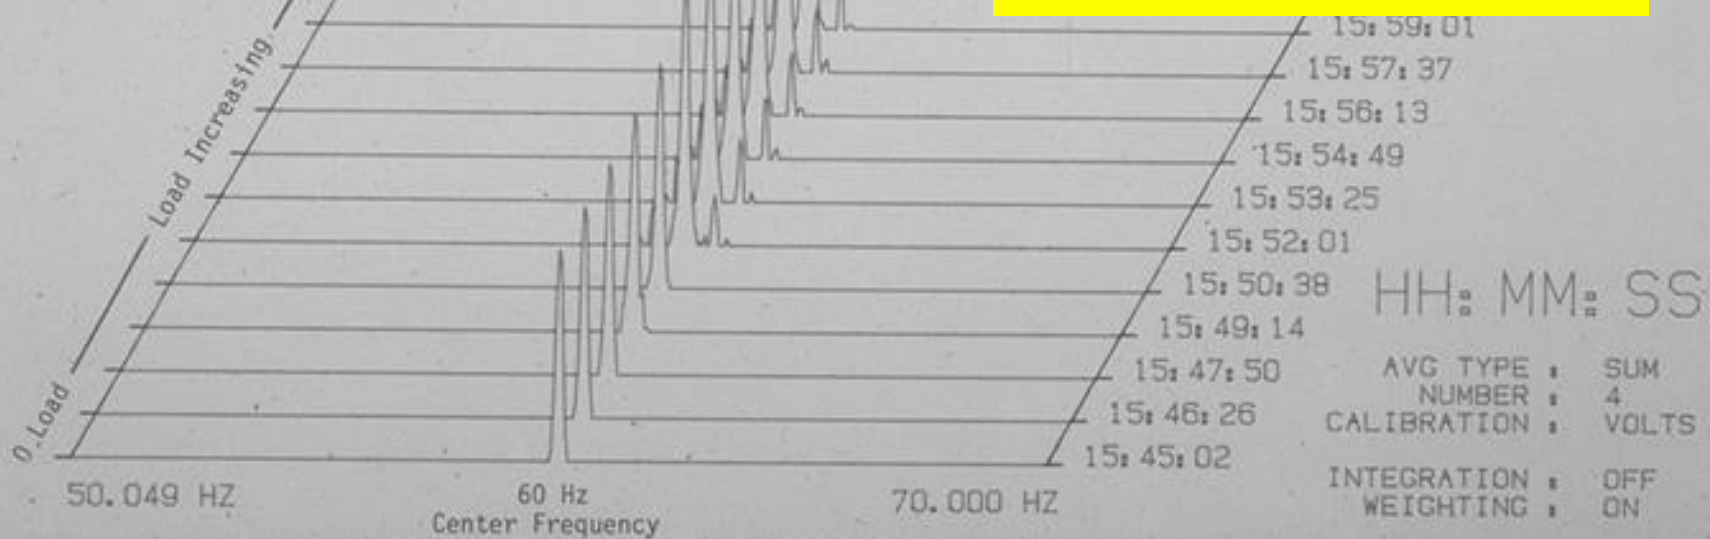
Vibration spectrum showing sidebands on a 250 HP 1800 RPM motor. As the load increases, the sidebands move away from the center frequency, due to increased amount of slip. The sidebands are the number of poles X the slip speed up and down from running speed. The sidebands also show up on the 2nd and 3rd harmonics.

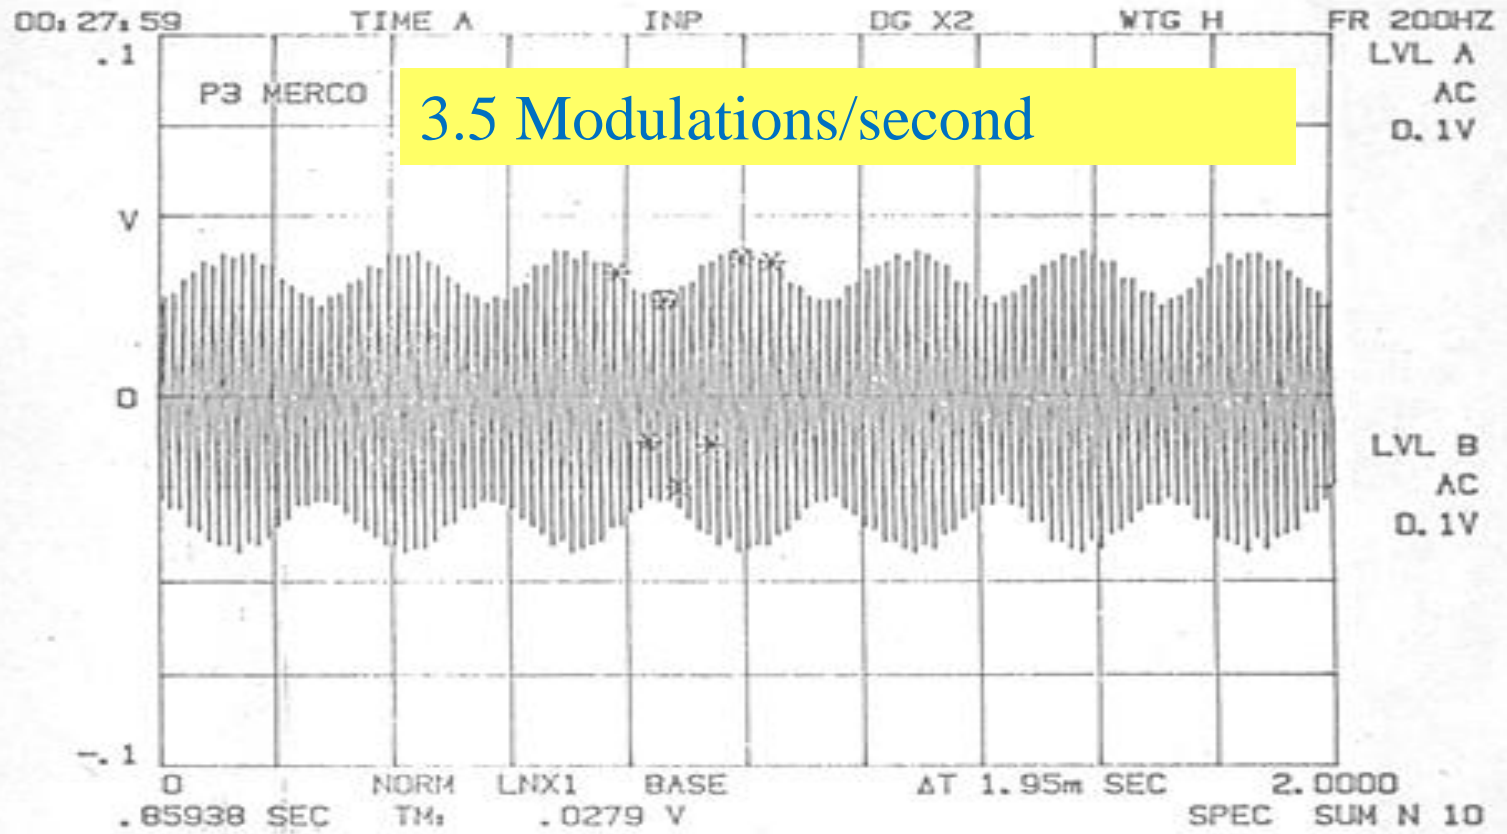
FIGURE 1

THIS FIGURE SHOWS THE MODULATION OF THE CURRENT GOING TO THE P-3 MERCO MOTOR. FOR A HEALTHY MOTOR, THE CURRENT WILL FLOW STEADILLY. WHEN BROKEN BARS ARE PRESENT, THE IMPEDENCE VARIES AS THE MAGNETIC POLES GO PAST THE BROKEN BARS. THIS CAUSES THE VARIATIONS IN MOTOR CURRENT. THE POLES PASS AT THE RATE OF THE NUMBER OF POLES TIMES THE SLIP FREQUENCY.

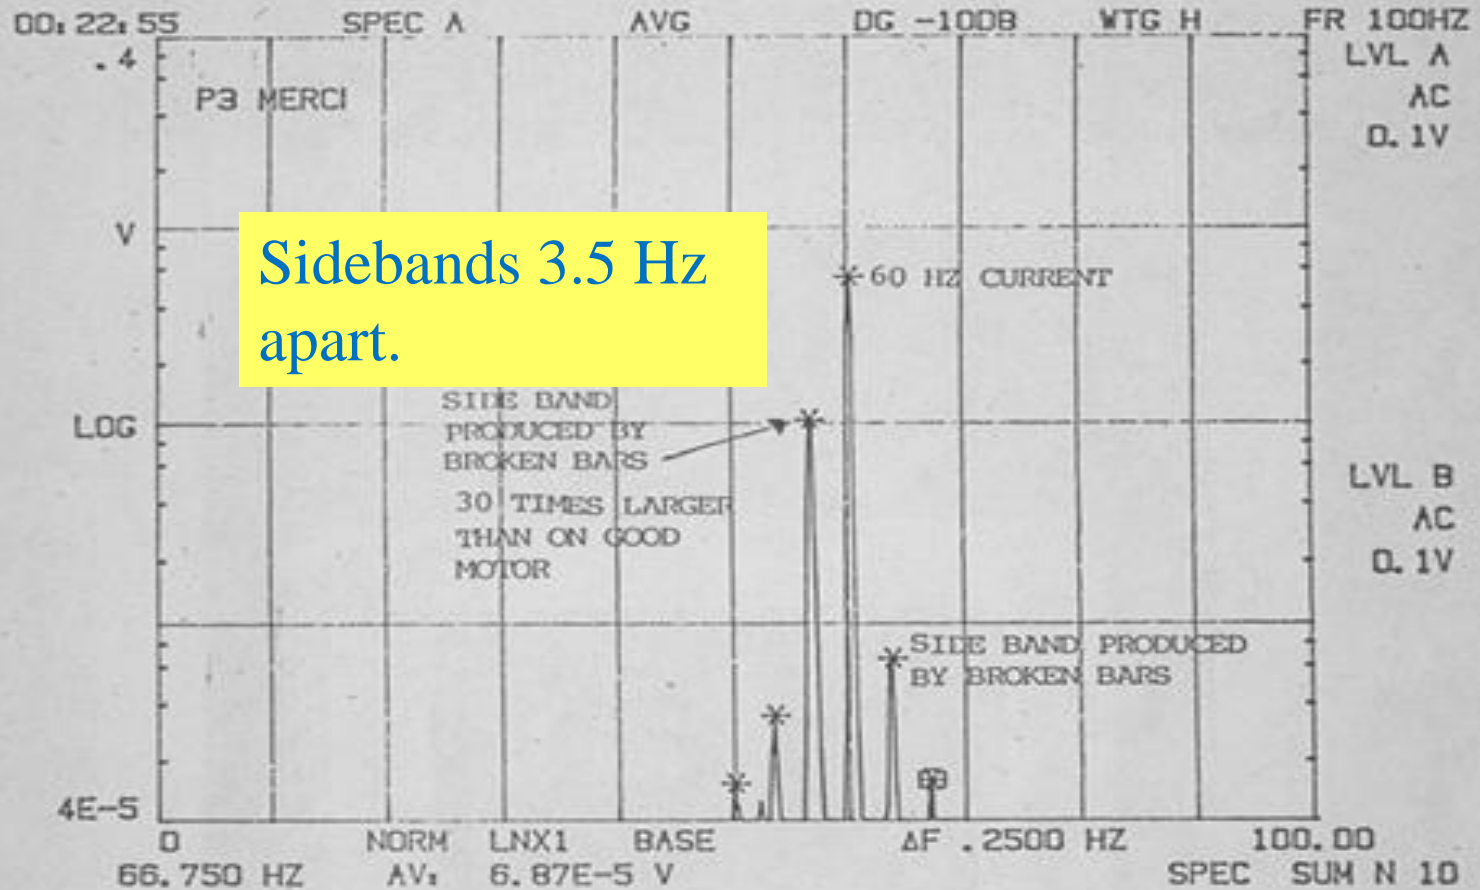
Sidebands 3.5 Hz apart.

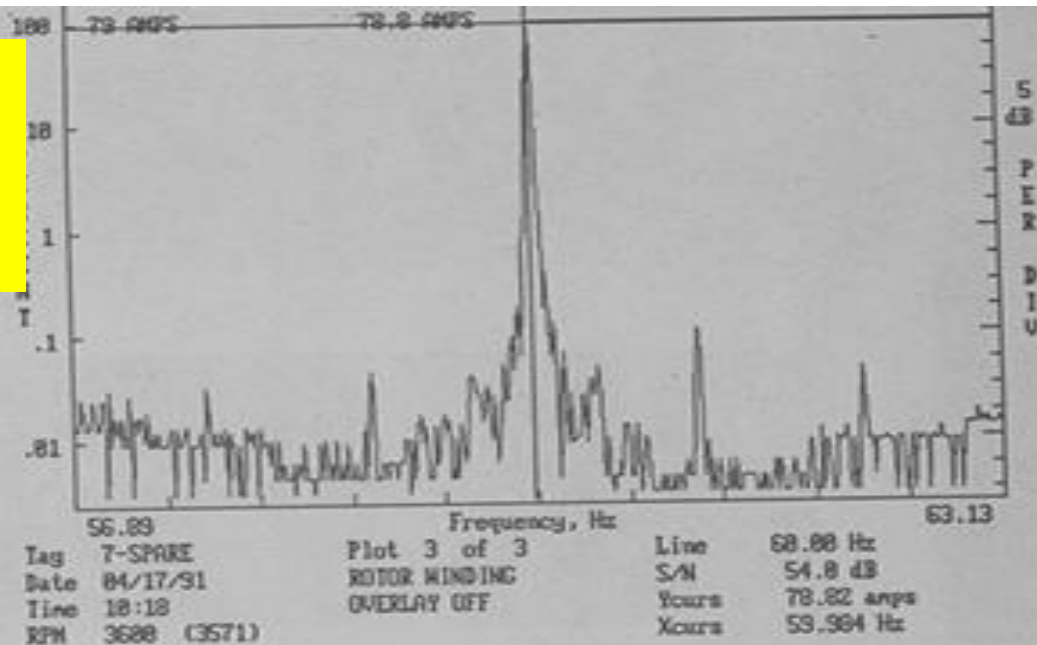
Current spectrum side bands were low

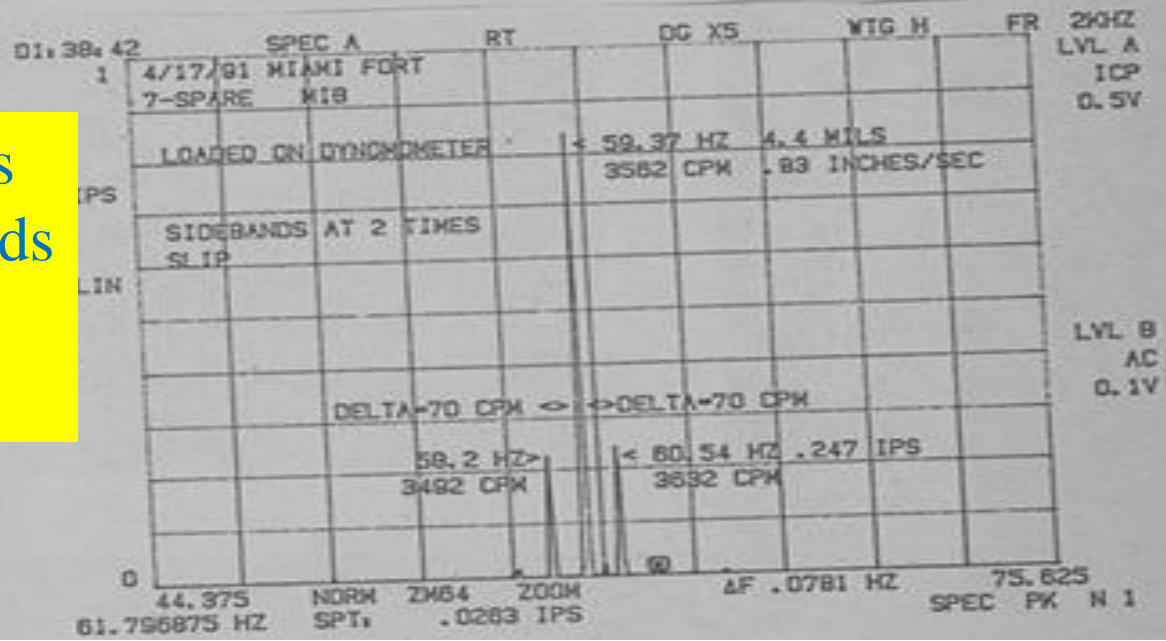
Vibration sidebands were high. Sidebands were at no. poles X slip frequency.

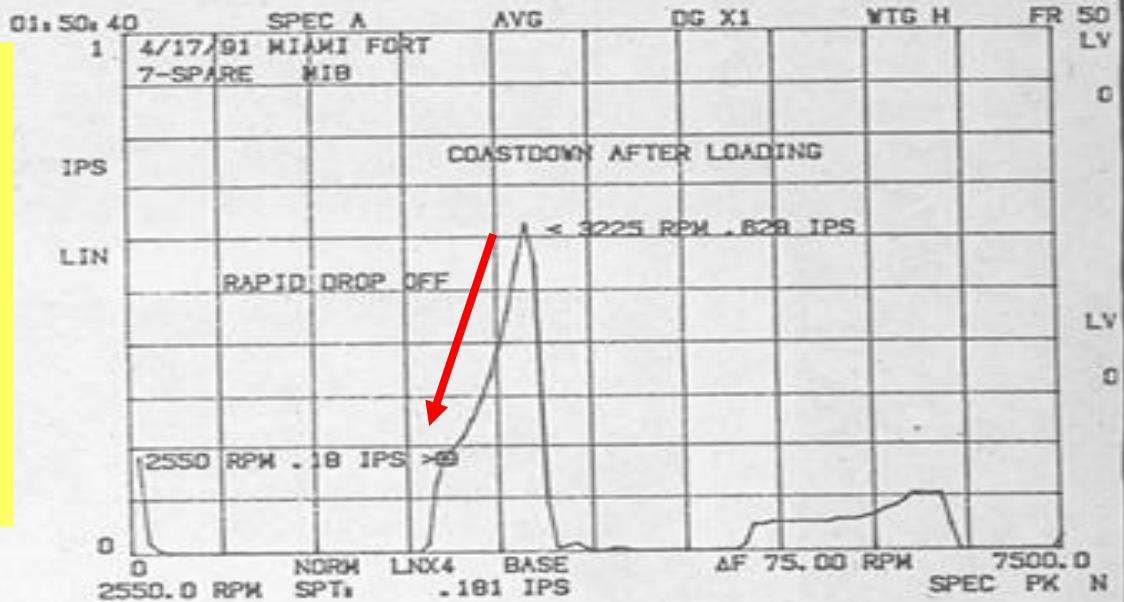
Coast down data was taken on the motor and is shown that it was operating near a natural frequency.

- Motor had originally had an aluminum cast rotor
- Owner decided to have someone build a copper bar steel lamination rotor.
- The change in mass resulted in pulling the rotor natural frequency down close to the operating speed.
- This caused the rotor to bow introducing rotating eccentricity.
- The rotating narrow air gap then interacted with the rotating stator's magnetic field. The interaction rate just like a broken rotor bar is no. poles times slip. This causes the vibration to modulate, but has no effect on current flow.
- By doing a precision field balance, the amount of rotor bow was reduced and the modulation was significantly lower.

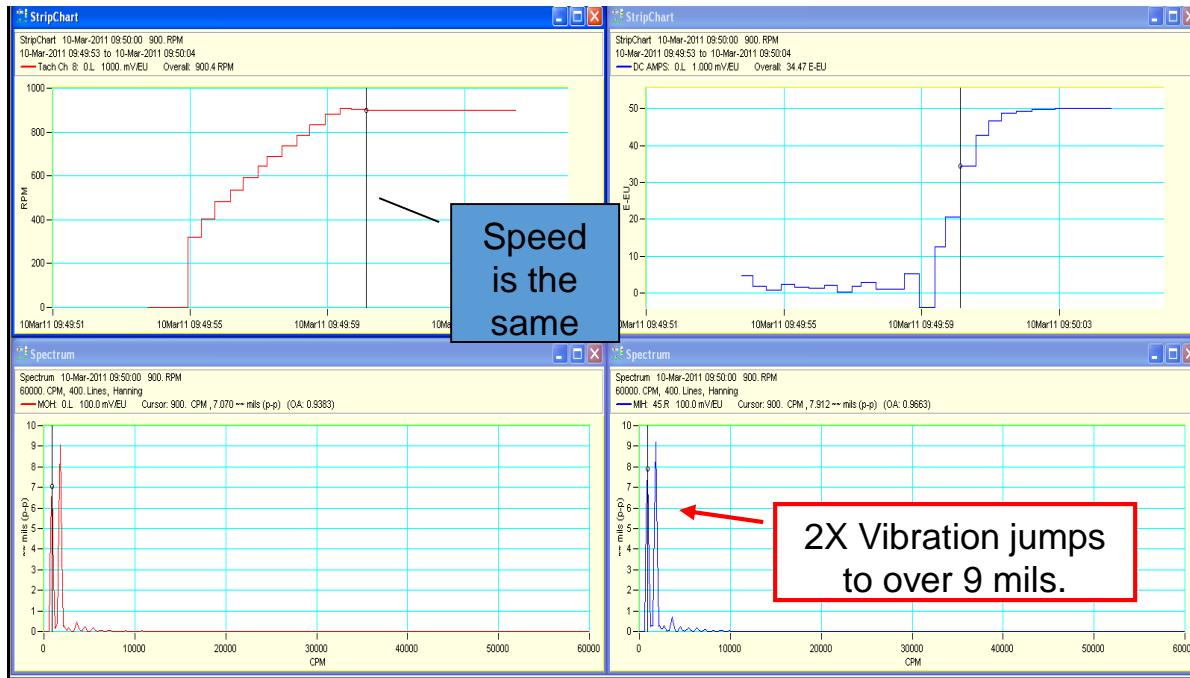
DC CURRENT IS APPLIED .4 seconds later high vibration

Problem was a shorted field coil that caused uneven magnetic field.

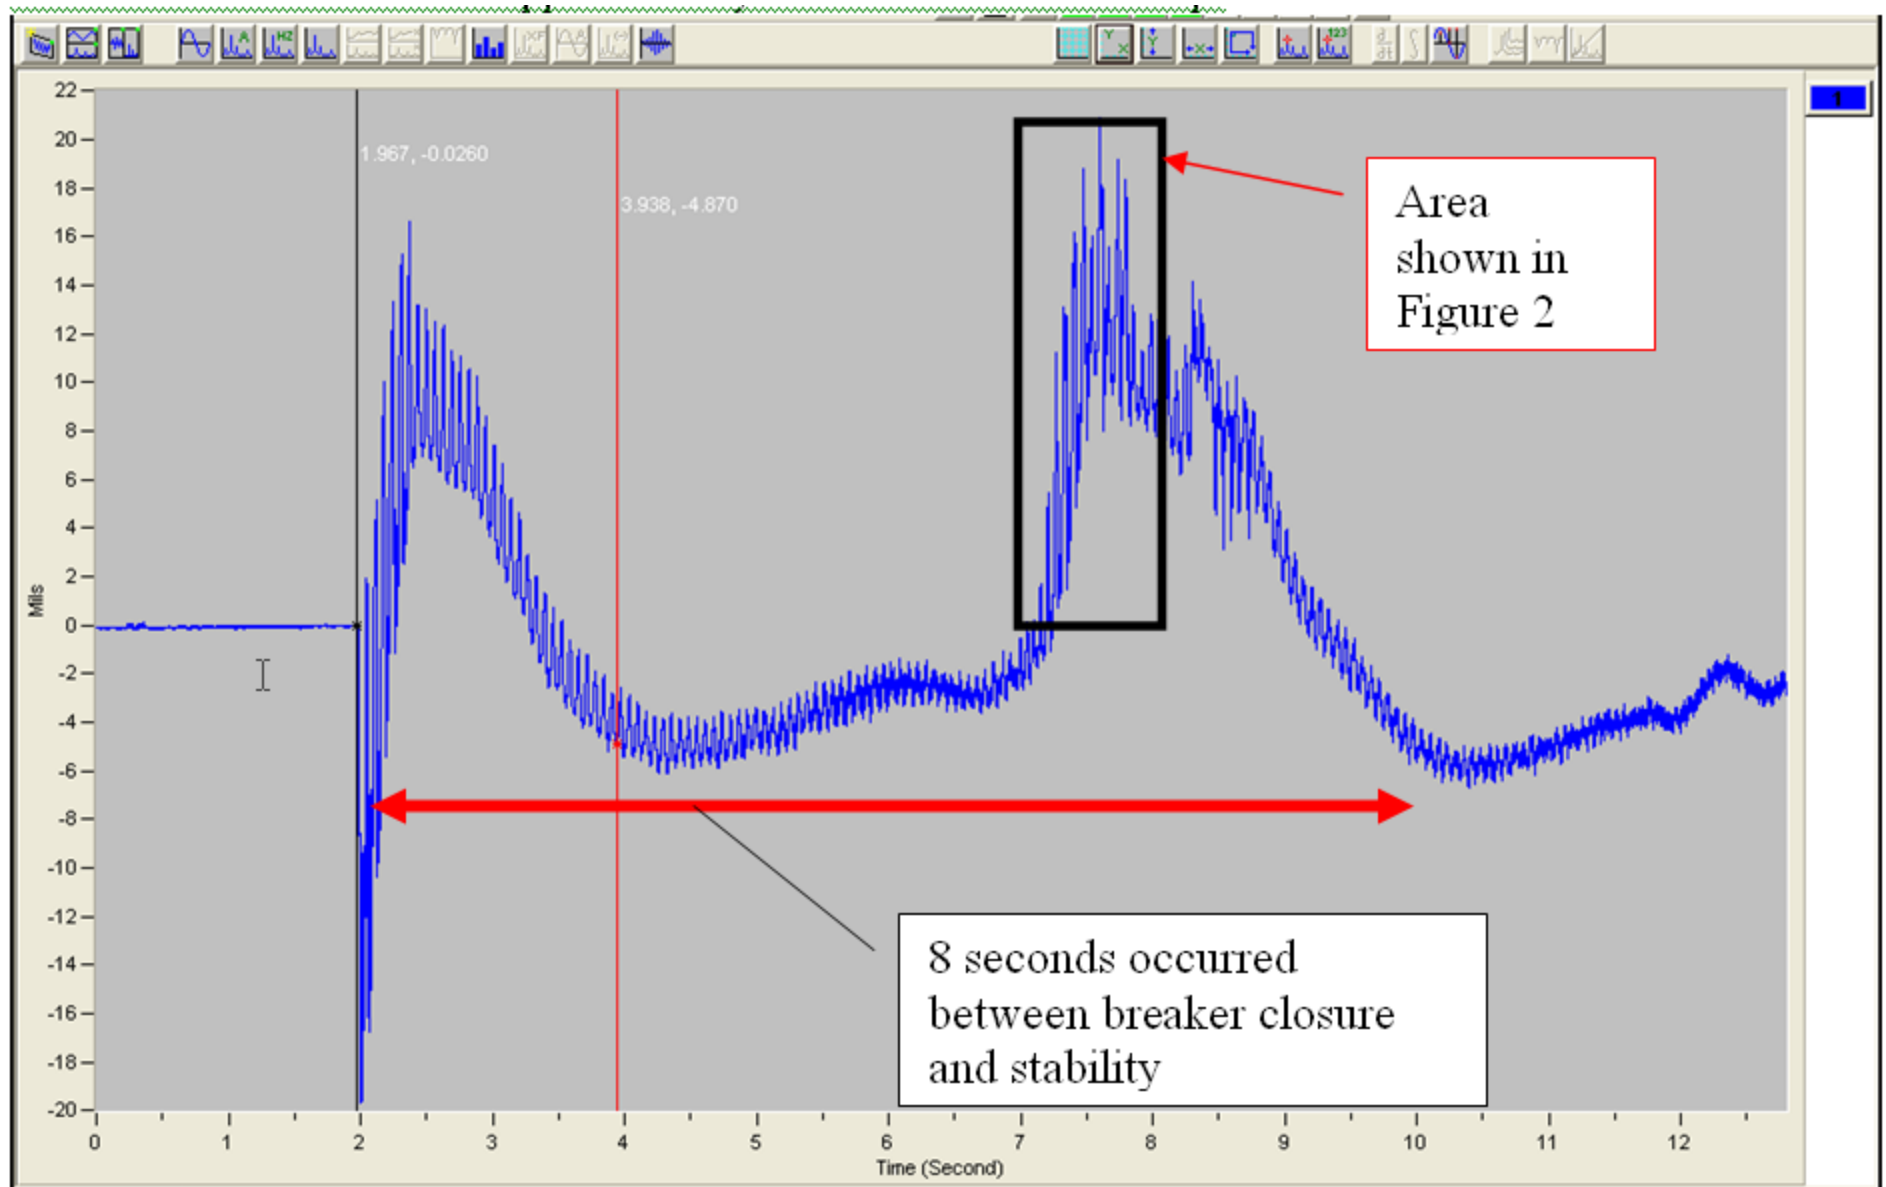
Figure 2

- This machine had a history of high vibration during the 6-8 second run up period.
- This was a newly overhauled unit. The aluminum seals rubbed. The aluminum built up on the shaft forcing the impeller into the scroll resulting in complete destruction of the impeller.

When clipping was occurring, the peak to peak motion was 12 mils for .6 seconds.

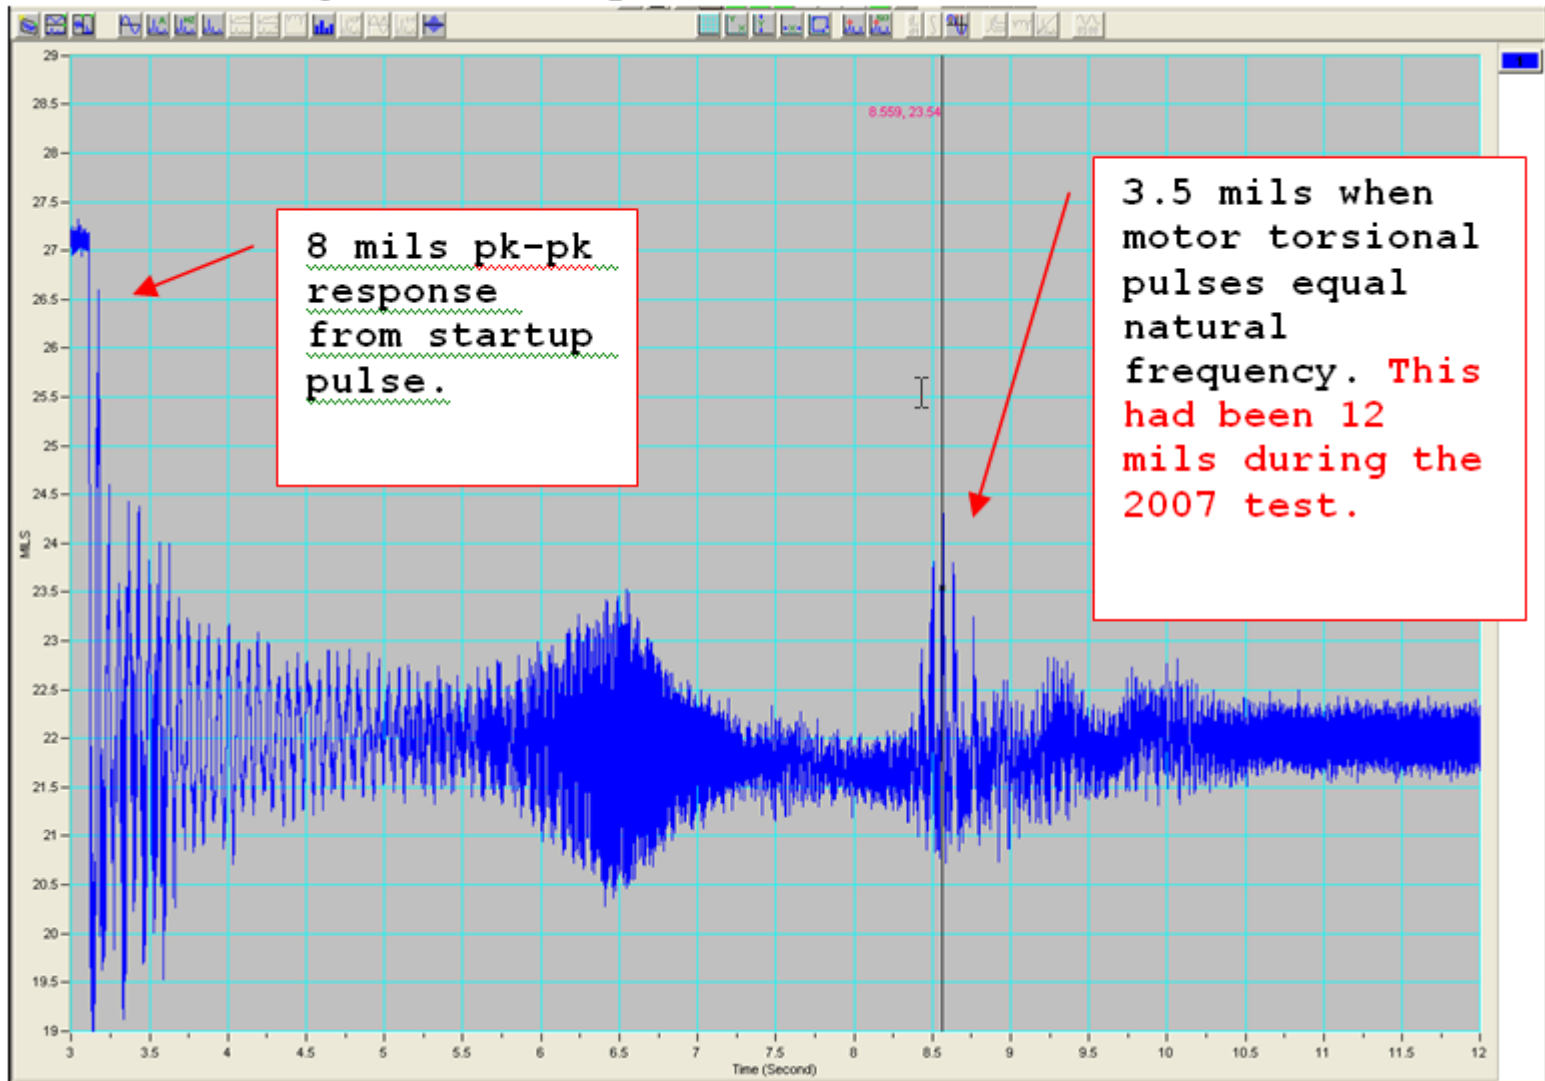
Coupling was badly worn. When it was replaced response dropped significantly. The 915 cpm component was still present, but at much lower levels.

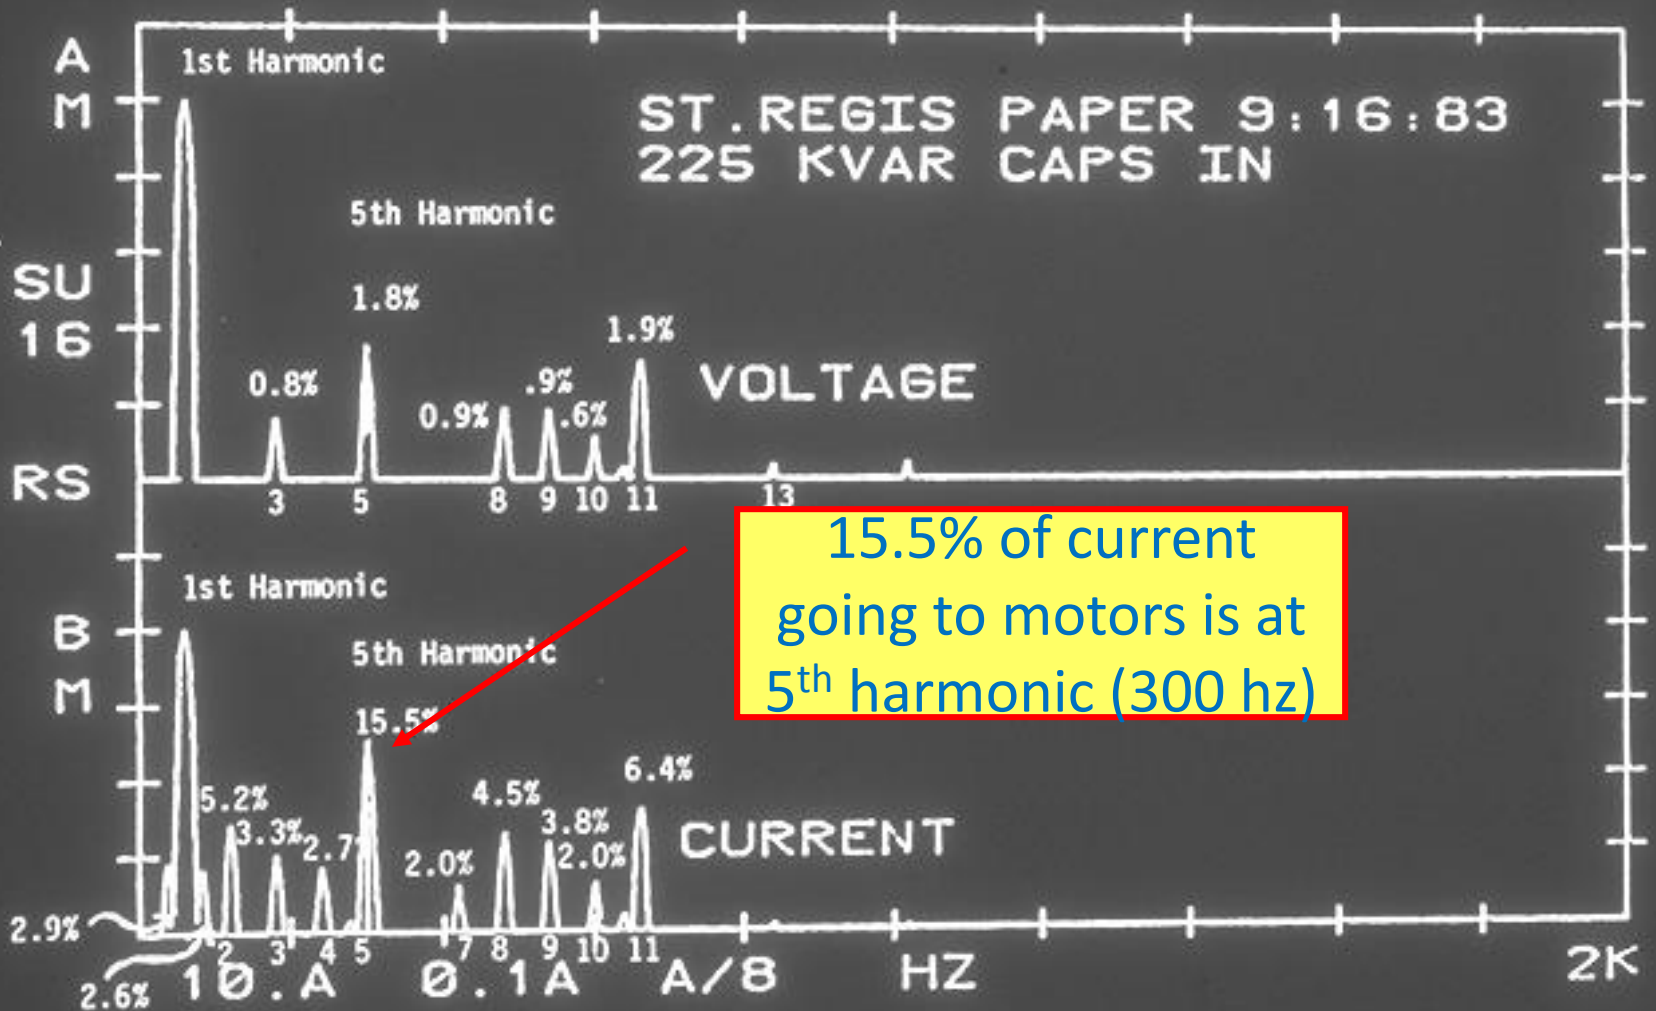
ALL CAPACITORS RACKED IN

- Excessive current at the 5th harmonic of line frequency was detected at this facility.
- The amplitude of the 5th harmonic nearly tripled when all the power factor correction capacitors were racked in.
- The 5th harmonic is a counter rotating field, so it was trying to drive the motor backwards at 5 times the operating speed. That energy was thus turned to heat.
- The 5th harmonic was most likely produced by some on site variable frequency drives.
- Electrical circuits can have resonances, just like mechanical system.
- Electrical circuits resistance to current flow (impedance) is a function of the resistance, capacitance and inductance.
- Recommendation: Have an expert in electrical power circuits model system and try to reduce harmonics with filters or alter system impedance.

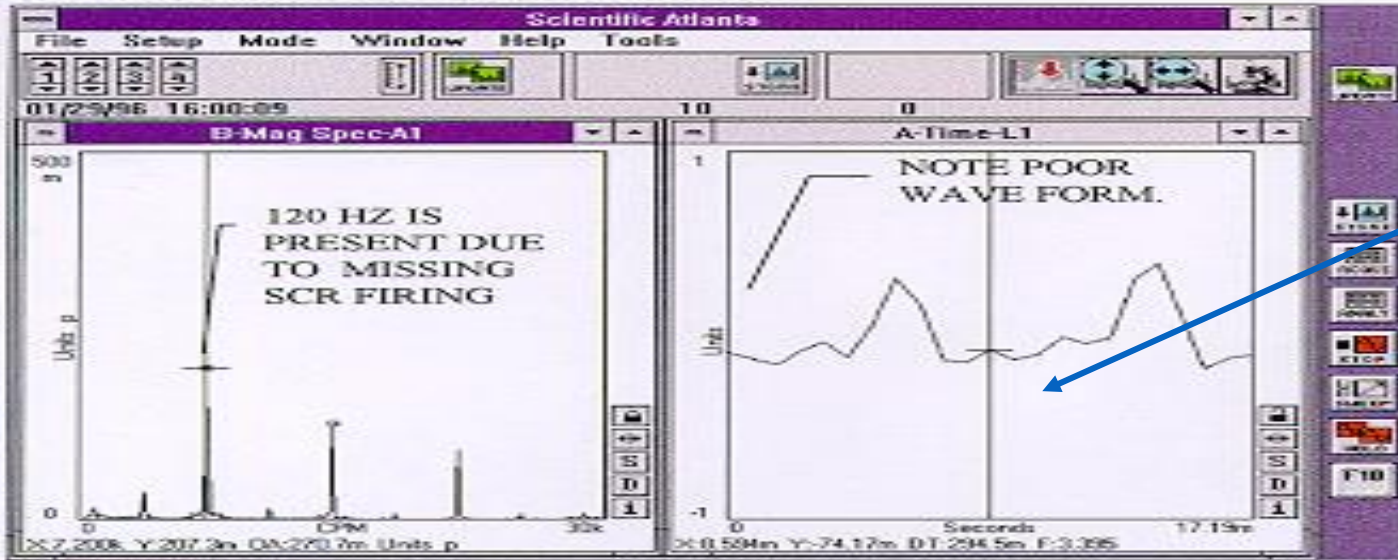
THIS IS AN EXAMPLE OF 2 SCRs NOT FIRING IN A FULL WAVE RECTIFIED DC DRIVE FILE IS STORED UNDER SCRMISS.WAV

WHEN SCR'S WERE REPLACED, THE WAVEFORM AND SPECTRUM RETURNED TO NORMAL.

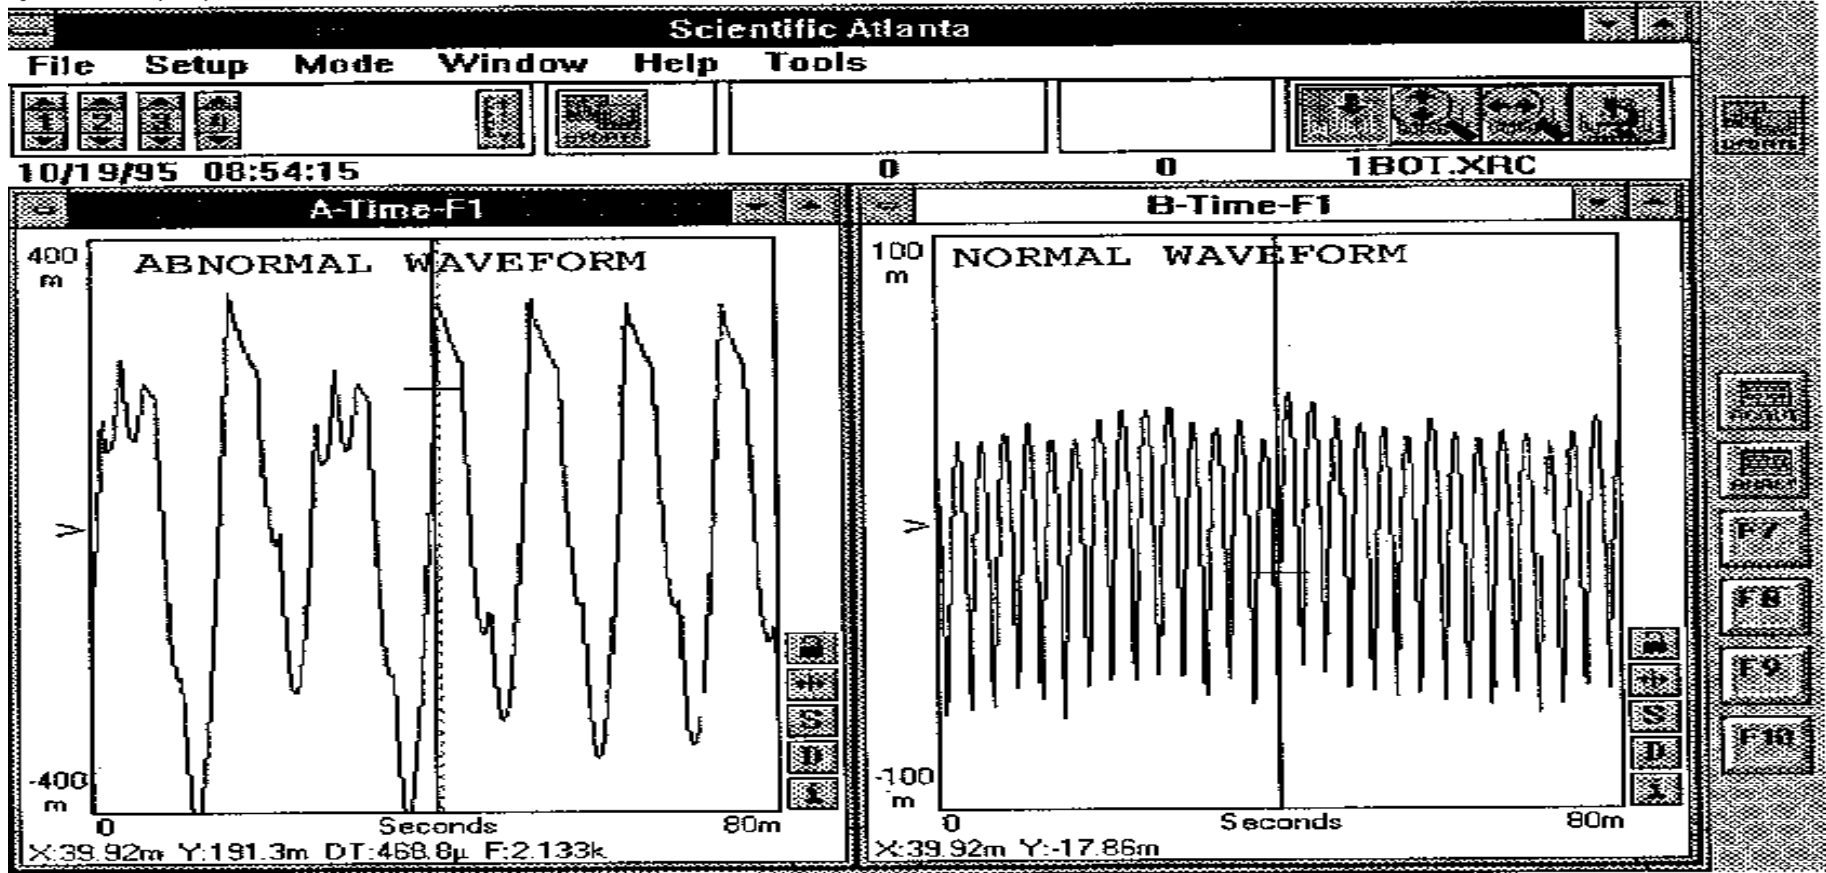
2nd PRESS CURRENT WAVEFORMS BEFORE ADJUSTMENTS AFTER ADJUSTMENTS

The upper left time plot of the motor current shows what was present on the 2nd press bottom drive prior to making adjustments to the drive. The figure to the right is from the 1st press bottom drive. The next page shows the FFT transform of the above data.

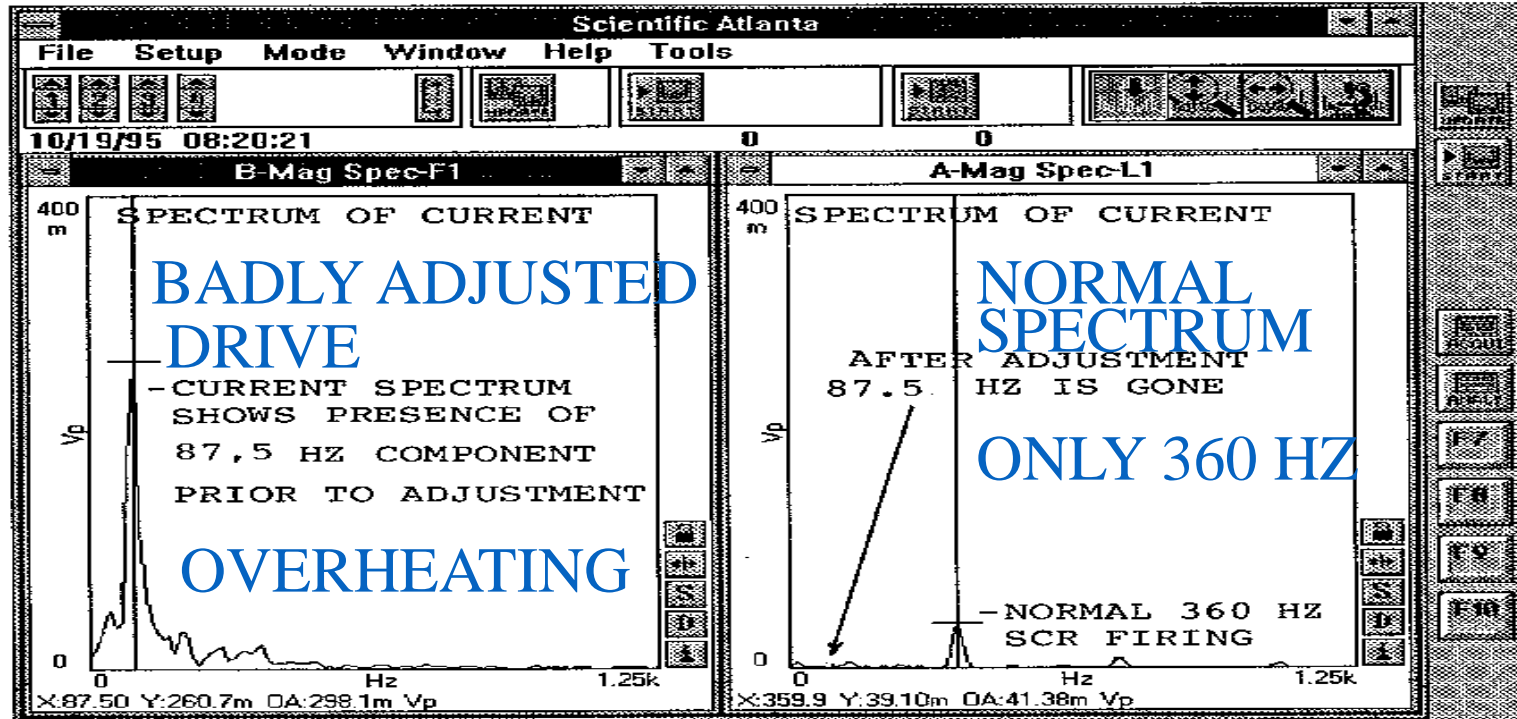
COMPARISON BETWEEN ABNORMAL CURRENT SPECTRUM FROM POORLY ADJUSTED DC DRIVE AND WELL TUNED DRIVE.

The spectrum on the left was taken from a current probe located on the 2nd bottom drive when the motor was vibrating at 1 inch/second and was operating at 180 degrees. The vibration signature showed a very high level of a 87.5 HZ frequency component, which is the identical frequency in the upper left spectrum.

The upper right spectrum was taken on the same motor after the drive controls were adjusted properly. Note that the only frequency which is present is the normal 360 HZ SCR firing frequency. The vibration on the motor dropped to below .1 in/sec and the 87.5 HZ component was no longer present after the drive was tuned properly.

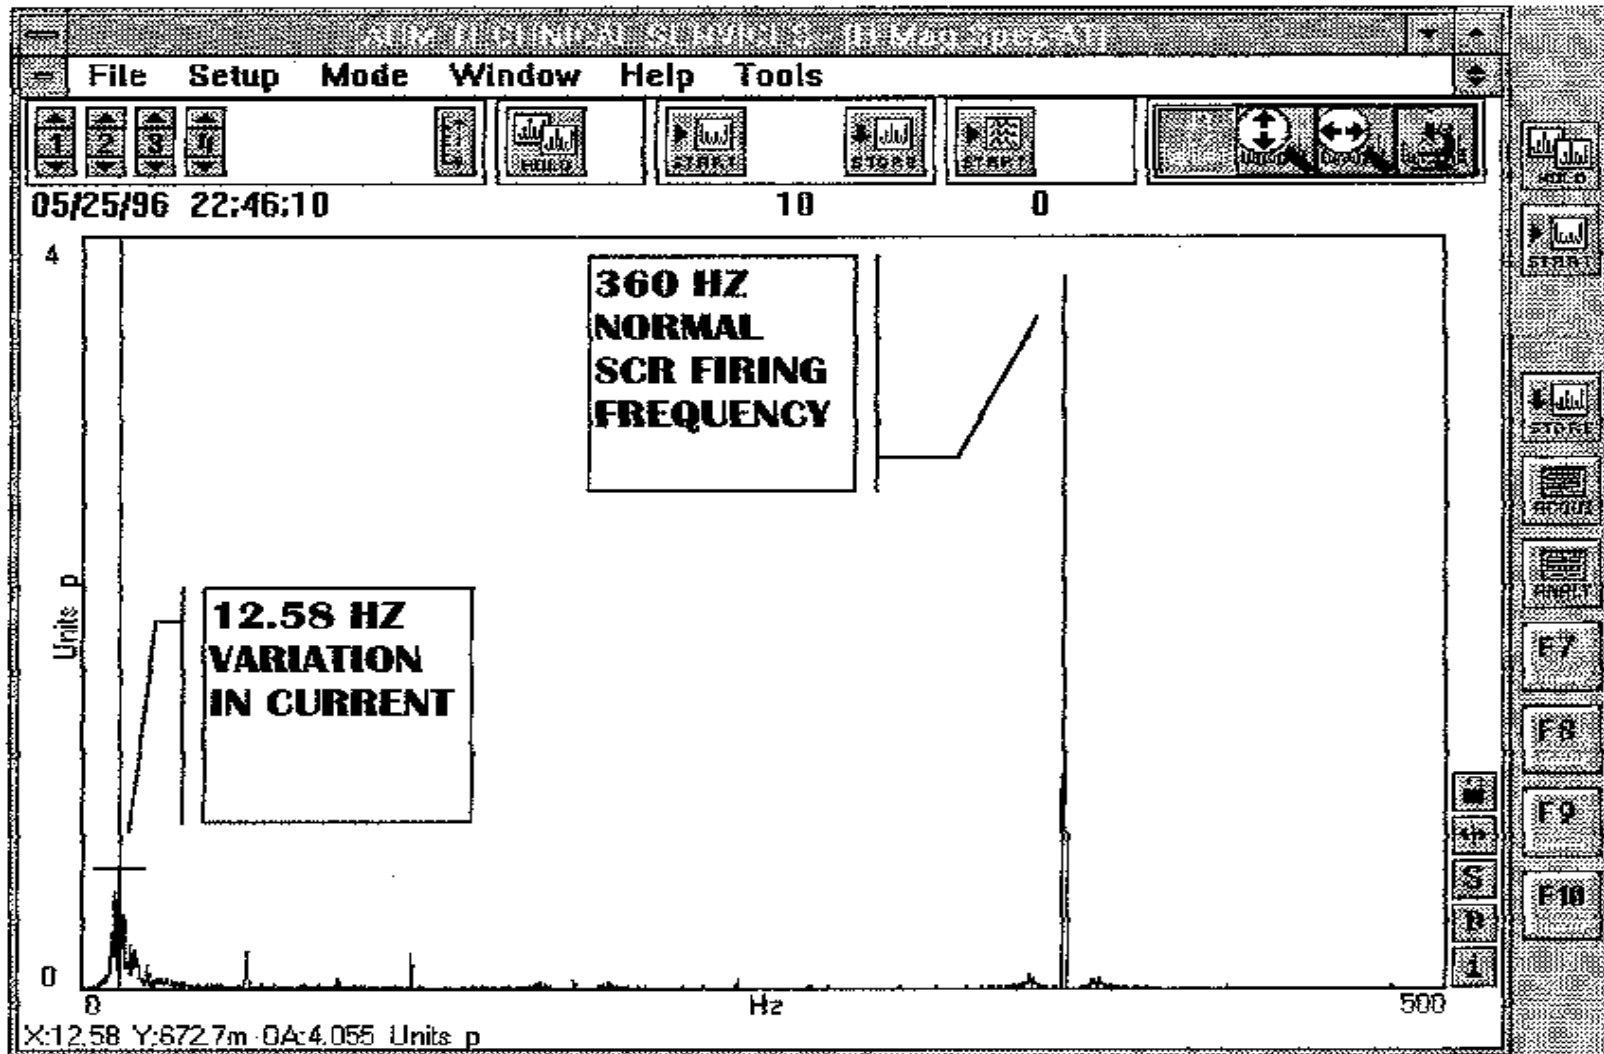
12.5 HZ VIBRATION DID
NOT MATCH
ANYTHING

MAY 25, 1996 COUCH ROLL DRIVE A1 LEAD CURRENT
