ELECTRIC MOTORS

OPERATION AND VIBRATION CASE HISTORIES

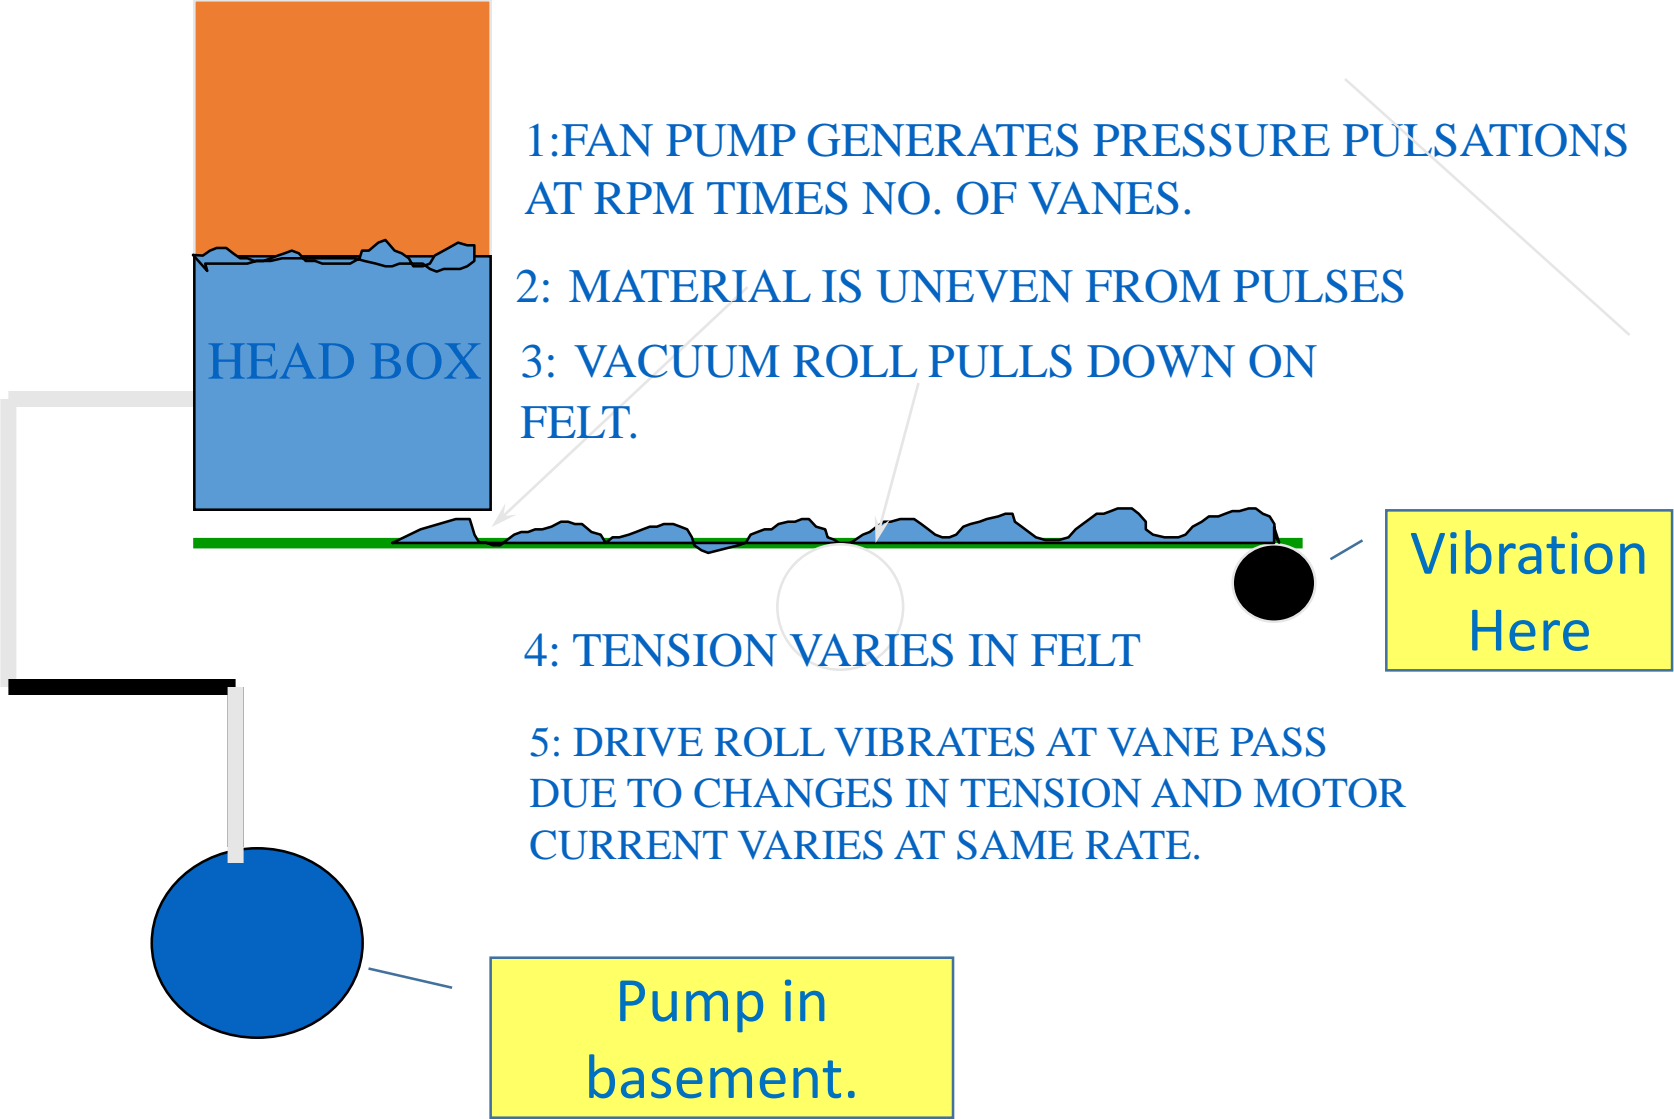
3: DC MOTORS- Unknown frequencies in the spectrum of the current going to a DC drive can originate from other mechanical equipment in the drive train. Case History- The current on a couch roll of a paper machine had an unknown component in its spectrum. It turned out to be the vane pass frequency of the fan pump located several yards away in the basement. The fan pump was causing pressure pulsations in the head box that caused the paper to be deposited in varying thicknesses. As the thicker material passed over the vacuum rolls, this caused the tension to increase which changed the tangential force on the couch roll which in turn caused the current draw to the couch roll to modulate at that rate.

12.58 HZ SIGNAL MATCHES VANEPASS OF FAN PUMP

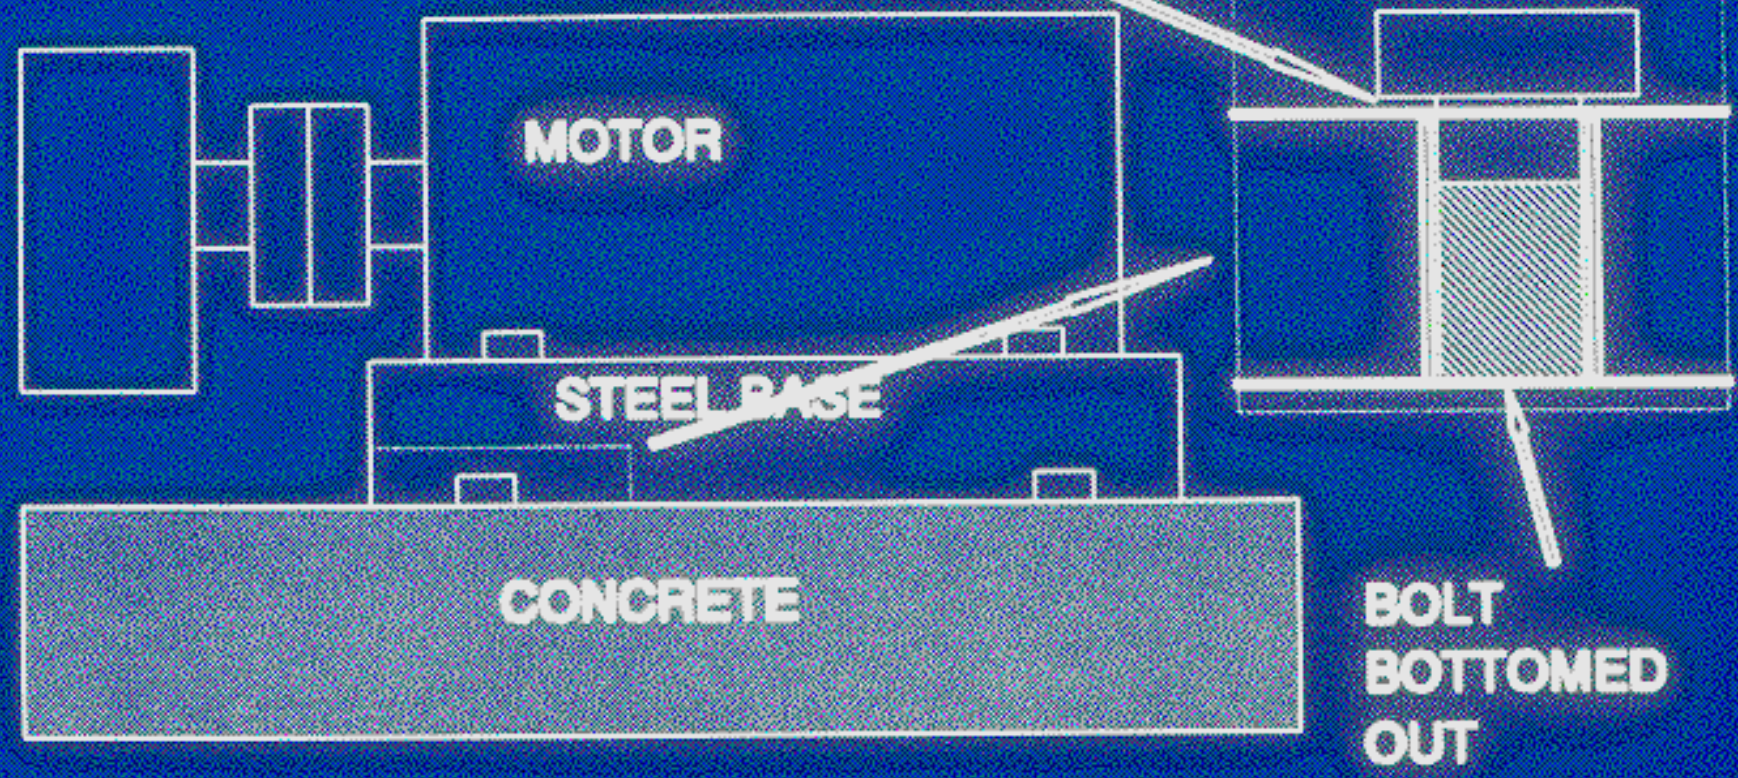
MOTOR VIBRATION WAS 8 MILS. BOLT WAS TIGHT BUT NOT MAKING CONTACT. WHEN WASHER WAS ADDED, VIBRATION DROPPED TO BELOW 1 MIL

HEAD NOT MAKING CONTACT **ADDED WASHER HERE**
