Four Vibration Case Histories

Barry T. Cease
Cease Industrial Consulting
ceasevibration@icloud.com
(843) 200-9705

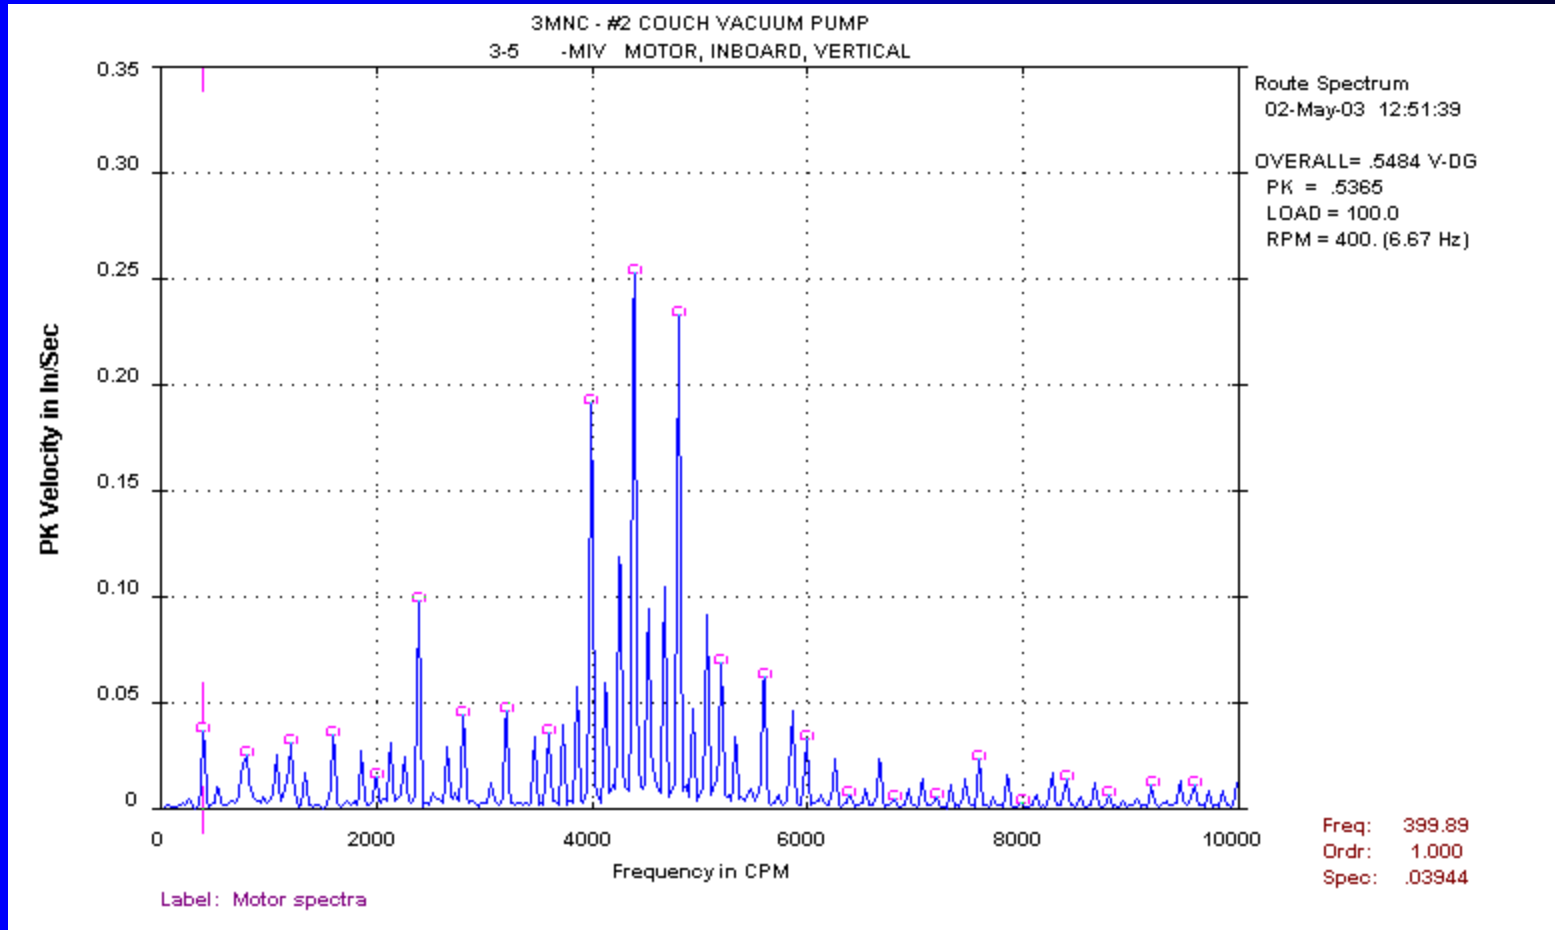
CH#1 - Motor Spectra

- Motor speed was exactly 400 rpm.
- Pump speed was 267 rpm.
- Pump vibration data showed no abnormal patterns or levels.
- Motor spectra showed many harmonics of running speed and of 133 cpm (1/3 x rpm).
- Motor waveform showed impacting at 400 & 133 cpm.

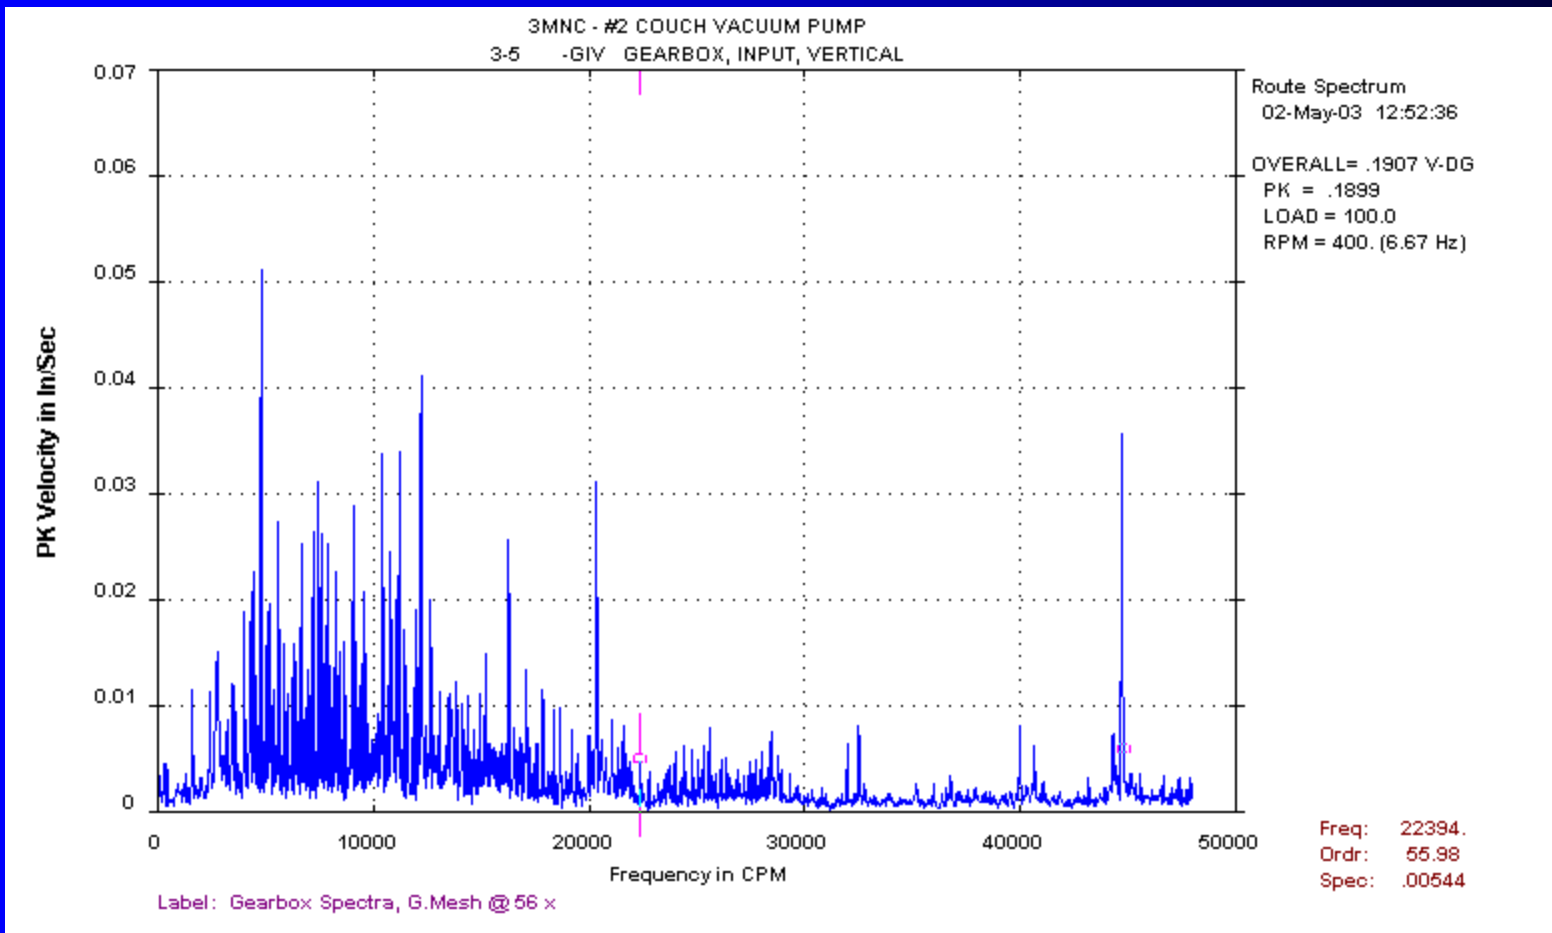
CH#1 – Gearbox Spectra

- Gearbox input speed was 400 rpm.
- Gearbox output speed was 267 rpm (1.5:1 ratio and 56T/84T).
- Gearbox spectra showed many harmonics of both input & output speed and 133 cpm (1/2 x output).
- Gearbox spectra didn't show high gearmesh frequency at 22,400 cpm.
- Gearbox waveform showed heavy impacting at 400 cpm.
- Gearbox Peakvue data showed many harmonics of 400 cpm.

- It was recommended that the gearbox be changed out when possible due to a probable gear fault.
- The gearbox was changed in 5/03.
- An inspection of the gearbox showed many gear teeth broken off on the pinion gear with significant wear on both gears.
- Follow-up data on both machines after the gearbox change showed much lower vibration levels – the problem vanished.

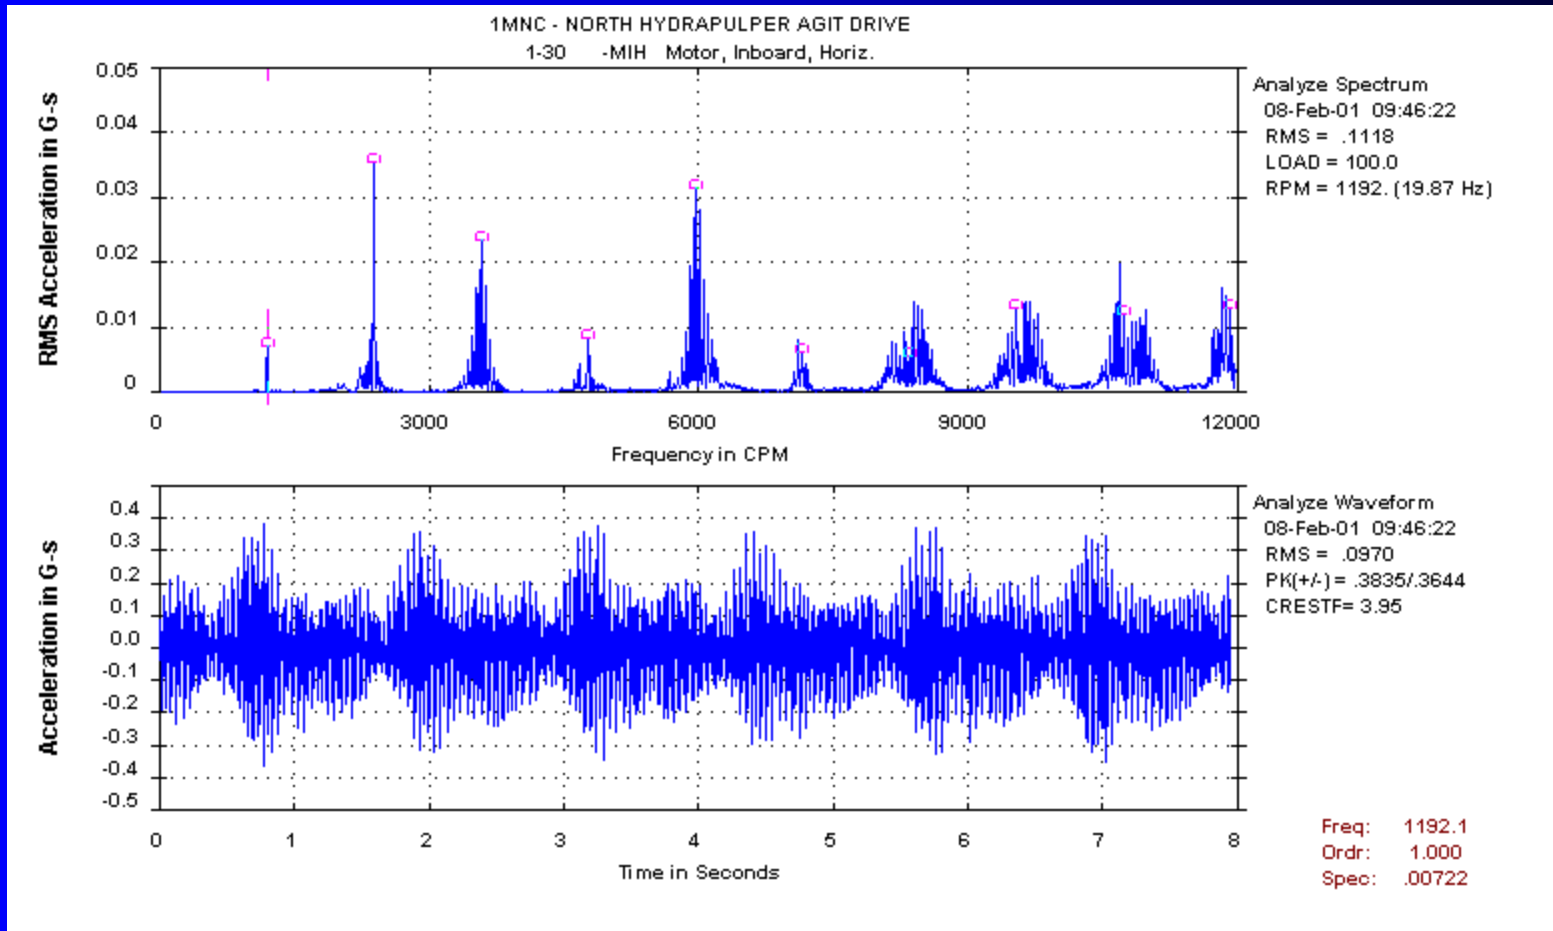
CH#2 – Motor Data

- Motor speed was exactly 1192 rpm.
- Agitator speed was 236 rpm (5:1 ratio).
- Motor spectra showed many harmonics of running speed & closer inspection showed 48 cpm sidebands around each harmonic.
- Motor waveform showed pulsations or modulation at a period of approx. 1.25 sec or 48 cpm.

- It was concluded that the strange vibration data on the motor was the result of broken rotor bars.
- The 48 cpm sidebands around the motor harmonics was a perfect match to its pole pass frequency.
- The classic spectral pattern of broken rotor bars is running speed harmonics with sidebands at pole pass frequency.
- The classic waveform pattern of broken rotor bars is pulsations at pole pass frequency.

- Pole Pass Frequency =
(Theoretical RPM – True RPM) * #Poles.
- PPF = (1200 – 1192) * 6 = 48 cpm.
- The recommendation was made to changeout the motor at the next outage.
- Later inspection by a motor repair shop showed many broken rotor bars.

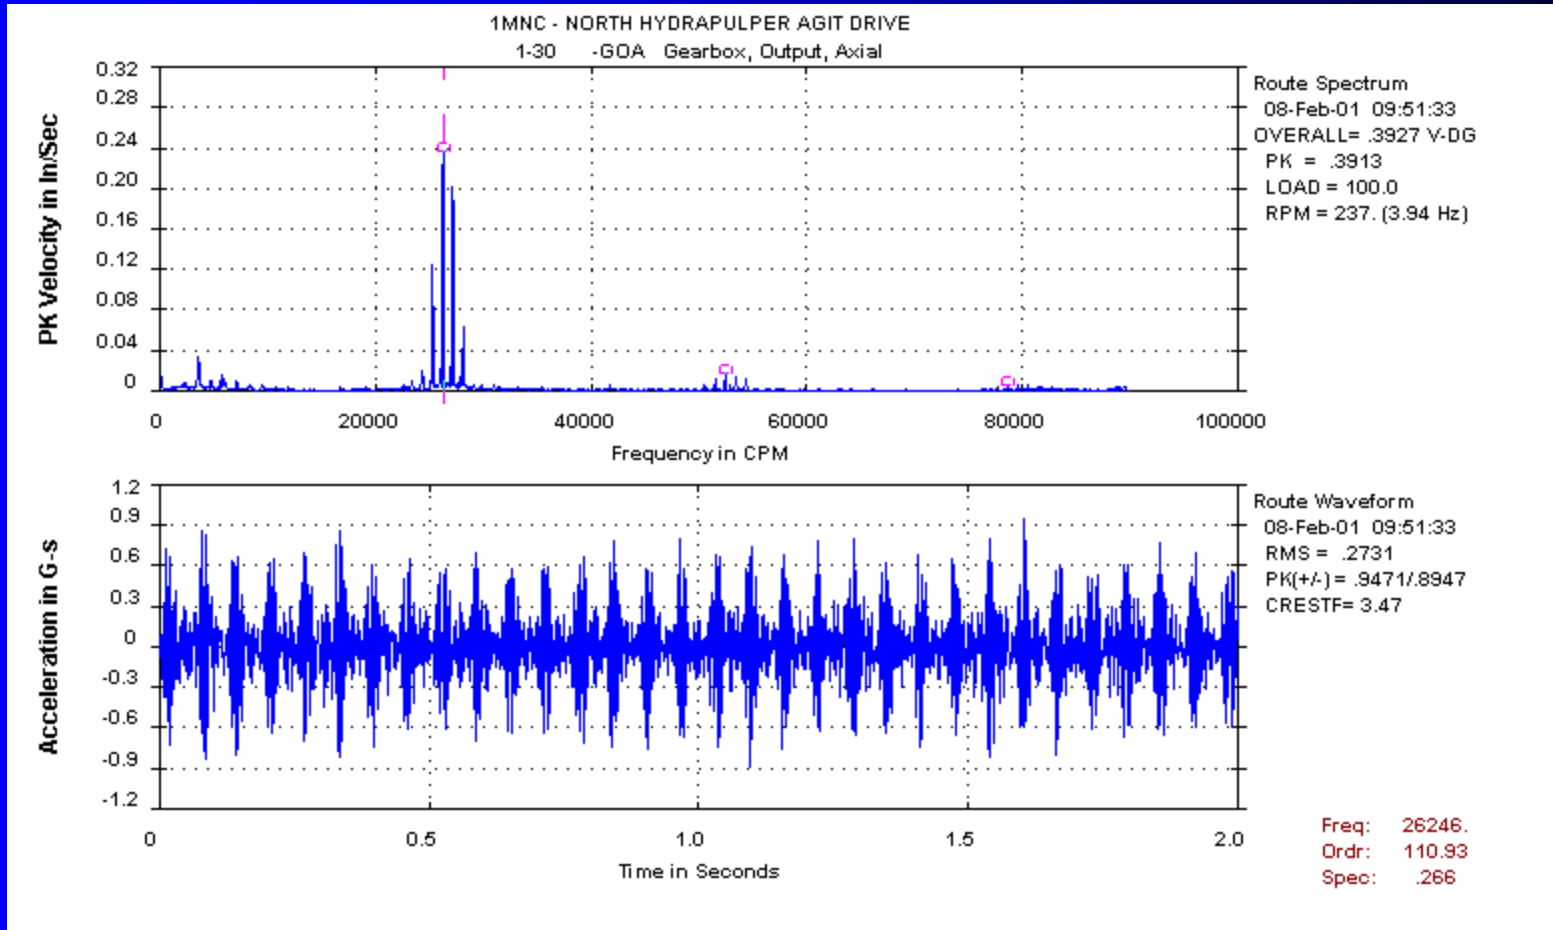
CH#2 – Gearbox Data

- Gearbox speed was 1192 rpm input & 236 rpm output (single reduction @ 5:1 ratio).
- Gearbox spectra showed high gearmesh frequency (26,200 cpm) with sidebands at 945 cpm.
- Gearmesh sidebands usually relate to one of the gear speeds, but 945 cpm didn't correlate to either speed (1192 or 236 rpm).

- Gearbox waveform showed impacting or modulation at 945 cpm.
- Agitator data showed nothing abnormal.

- After consultation with the gearbox OEM, it was concluded that the strange data from the gearbox was likely due to the 4-yoke design of the bull gear.
- The 4-yokes in the gear hub result in minor deviations from the gear pitch circle causing modulation each time the effected teeth move in and out of the mesh.
- $4 * 236 \text{ rpm} = 945 \text{ cpm}$.

- The gearbox vendor indicated the vibration measured shouldn't be a problem, but recommended an annual gear inspection & continued vibration monitoring looking for any change in condition.

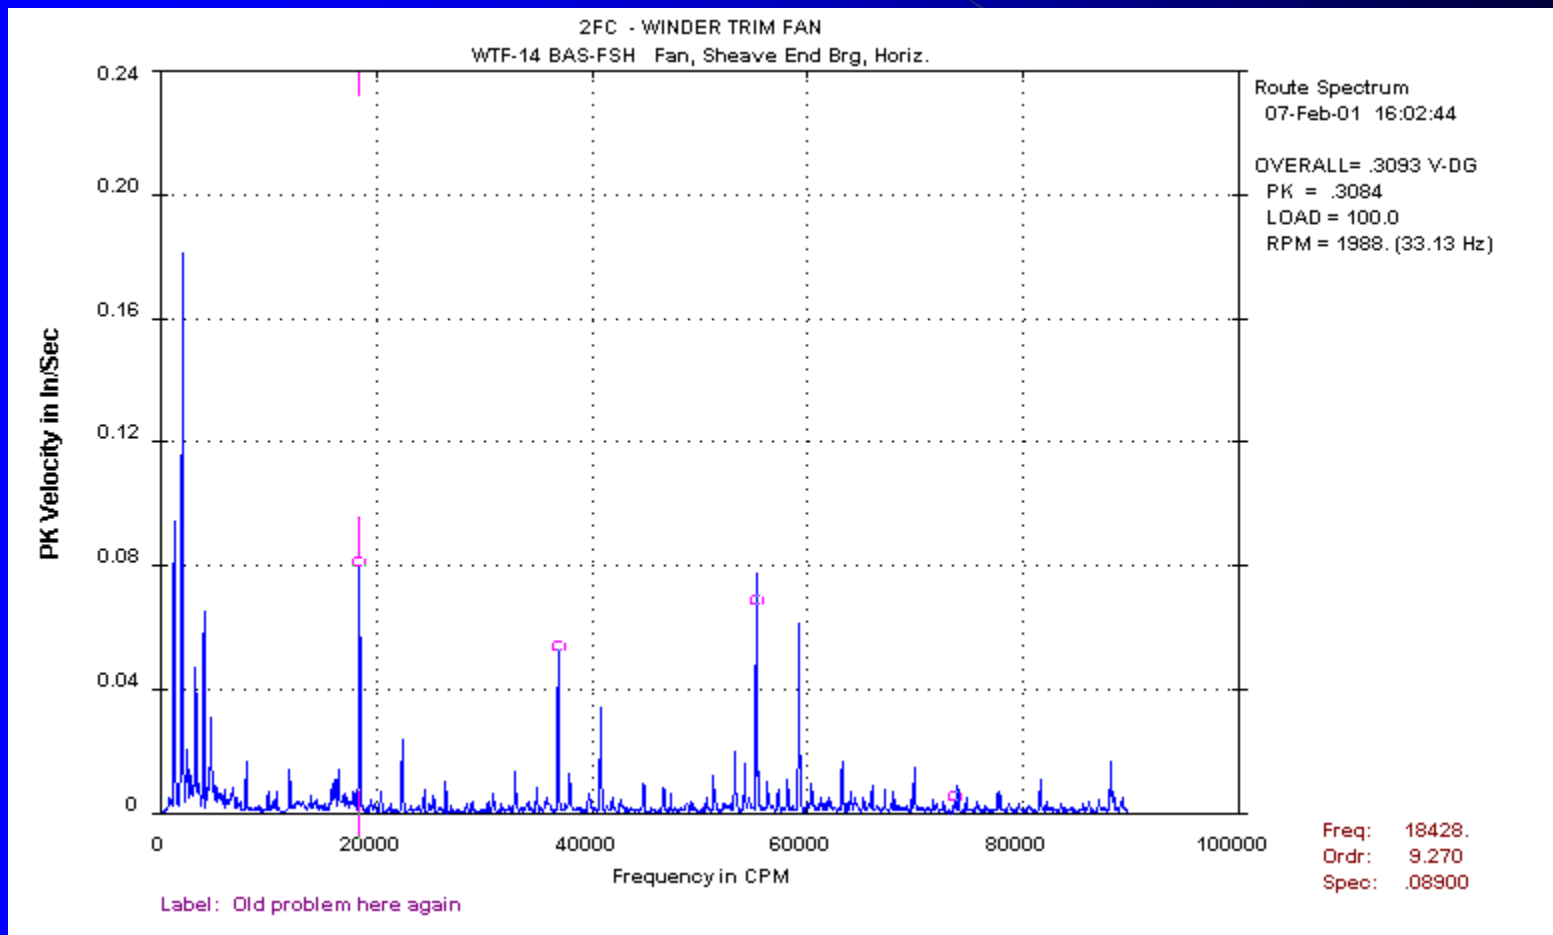
CH#3 – Fan Spectra

- Motor speed was 1786 rpm
- Fan speed was 1985 rpm
- Motor spectra showed running speed & harmonics, fan speed & harmonics, belt frequencies & little else.
- Fan spectra was similar to motor data, but also showed fan bearing defect frequencies (BPFO & harmonics).

- The relatively tight alignment tolerances of the existing tapered roller bearings combined with the poor condition of the fan base made for short bearing life.
- We asked our bearing supplier for a replacement bearing that would carry similar loads, but be more forgiving for misalignment.
- We also had our machine shop fabricate a new fan base that was machined flat & line bored to perfectly fit the new pillow block bolt pattern.

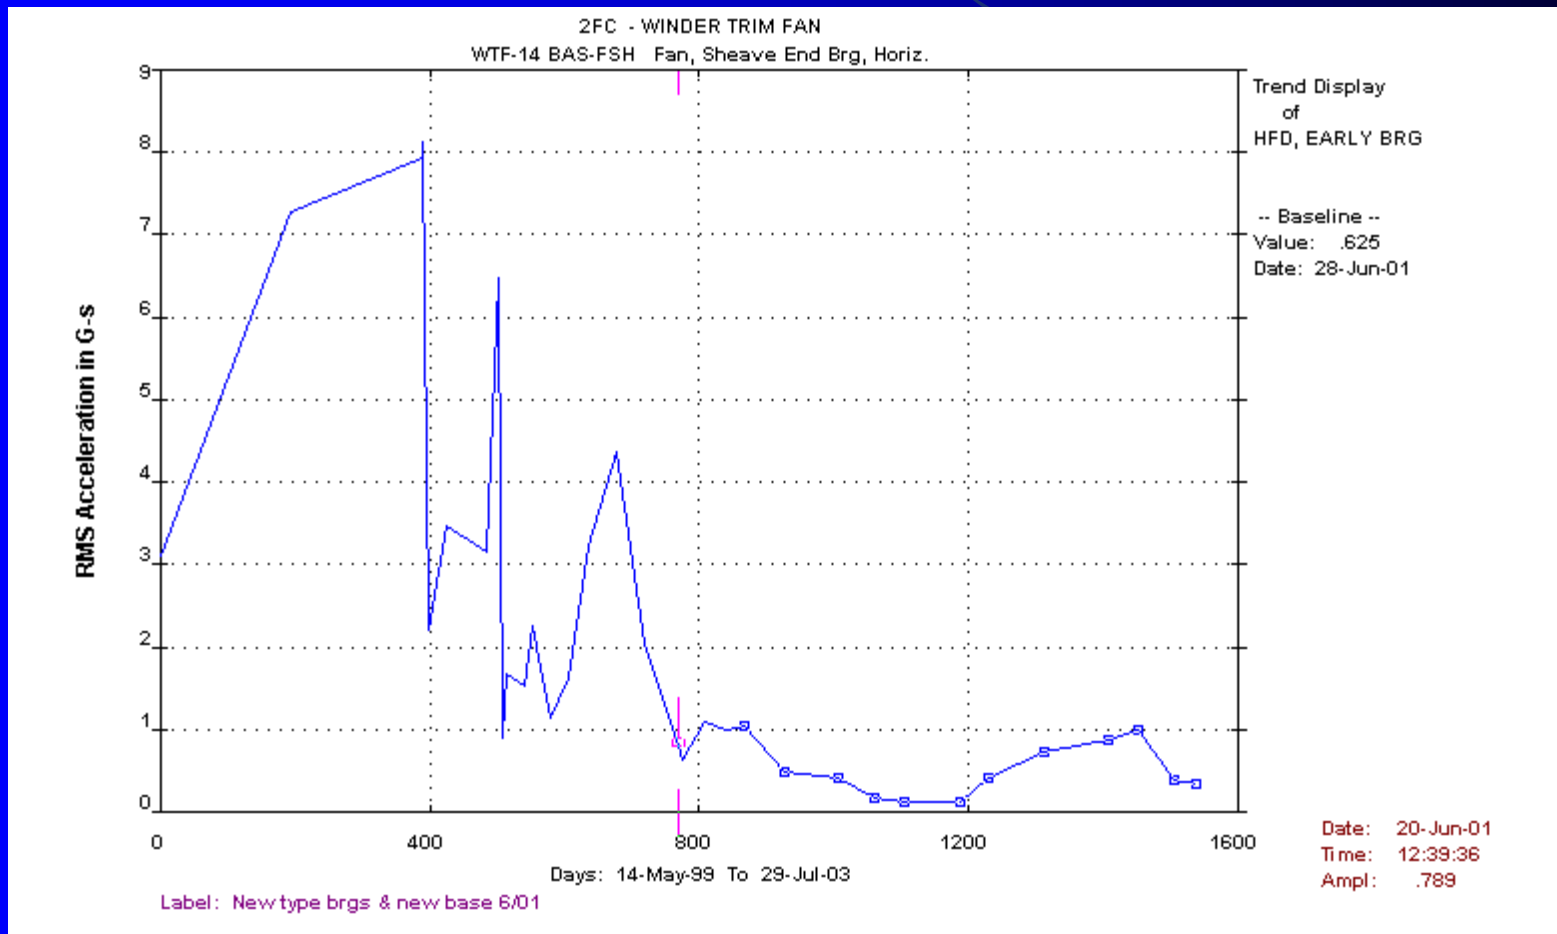
CH#3 – Fan Trend Data

- Fan trend data showed initial drop when bearings were changed, but soon rose to previous high levels days or weeks after changeout.
- After conversations with mechanics involved in the bearing change we learned that “it took us over an hour to get the bearings aligned to where the shaft would even turn”.

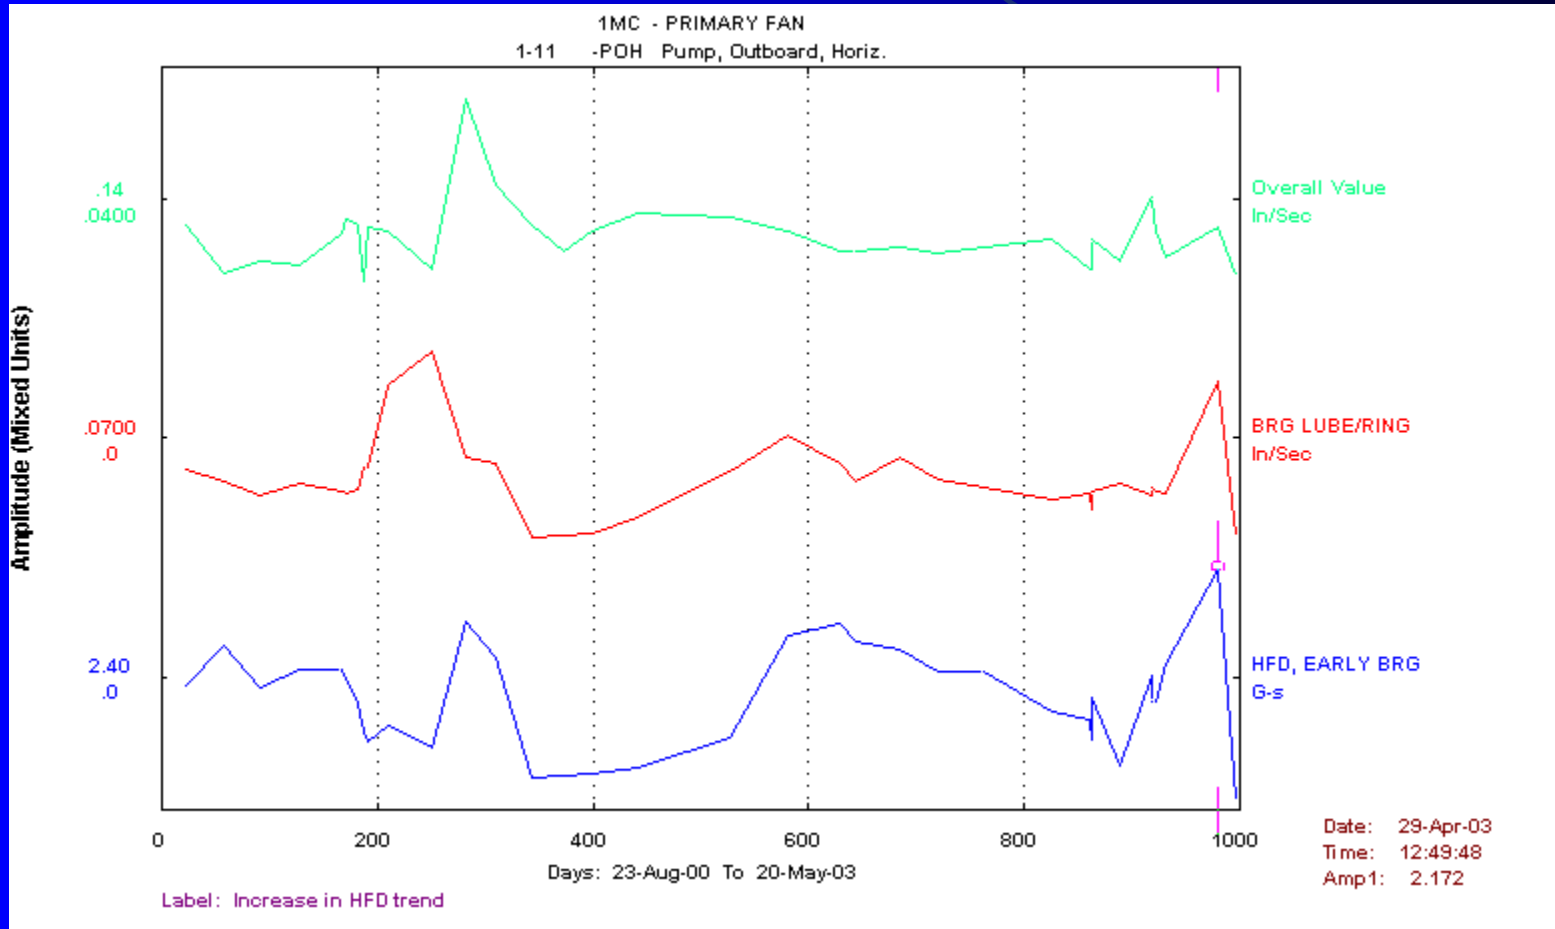
CH#4 – Vibration & HFD Trends

- Increasing HFD vibration levels at pump outboard. Current levels had exceeded maximum of long term trend.

- Since the bearing was oil lubricated, an analysis of the outboard bearing oil was requested.
- Oil analysis results showed very high copper levels indicating cage wear.
- Vibration data showed very high HFD levels on outboard bearing.

- The recommendation was made to changeout the pump outboard bearing.
- Later inspection of the bearing showed the cage worn badly particularly in the area separating the rolling elements from one another.
- During the bearing change, shims were found under the bearing making up the fit with the housing.

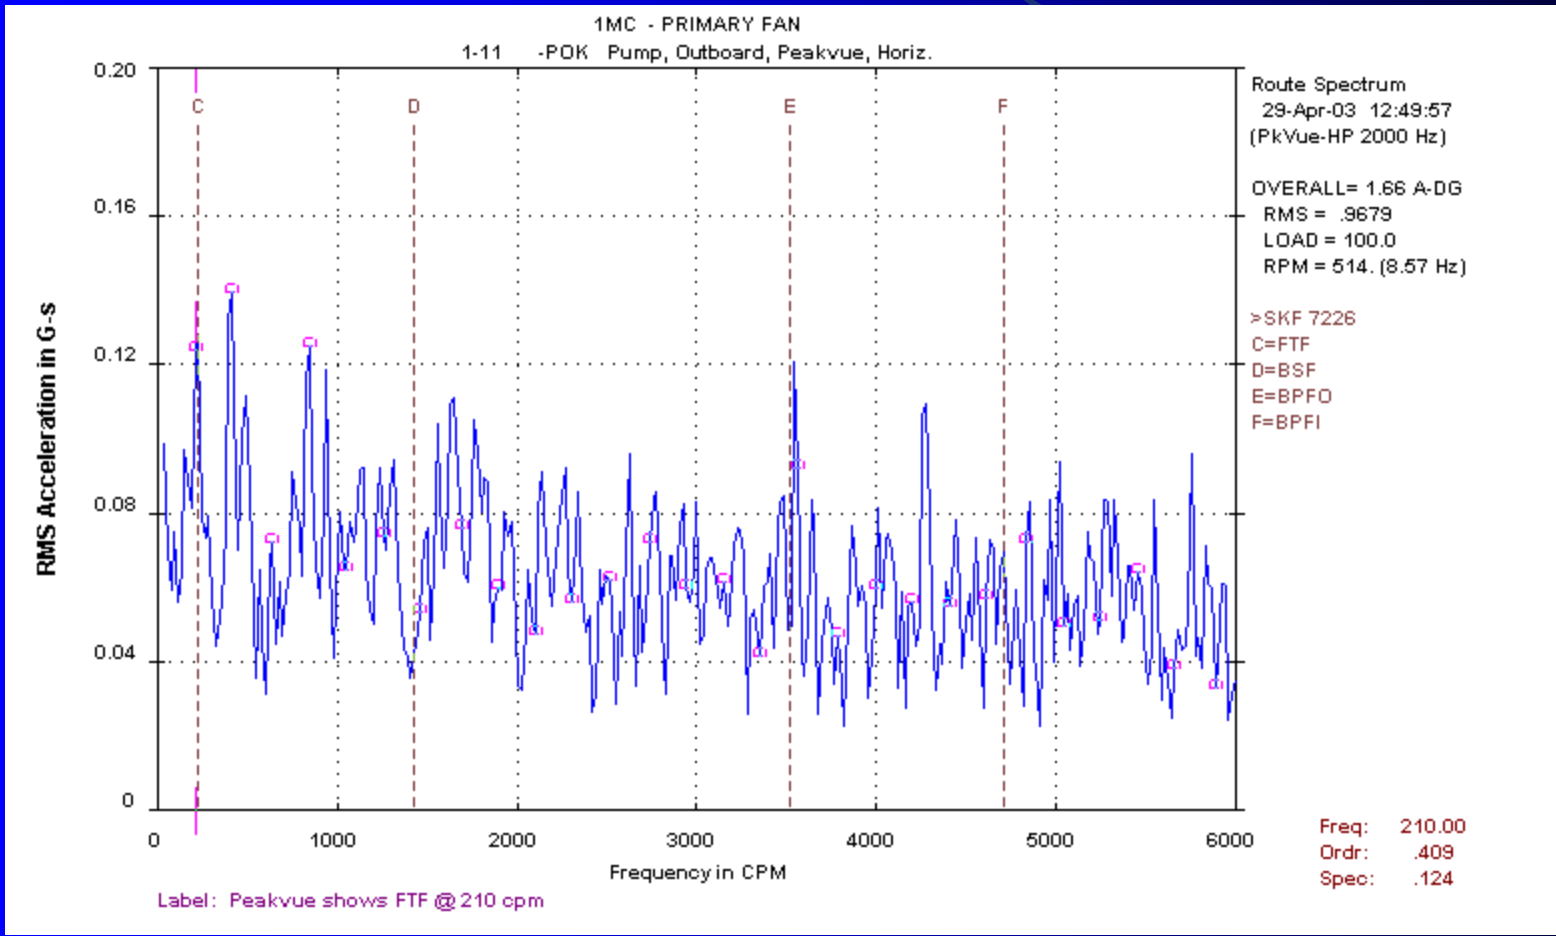
CH#4 – Peakvue Spectra, P1

- Peakvue spectra showed harmonics of fundamental train frequency (cage).
- An 10/01 paper by J. Robinson & J. Berry recommended a Peakvue fault level of 4.0 g's pk-to-pk for a 500 rpm machine.
- Peakvue waveform on outboard bearing showed levels at 11.3 g's pk-to-pk!!!
- Maintenance history showed a continuing problem of a leaking pump outboard seal.

- Later failure analysis of the bearing found lube contamination and skidding as the primary causes of failure. Corrective actions were as follows:
 - 1) Replace the outboard bearing housing,
 - 2) Repair or replace the pump outboard packing gland,
 - 3) Replace the worn pump rotor causing abnormal thrust loading, and
 - 4) Upgrade the lube from an ISO 68 to an ISO 150 weight oil (temporarily use grease until packing gland repaired).
