HIGH VIBRATION AT A VERTICAL AGITATOR

Barry T. Cease

Cease Industrial Consulting

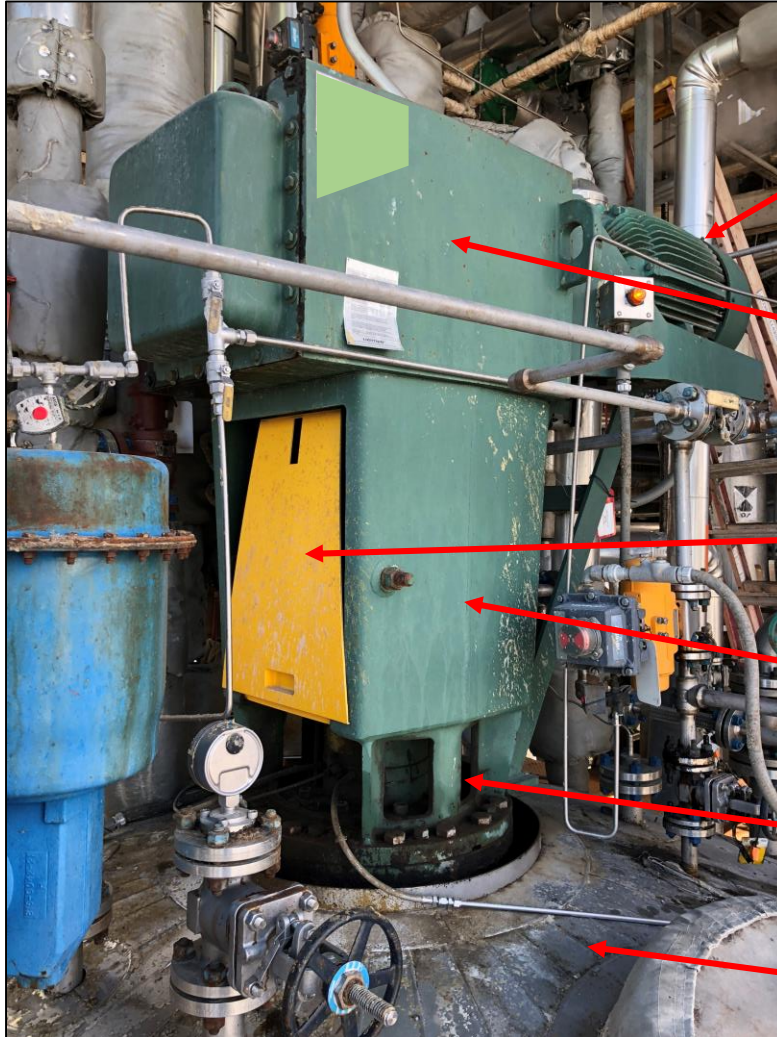
PHOTO OF VERTICAL AGITATOR

- High horizontal vibration levels were noted at a vertical agitator that mixed product at a chemical plant.
- The agitator was bolted to the top center of the tank.

Plastic Access Door (seal & agitator coupling)

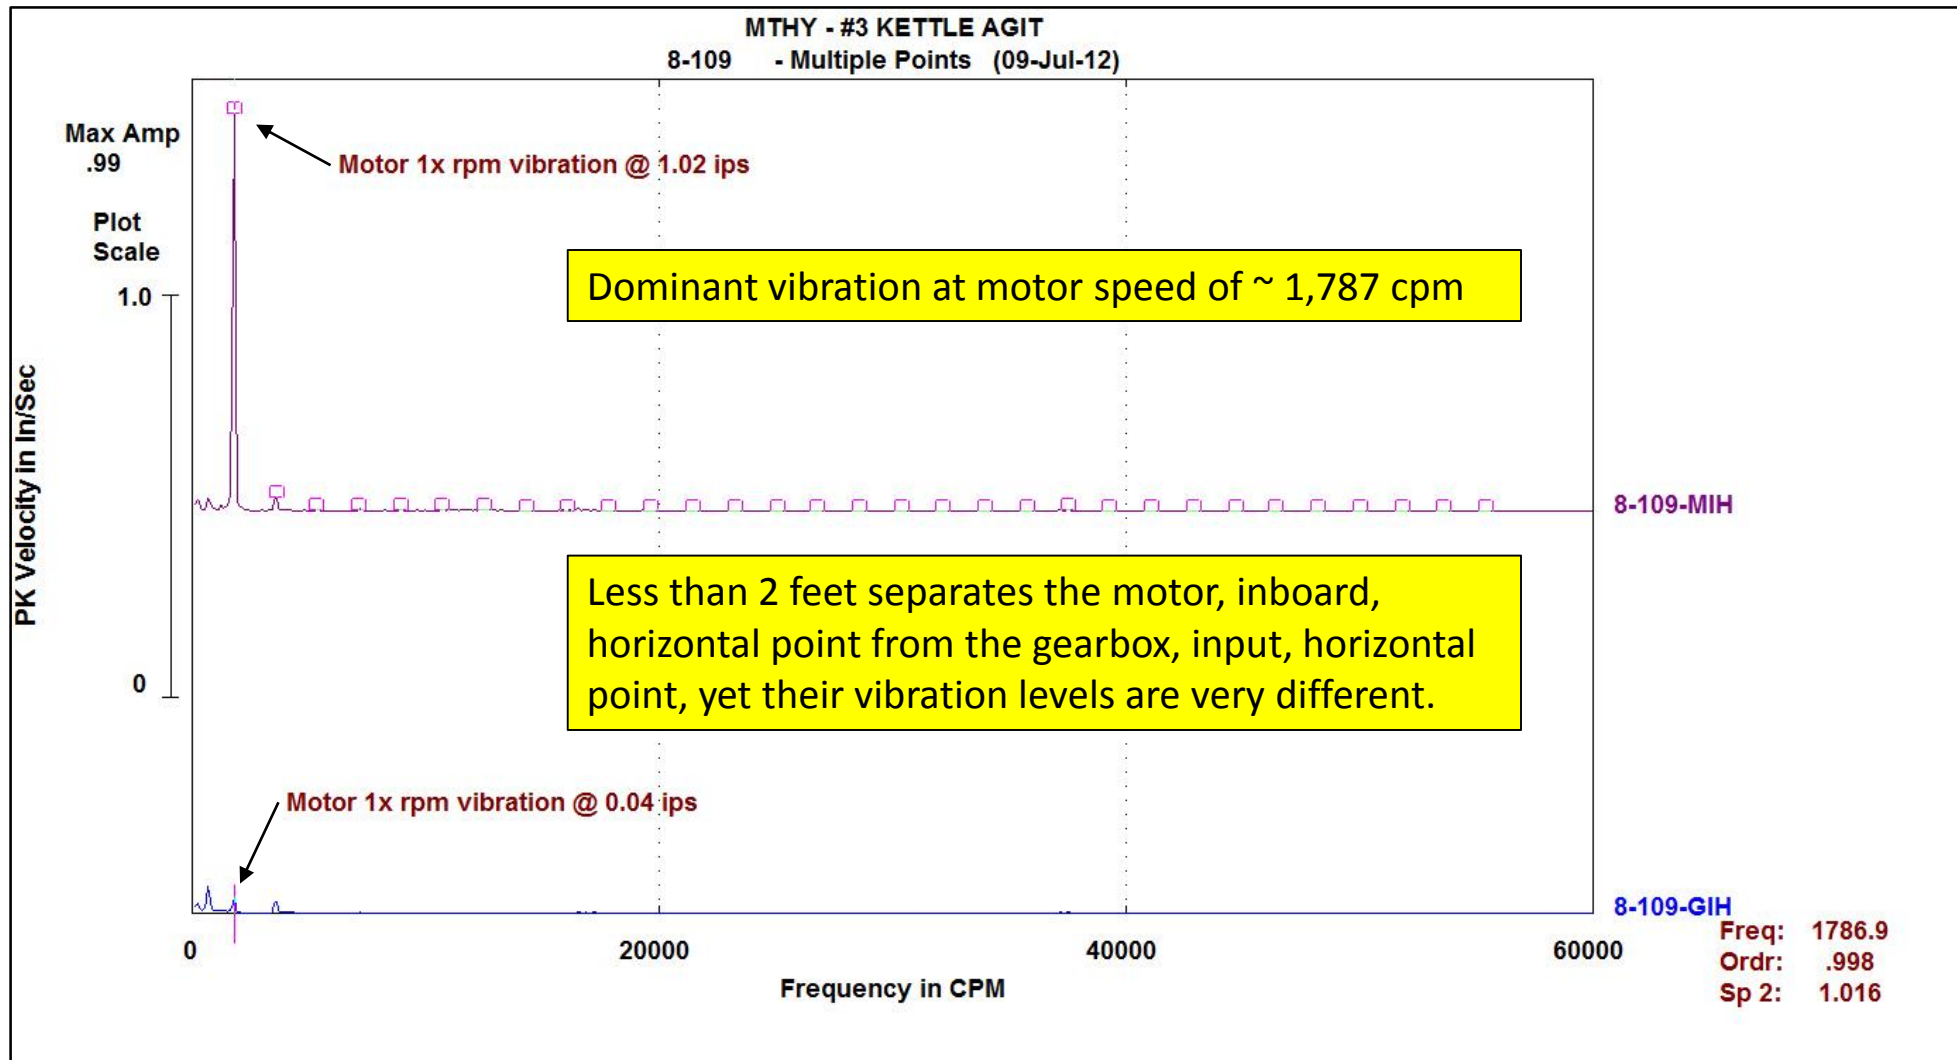
SPECTRAL DATA - MOTOR & GEARBOX, HORIZONTAL POINTS

- Spectral analysis on the agitator showed the highest vibration occurring at the motor in the horizontal direction with dominant vibration occurring at the motor speed of ~ 1,780 rpm.

- Vibration levels were very low at the gearbox input bearing, but higher at the opposite end of the gearbox (opposite motor end).
- After analysis of the route vibration data, the recommendation was made to verify the alignment condition between the motor & gearbox and inspect the coupling for wear or damage.

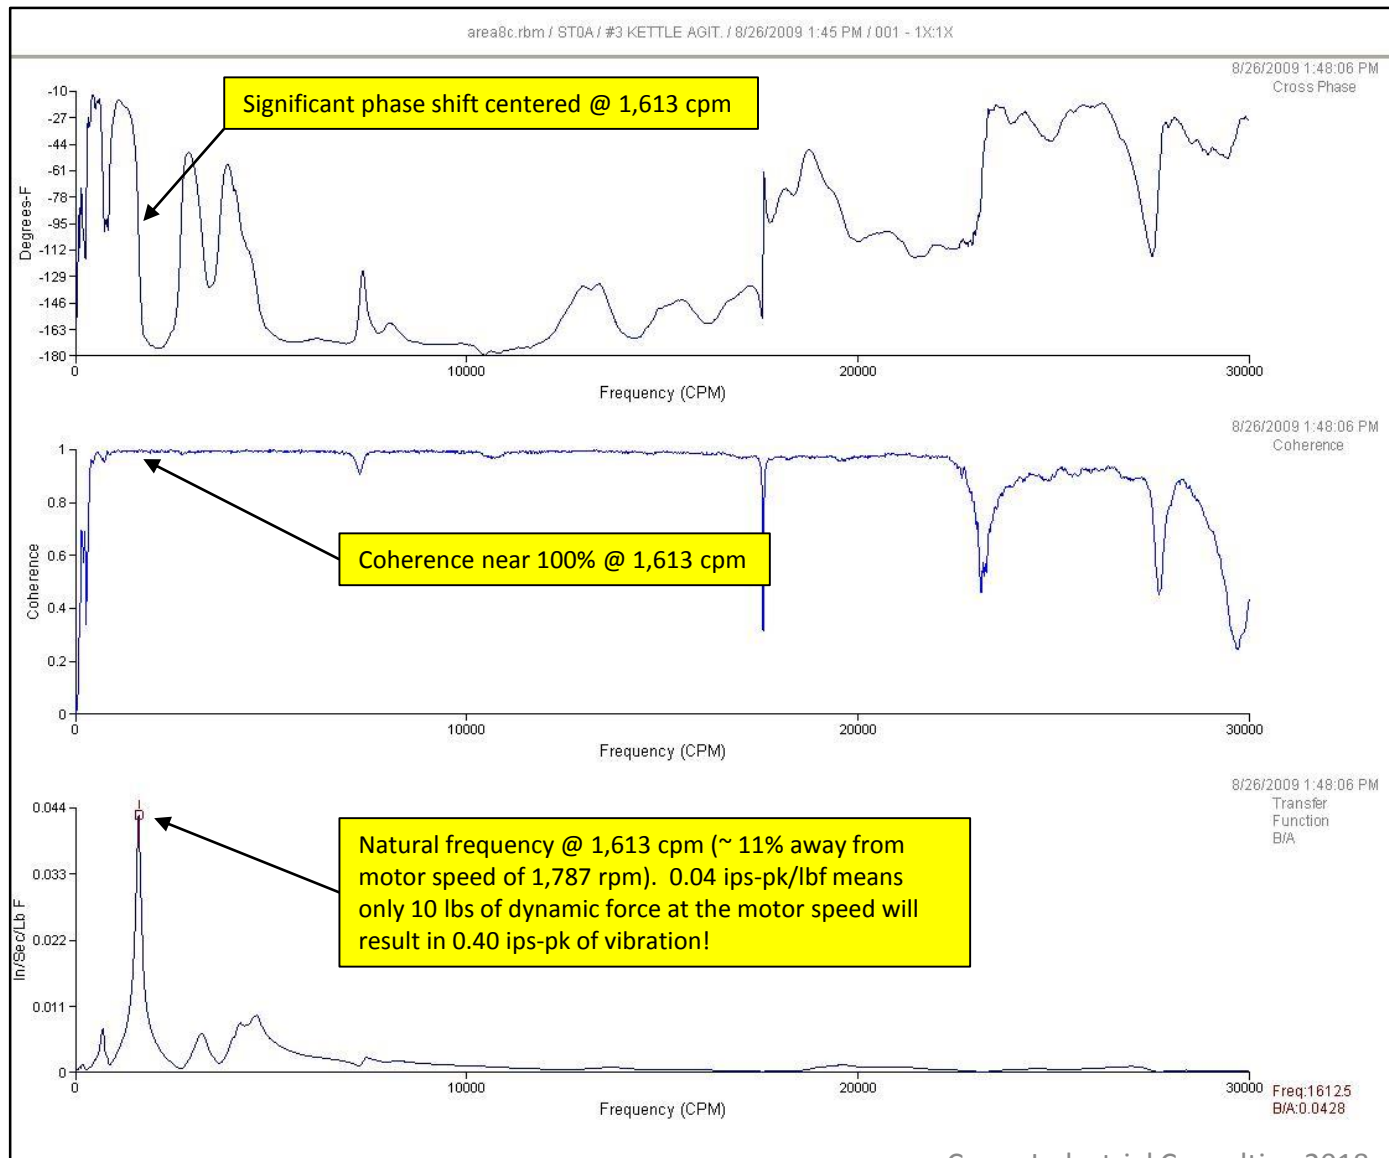
IMPACT TESTING AT MOTOR INBOARD HORIZONTAL POINT (MIH)

- Impact testing was performed at the vertical agitator.
- The plot at left shows the results from impact testing at the motor, inboard, horizontal point (MIH).
- Note the high peak at 1,613 cpm at bottom associated with high coherence at the middle plot and a significant phase shift at the top plot.
- The agitator has a strong horizontal natural frequency centered at 1,613 cpm. This natural frequency is only 11% away from our motor speed of 1,787 rpm meaning resonance at the motor speed is likely occurring here.
- The amplification at this natural frequency is high at 0.04 ips/lbf meaning if only 10 lbs of dynamic force is input at 1,613 cpm, 0.40 ips of vibration will result.
- So from this impact testing we knew resonance was occurring at the motor speed, but we didn't know the **shape** or **mode** of this resonance.

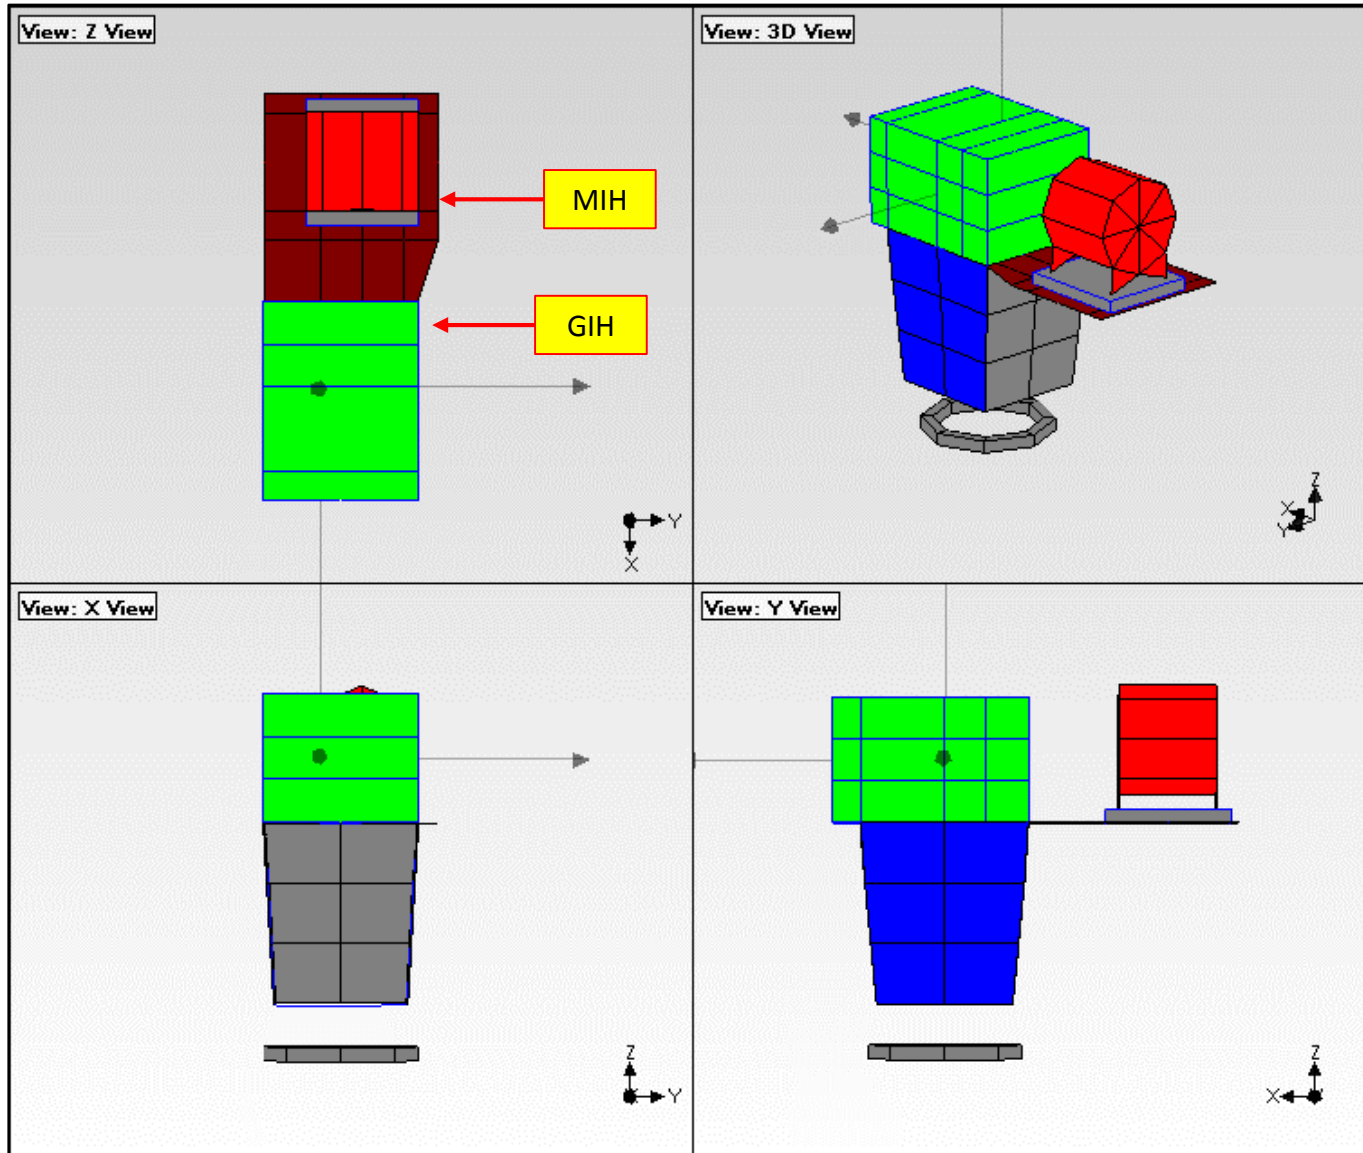
ODS ANALYSIS, VERTICAL AGITATOR, JULY 2012

- 1) Twisting of agitator, gearbox & motor about the Z axis at the motor speed of ~ 1,787 rpm. See [video1](#), [video2](#).
- 2) Approximate center of twisting at or near where GIH is measured. See [video3](#).
- 3) Flexure (distortion) of the motor base particularly in the vertical direction at 2x motor speed. See [video4](#) & [video5](#).

- 1) Stiffen the agitator column by replacing the existing void with a bolted aluminum door at the opposite motor end of the agitator column. Use at least 8-ea bolts to secure this door to the column and incorporate handles to the door design to allow easy removal and installation by mechanics. **Move from a channel to a rectangular tube.**
- 2) Consider adding bracing under the motor base to eliminate deflection at 2x motor speed.

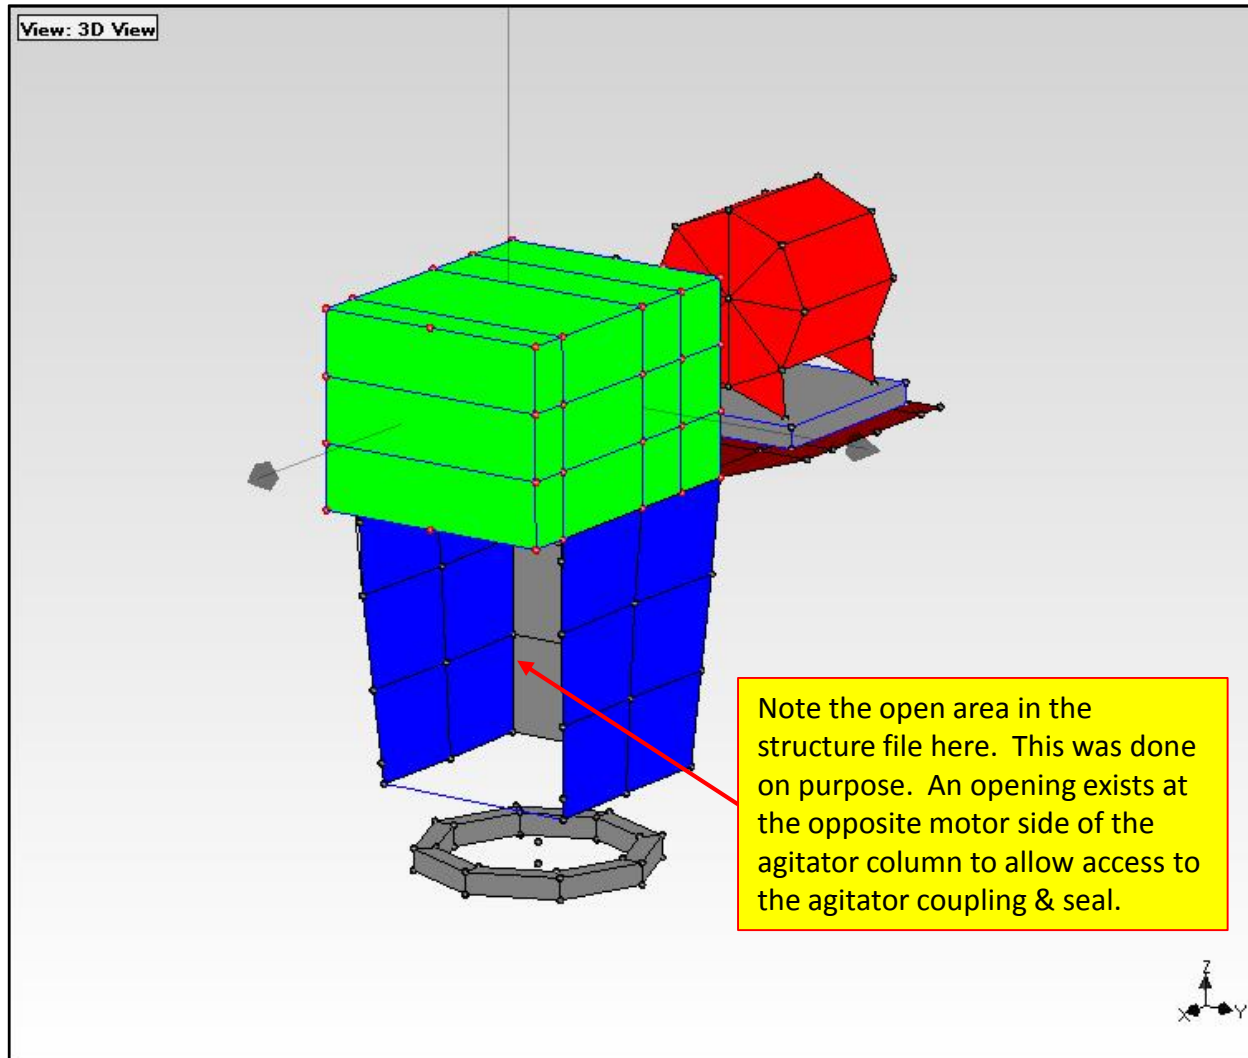
ODS ANALYSIS, VERTICAL AGITATOR, JULY 2012

- The open area at the opposite motor end of the agitator column was there on purpose – to allow access to the agitator seal & coupling.
- A plastic door was in place to protect the agitator shaft, seal, coupling, etc from the elements and to comply with OSHA regulations.
- Note how due to this opening at the agitator column, the cross sectional area of our agitator column essentially resembles a channel and not a rectangular tube.
- The torsional stiffness of a rectangular tube is much greater than that of a channel of equal dimensions (higher geometric torsional stiffness).

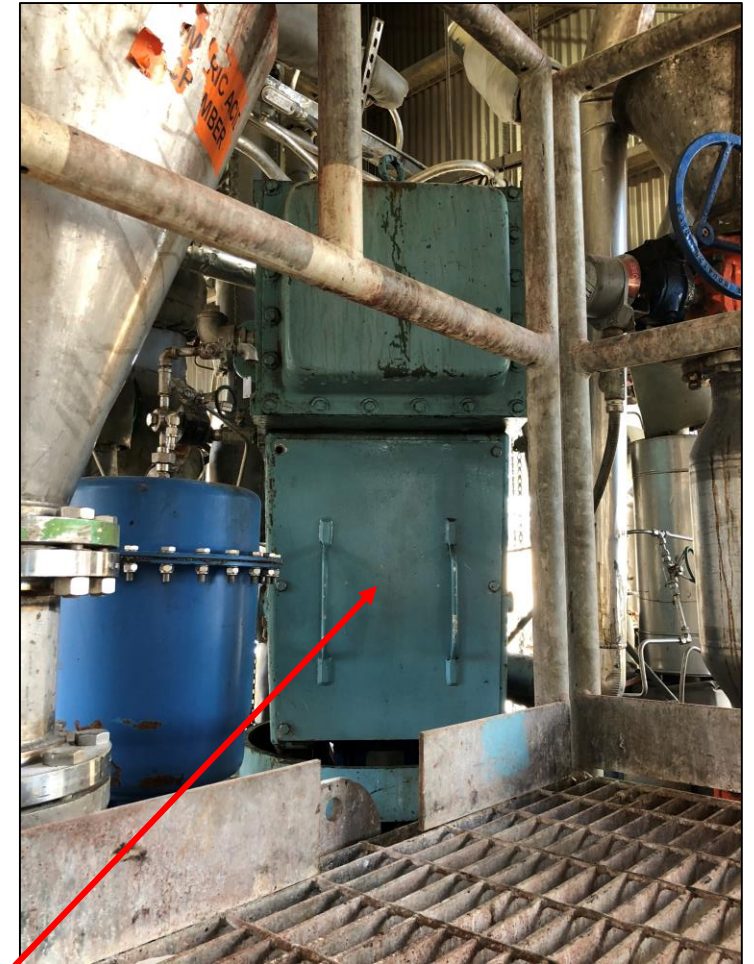
AFTER DOOR MODIFICATIONS
(Bolted Aluminum Door)

The addition of the bolted aluminum door and the bottom collar acted to increase the torsional stiffness of the agitator column.

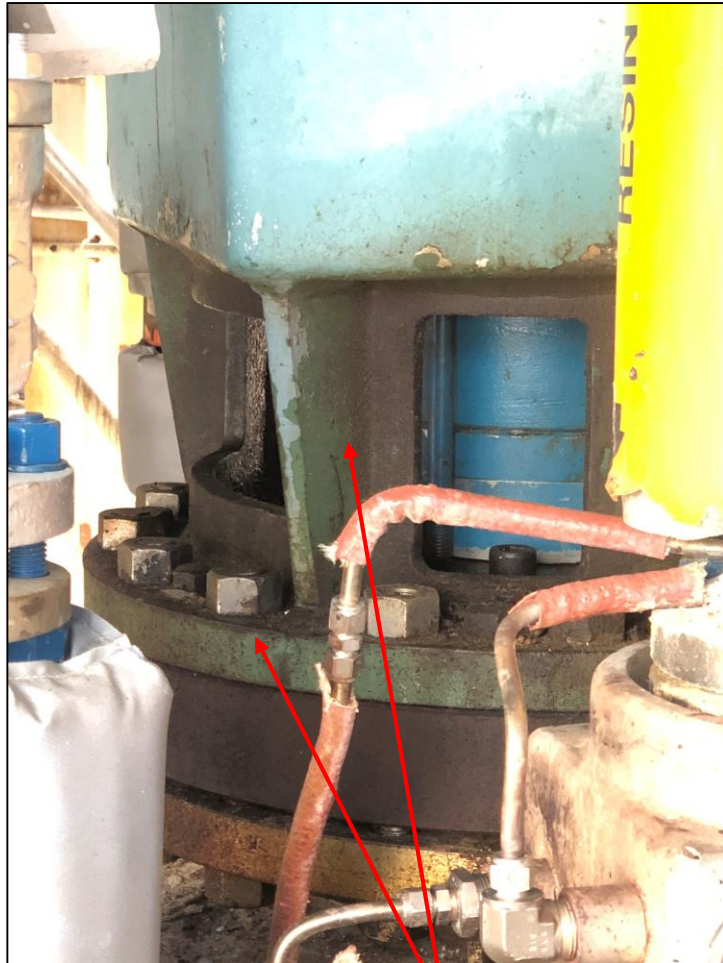
ADDITIONAL OEM MODIFICATIONS (COLLAR)

Note how the agitator column is supported by a bolted flange attached to the column via essentially 6-ea individual pieces of angle (not continuous).

In addition to replacing the plastic door with an aluminum bolted door, the OEM decided to connect all six supporting angles together with a steel collar sized for this purpose. The collar was designed to bolt tightly to the existing angle.

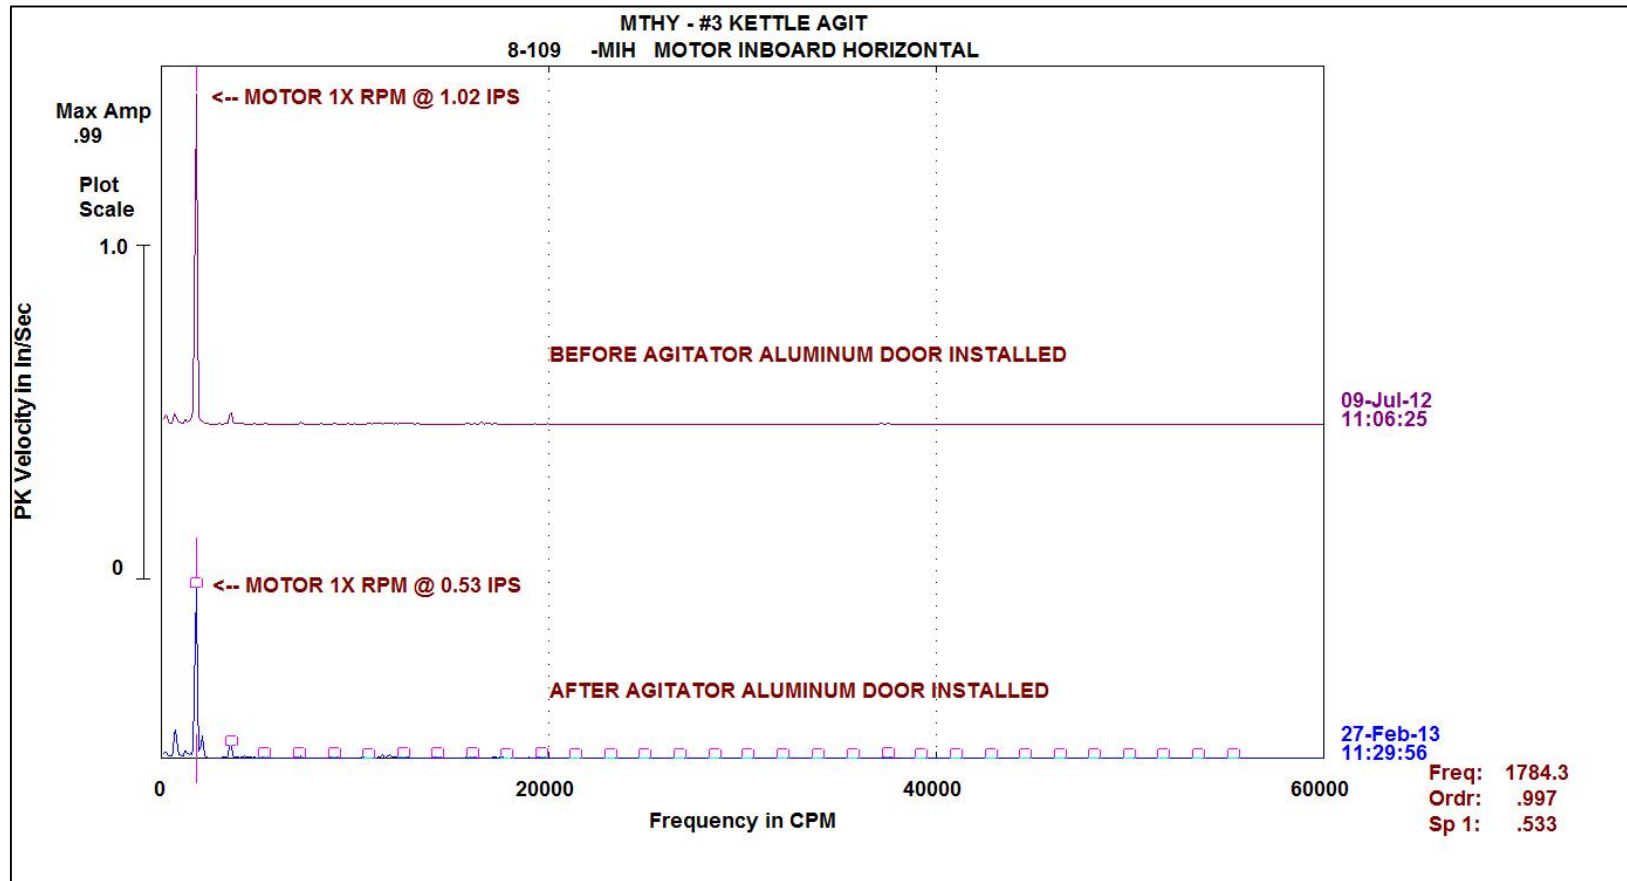
FOLLOW-UP VIBRATION DATA (MOTOR, HORIZONTAL)

- The aluminum door was installed at the void on the backside of the agitator column and the collar installed near the agitator-tank flange.
- Follow-up vibration data after these modifications showed a 50% drop in vibration levels at the motor speed of ~ 1,784 rpm at the point of highest vibration (MIH).
- Unfortunately, all the recommendations from the July 2012 analysis were not yet completed, namely, the bracing of the motor base was not yet installed.

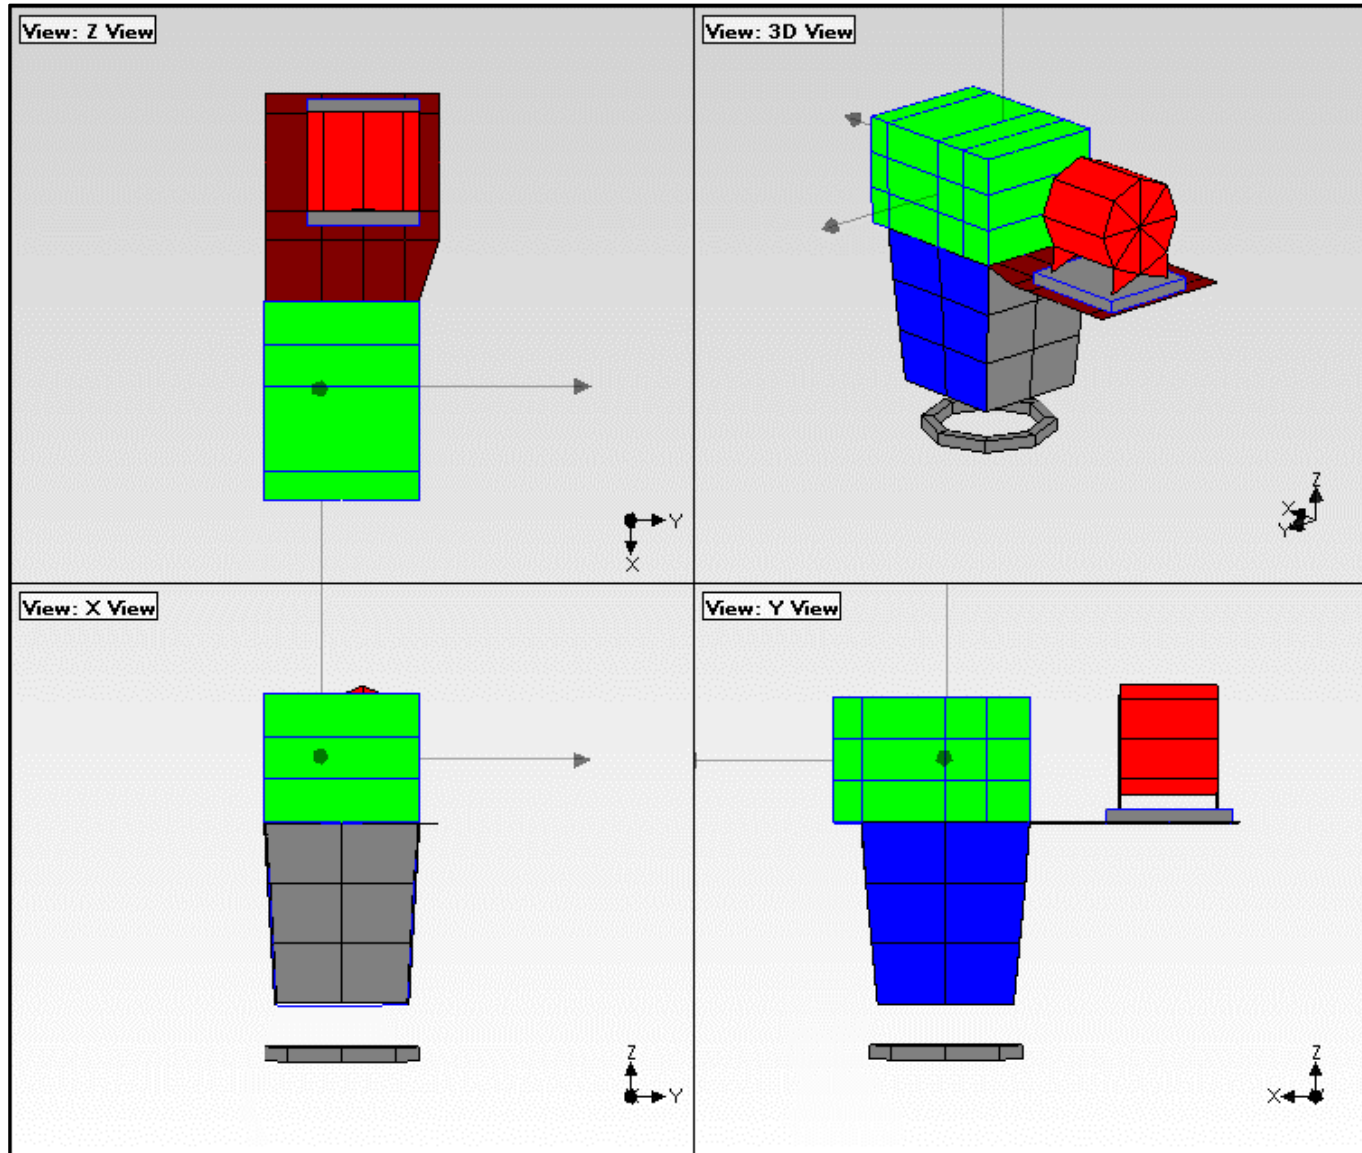
FOLLOW-UP ODS ANALYSIS, VERTICAL AGITATOR, MARCH 2013

- 1) Dominant motion at 1x motor speed is vertical flexing of motor & motor base particularly at the outboard, left corner of the motor base. See [video6](#), [video7](#), [video8](#) & [video9](#).
- 2) Compared to the July 2012 ODS of this machine, comparatively little twisting motion of entire agitator column (the new door and collar helped with this problem). Compare [video3 \(7/12\)](#) to [video10 \(3/13\)](#).
- 3) Flexure (distortion) of the motor base particularly in the vertical direction at 2x motor speed. See [video11](#) & [video12](#).

- 1) Add bracing under the motor base to eliminate deflection at 1x & 2x motor speed. For maximum effect, ensure this new bracing supports the motor base at or near its outboard end.

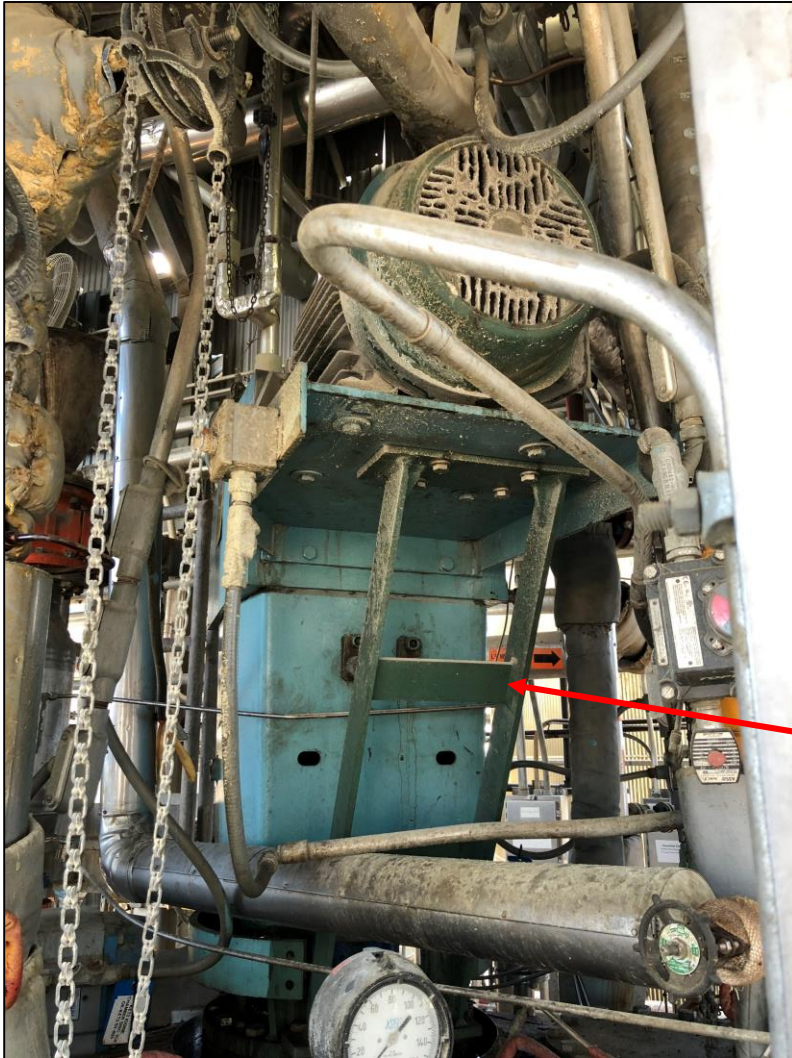
PHOTO OF MOTOR BRACING

- The motor brace was installed and follow-up vibration measurements were made.
- The follow-up vibration data showed a significant drop in vibration levels and acceptable levels across the entire machine.

Bracing was installed between the agitator column and the motor base. No connections were possible between the tank itself or nearby structure and the motor base.

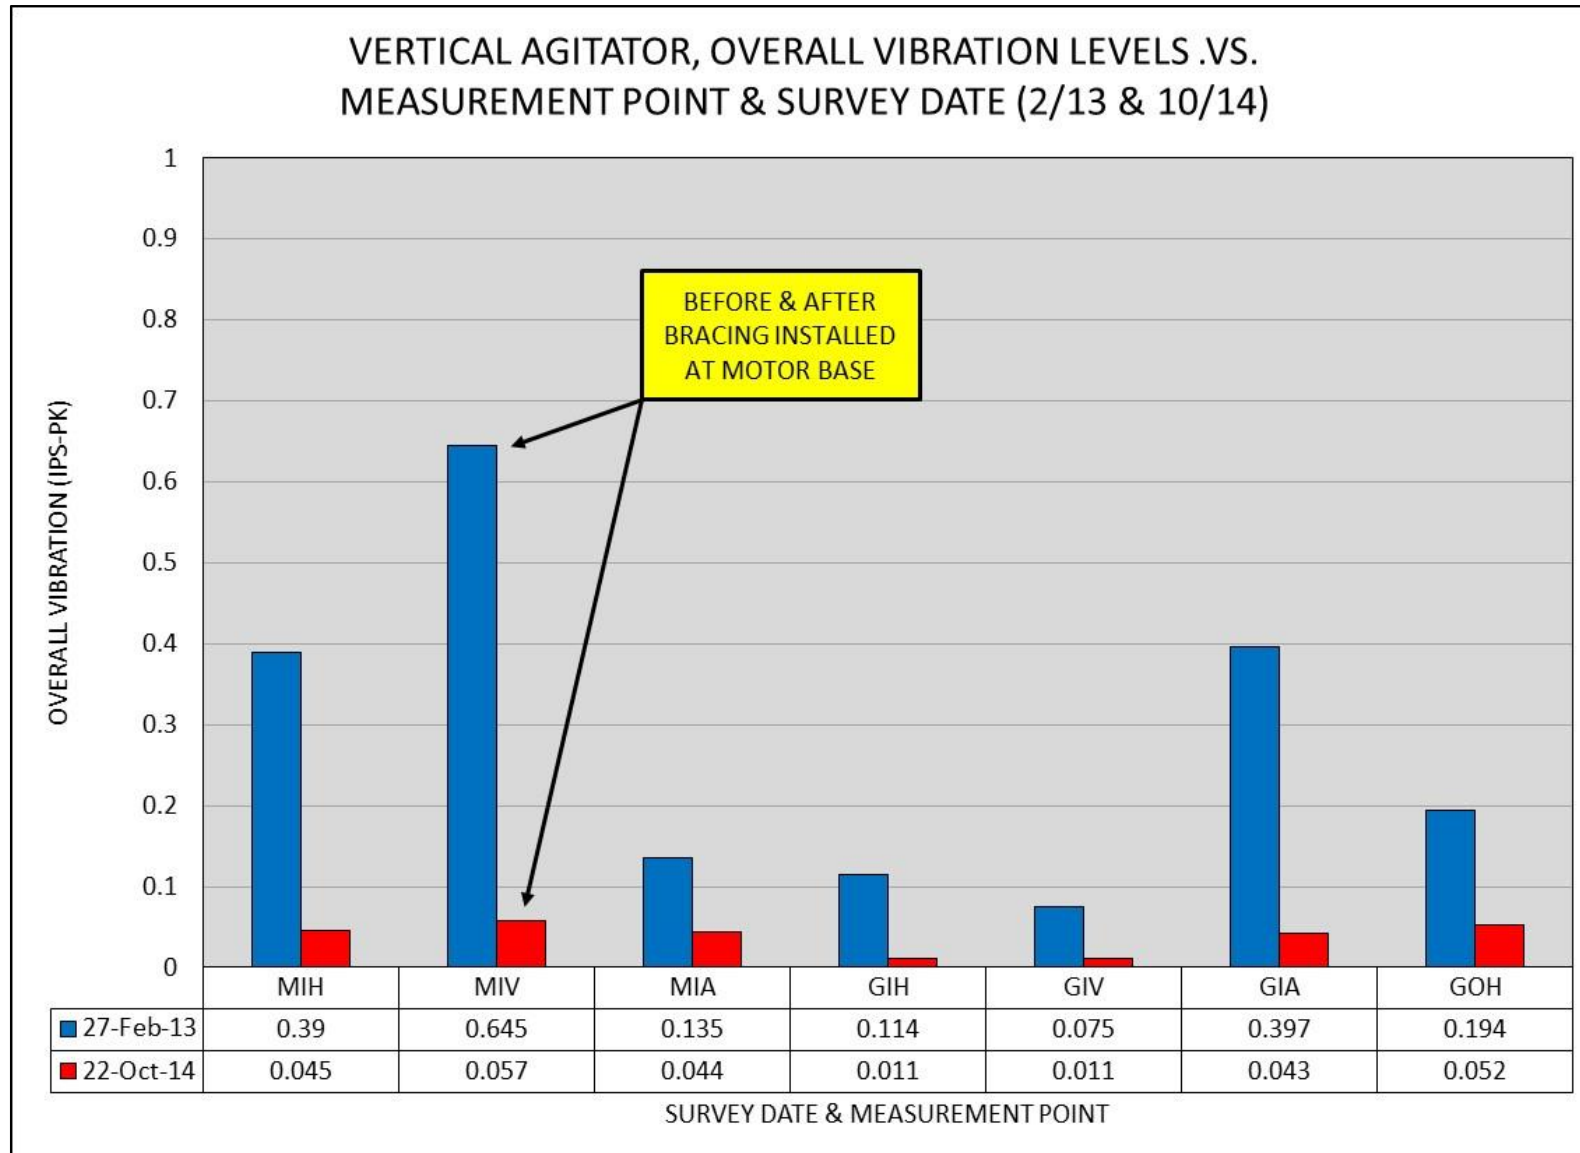
FOLLOW-UP VIBRATION DATA – OA PROFILE PLOT

- All measurements across the entire machine are now < 0.10 ips-pk (excellent).

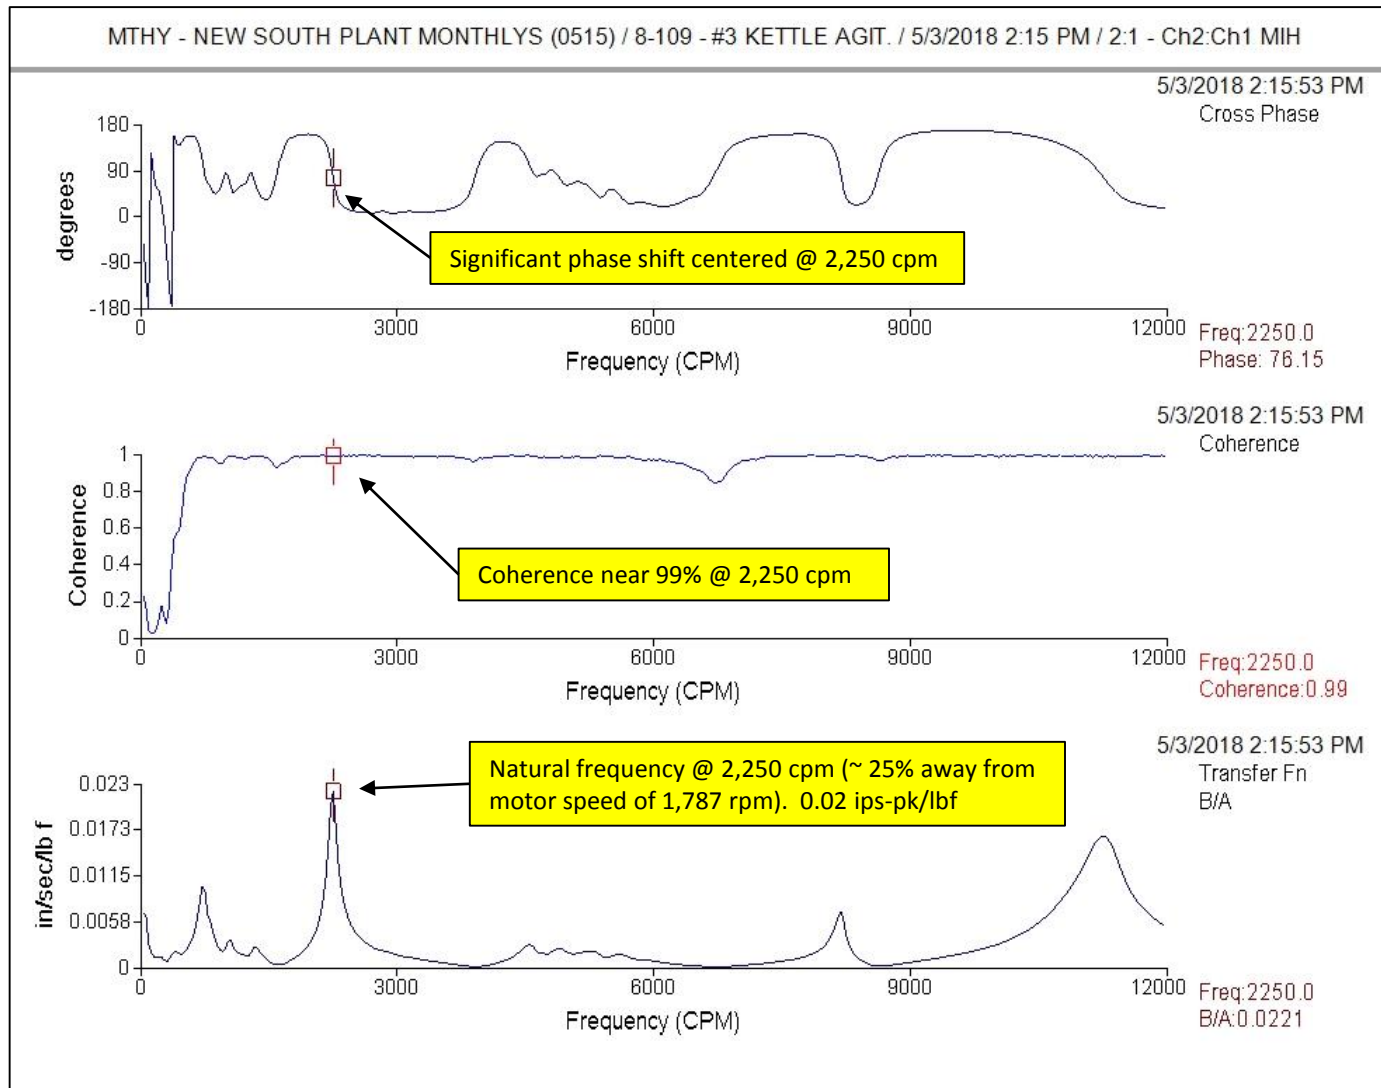
FOLLOW-UP IMPACT TESTING AT MOTOR INBOARD HORIZONTAL (MIH)

- Follow-up impact testing was performed at the vertical agitator after all repairs and modifications were complete.
- The plot at left shows the results from impact testing at the motor, inboard, horizontal point (MIH).
- Note the high peak at 2,250 cpm at bottom associated with high coherence at the middle plot and a significant phase shift at the top plot.
- All the modifications to the agitator mentioned earlier have moved our natural frequency from 1,613 cpm to 2,250 cpm.
- Not only did we move the natural frequency from 11% to 25% away from 1x rpm, we also doubled our effective dynamic stiffness at resonance from 0.04 ips/lbf to 0.02 ips/lbf.
