# Using Vibration Analysis To Identify & Help Correct An ID Fan Foundation Problem

Barry T. Cease  
Cease Industrial Consulting  
Charleston, SC  
[barrycease@bellsouth.net](mailto:barrycease@bellsouth.net)  
[ceasevibration@icloud.com](mailto:ceasevibration@icloud.com)

# MACHINE & PROBLEM DESCRIPTION

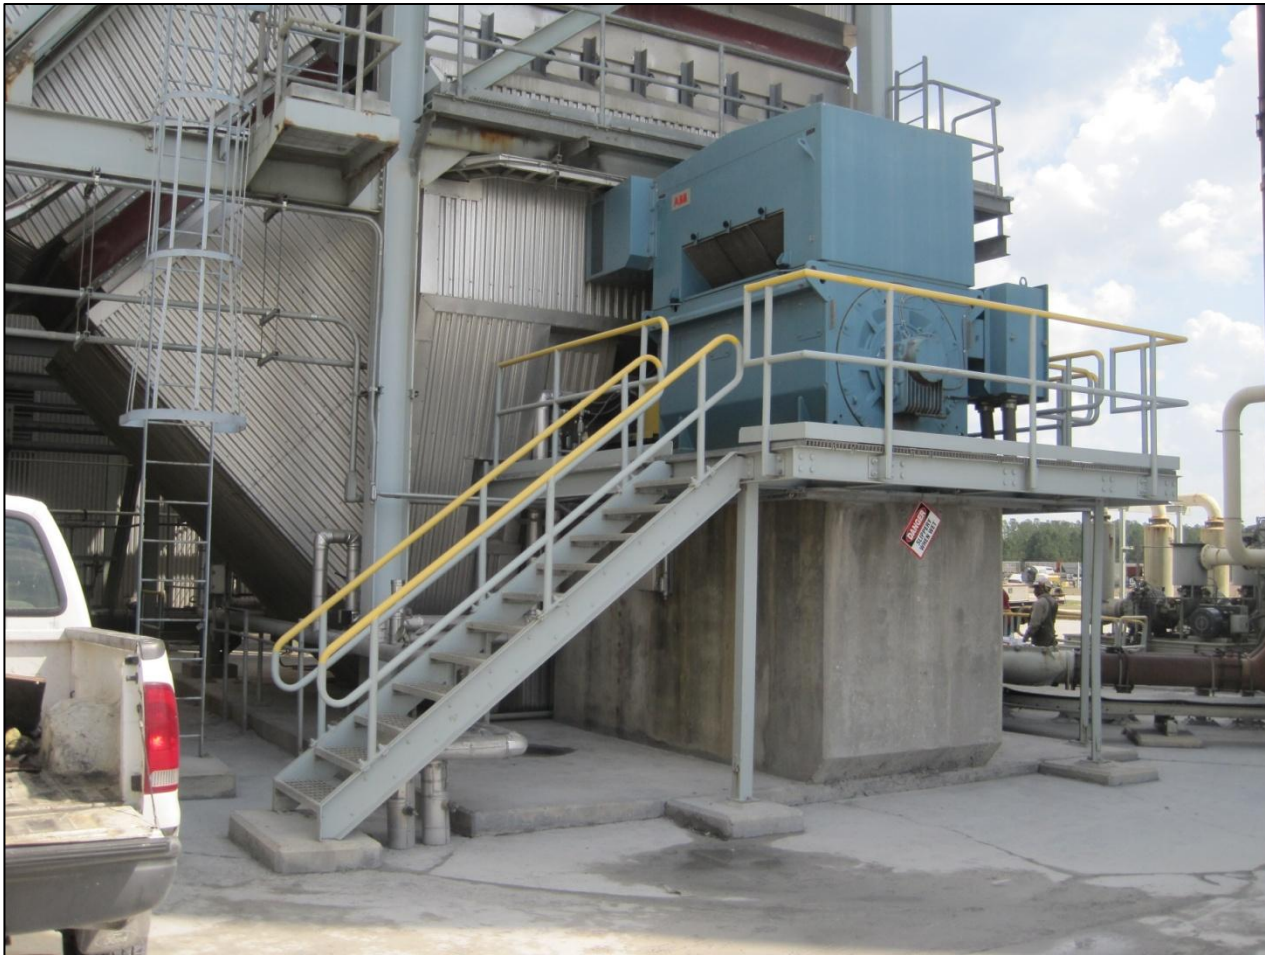
# PHOTO OF FAN FROM REAR

- Large induced draft fan, directly driven by a VFD controlled induction motor.
- Normal operating speeds were from 500 – 900 rpm with most typical being 600 – 800 rpm.
- Job began with a call to balance this fan.
- Others had tried unsuccessfully to balance it in the past.
- Plant had run the motor solo prior to my arrival and solo motor levels were significantly lower leading us to believe the problem wasn't the motor.

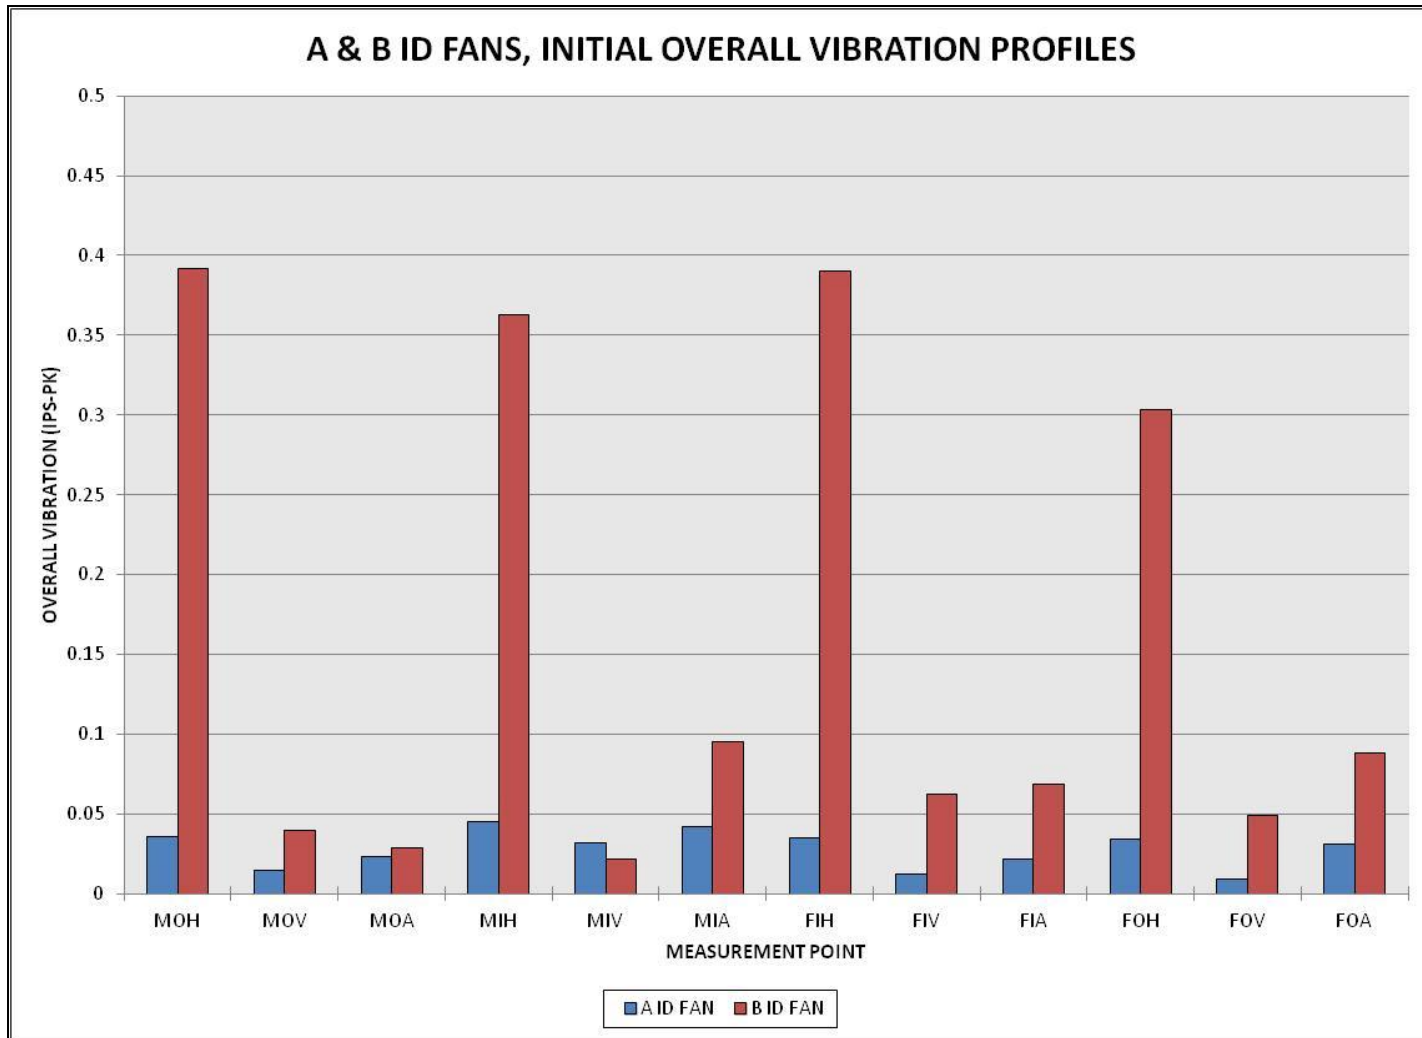
# INITIAL OA VIBRATION PROFILES - A & B ID FANS

- Vibration spectral data showed *dominant vibration occurring at 1x rpm with no significant vibration occurring at any other frequency.*
- Coast-down data showed 1x rpm levels *increasing significantly with increasing speed.*
- 1x Peak/Phase data showed high *in-phase* vibration in the *horizontal* direction at both motor & fan.
- Vibration levels in the *horizontal* direction across the entire machine were much higher than either the vertical & axial directions (see profile plots).

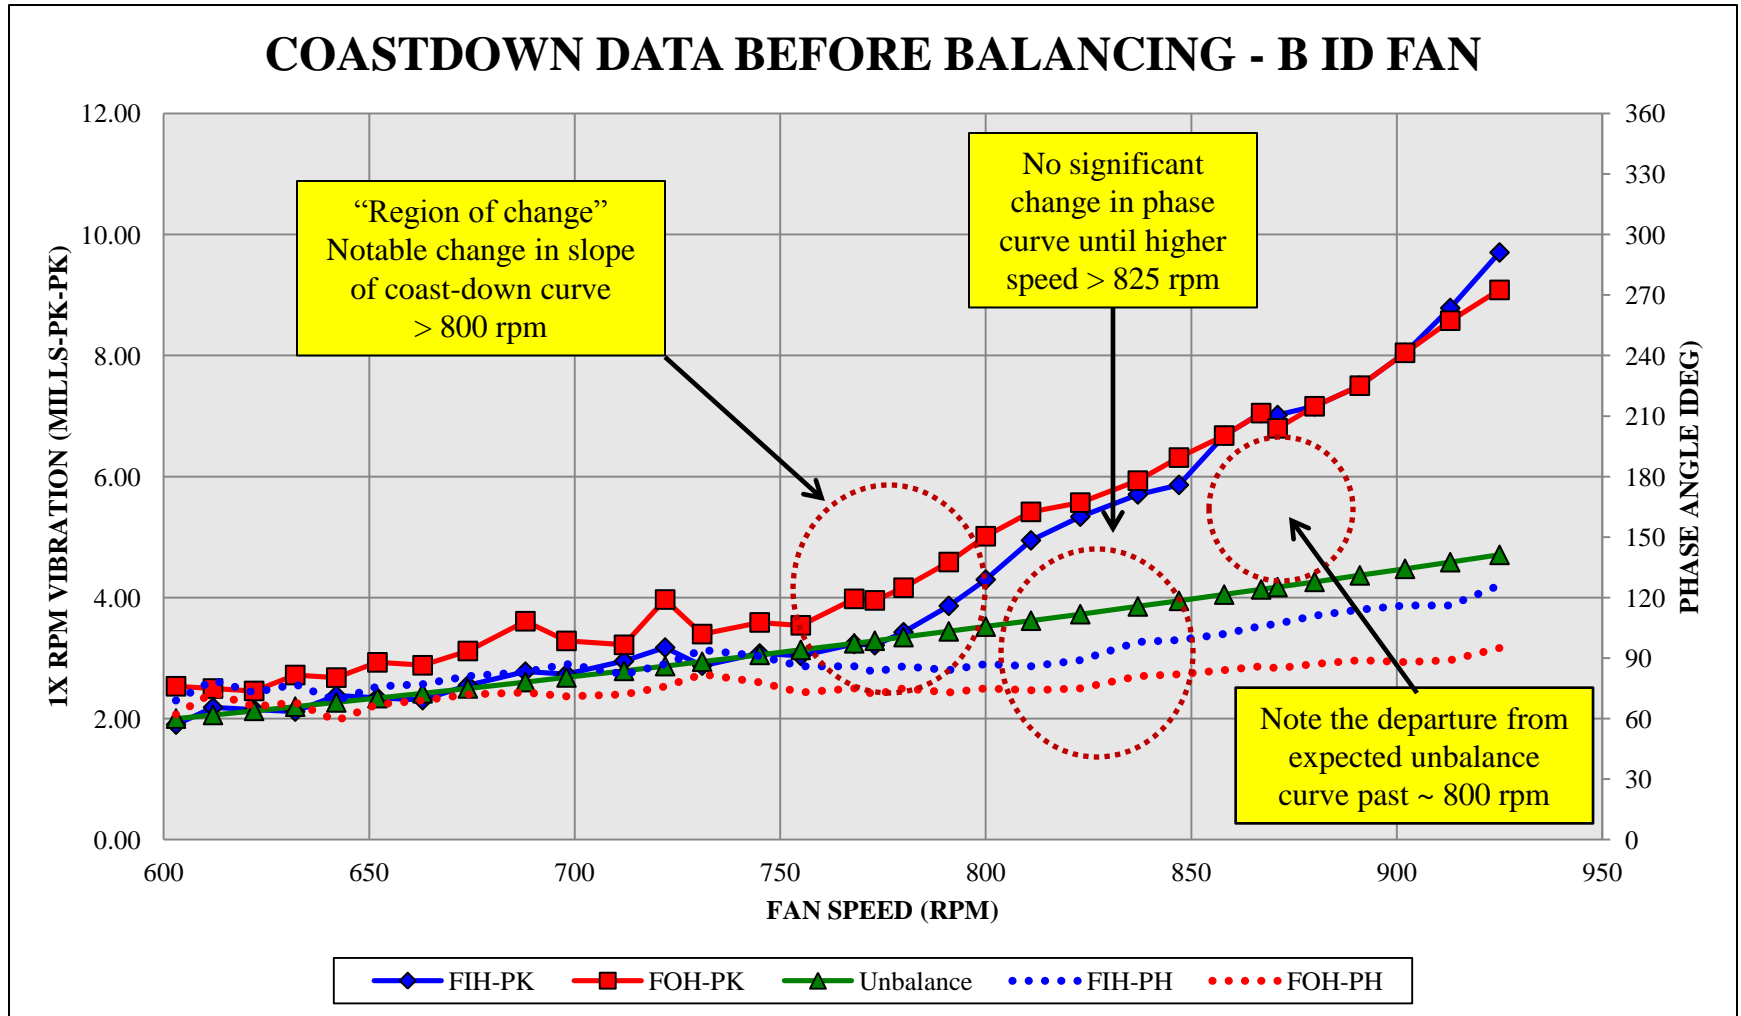
# COASTDOWN DATA, BEFORE BALANCING – B ID FAN

- Due to production concerns, balancing of the fan took place weeks later at a time better suited for the plant (lower demand).
- Due to the *non-linear* nature of the coast-down data collected, a two-step balancing process was decided upon as follows:
  - 1) Initial balancing would be performed at the slower speed of 675 rpm.
  - 2) Final (trim) balancing would be performed as needed at a higher speed (800 to 900 rpm).
- By first balancing the fan at a lower speed, we would lower the dynamic forces present at higher speeds and hopefully avoid the non-linear aspects of the system.

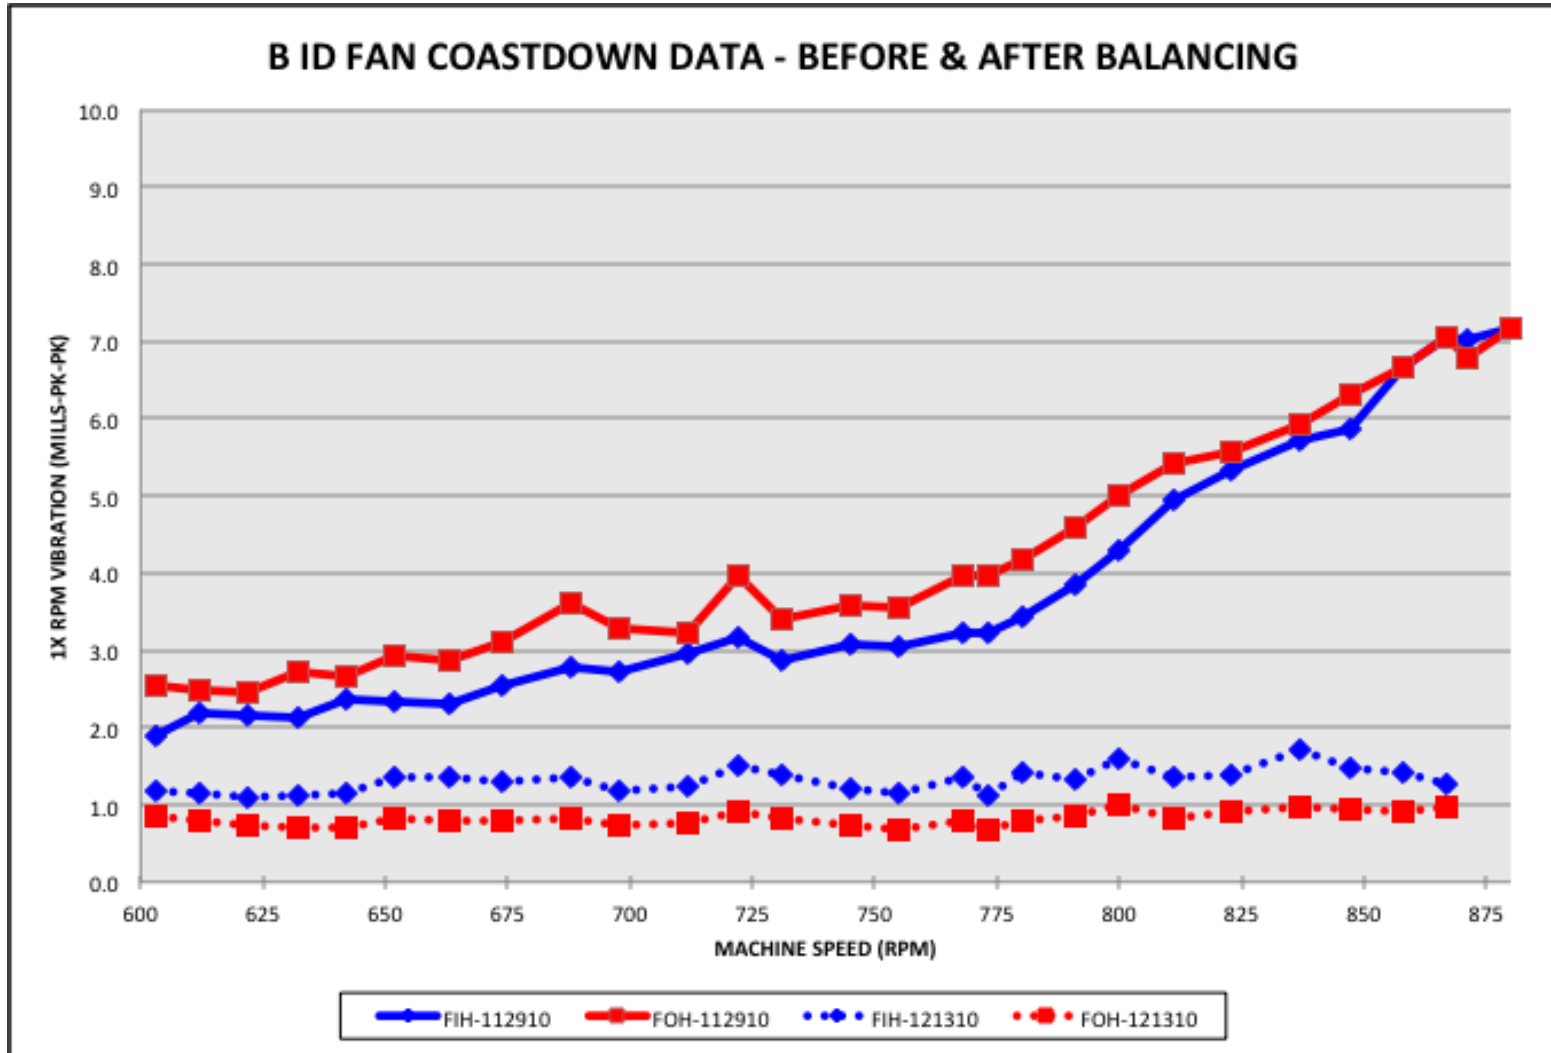
# COASTDOWN DATA, BEFORE & AFTER 1<sup>ST</sup> BALANCING

- Balancing of fan reduced 1x rpm vibration levels by 80 to 85% with final levels at or very near 1 mills-pk-pk.
- Fan was run thru its normal operating speed range after the initial balance @ 675 rpm and even at 900 rpm, its levels were acceptable so no trim balance was necessary.
- Conclusions from the balance report listed concerns as to the integrity of the foundation due to the following:
  - 1) Significant vibration felt in the surrounding area (pedestals, foundation & ground) around the fan prior to balancing.
  - 2) Much higher horizontal versus vertical or axial levels across entire machine.
  - 3) Extreme difficulty experienced by others who previously attempted to balance this fan.
- Recommendation was made to have the foundation evaluated by a civil engineering firm and follow their recommendations towards improving its stiffness & integrity.

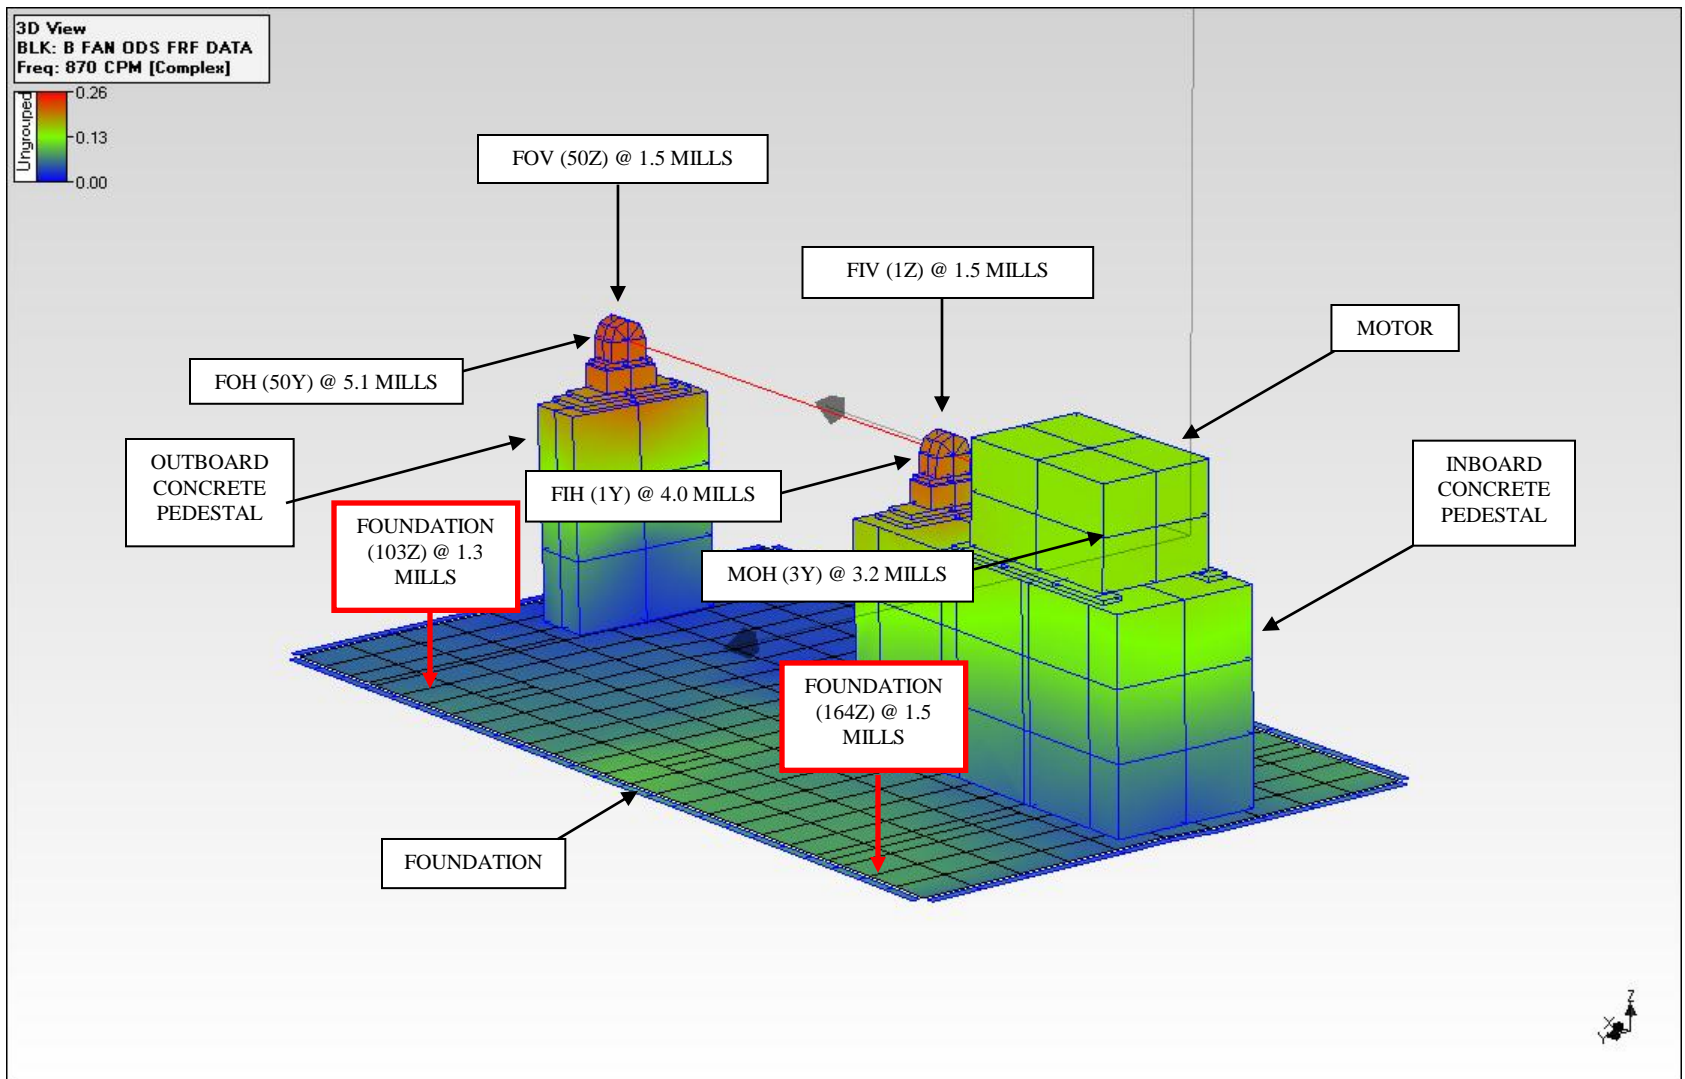
ODS Model of B ID Fan. Vibration levels are at 1x rpm (~ 900 rpm). Condition is with ~ 50 oz weight attached to fan wheel at ~ 56" radius (2,800 oz-in of unbalance) applying an estimated centrifugal force of 4,000 lbs on the machine in the radial directions. Note how vertical foundation levels are similar to vertical measurements at fan bearings.
