### MOTOR AND RELATED EQUIPMENT PROBLEMS

SHARING PICTURES AND STORIES FROM AN ELECTRO-MECHANICAL REPAIR SHOP

WAYNE HALL and EDWARD JENKINS
Vibration Institute, Piedmont Chapter #14
20 January 2017

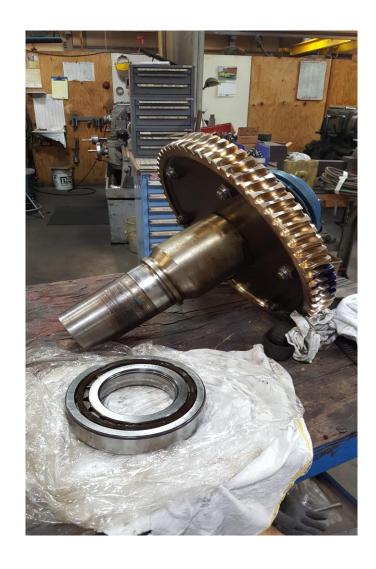
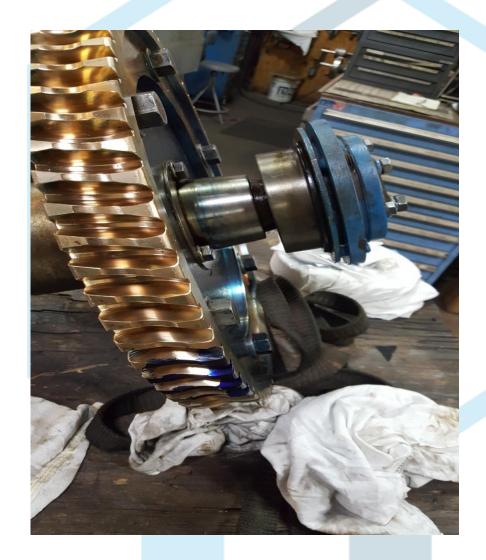
# A Bumpy Elevator Ride in a Hospital

- Passenger elevator in a hospital
- Few were willing to ride it
- Motor was suspect, no fault found
- Electronic Drive was suspect, replaced
- €Then, \$ 90,000 later, an elevator mechanic had a thought

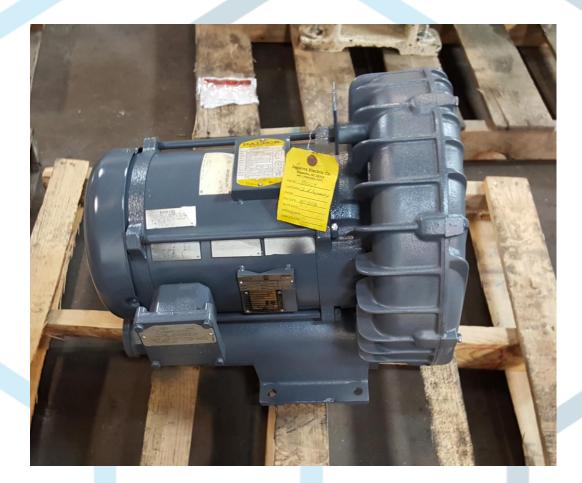
#### **Loose Internal Fan**

#### The last of the several times it was

- Put together for dispatch.
- A little clicking noise kept appearing each time it was run.
- Nothing showed up on vibration monitor.
- Finally discovered a loose internal fan on the rotor inside the motor.

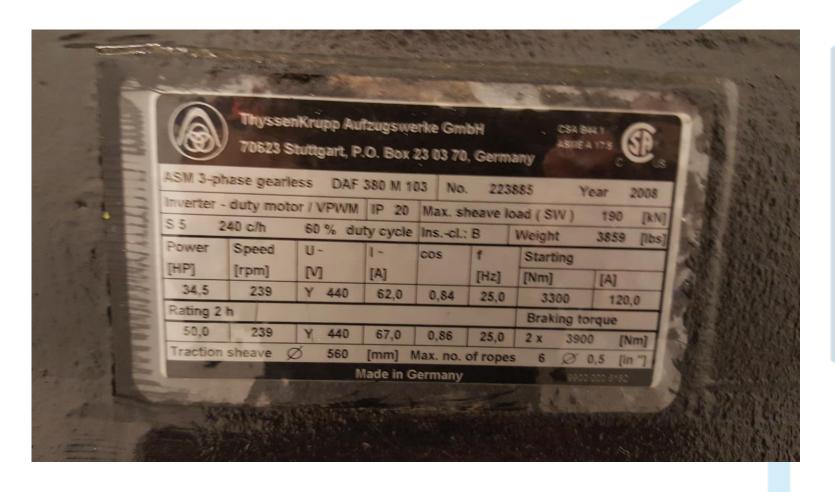
# Gearless Elevator Drive at Duke Energy Bldg.

#### **Rotor Moves Before Shaft Starts Turning**

- Gearless Elevator Drive built into an office building
- After it warmed up, it would "clunk" every time it started or stopped.
- Rotor loose on shaft, keyway bad
- Some temporary repairs are done with epoxy
- Other attempts involve welding.

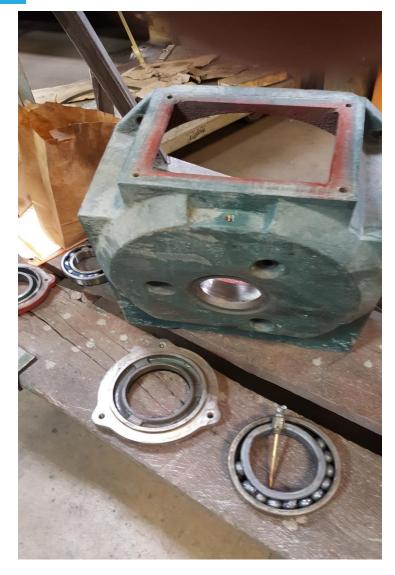
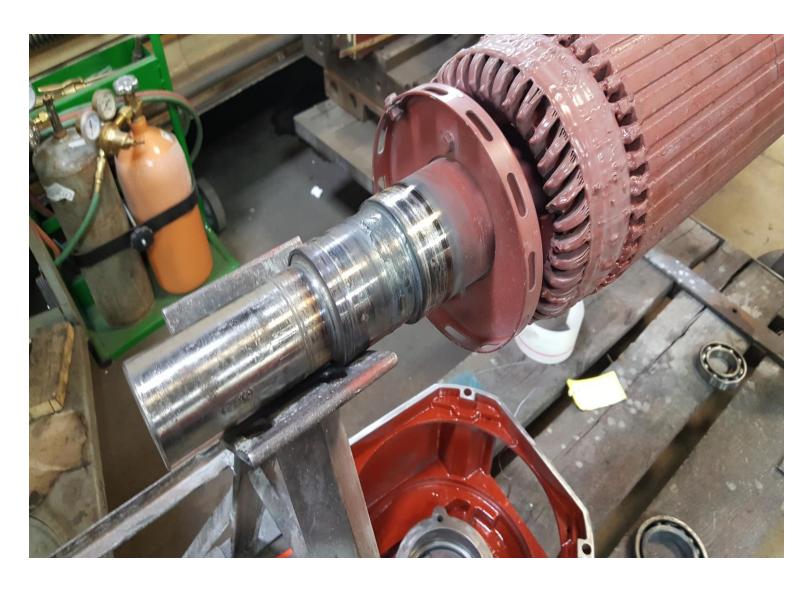
# **Bearing Failure in Service – Recently Checked**

- The following motor was monitored about six weeks before it failed
- ELubrication may be needed more often than the route is run
- ©On line monitoring may have been needed
- An observant operator noted problems and had the motor removed from service
- Shaft journal needed repair, but no other damage occurred

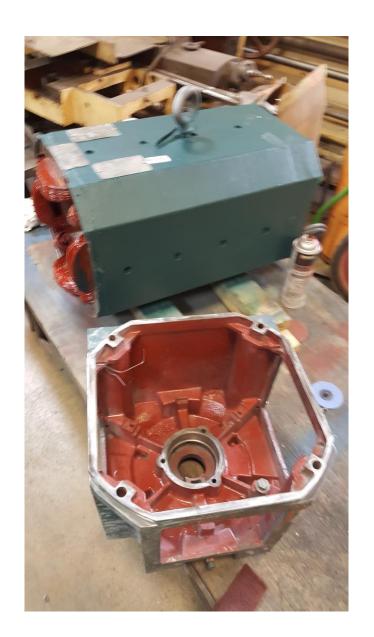
### Spectrum a month ago

- Note that the maximum vibration level observed was at running speed and well below alarm.
- No unusual peaks occurred at bearing frequencies
- No evidence bearing was greased in service

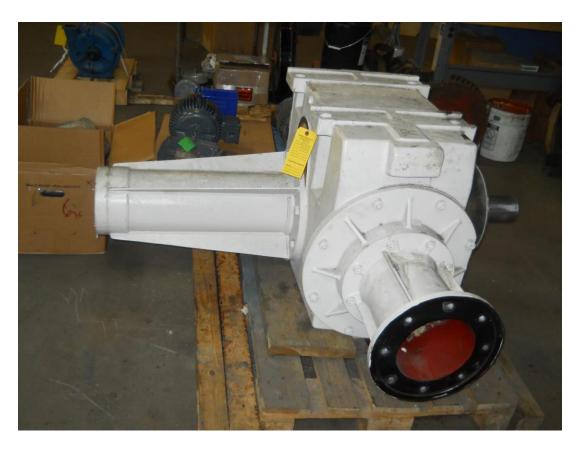
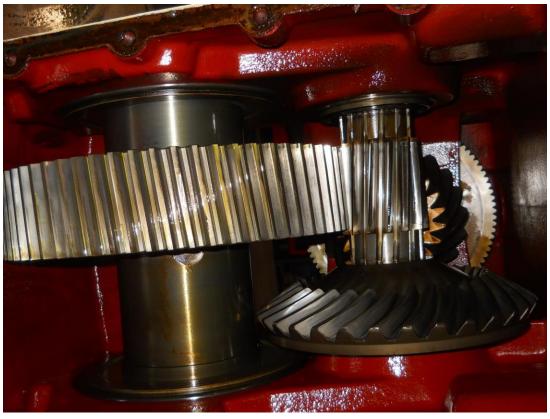
# **A Well Planned Maintenance Procedure**

- ☼Tooth paste manufacture is a never ending process
- Mixing/ grinding require high torque and low speeds
- Reliable Gear Boxes are vital
- Running to problem detection or failure may not make economic sense
- This gear box is removed from service every two years and all bearings and seals are replaced

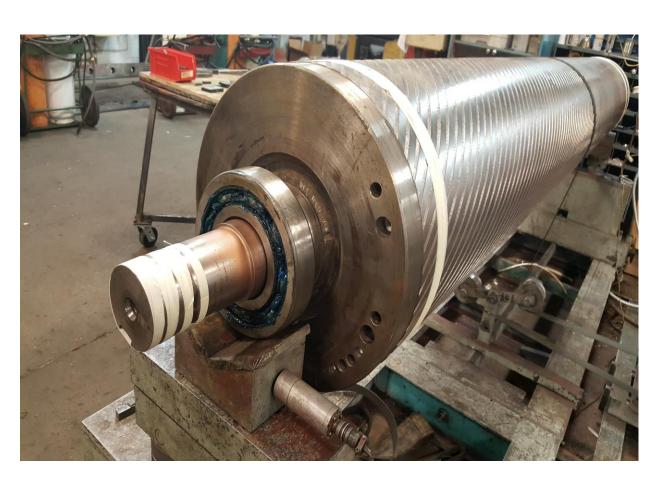
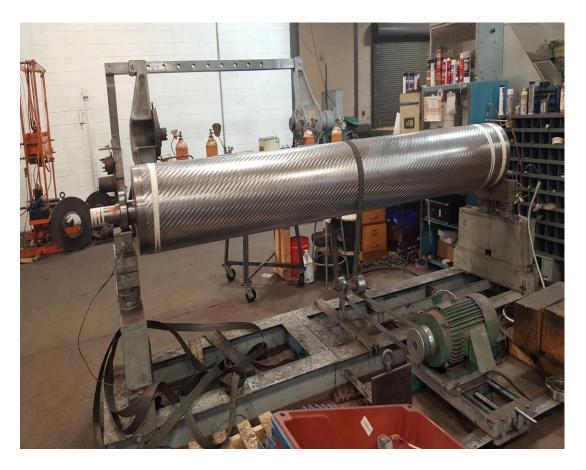
# Final Balance of Roll - Trim by Weight Removal

- ⊕Two plane balance
- Operating speed 1150 rpm
- ☼ Target Residual Unbalance 5 grams, regardless of roll size or weight??
- **Results:** 
  - €0.001 and 0.003 inch/second
  - €0.91 and 2.12 grams Residual
  - €0.04 and 0.13 mils

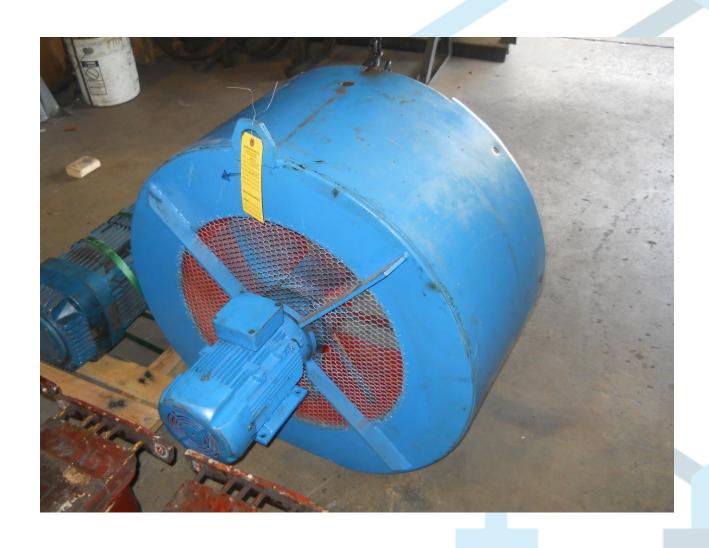
# **External Blower Motor**

- This external blower had a heavy steel blade
- The blade was balanced within specs
- The drive motor was balanced within spec
- Excess Vibration still occurred

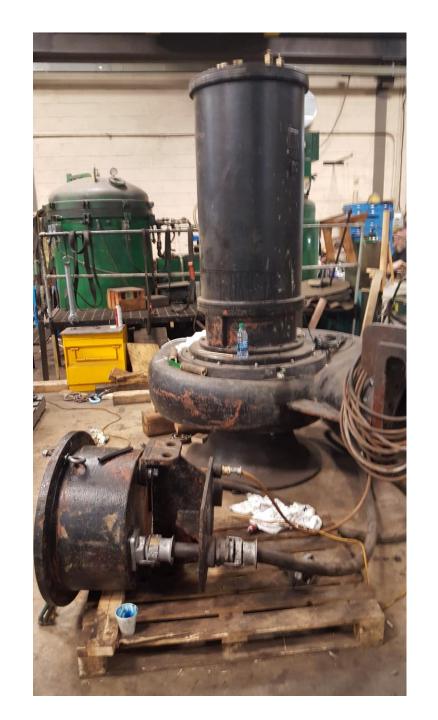
## **Vibration in Sewage Pump**

- ©Once the "Stuff" was cleaned out, the pump ran smoothly.
- No problems in bearings

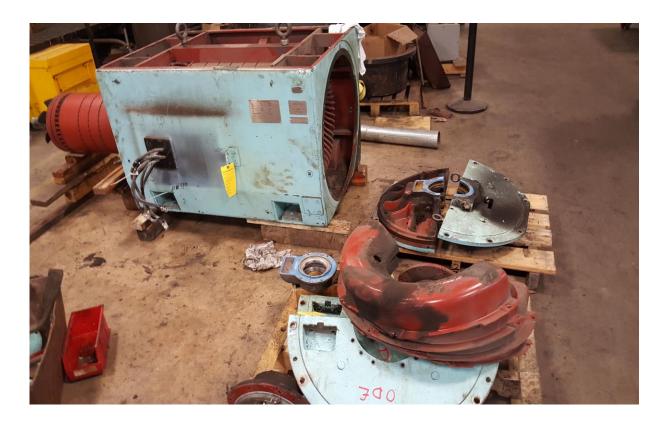
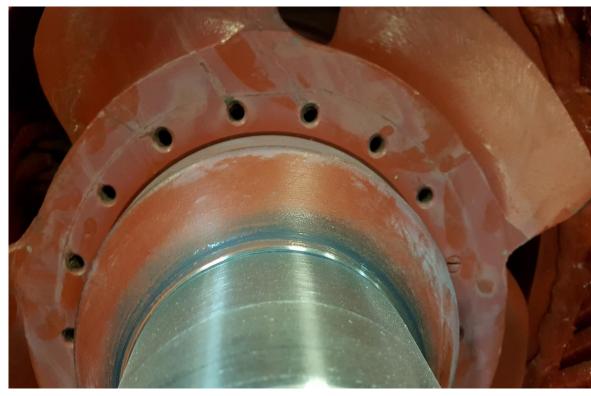
# **Balance Weights Can Come Off**

- Epoxy balance compound relies on adhesion /support
- Sometimes mixed with lead shot to increase weight
- Welds on weights can crack
- Balancing rings provide many angular positions
- Weights on fan blades? Stress, air flow, appearance?

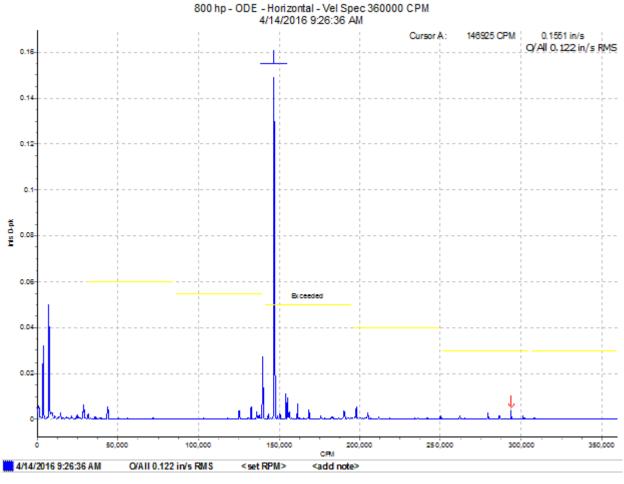
Here is the Vibration data taken on the Charlotte Pipe with loose rotor bars.

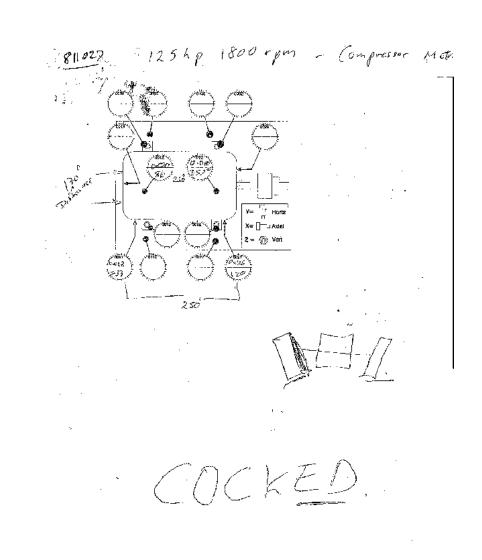
#### **Error in Machining the End Brackets**

- Motor received with both end brackets oversize and one journal undersize.
- Repairs made, but DE end bracket slipped in the lathe and was bored cocked, 0.004 inch.
- ♥Vibration levels OK (0.02 in/sec), but Roller bearing was noisy.
- ODE readings out 170 degrees.

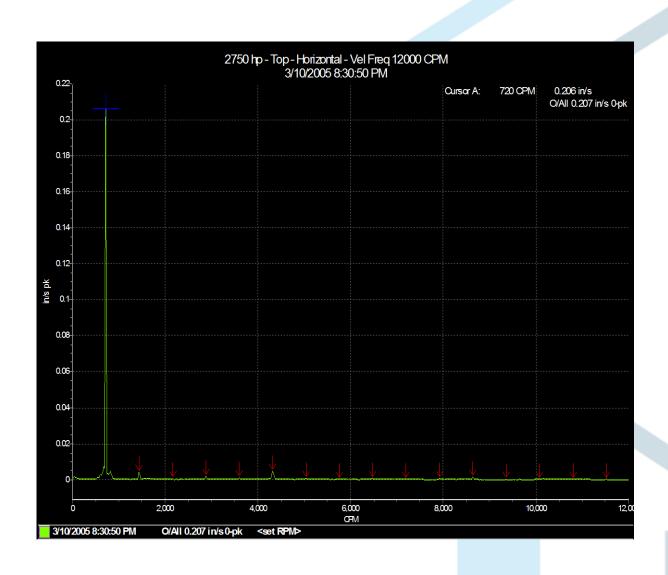
## **2750 Hp Vertical Pump Motor**

- Pump motors manufactured in Brazil
- Moved to Mexico for acceptance testing
- One hit a bridge during road transport
- Installed in water supply pump station
- **Excess vibration occurred**
- Rotors were balanced
- Reed vibration occurred... strengthening required in motor frame
- Final trim balance was acceptable

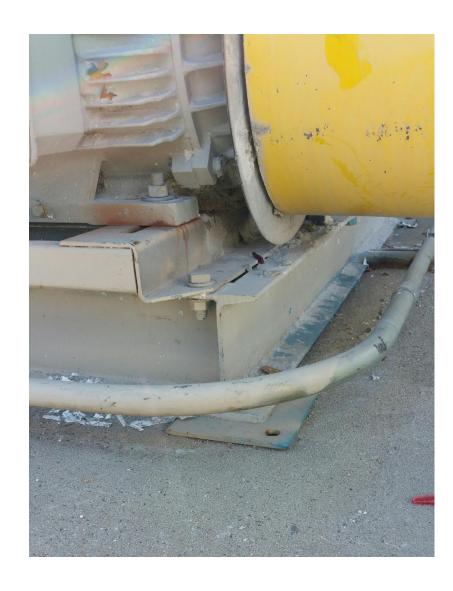
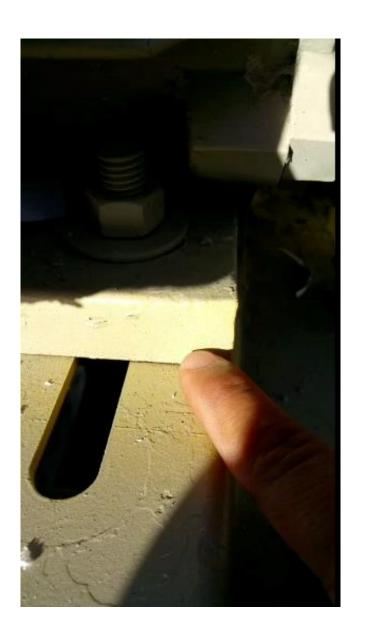
# **Blower Configuration**

- ELarge 30 HP blower on shredded paper transport
- ©Tools, etc may enter the waste stream and impact the blade
- Paper can coat the TEFC motor fan cover
- The system base had many loose bolts
- Some foundation bolts were missing
