**POWER HOUSE FD & ID FANS
ANALYZING CONCRETE FOUNDATION RESONANCE**

Ken Singleton

**Bob McGinnis, P.E.
McGinnis Engineering LLC, Kingsport TN**

Abstract: A request was received to investigate high amplitude vibration of forced draft (FD) and induced draft (ID) fans at a coal fired power plant. Operating deflection shape analysis (ODS) and experimental modal analysis (EMA) were specifically requested. Of most concern was reported vibration amplitude over 0.40 in/sec pk on the ID Fan A outboard bearing. Steel bracing had been bolted to the ID Fan's outboard pedestals in an attempt to reduce vibration. In-place balancing had been performed but was not effective in reducing the primarily axial direction vibration. Vibration data on the motor and fan bearing housings were monitored by a System 1 online acquisition system acquiring data from velometers. Proximity probes were not installed in the fluid film bearings. During three days onsite, test data were measured that included standard vibration data, ODS, EMA and multi-channel continuous data acquisition. Natural frequencies of the outboard pedestal of ID Fan A, inadequate hold down bolt tightness, inadequate and improper bracing

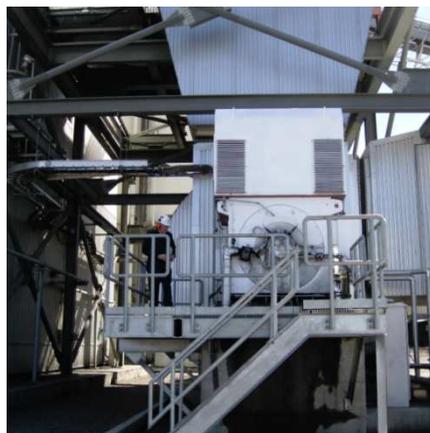
- The ID Fan bearing housings were bolted to fabricated steel bases which were bolted to soleplates. The soleplates were bolted and grouted to the concrete pedestals. The pedestals appeared undersized for the 30,000 lb_f fan rotor.
- The two ID Fans were located end-to-end with the outboard pedestals 12' 6" apart. ID Fan A is shown in **Figure 1**. This fan had the highest reported vibration amplitude of the outboard bearing housing axial

Figure 1. ID Fan A.

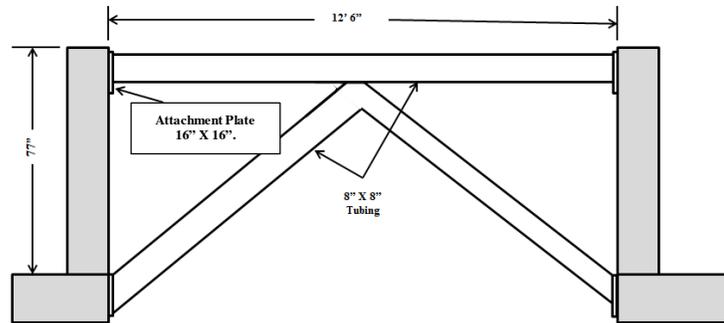
direction. Vibration had reportedly exceeded 0.40 in/sec pk. A Steel brace had been installed in an attempt to reduce the bearing housing axial vibration. The brace was fabricated of 8" square tubing and bolted to both ID Fan's outboard pedestals, as shown in **Figures 2 & 3**.

Figure 2. Brace of 8" Square Tubing Bolted to ID Fan Outboard Bearing Concrete Pedestals.

5. Insure that the Dodge Sleeve Bearing plunger bolts are torqued to 3600 in/lb_f = 300 ft/lb_f as stamped on the plunger stud.
 6. Remove the steel bracing connecting the ID Fan A & B outboard pedestals. Replace with individual bracing bolted to a massive concrete pad per drawings, see **Figure 35 & 36**. Install the pedestal reinforcing plates per **Figure 35**.

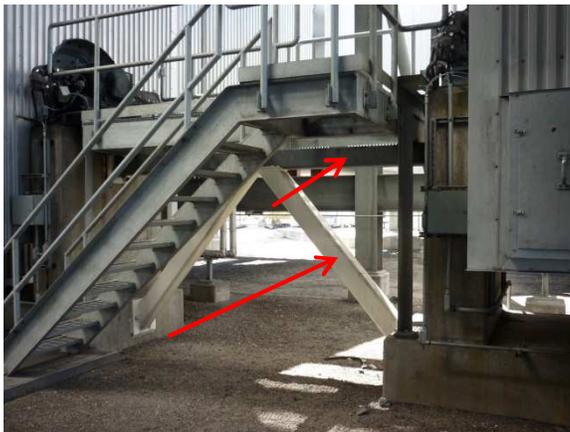
Figure 3. ID Fan A & B, Outboard Pedestals, Steel Bracing Bolted to Each Pedestal.

- ID Fans A & B outboard pedestals were connected by a steel brace fabricated of 8" square tubing. Brace steel plates were bolted to the concrete pedestals. These plates had a thickness to width ratio which allowed flexing between the attaching bolts and the 8" square tubing. This was also a contributing factor to excessive vibration.

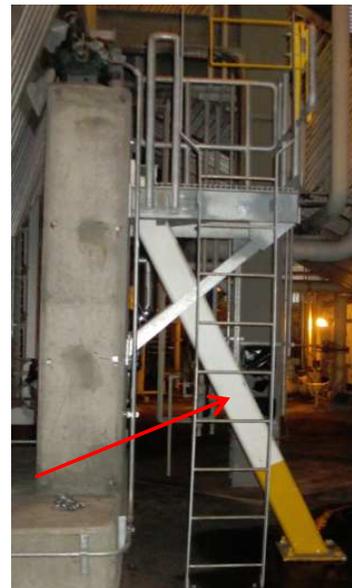
Figure 4: ID Fan A Outboard Bearing Pedestal Single Brace 30 Deg Angle.

- Bracing had also been installed on the FD Fan's outboard fan pedestals, **Figure 4**. These braces were also fabricated of 8" square tubing and installed at 25 degree angle. Access to the bearings was by ladder. Brace plates were bolted to the concrete pedestal and concrete floor. The brace was not completely effective in reducing vibration to acceptable amplitudes.
- ID and FD fan's concrete foundations had many cracks that appeared to extend deep within the foundations, **Figure 5**. The quality of the concrete appeared substandard.
- ID and FD Fan concrete pedestals did not appear bonded to the concrete foundations although rebar likely extended from the foundation up into the pedestals. Drawings were not available to verify construction details. The joint was cracked at the interface of the pedestals and foundation, shown by photo of ID Fan A outboard pedestal, **Figure 6**.

- FD Fan A & B outboard pedestals were braced in the axial direction at 25 degree angle with fabricated 8" square tubing. Brace steel plates were bolted to the concrete floor and concrete pedestals. High amplitude axial vibration was reported to have occurred although vibration data we measured was low amplitude.

- Consider replacing the bracing of the fan outboard bearing pedestal per **Figure 37**.
- Consider modifying the fan outboard pedestal ladder access with platform and stair access.

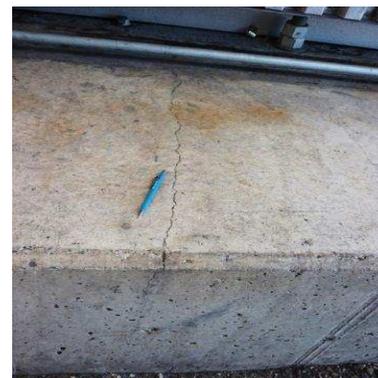
Figure 5. ID Fan A Foundation Crack.

- ID fan concrete foundations had many cracks that appeared to extend deep within the foundations. The quality of the concrete appeared substandard.
 - ID and FD Fan pedestals did not appear bonded to the concrete foundation.

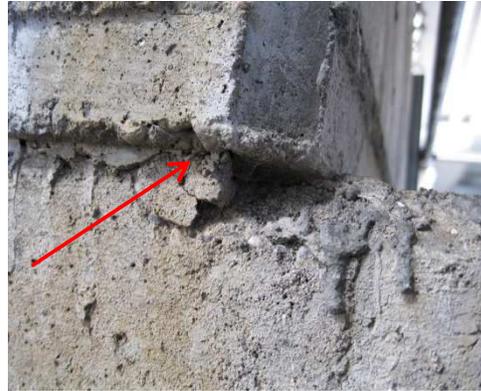
Figure 6. ID Fan A, OB Concrete Pedestal & Foundation Interface.

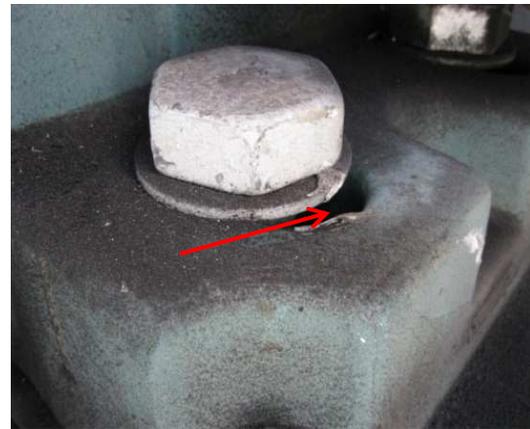
Figure 7. ID Fan A, Inboard Bearing Housing Hold Down Bolt – Washer Was Too Thin.

4. Insure that the fan bearing housing hold down bolts are properly lubricated and correctly torqued. A minimum ½ inch thick washers and Grade 8 bolts should be used. Thread lubricant should be applied to the threads, bolt heads and nut faces.

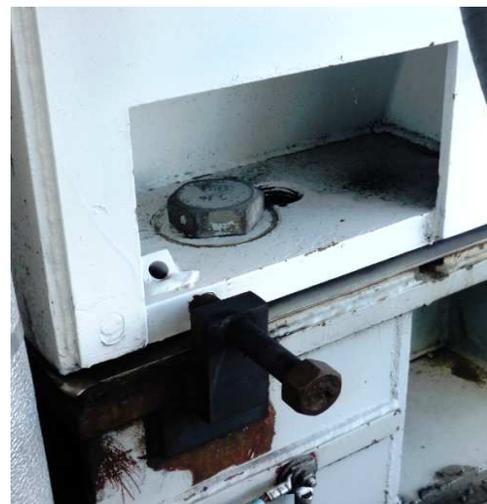
Figure 8. ID Fan A & B Motor Hold Down Bolts Used Tapped Holes in Fabricated Steel Base.

- ID Fan Motors were bolted to a fabricated steel base using tapped holes in 1" thick steel. Through bolting using Grade 8 bolts with thick washers and nuts would have been preferred.

2. Consider modifying the ID Fan's motor hold down bolts to through bolts with washers and nuts. Grade 8 bolts, nuts and washers should be used.
 3. Insure that the fan bearing sole plate anchor bolts are correctly torqued.

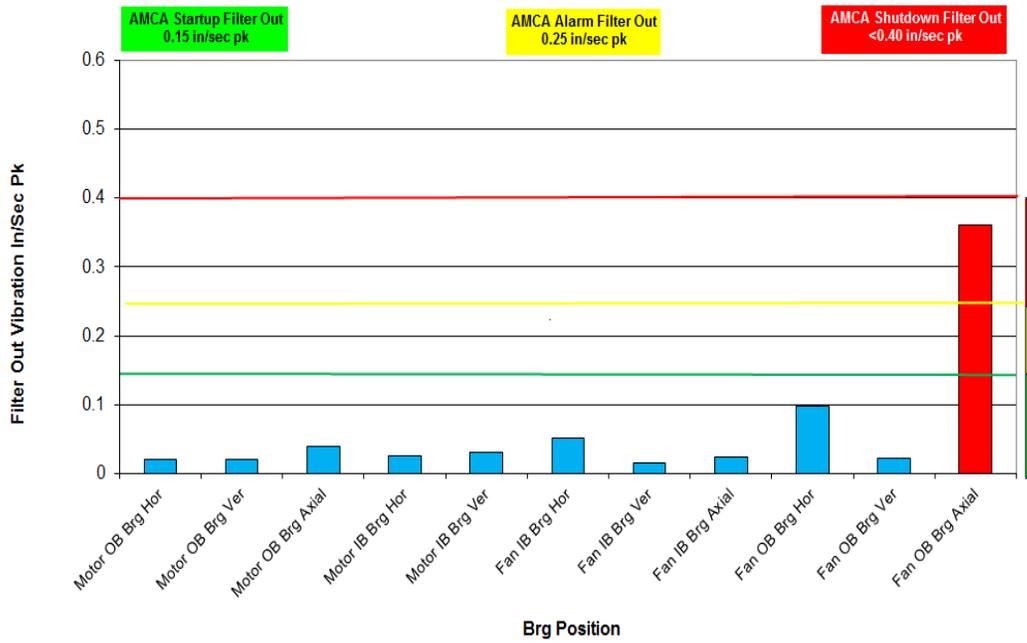
Overall vibration data on the motor and fan bearing housings of ID Fan A showed that the outboard bearing housing axial vibration at 0.36 in/sec pk was the point with highest amplitude, see **Figure 9**. Note that the chart shows AMCA Alarm Filter Out (overall) for Startup (Green), Alarm (Yellow) and Shutdown (Red).

Figure 9. ID Fan A Overall Vibration (Filter Out) in/sec pk.

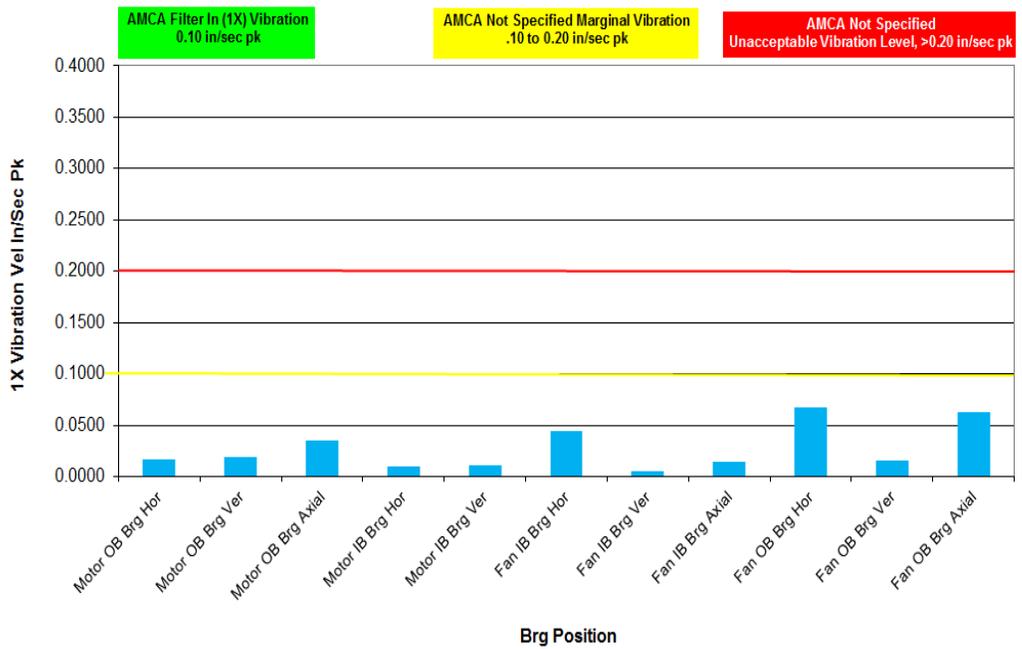
Data at 1X the shaft's rotational frequency showed vibration amplitudes at all points were acceptable, as shown in **Figure 10**. The chart shows AMCA Filter in (1X) recommended Startup (Green) and Shutdown (Red). AMCA does not publish an alarm value for Alert (Yellow).

Figure 10. ID Fan A, 1X Vibration in/sec pk.

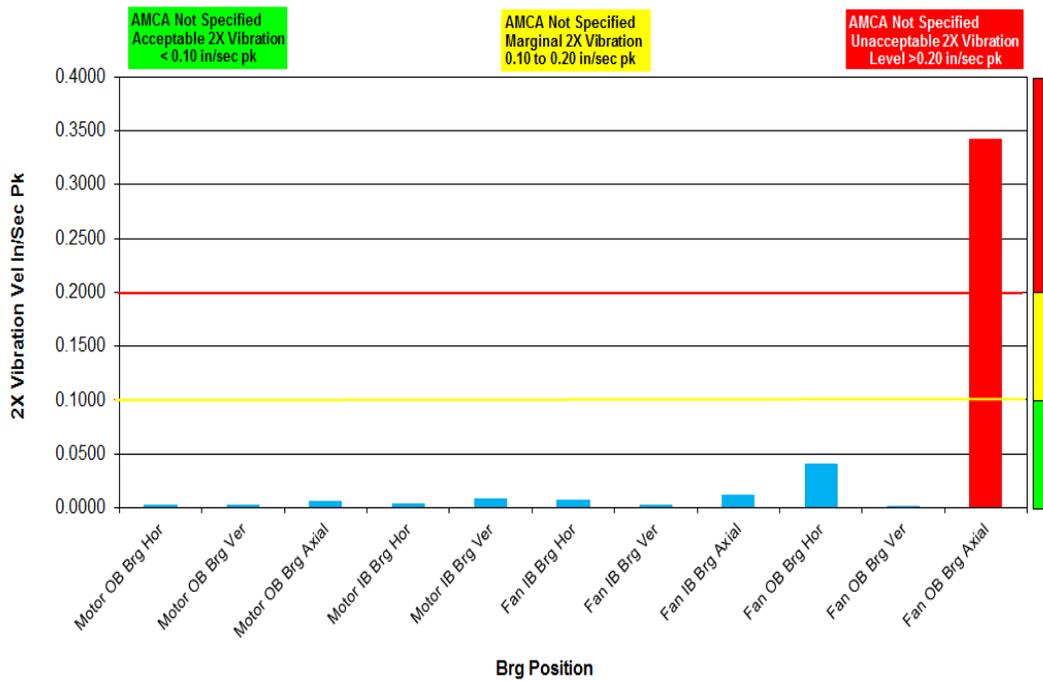
Vibration at 2X measured on the motor and fan bearing housings is shown in **Figure 11**. The outboard bearing housing clearly had the highest vibration amplitude in the axial direction at 2X the rotor rotational frequency. AMCA does not publish vibration tolerances for the 2X frequency so the alarm levels are estimated.

Figure 11. ID Fan A, Bearing Housing 2X Vibration in/sec pk.

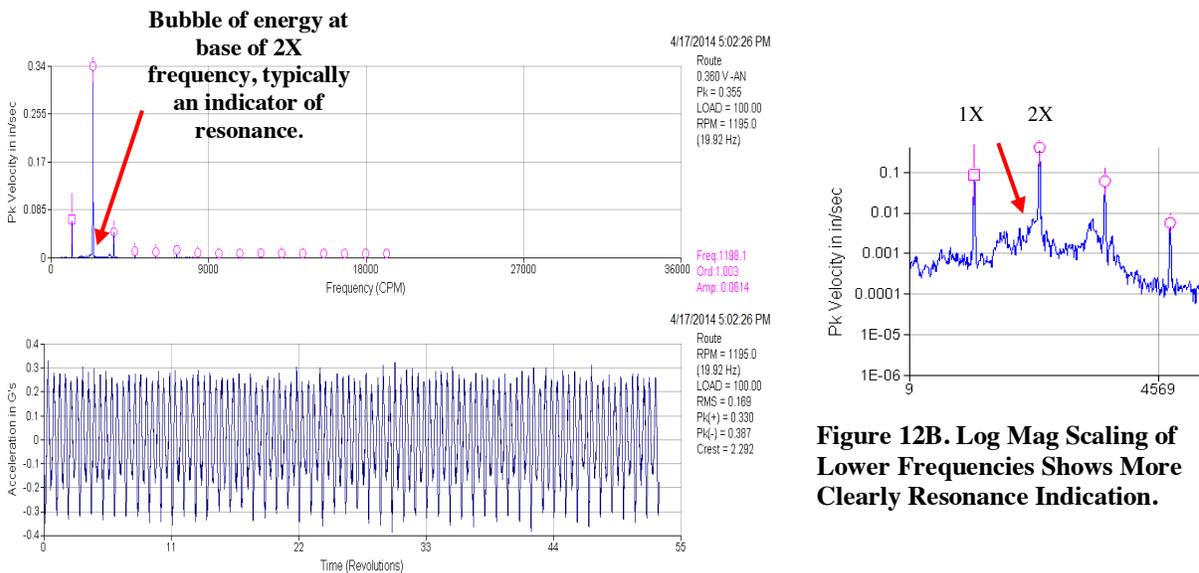
The frequency spectrum and waveform data for the fan outboard bearing housing, axial direction is shown in **Figure 12A**. Note the bubble of energy at the base of the 2X frequency which typically is an indicator of resonance. The lower frequency portion of the spectrum plot with log magnitude scaling is shown in **Figure 12B**. This plot more clearly shows indication of resonance near the 2X frequency.

Figure 12B. Log Mag Scaling of Lower Frequencies Shows More Clearly Resonance Indication.

Figure 12A. ID Fan A, Outboard Bearing, Axial Direction in/sec pk.

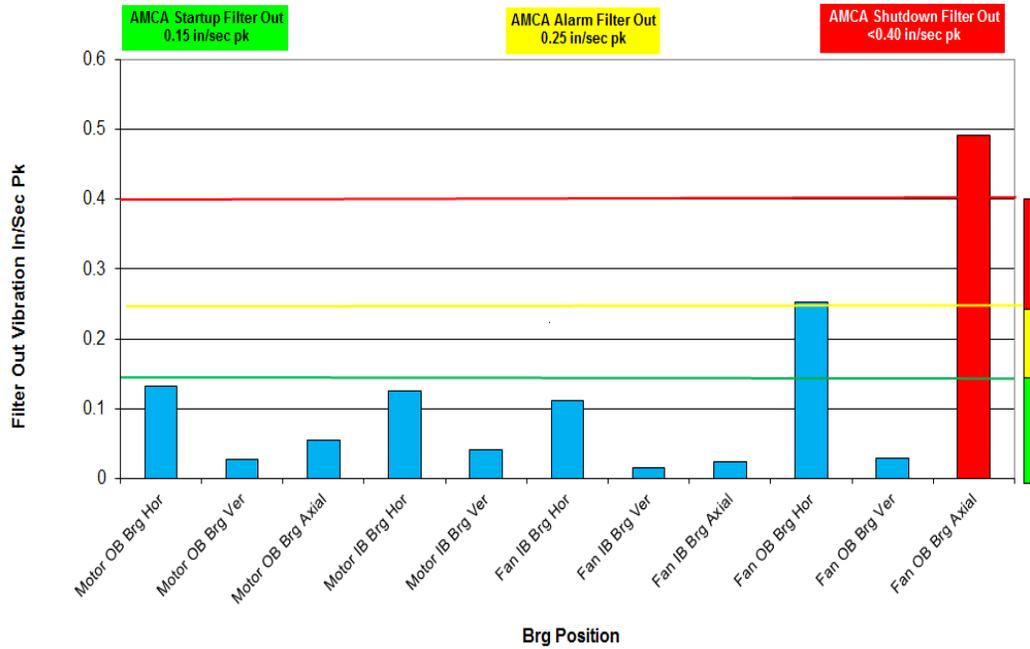
Our data showed that ID Fan B had higher amplitude vibration than ID Fan A. The overall vibration amplitudes are shown in **Figure 13**. Outboard bearing housing horizontal vibration measured 0.252 in/sec pk and axial vibration at the top of the housing measured 0.492 in/sec pk.

Figure 13. ID Fan B, Overall Vibration in/sec pk.

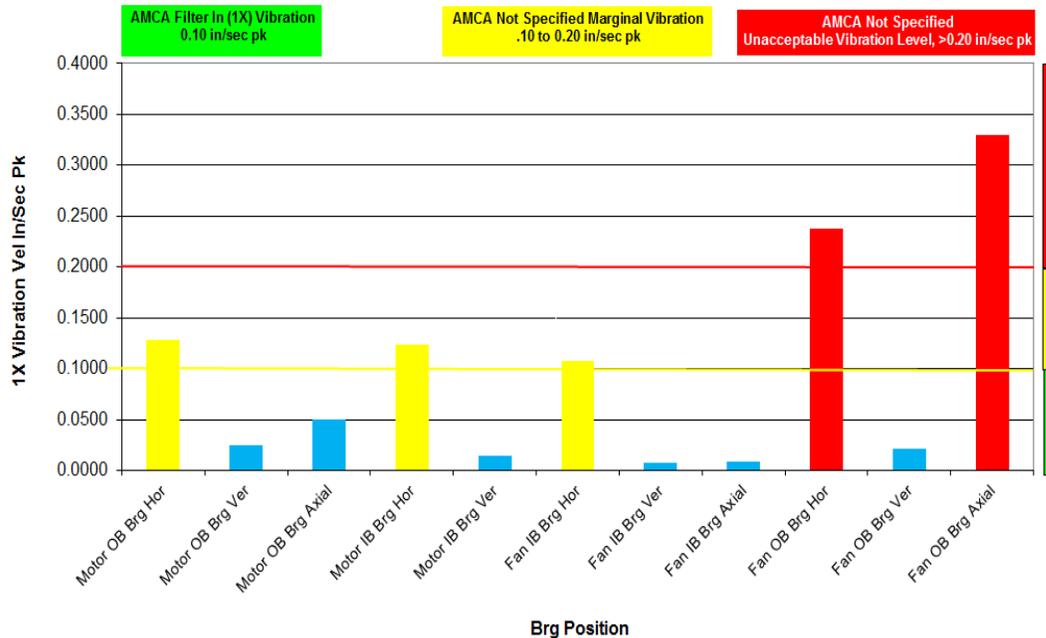
Vibration at 1X shaft rotational frequency is shown in **Figure 14**. Amplitudes were higher than ID Fan A. Misalignment of the Sleeve bearing to the journal was considered likely as well as amplification of the vibration by structural natural frequencies. Amplitude in the axial direction of the outboard bearing housings was 0.333 in/sec pk.

Figure 14. ID Fan B, 1X Vibration in/sec pk.

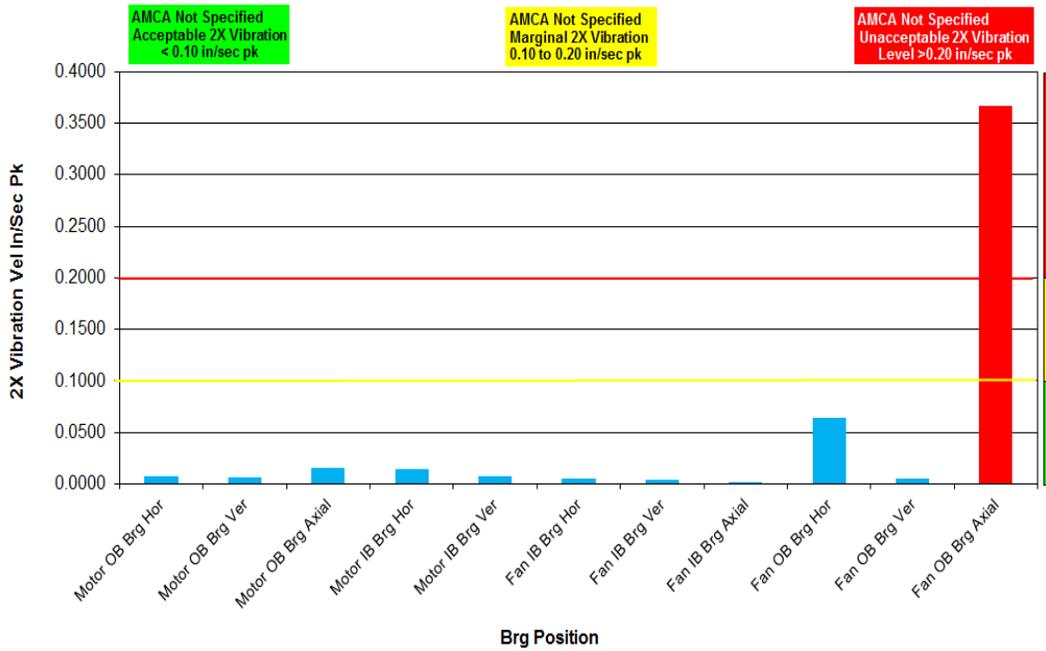
Vibration at 2X is shown in **Figure 15**. The highest amplitude was 0.367 in/sec at the outboard bearing housing axial direction.

Figure 15. Fan ID B, 2X Vibration in/sec pk.

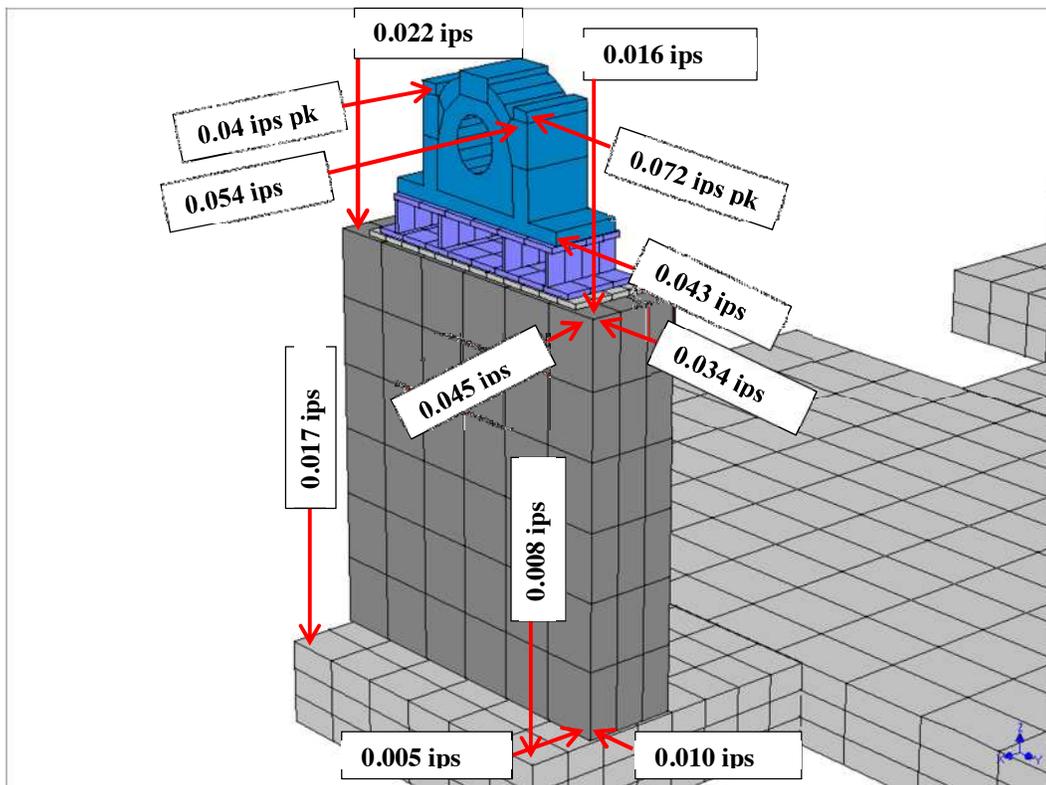
The vibration amplitudes at some DOF for 1X run speed frequency on ID Fan A outboard pedestal are shown in **Figure 20**. The amplitudes were not considered excessive.

Figure 20. ID Fan A OB Pedestal Vibration at 1X Run Speed Frequency.

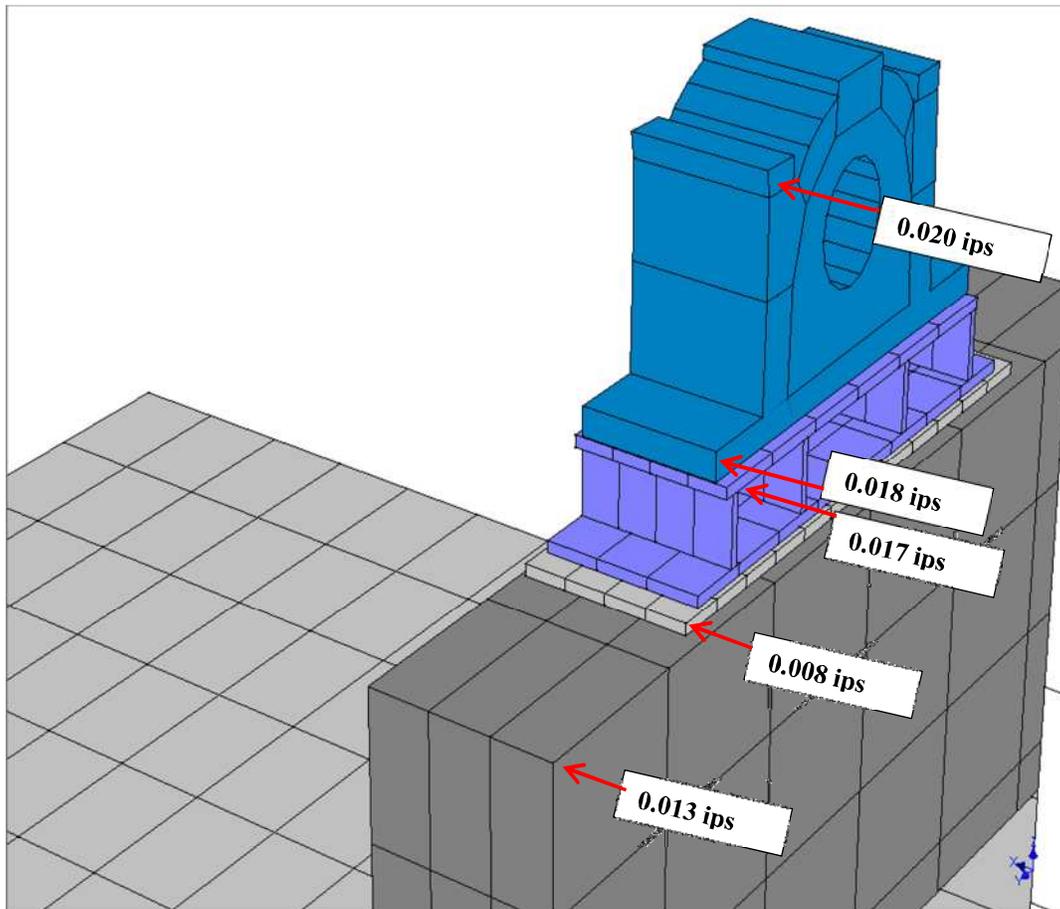
The ODS model of the inboard bearing housing, fabricated base, soleplate and pedestal are shown in **Figure 22**. Some DOF are labeled with vibration amplitude at 1X. Low amplitude slippage of the bearing housing on the fabricated steel base was indicated by the ODS data. However, very little relative vibration of the soleplate to the concrete was indicated.

Figure 22. ID Fan A, IB Brg Housing, Support and Pedestal. ODS Amplitude at 1X Shaft Rotational Frequency.

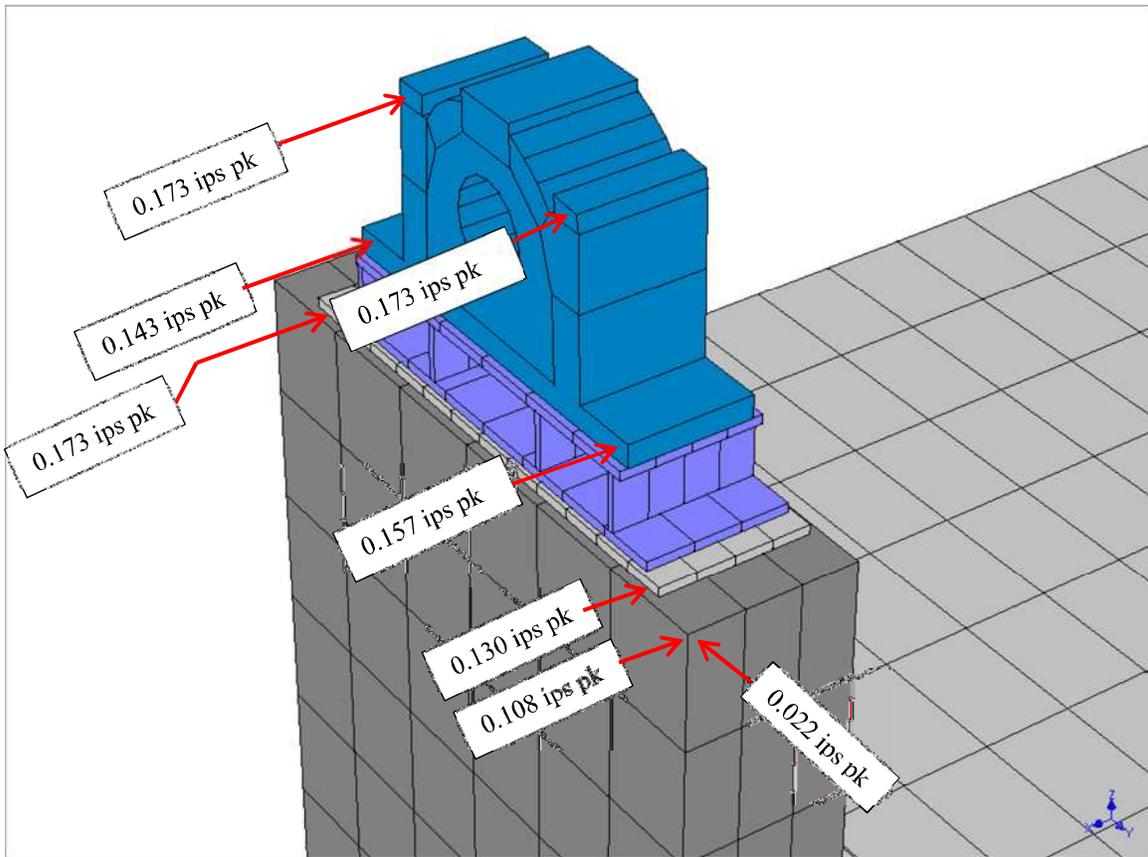
ODS Analysis of Vibration at 2X: ODS data at 2X rotor run speed showed much higher amplitude vibration of the outboard bearing housing and pedestal. The ME'scopeVES model is shown in **Figure 24** with some DOF labeled with vibration amplitude. Slippage of the soleplate on the concrete pedestal was indicated which could be caused by inadequate tightness of the anchor bolts. Continual slippage would wear the grout.

Figure 24 ID Fan A OB Bearing & Pedestal With Some DOF Vibration Amplitude Labeled at 2X Run Speed.

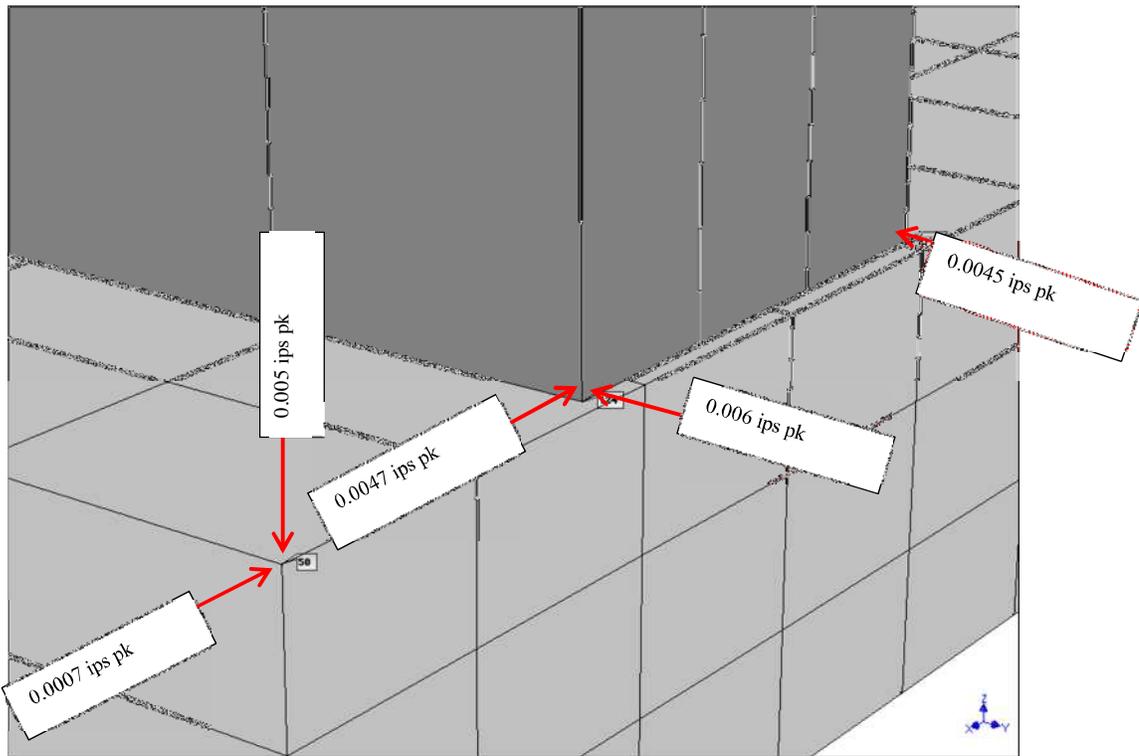
A view of the ODS Model for ID Fan A OB Pedestal to concrete foundation interface is shown in **Figure 25**. The pedestal had a rocking motion. Low amplitude slippage at 2X was indicated by the data although the vibration amplitudes were very low.

Figure 25. ID Fan A, OB Bearing Pedestal Interface to Concrete Foundation.

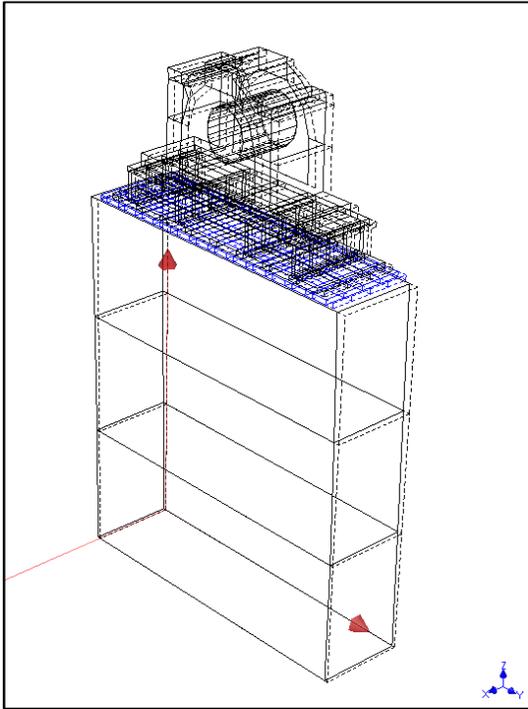
Figure 31. ID Fan A Outboard Bearing Pedestal Modal Test, Mode Shape 1401 CPM Rocking Side-to-Side in Y.

- Pedestal natural frequencies in the Y Axis near 1X and 2X fan run speed frequency frequencies.
 - Pedestal natural frequency in the X Axis near 1X fan run speed frequency.

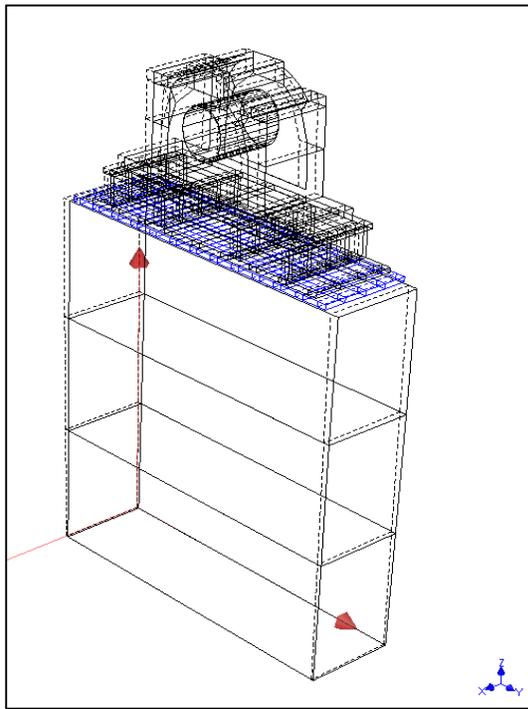
Figure 32. ID Fan A Outboard Bearing Pedestal Modal Test, Mode Shape 2509 CPM Rocking Side-to-Side in Y.

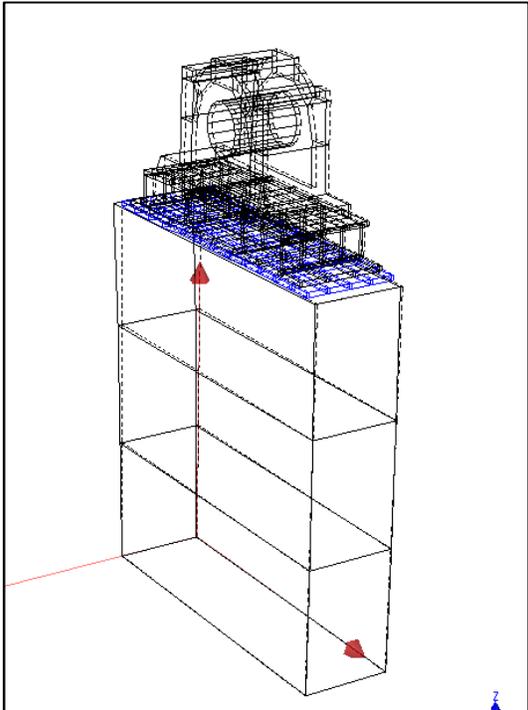
Figure 33. ID Fan A Outboard Bearing Pedestal Modal Test, Mode Shape 1378 CPM Rocking in X (Axial).

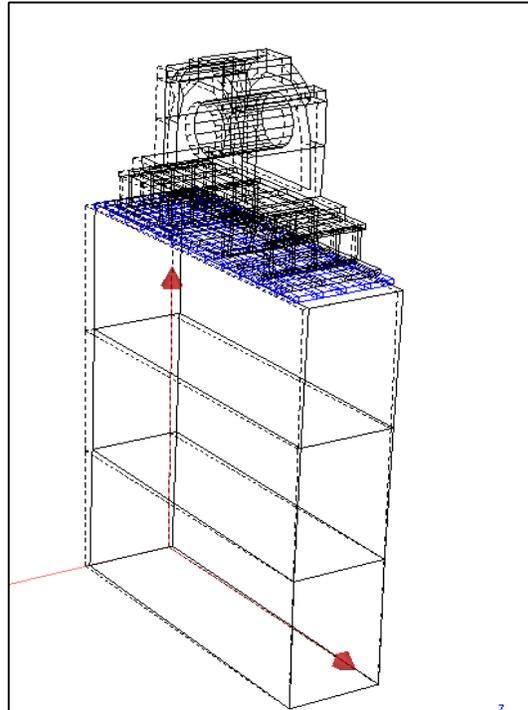
Figure 34. ID Fan A Outboard Bearing Pedestal Modal Test Mode Shape 5107 CPM Rocking in X (Axial).
