# CASE HISTORY#1

## BAD COOLING TOWER GEARBOX?

# CASE HISTORY – BAD CT GEARBOX?

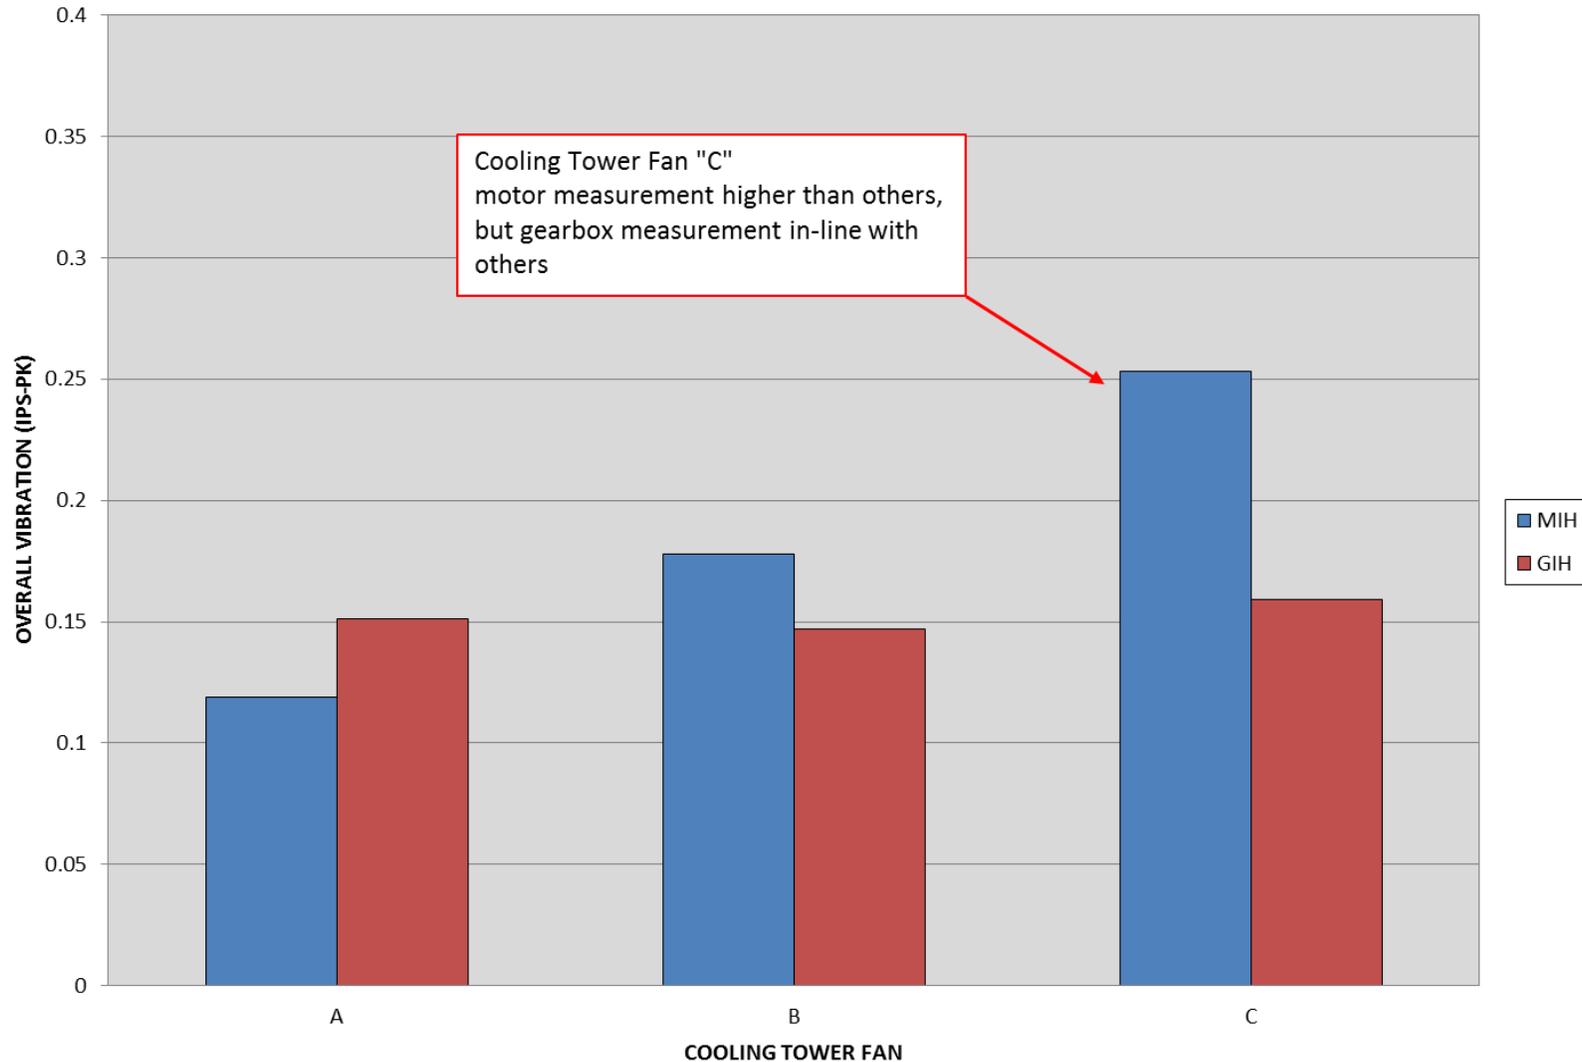
## COOLING TOWER FANS, OVERALL VIBRATION LEVELS

- All gearbox levels were < 0.2 ips-pk (not that bad).
- Gearbox levels at fan “C” were in-line with the other two units.
- Motor levels at fan “C” were clearly higher than the others (potential problem).

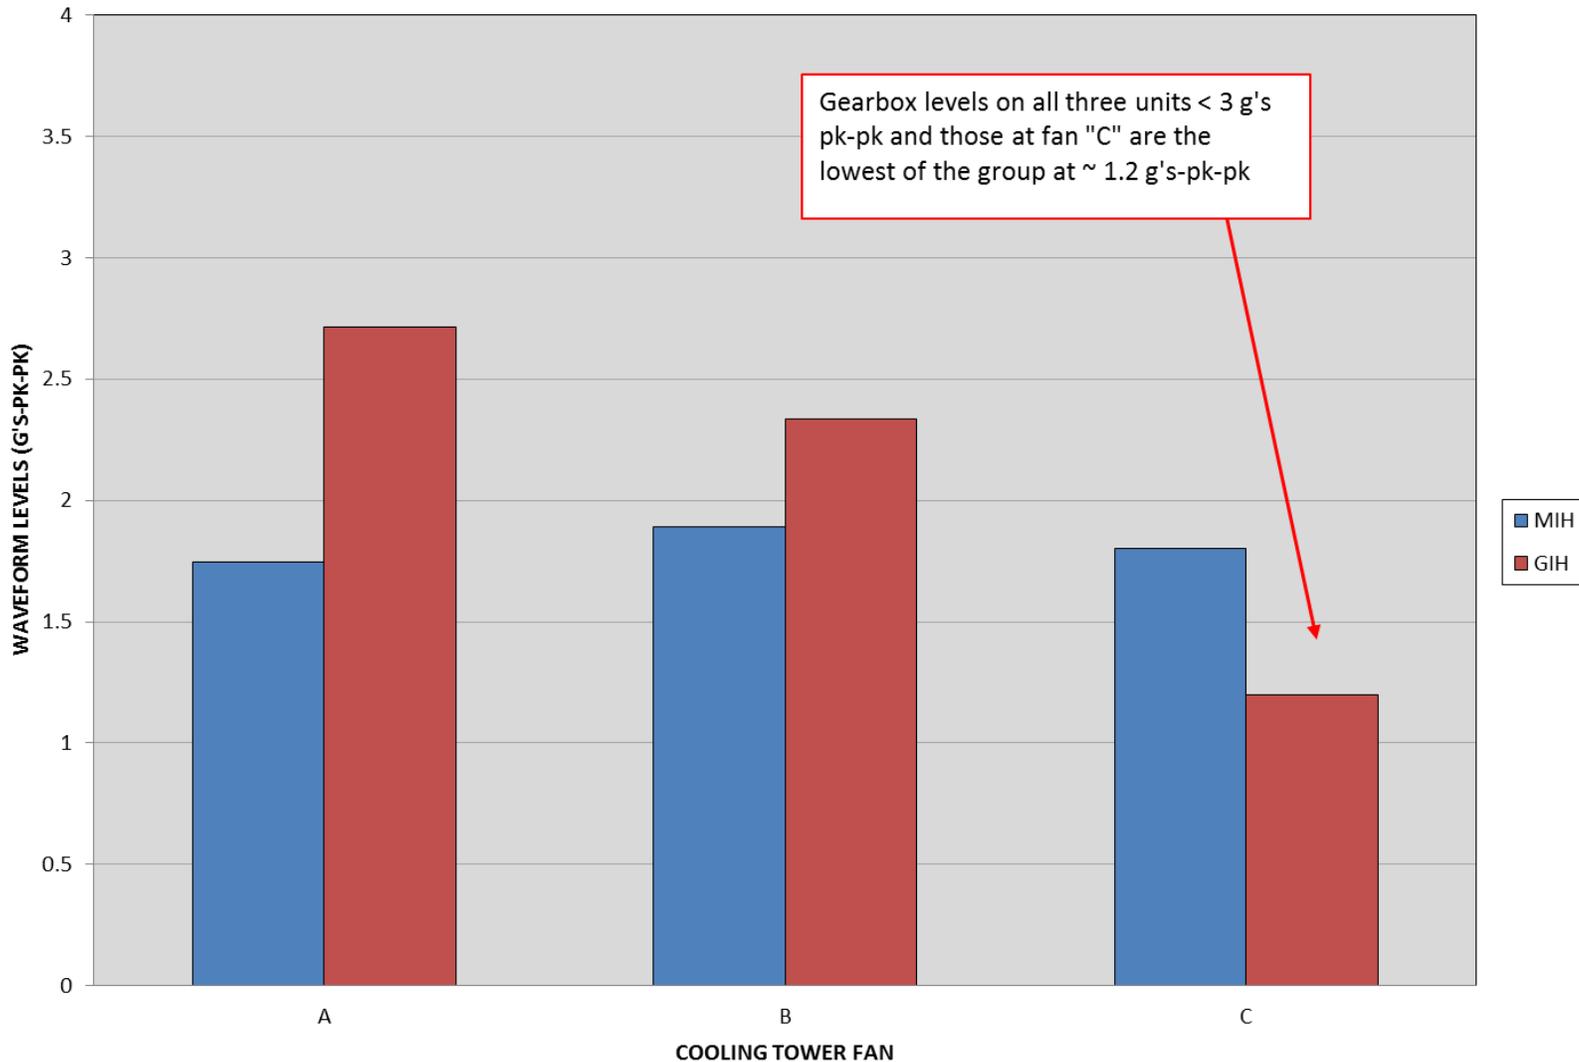
## COOLING TOWER FANS, WAVEFORM VIBRATION LEVELS

- All waveform levels were < 3 g's-pk-pk (not that bad for gearboxes).
- Gearbox levels at fan "C" were the lowest of the group at ~ 1.2 g's-pk-pk.
- No significant motor or gearbox bearing or gear faults were expected.

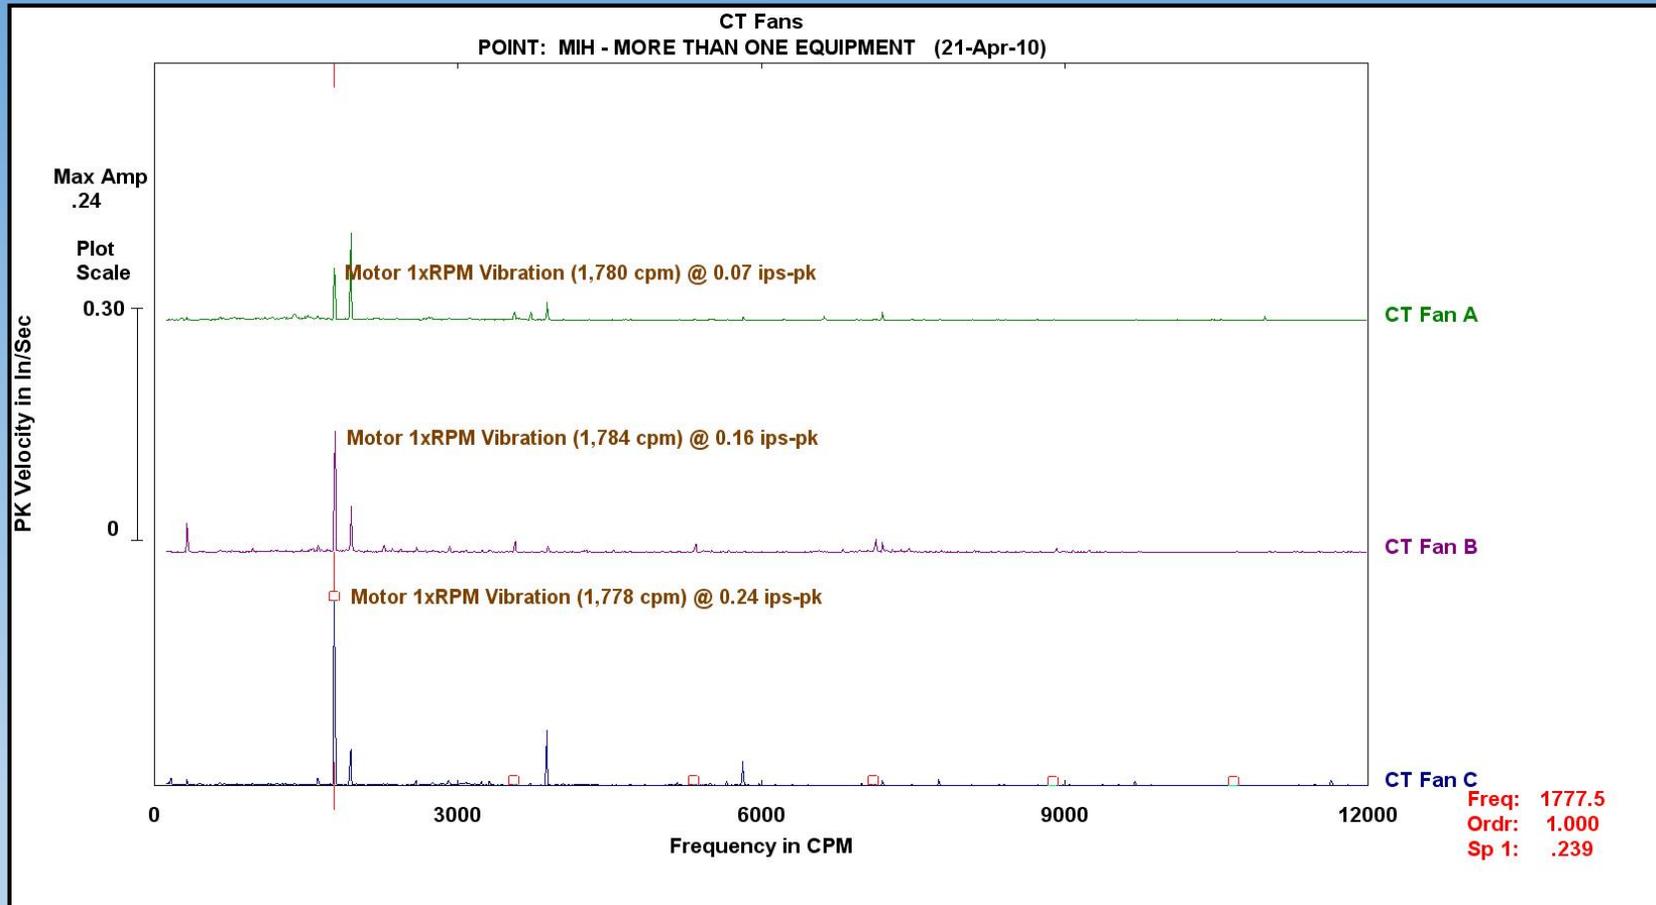
# CT MOTOR SPECTRAL DATA (A, B & C)

- Vibration levels were clearly highest at CT fan “C” motor.
- Dominant vibration at CT fan “C” motor occurred at the motor speed of ~ 1,778 rpm (0.24 ips-pk).
- Potential causes for the higher levels at motor 1x rpm for “C” fan were unbalance at coupling or shaft, misalignment or coupling problems.
- Vibration at blade-pass frequency was low at all motors, but a 2x & 3x blade-pass vibration component were noted at “C” motor.

- 6) Consider an alignment check at this fan at your next opportunity.

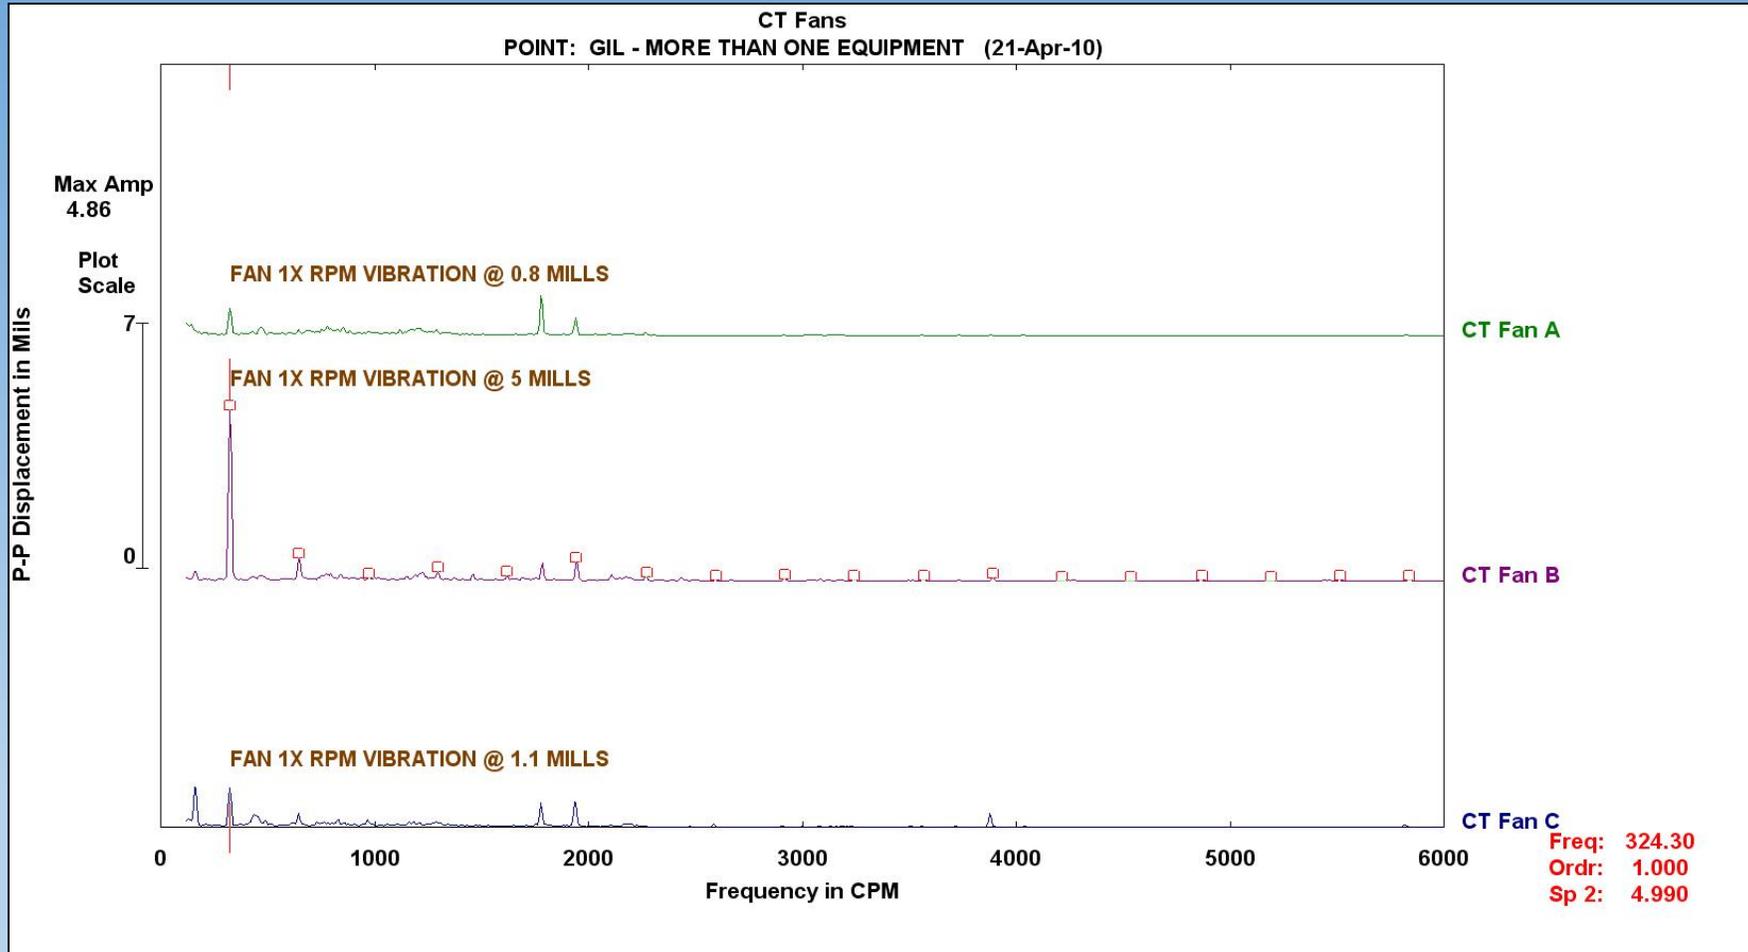
# CT GEARBOX SPECTRAL DATA (DISPLACEMENT)

- By converting our spectral units from velocity to displacement, a **minor** fan balance issue at CT fan “B” becomes clear (5 mills-pk-pk).

- Cooling Tower Fan A: On-site inspections as well as the vibration data collected showed no signs of significant problems with this fan at this time. Other than the general comments mentioned above for all fans, no specific recommendations are made at this time.
- Cooling Tower Fan B: This fan suffers from a higher level of unbalance when compared to the others (ie: compare fan A (0.8 mills), fan B (5 mills), and fan C (1.1 mills). Having this fan balanced at your next *convenient* opportunity would reduce its vibration levels and likely extend its life.

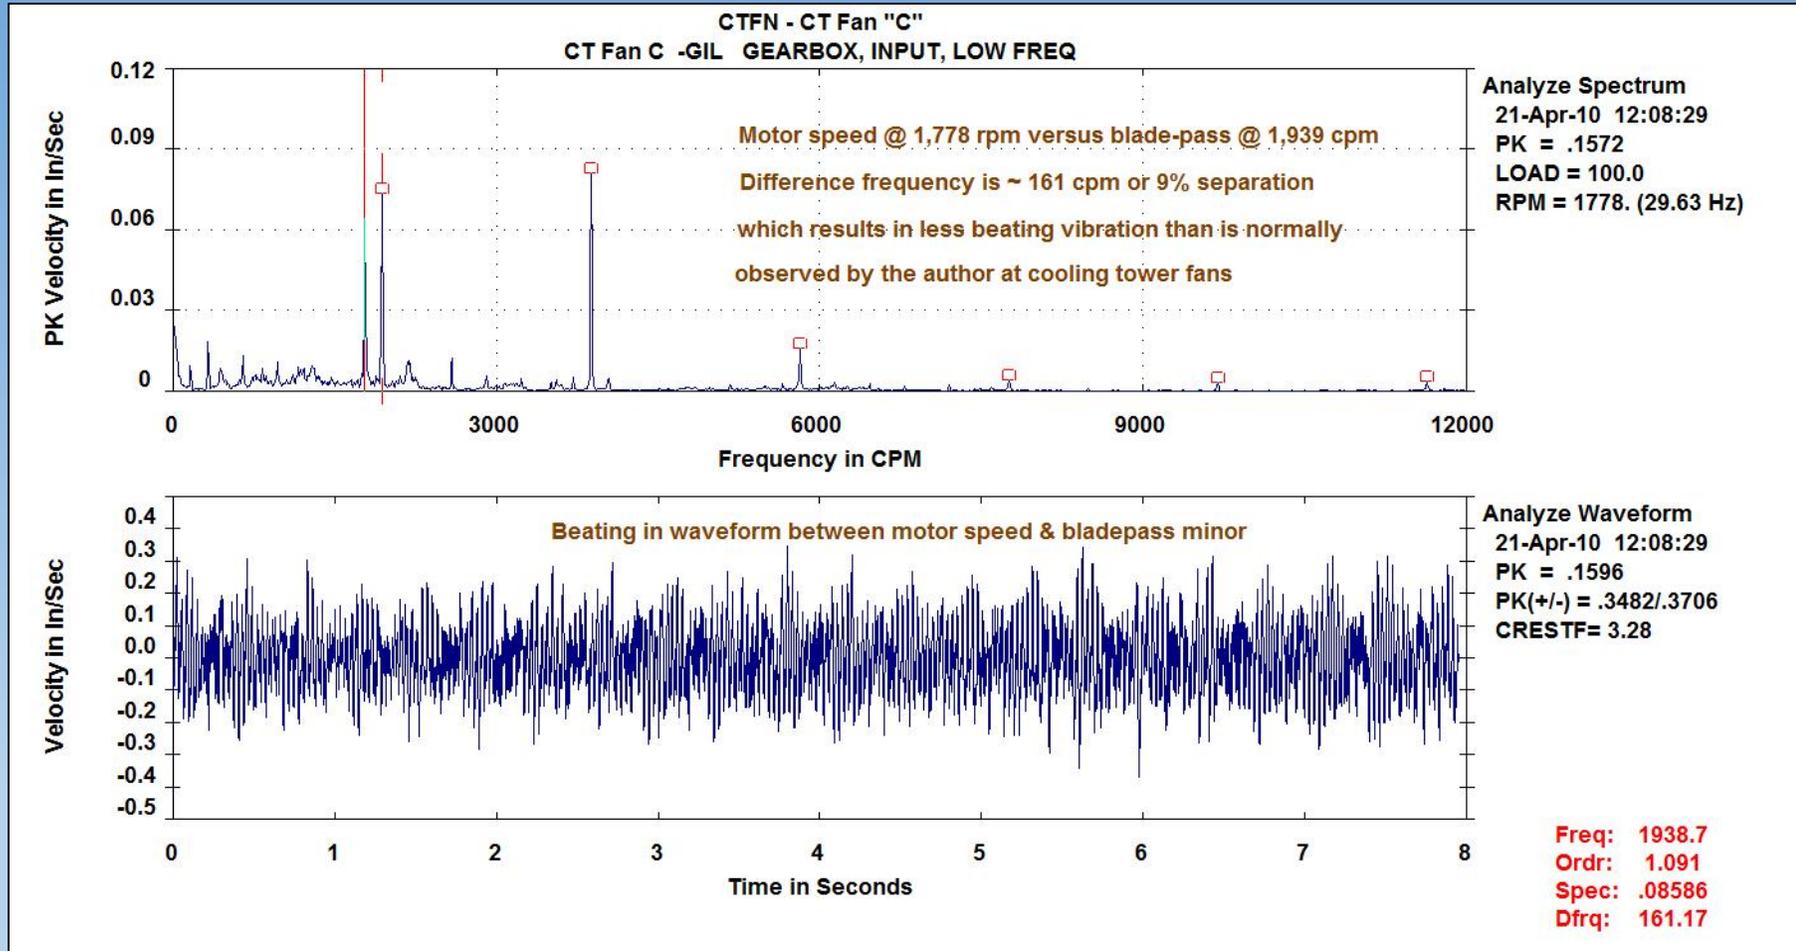
# GEARBOX SPECTRAL & WAVEFORM DATA

- From the waveform vibration data below, note how beating vibration is small at CT fan "C" despite the fact that it had the highest levels of vibration at 1x & 2x blade-pass frequency.
- It is the opinion of the author that CT fans with a 10% or greater separation between motor speed & 1x blade-pass frequency would represent one aspect of good design for these machines.

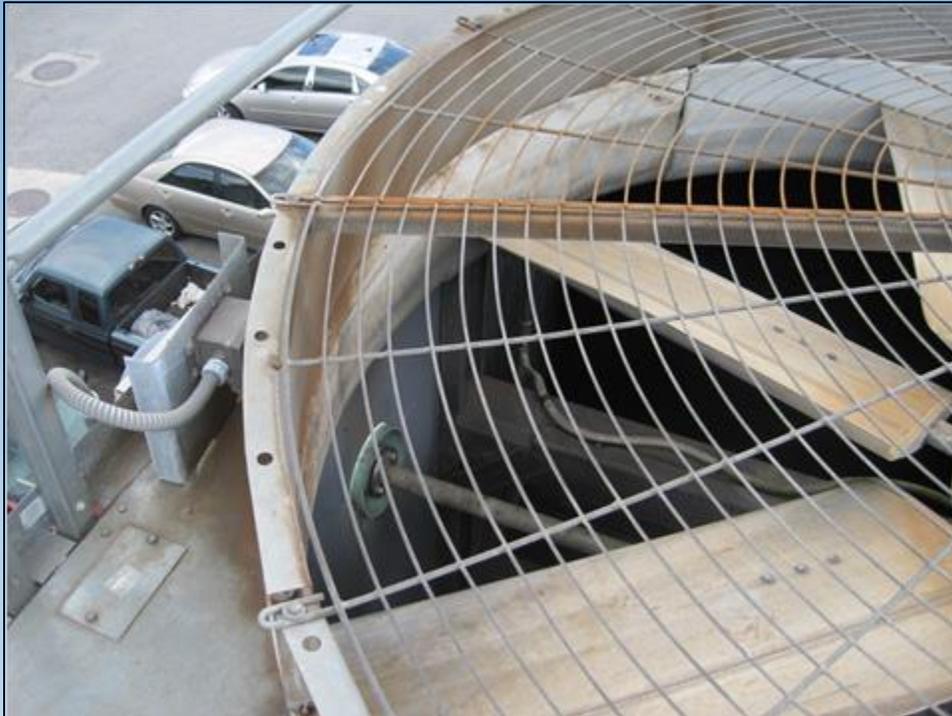
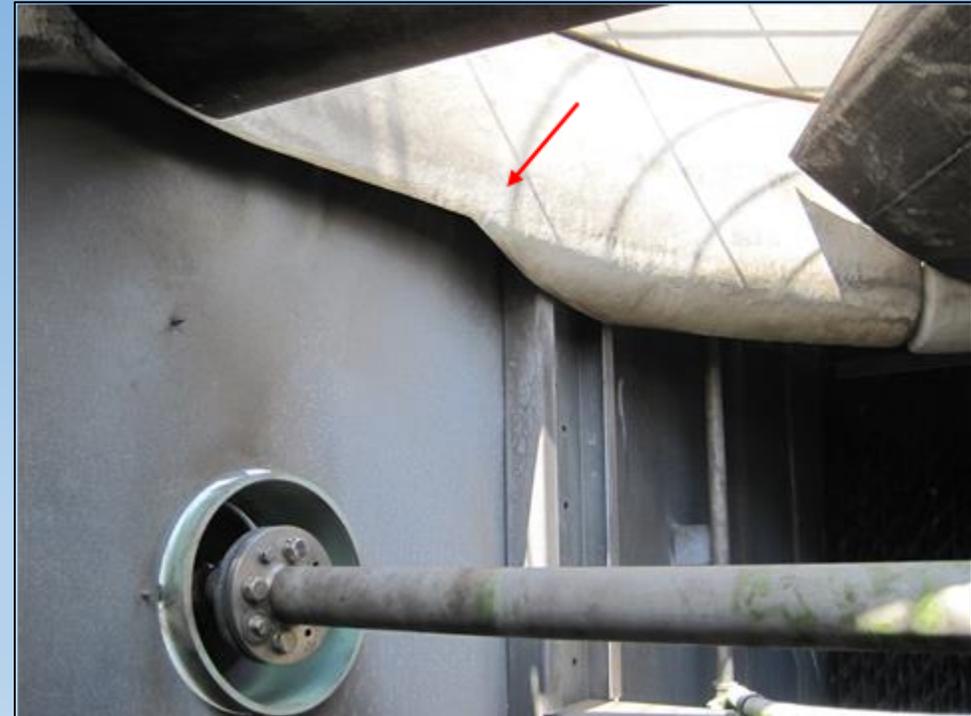
# RUNNING INSPECTION OF CT FAN "C"

- After all vibration data was collected, an **on-site running inspection of CT fan "C"** was performed in an effort to help determine the source of the unusual noise at this fan during operation.
- This running inspection identified a portion of the shroud that was cracked and only visible at certain fan speeds when it apparently resonated and made a terrible noise.

- 3) From this inspection, I discovered a portion of the fiberglass shroud cracked and the steel grating covering the top of the fan loose at spots.
- 4) Excessive vibration, noise and visible movement of the shroud itself in the general area of the crack were observed while fan "C" was running at the higher speeds. Similar problems were simply not found at any other part of this fan's shroud or at the shrouds of any of the other fans.

- 5) *In my view, the high vibration at blade-pass frequency at this fan is in large part due to this damaged shroud. Please have this shroud & grating repaired or replaced as needed, and check all bolts holding the shroud to the structure to ensure they are all tight.*

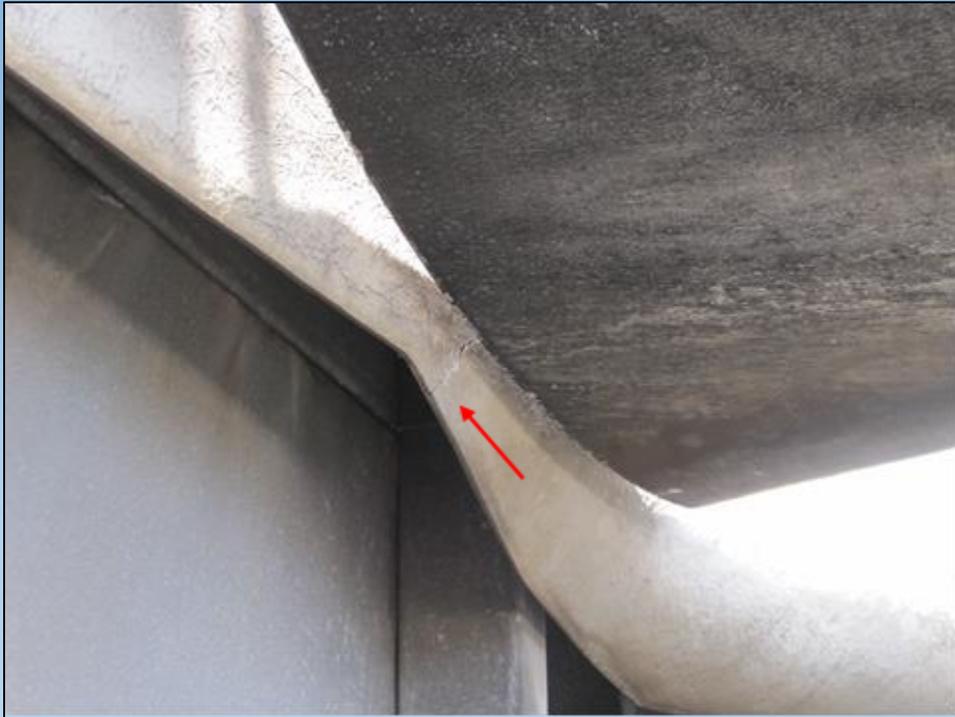
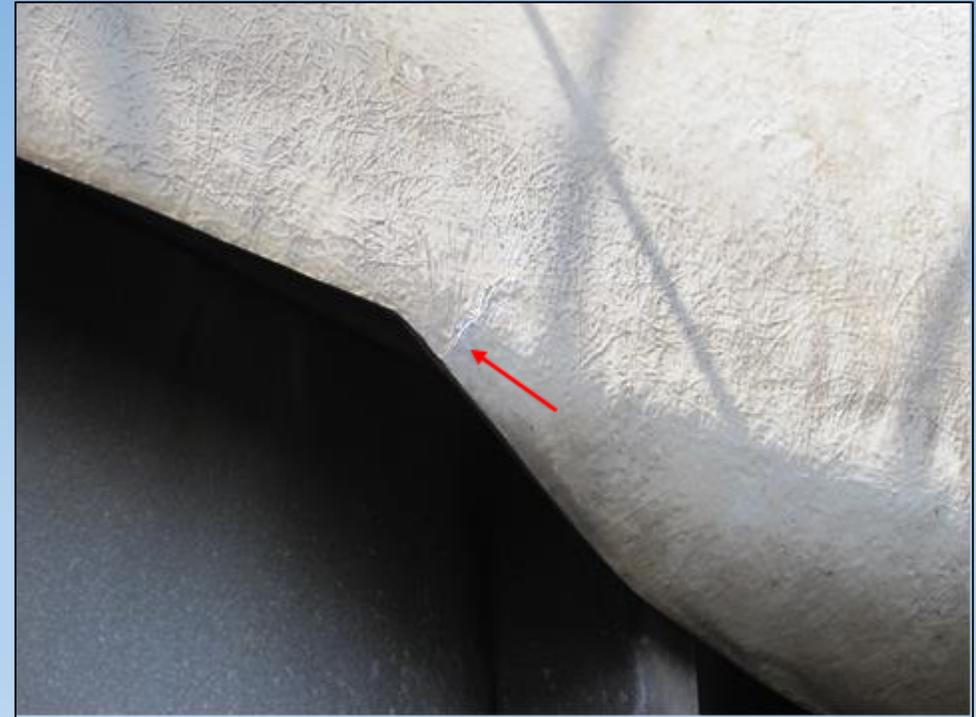
# RUNNING INSPECTION OF CT FAN "C"

- The running inspection found a cracked portion of the fan shroud that was clearly visible from above at the higher fan speeds when it began vibrating excessively coming close to touching the fan blades – this no doubt was the source of the terrible noise heard at this fan.
