CASE HISTORY#3

COOLING TOWER GEARBOX BEARING FAULT

Barry T. Cease
Cease Industrial Consulting
ceasevibration@icloud.com
(843) 200-9705

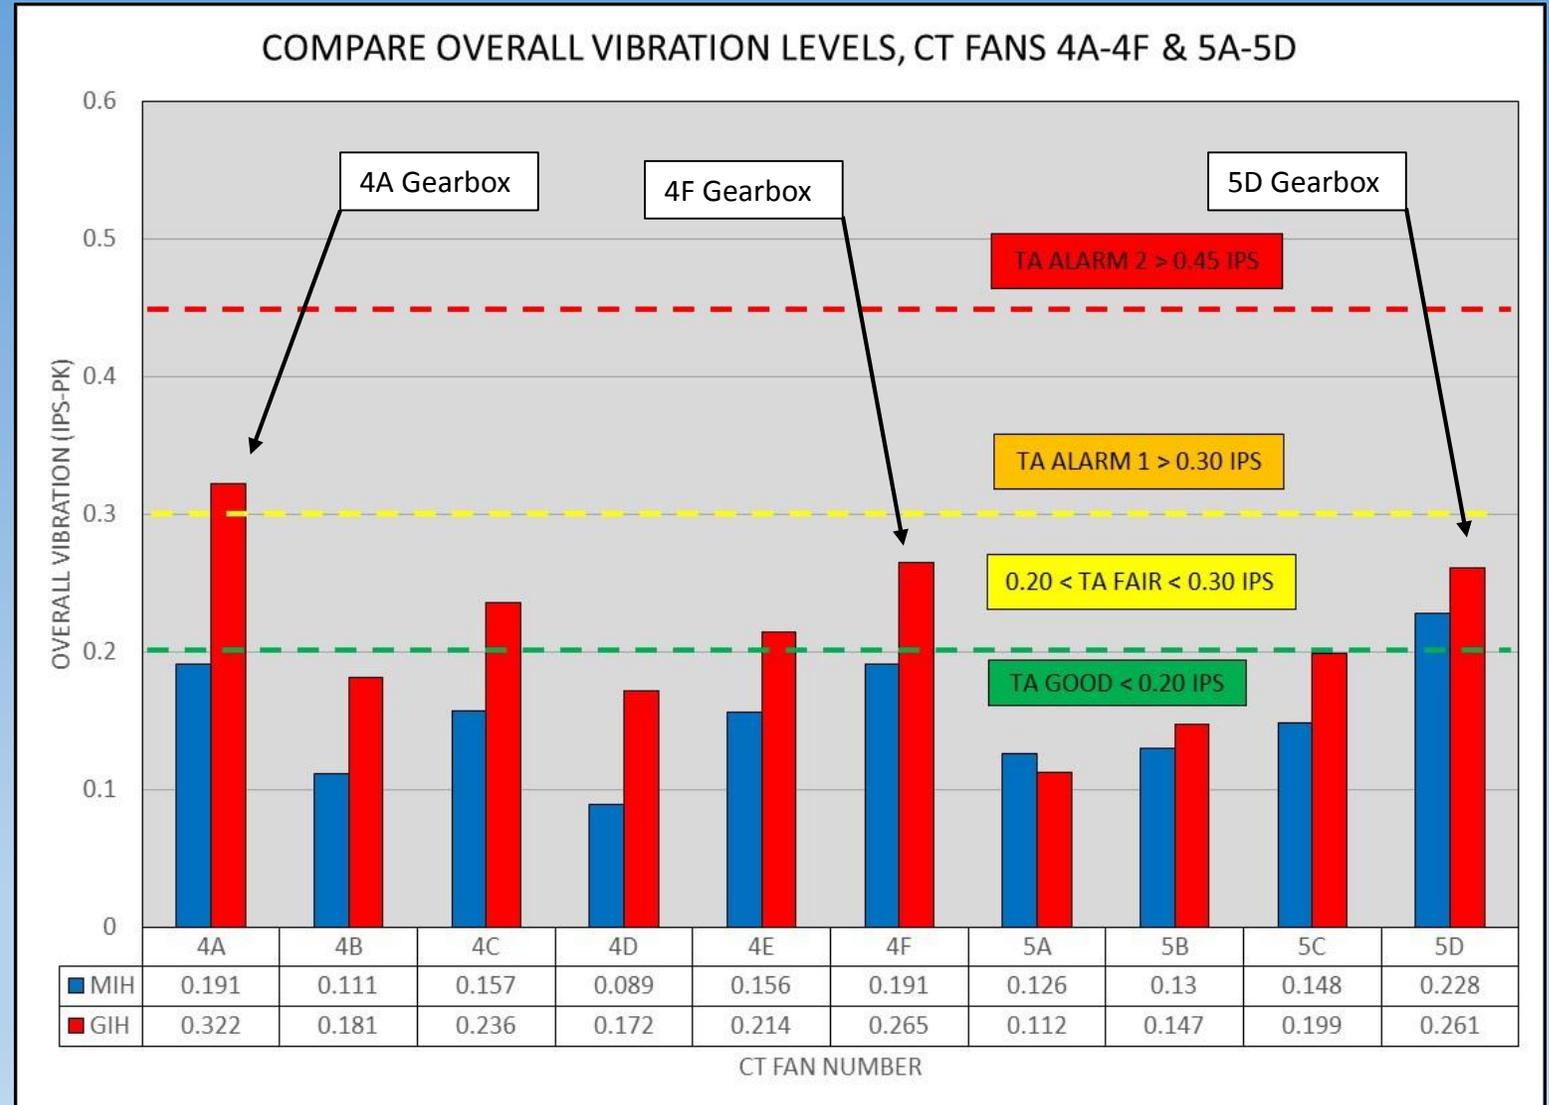
COMPARE OVERALL VIBRATION LEVELS – ALL CT FANS

- The plot at right shows the overall vibration levels measured at the motor & gearbox of each CT Fan (4A-4F & 5A-5D).
- Similar conditions of speed & load were present for all fans (80% full speed).
- Note how in general, levels are higher at the gearboxes versus the motors.
- Note also how gearbox levels at 4A, 4F & 5D approach or exceed the TA alarm 1 levels for close-coupled CT fans.

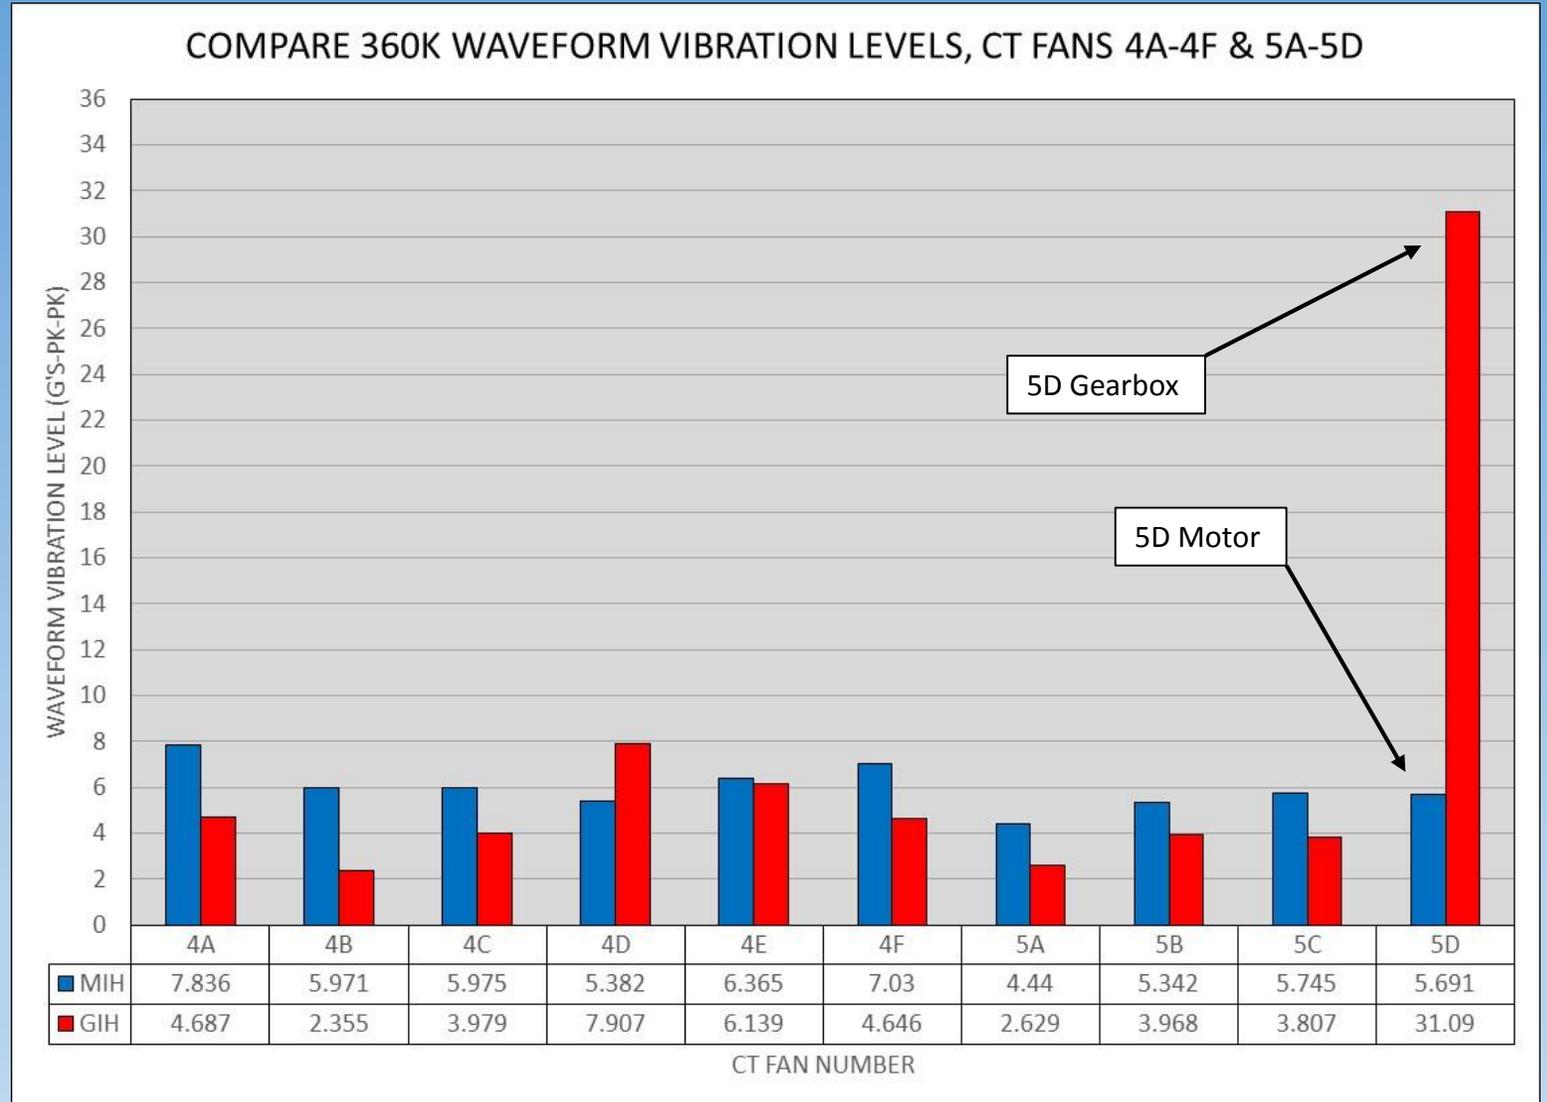
COMPARE 360K WAVEFORM VIBRATION LEVELS – ALL CT FANS

- The plot at right shows the 360K waveform vibration levels measured in units of acceleration at the motor & gearbox of each CT Fan (4A-4F & 5A-5D).
- This vibration parameter emphasizes the high frequency energy present at each point much more than the overall levels expressed earlier.
- Similar conditions of speed & load were present for all fans (80% full speed).
- Note how the levels at 5D gearbox clearly stand out in comparison to all others.
- Note also how corresponding 5D motor levels are in line with the other motors.

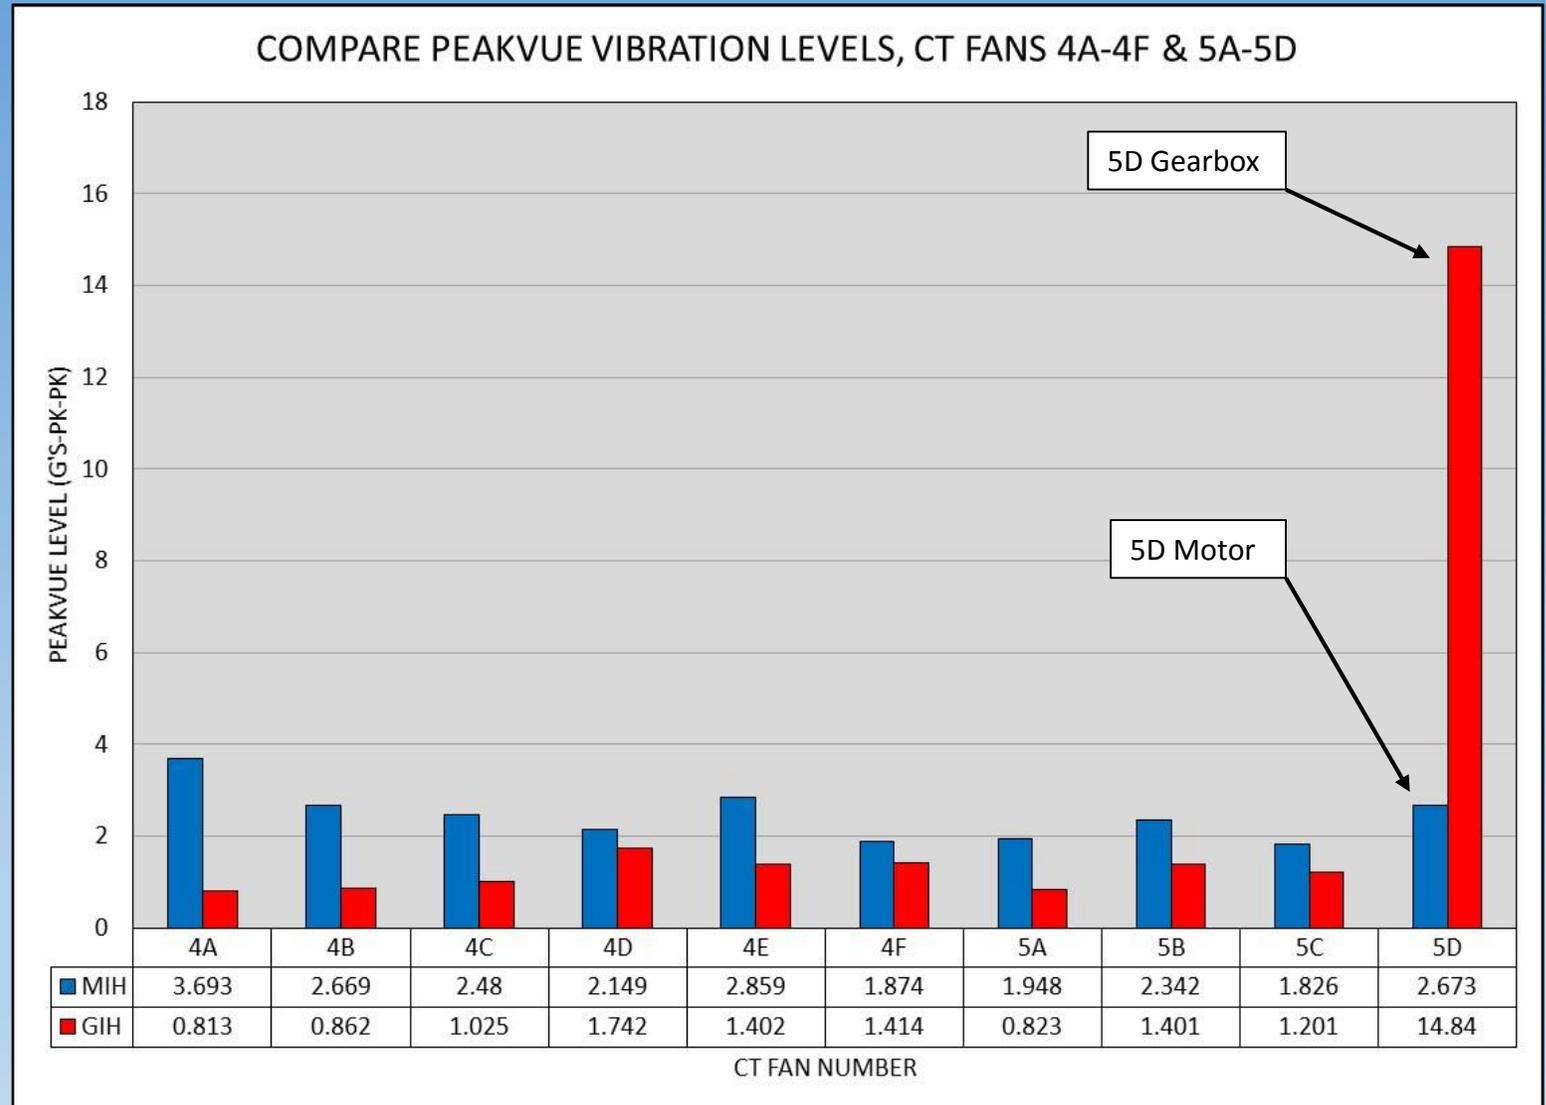
COMPARE PEAKVUE WAVEFORM VIBRATION LEVELS – ALL CT FANS

- The plot at right shows the Peakvue waveform vibration levels measured at the motor & gearbox of each CT Fan (4A-4F & 5A-5D).
- This vibration parameter also emphasizes the high frequency energy present at each measurement point much more than the overall levels expressed earlier.
- Similar conditions of speed & load were present for all fans (80% full speed).
- Note how again the levels at 5D gearbox clearly stand out in comparison to all others.
- Note also how again corresponding 5D motor levels are in line with the other motors.

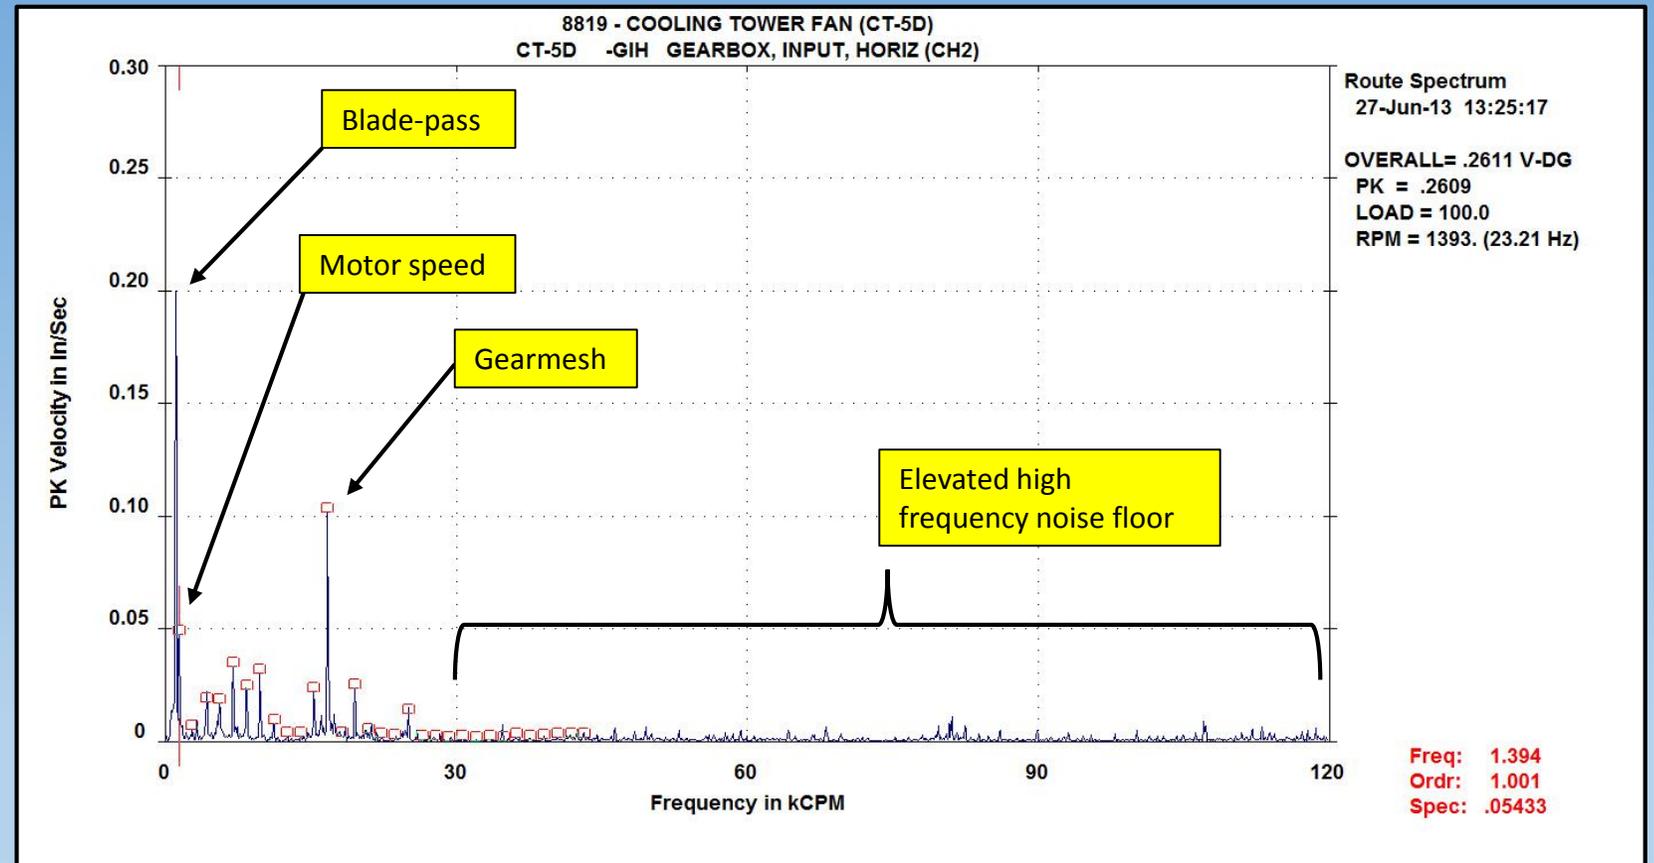
5D GEARBOX VIBRATION SPECTRAL DATA

- The plot at right shows the vibration spectral data measured at 5D gearbox at 80% full speed.
- Note how this plot in velocity units shows dominant vibration occurring at:
 - 1) Fan blade-pass
 - 2) Motor speed
 - 3) Gearmesh
- A higher than expected noise floor is also seen at higher frequencies (> 30kcpm).

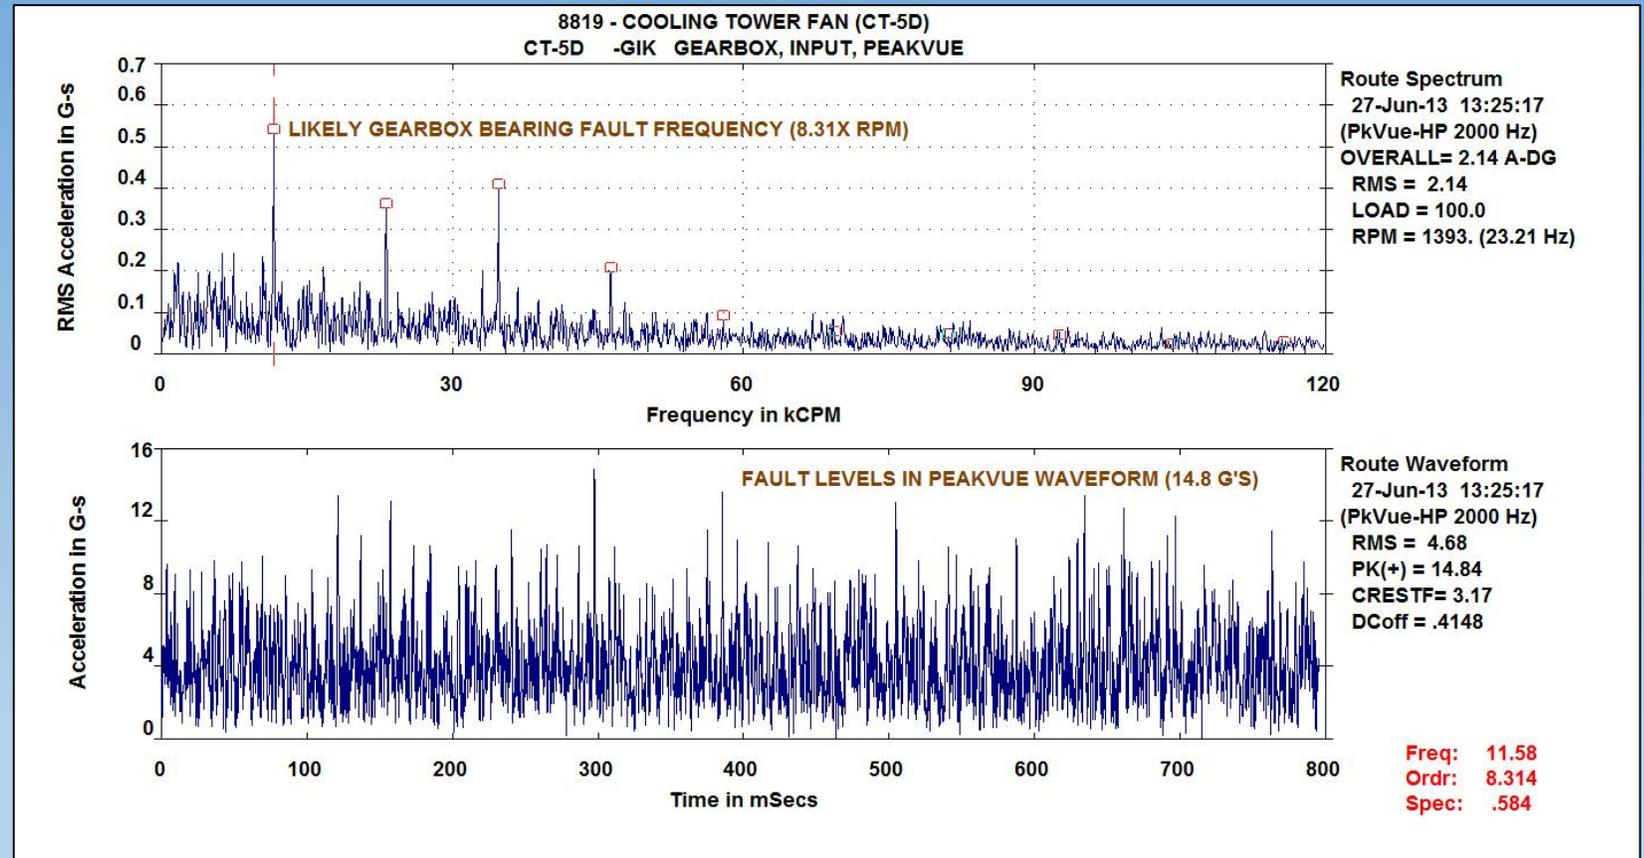
5D GEARBOX PEAKVUE SPECTRAL DATA

- The plot at right shows the Peakvue spectral & waveform data measured at 5D gearbox at 80% full speed.
- Note how unlike the earlier plot in velocity, this plot is in units of acceleration and shows dominant vibration occurring at 8.31x rpm and a raised noise floor.
- Waveform levels at bottom are also very high at 14.8 g's-pk-pk.
- This vibration at 8.31x input rpm with multiples is non-synchronous and a likely gearbox bearing defect frequency.

- 6) The recommendation was made to change the gearbox when possible due to suspected bearing faults there. Prior to the gearbox change, an inspection of the gearbox oil level found very little oil present. Close inspection of the oil fill line (hose) going to the gearbox from the outside found no leaks present. Close inspection of the input seal and all around the gearbox found no obvious oil leaks.

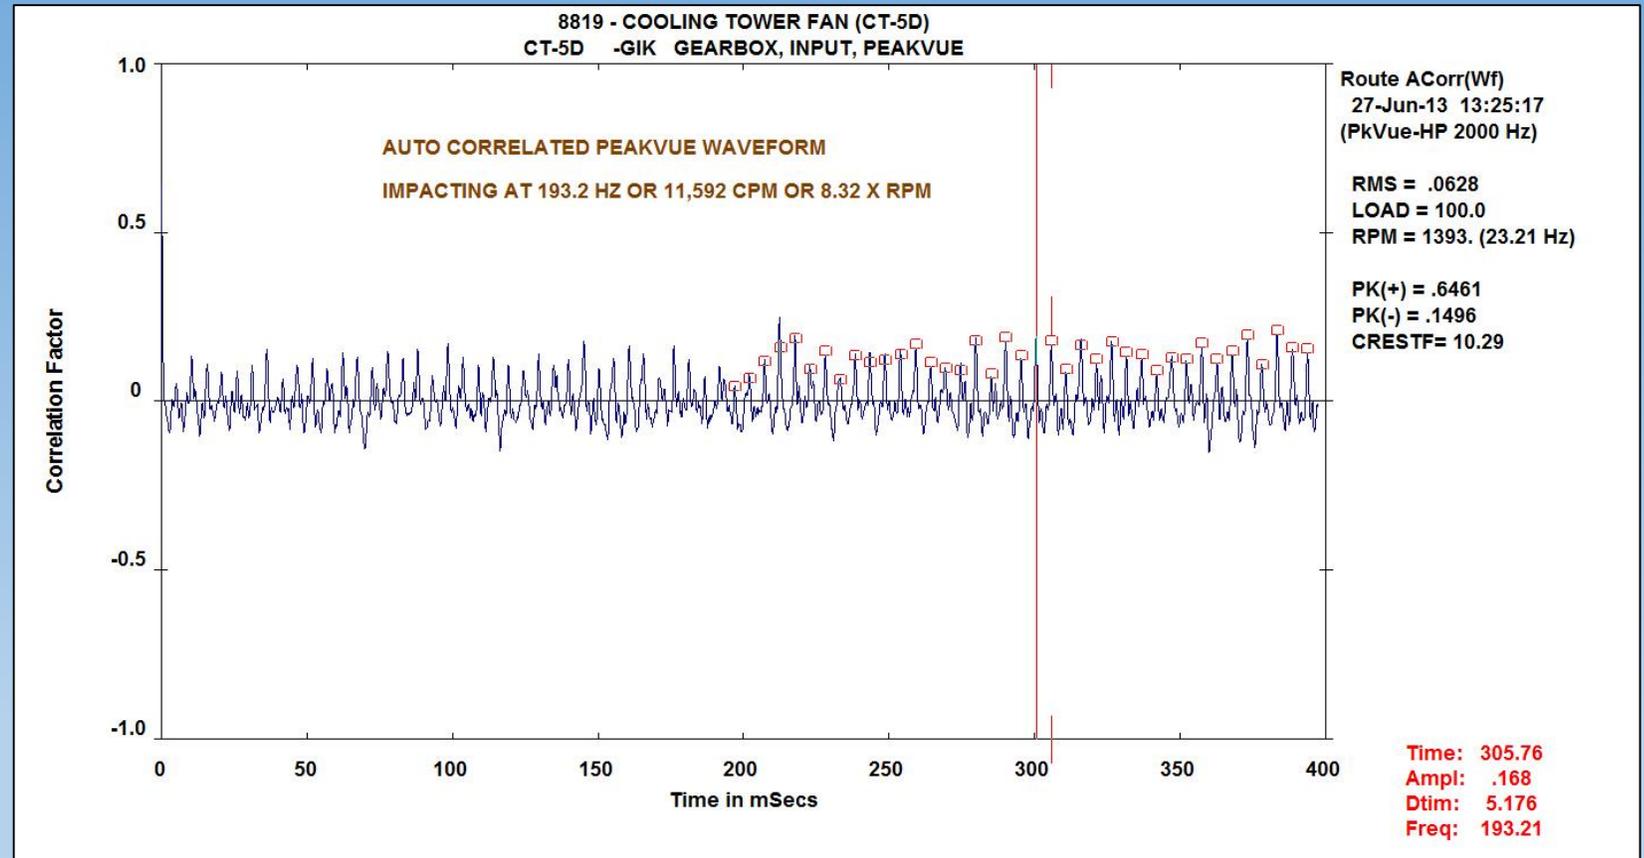
5D GEARBOX PEAKVUE AUTO-CORRELATED WAVEFORM DATA

- The plot at right shows the auto-correlated Peakvue waveform data measured at 5D gearbox at 80% full speed.
- The auto-correlation process attempts to “pull out” or amplify the repeating or periodic portions of the signal and diminish the non-periodic, transient or random aspects.
- Note how the dominant, periodic or repeating part of this signal is impacting at ~ 193.2 Hz or 11,592 cpm or 8.32x input speed.

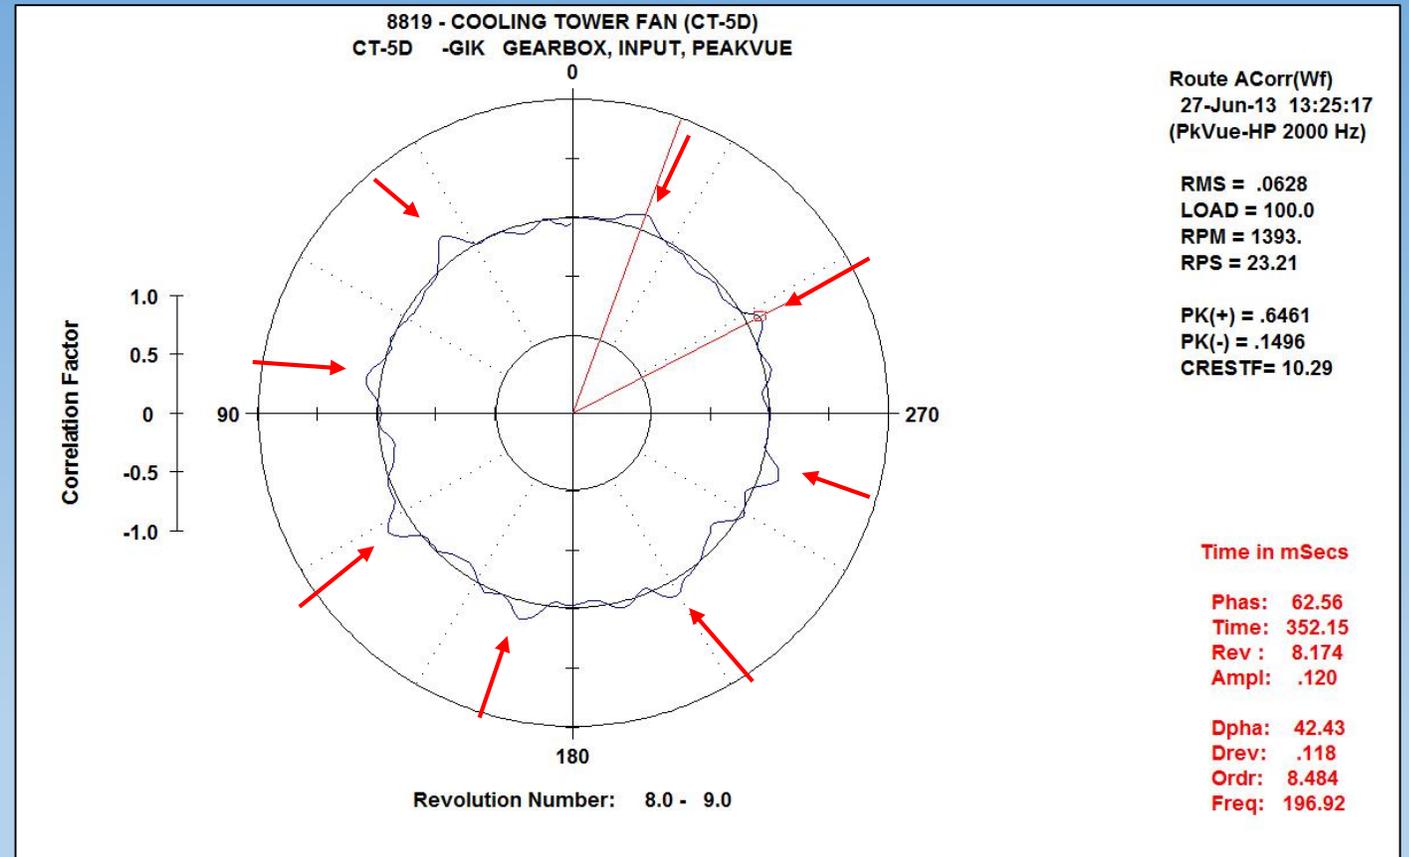
5D GEARBOX PEAKVUE AUTO-CORRELATED WAVEFORM DATA – CIRCULAR PLOT

- The plot at right shows a circular plot of the auto-correlated Peakvue waveform data shown earlier.
- This unique plotting method departs from normal, linear plotting and instead plots the waveform in a circle with one shaft revolution of time = one revolution on the plot.
- **Note how a little more than 8 impacts occur over one revolution of the input shaft** – this is due to the suspected gearbox bearing fault.
