## The Boundary Carbondale, CO

Report #: 22010-1  
Beginning: January 1, 2025  
Expires: December 31, 2025

# RESERVE STUDY

## Update "With-Site-Visit"

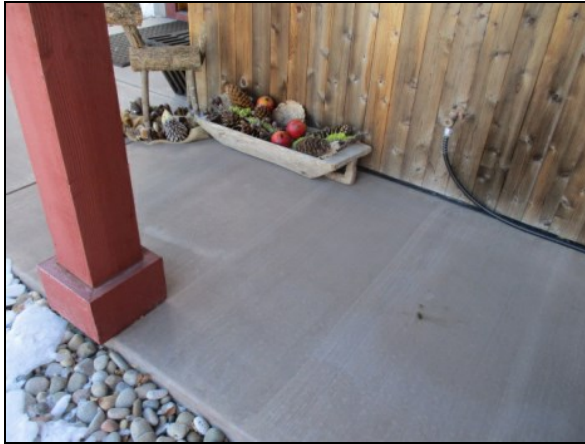
**Comp #: 21090 Concrete Patio/Walkways Repair - 5%**

Useful Life:  
5 years

Remaining Life:  
0 years

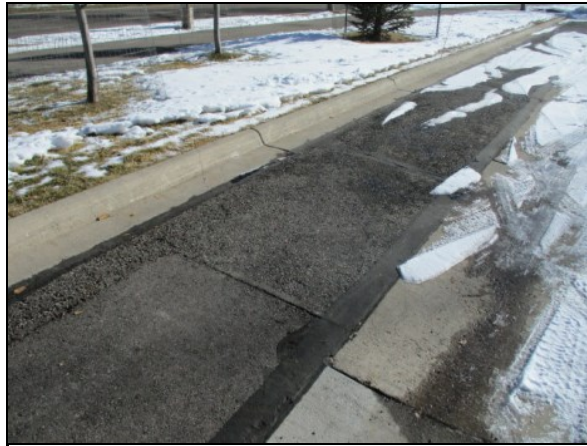
**Comp #: 21190 Asphalt - Seal/Repair****Quantity: ~ 36400 GSF**

Remaining Life:

0 years

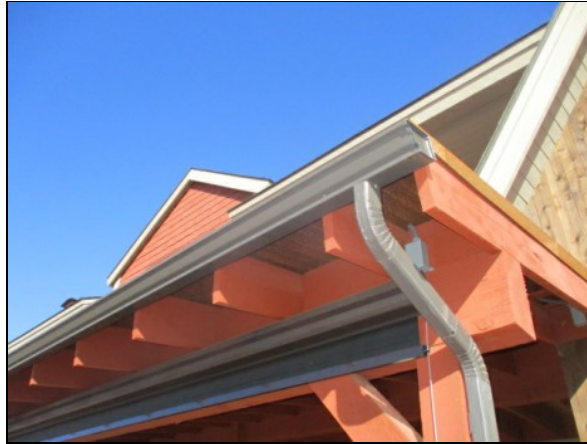
Comments: Includes (88 LF) Buildings 1, 2, (388 LF) Building 3, (208 LF Aluminum) Buildings 4, 5, (168 LF Copper) Buildings 4, 5, (1050 LF) Buildings 6, 7, 8, 9, 10, (93 LF) Building 11. Gutters and downspouts determined to be in fair condition typically exhibit some normal wear and tear but drainage away from the roof and building appears to be adequate. Generally believed to be aging normally. Gutters and downspouts are assumed to be functioning properly unless otherwise noted. As routine maintenance inspect regularly keep gutters and downspouts free of debris. If buildings are located near trees keep trees trimmed back to avoid accumulation of leaves on the roof surface which will accumulate in the gutters and increase maintenance requirements while reducing life expectancy. Repair or replace individual sections as needed as an Operating expense. We generally recommend that the gutters and downspouts be replaced when the roof is being resurfaced/replaced. National Roofing Contractor client (NRCA) roofing standard includes installing eave flashings at the gutters. We suggest to plan for total replacement of gutter and downspouts at the same intervals as roof replacement for cost efficiency. Unless otherwise noted costs shown here assume replacement with similar type as are currently in place.

Useful Life:  
30 yearsRemaining Life:  
6 years
