# MARINO STRUCTURAL SOLUTIONS

NICHOLAS MARINO, P.E.

RE: **Building Evaluation**  
Vineland Historical Society  
108 S. 7<sup>th</sup> Street  
Vineland, Cumberland Co., NJ  
**MSS #18167**

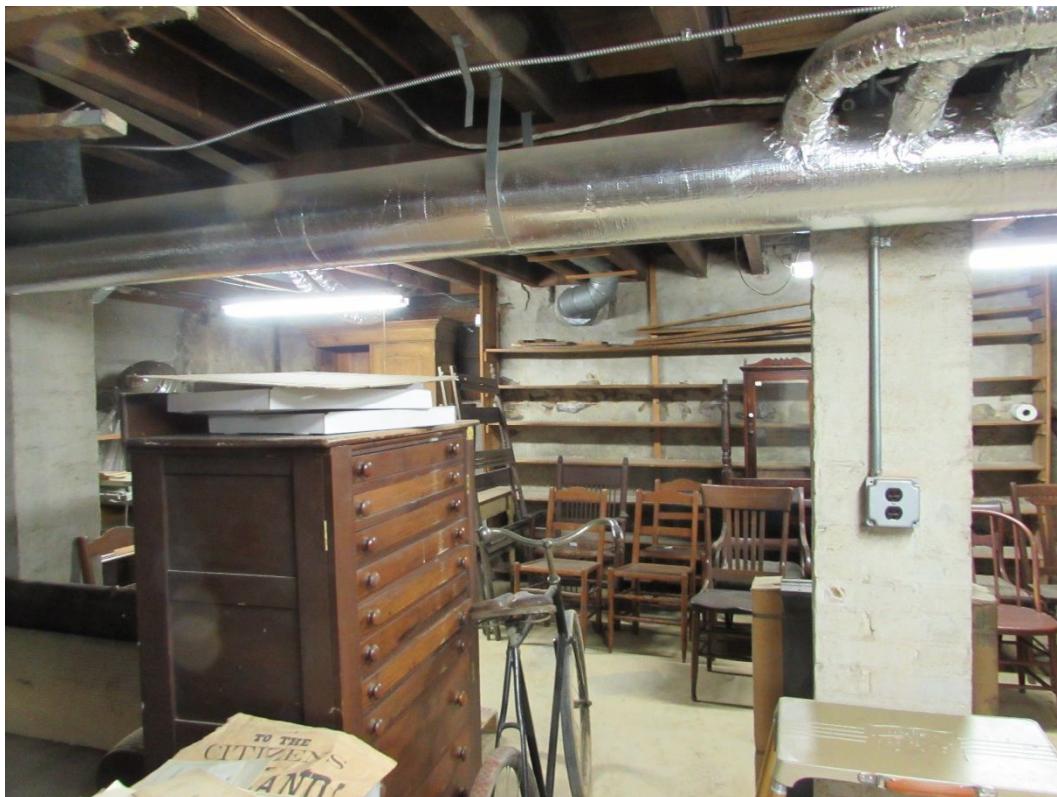
**Photo #1** – Basement conditions, front left building corner in background

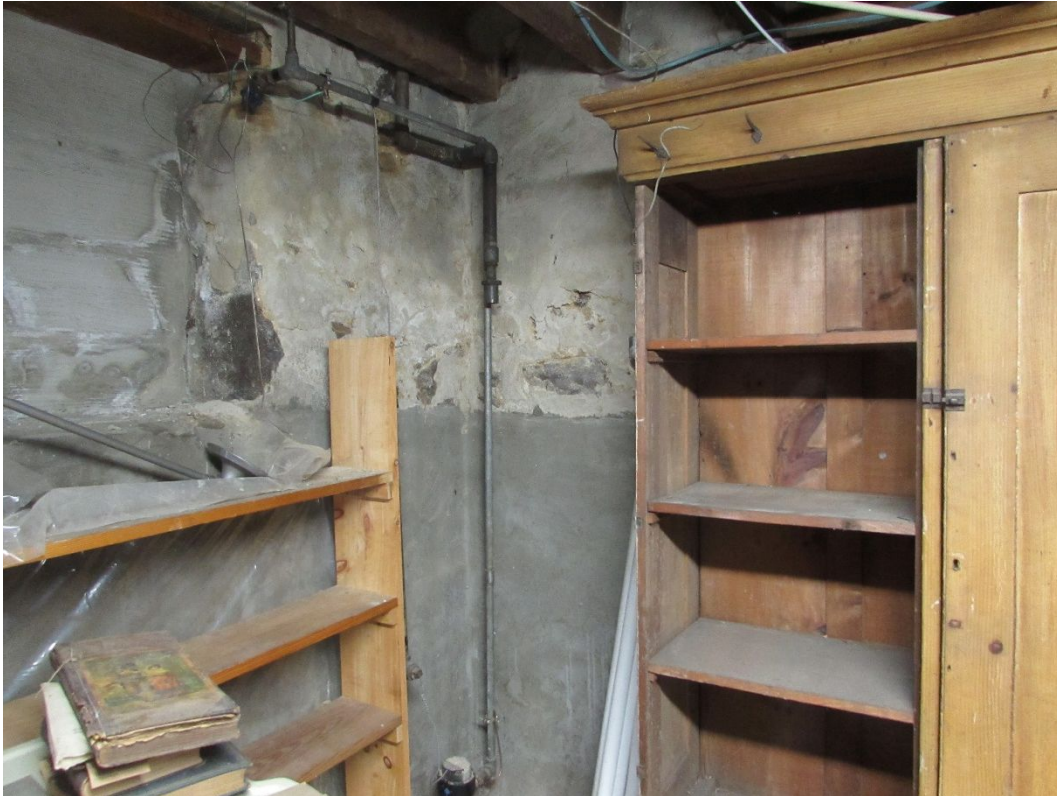
**Photo #2** – Front left building corner, newly applied stucco finish on lower section of wall

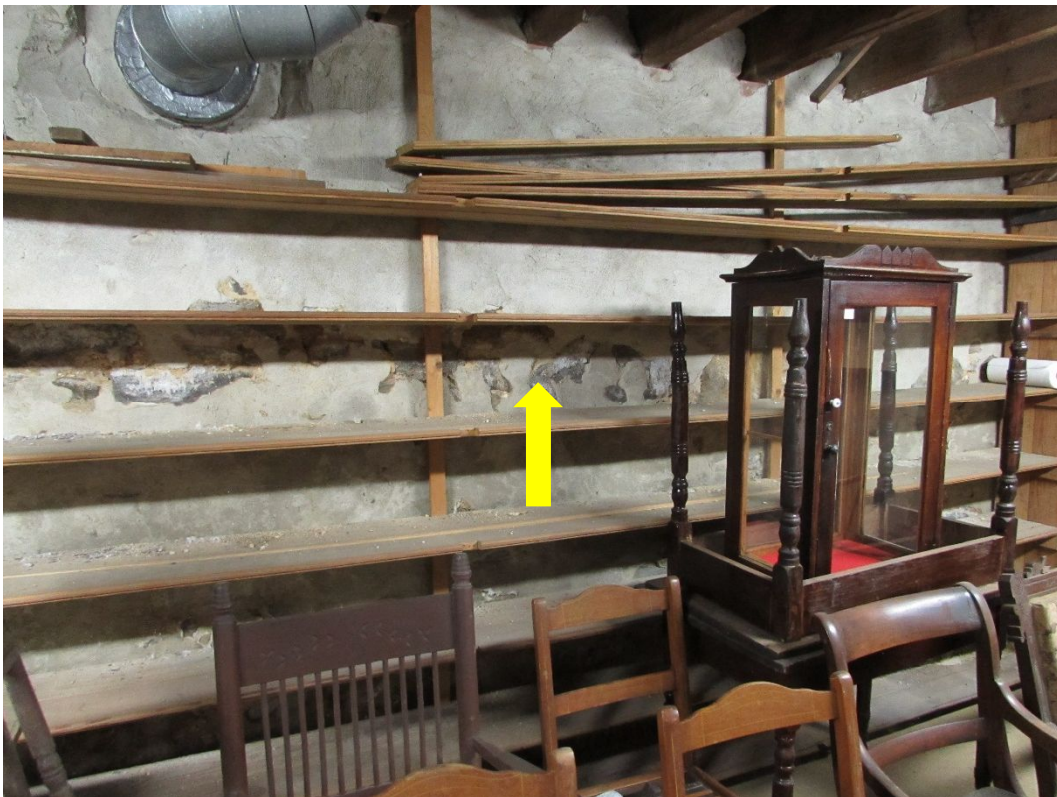
The stucco surface was found to be cracked and loose at several locations exposing the underlying stone foundation wall. Where exposed, the mortar of the stone foundation wall was often deteriorated to a depth of approximately 2” – 3”. It appeared that a section of the stucco finish had been recently removed and replaced at the front left corner of the basement.

**Photo #3-** Loose spalled stucco finish on left foundation wall

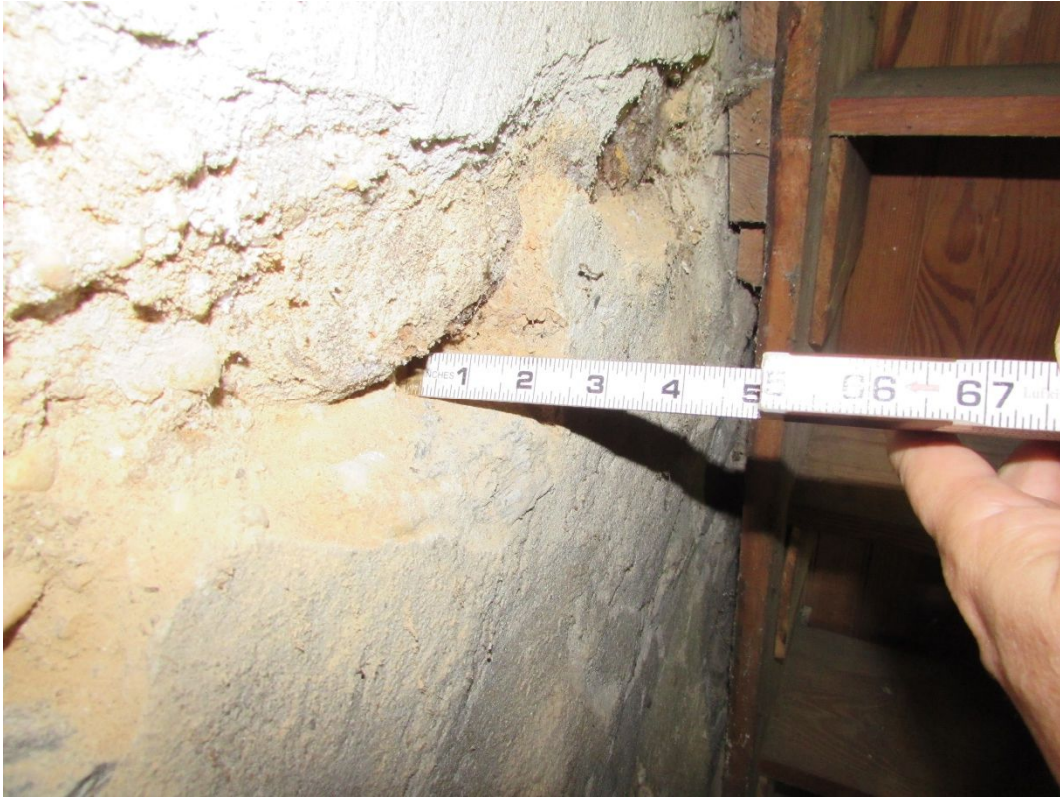
**Photo #4** – Loose deteriorated mortar

1. The basement foundation walls did not display any evidence of movement. However, the mortar joints of the stone foundation walls are worn to varying degrees due to water infiltration over the life of the structure; the most advanced state of deterioration occurs along the left sidewall. Removal of loose debris and rebuilding of the mortar joints is required to ensure the long term stability of the foundation walls. Application of a wire lath in the pointing/parging process is recommended to reinforce and solidify (unify) the stone mass. In my opinion, parging and dampproofing of the exterior face of the foundation walls is not feasible; this work would require excavation along the building perimeter to expose the exterior face of the foundation walls.

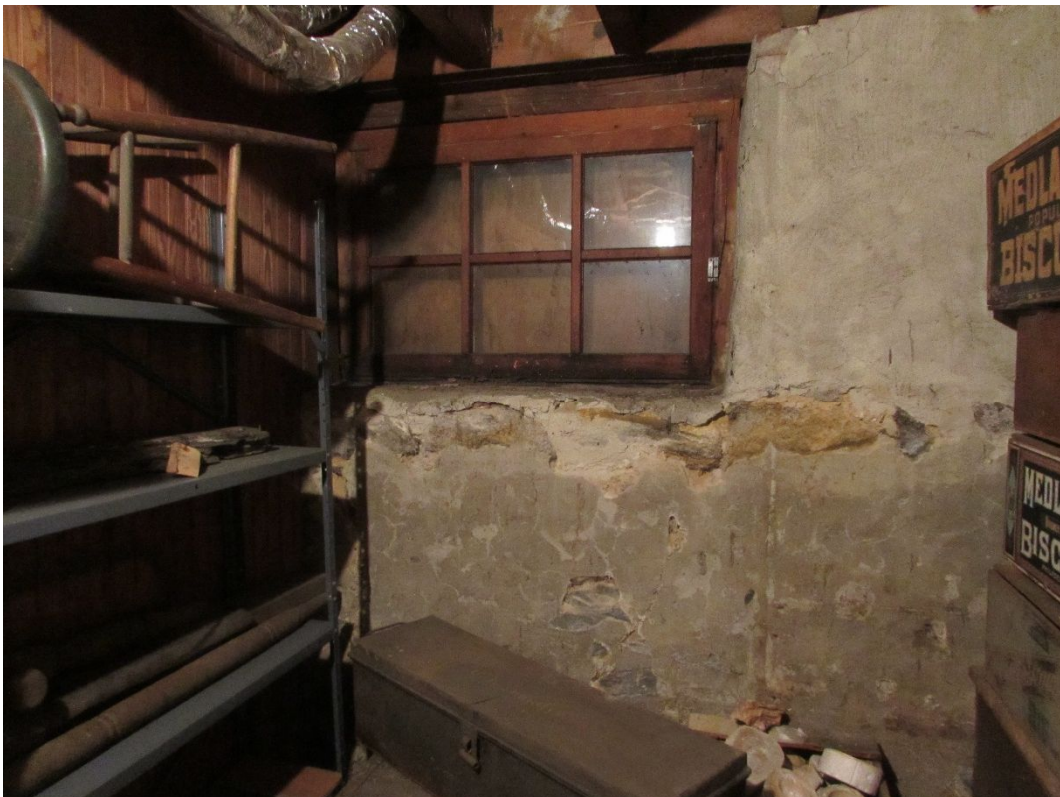
**Photo #5** – Typical foundation condition along left foundation wall

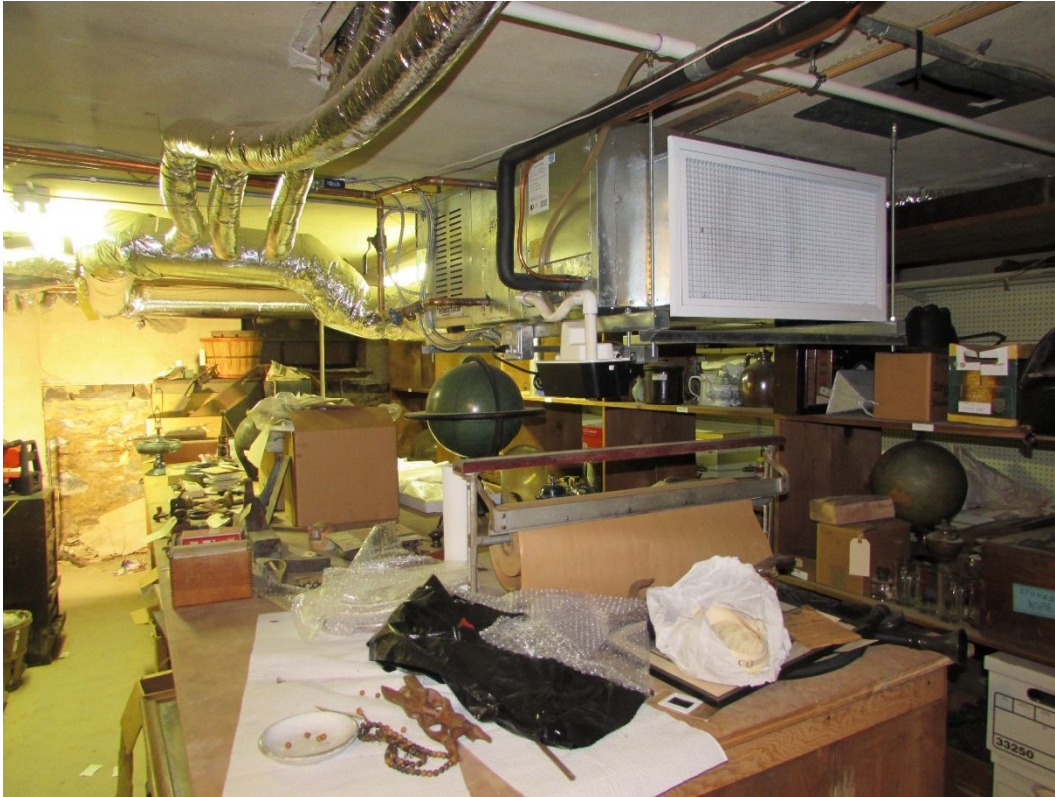
The rear half of the left foundation wall was found to be in poor condition. Although no evidence of bowing or displacement was observed, this section of the foundation walls has experienced excessive widespread deterioration of the mortar joints due to water infiltration. The interior plaster finish along this wall section has completely collapsed.

**Photo #5** – Rear left quadrant of original basement foundation

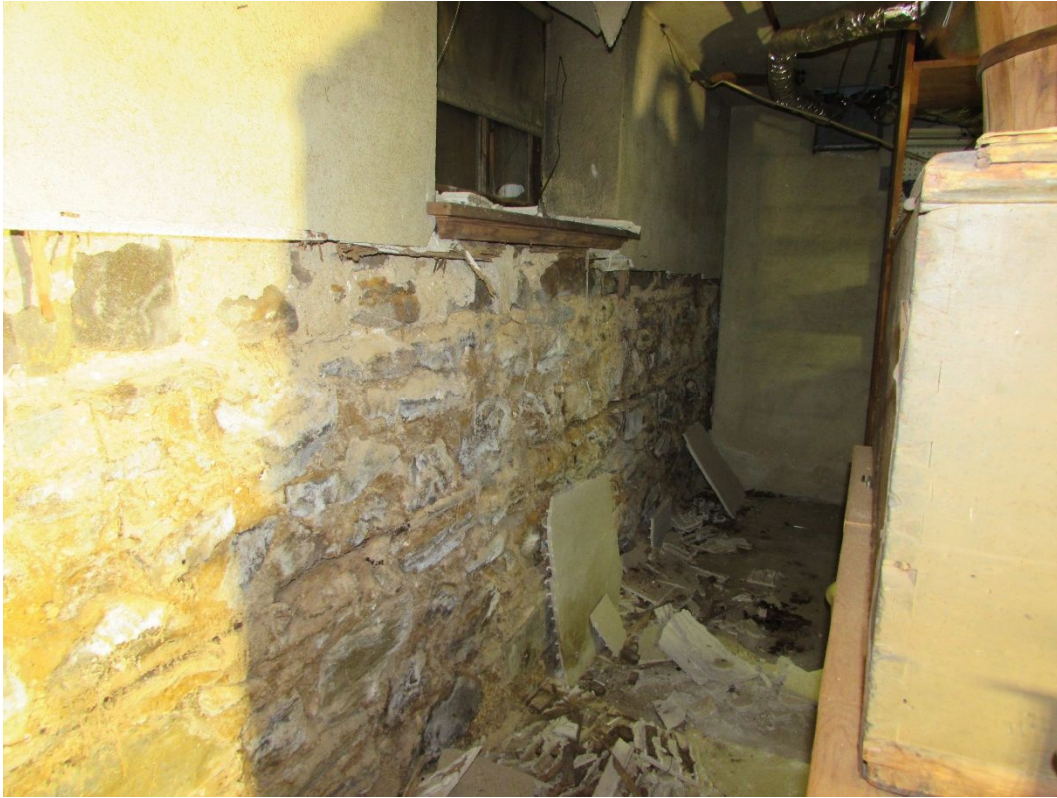
**Photo #6** – Deteriorated rear left foundation wall

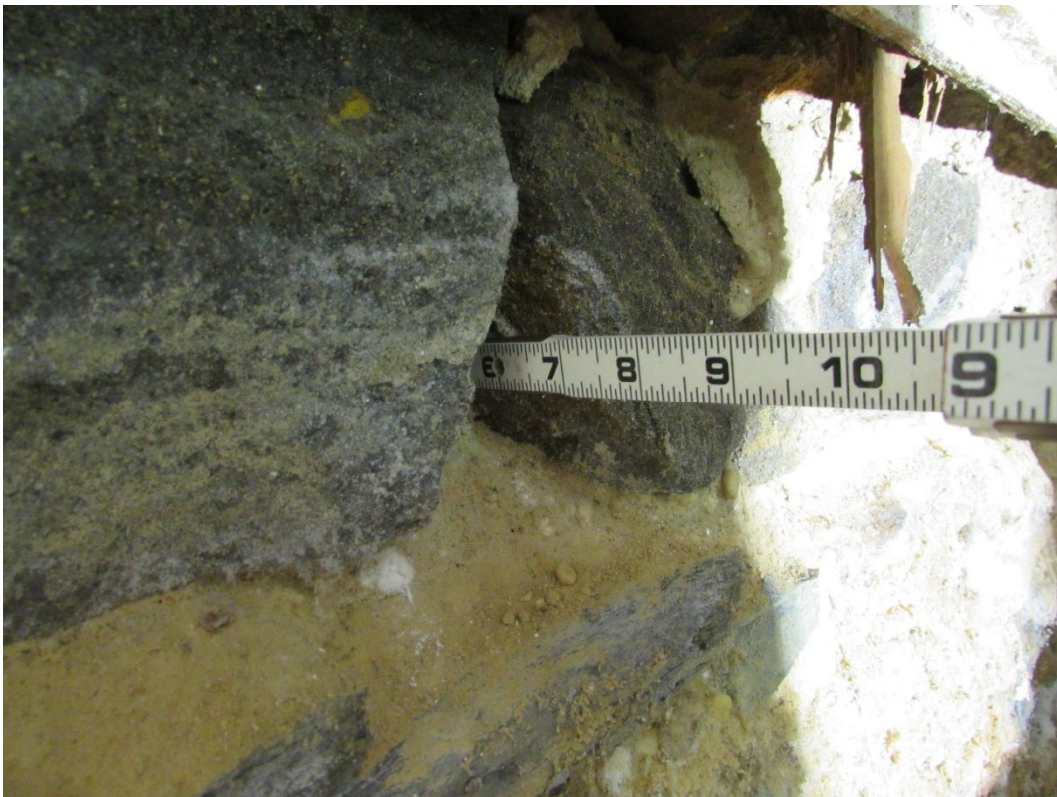
**Photo #7** – Eroded mortar joint in photo #6 above

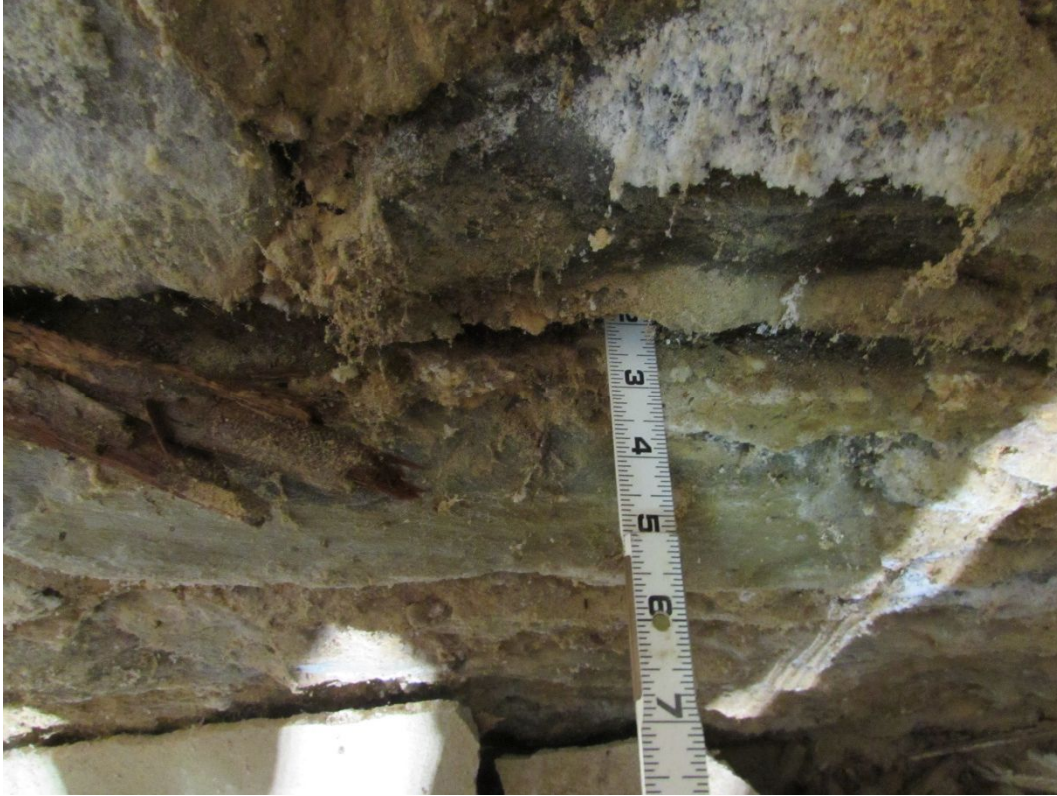
**Photo #8** – Decayed wood nailing joint in foundation wall of photo #6

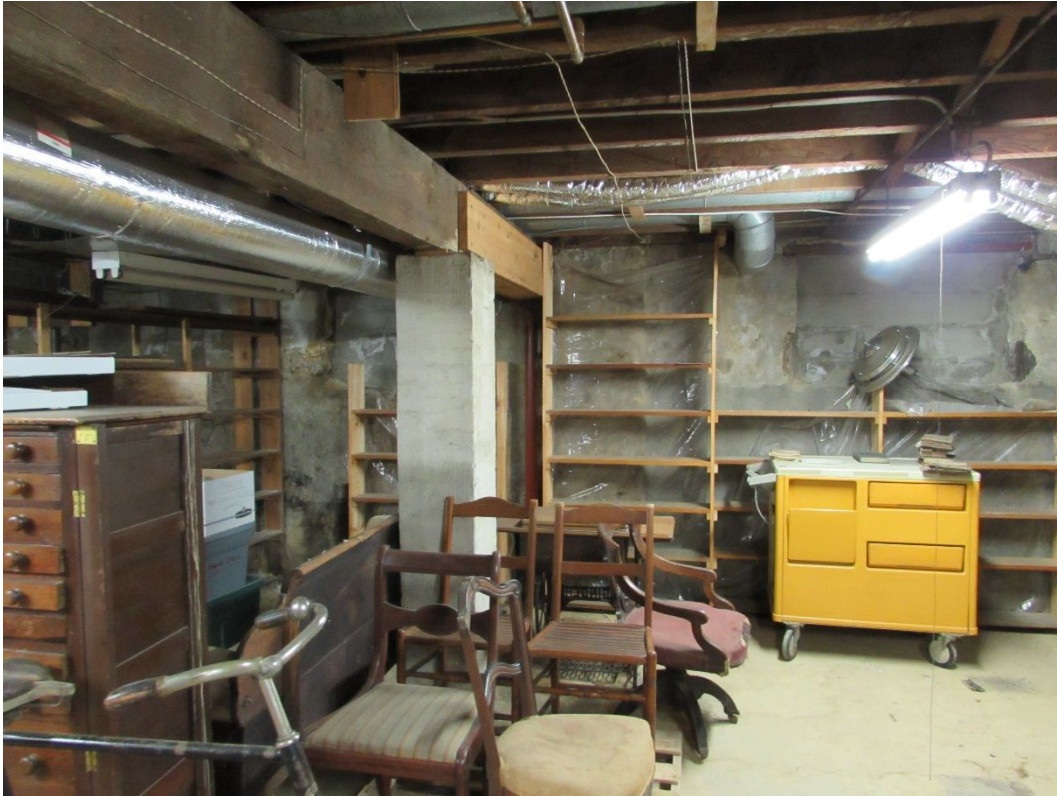
The basement windows were found to have been removed and replaced with masonry infill along the front foundation wall. However, the thickness and height of the masonry infill did not match either the thickness of the exterior brick wall above or the full height of the framed opening. Subsequently, the brick wall above was left either poorly supported or unsupported by a header or lintel.

**Photo #9** – Right end of original front foundation wall

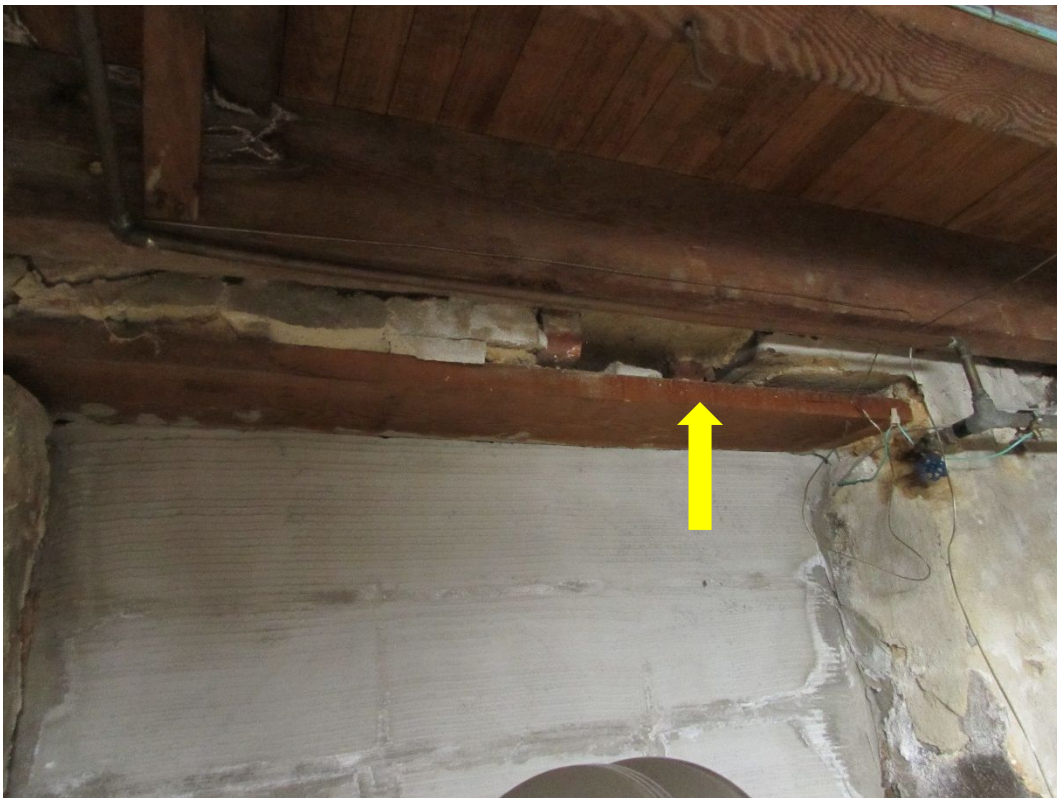
**Photo #10** – Poorly infilled window opening, note wood header with loose brick above

2. Basement windows that were removed were poorly infilled. It is recommended that the remaining wood lintels be removed at these locations and that additional masonry infill be provided to fully infill the area and adequately support the brick above.

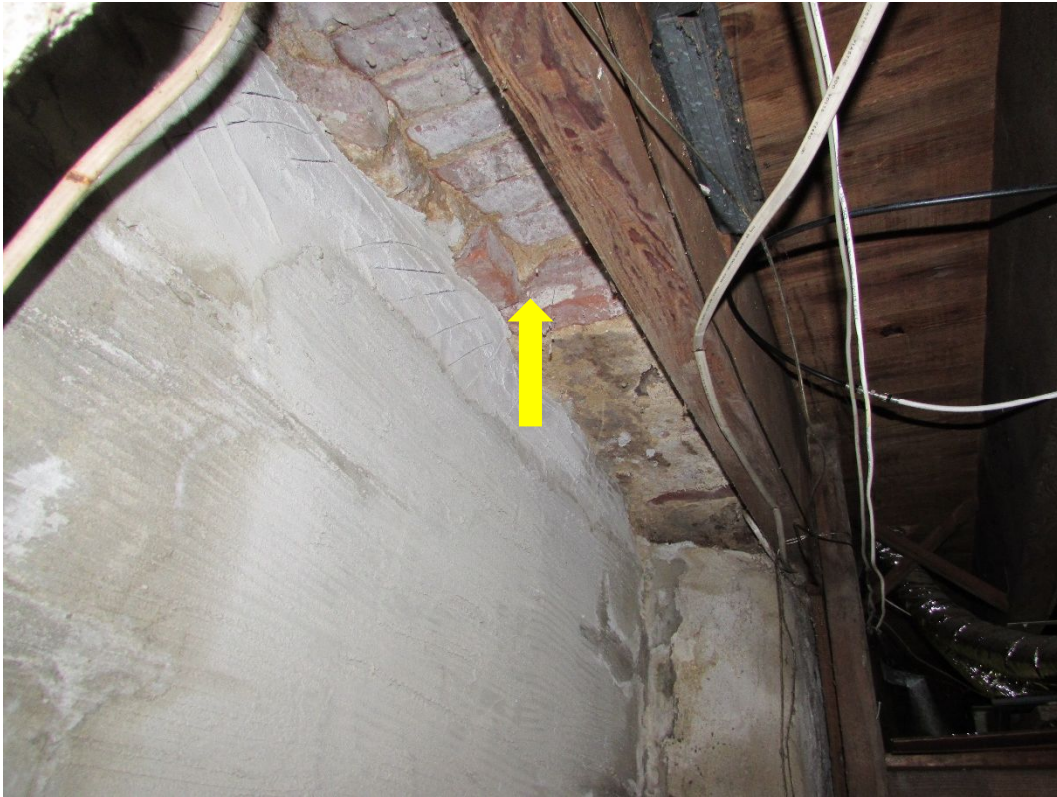
**Photo #11** – Unsupported brickwork at infilled window opening

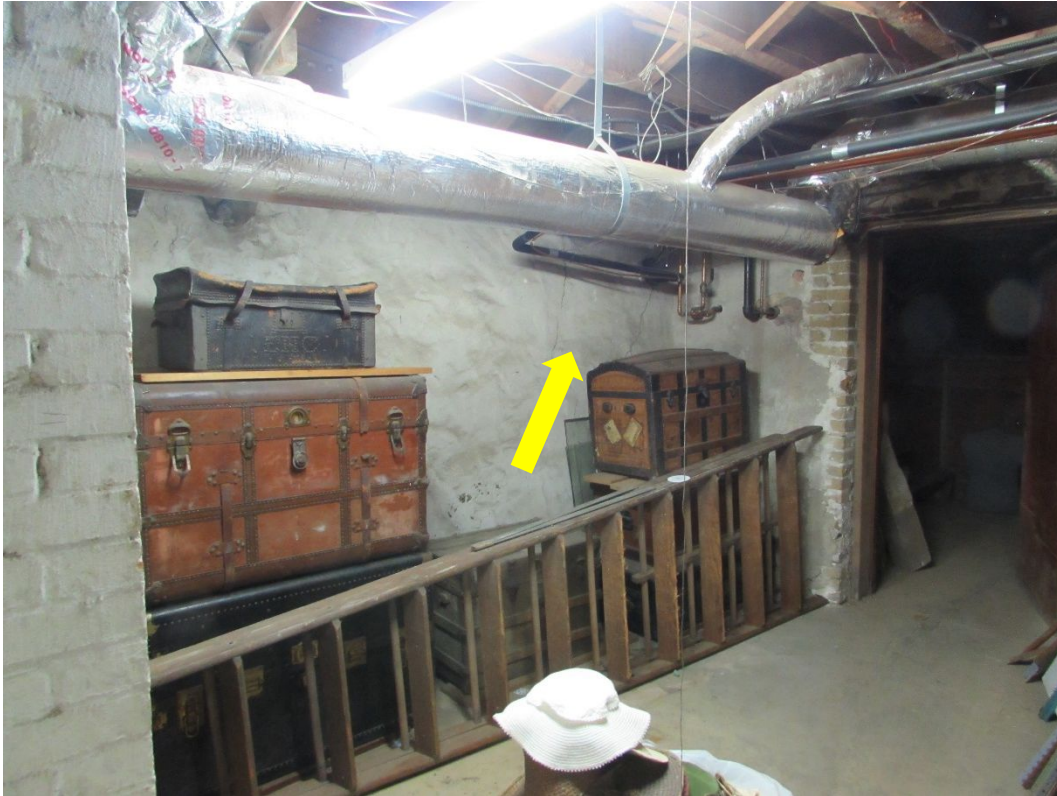
A vertical crack and a diagonal crack were found in the interior foundation wall that is common to the front basement and rear workshop on the right side of the original structure. Random hairline cracks were also noted in the remaining workshop foundation walls. No evidence of bowing or displacement were observed.

**Photo #12** – Interior foundation wall common to workshop, location of cracking noted

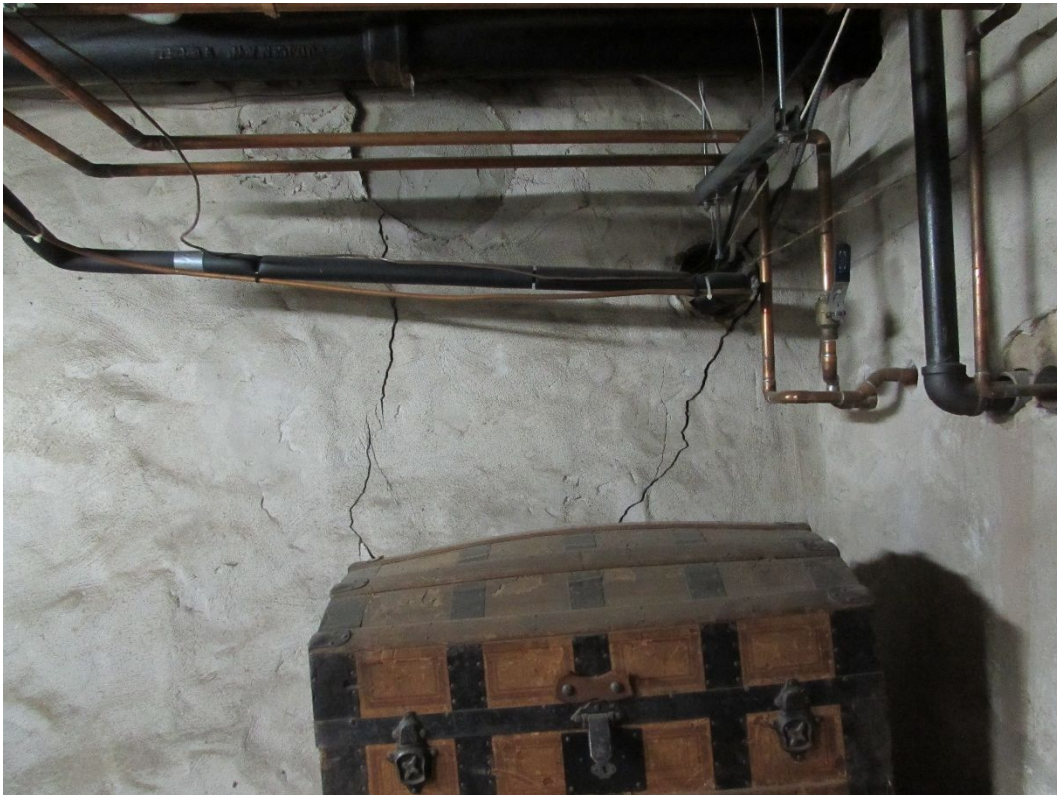
**Photo #13** – Vertical and diagonal cracking noted in photo #12 above

3. Where basement windows remain in place, the decayed wood lintels must be removed and replaced to prevent movement in the brick above.
4. Hairline cracking observed in the cement stucco surfaces of the foundation walls at the workshop are considered negligible and no repairs are required. Two (2) moderate cracks were noted in the interior basement wall common to the workshop. The exact cause of these cracks are not known at this time. The cracks do not extend completely through the wall, appear to have existed for an extended period of time and also appear stable. Cosmetic repairs may be made to these cracks; which can be used as a means of monitoring. If the cosmetic repairs crack in the future, then additional movement has occurred and further investigation may be required.

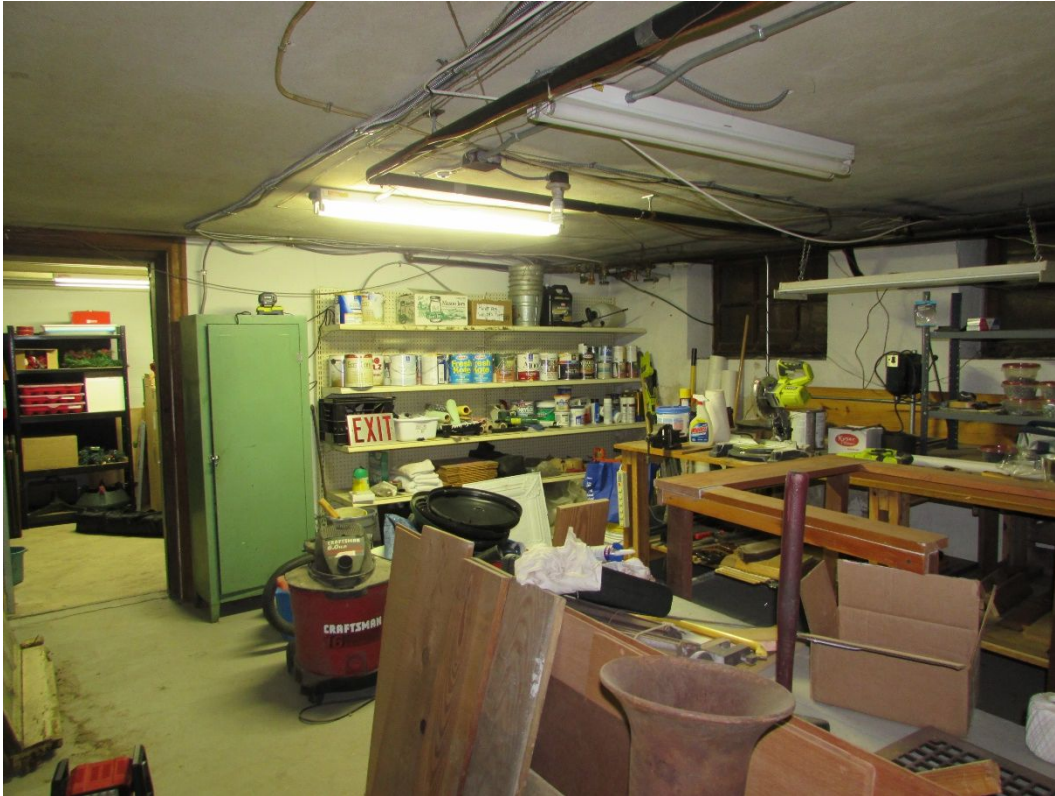
**Photo #14** – Overview of workshop, rear addition in photo background

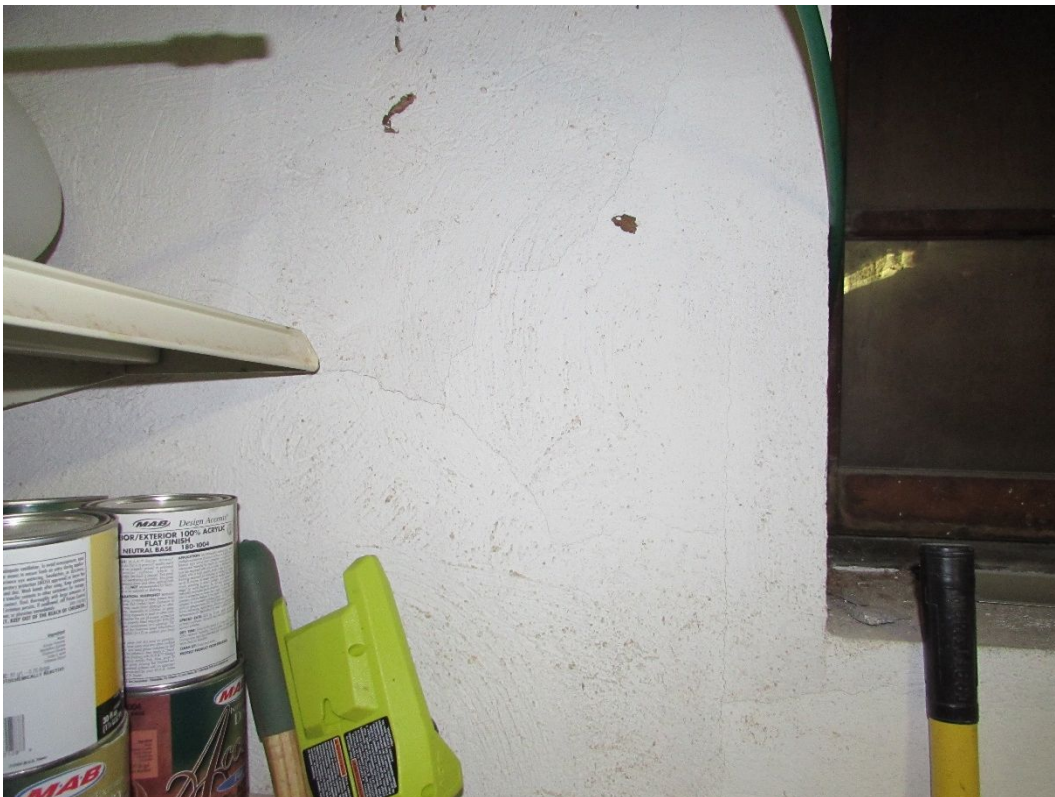
**Photo #15** – Minor random hairline cracks in exterior workshop foundation wall

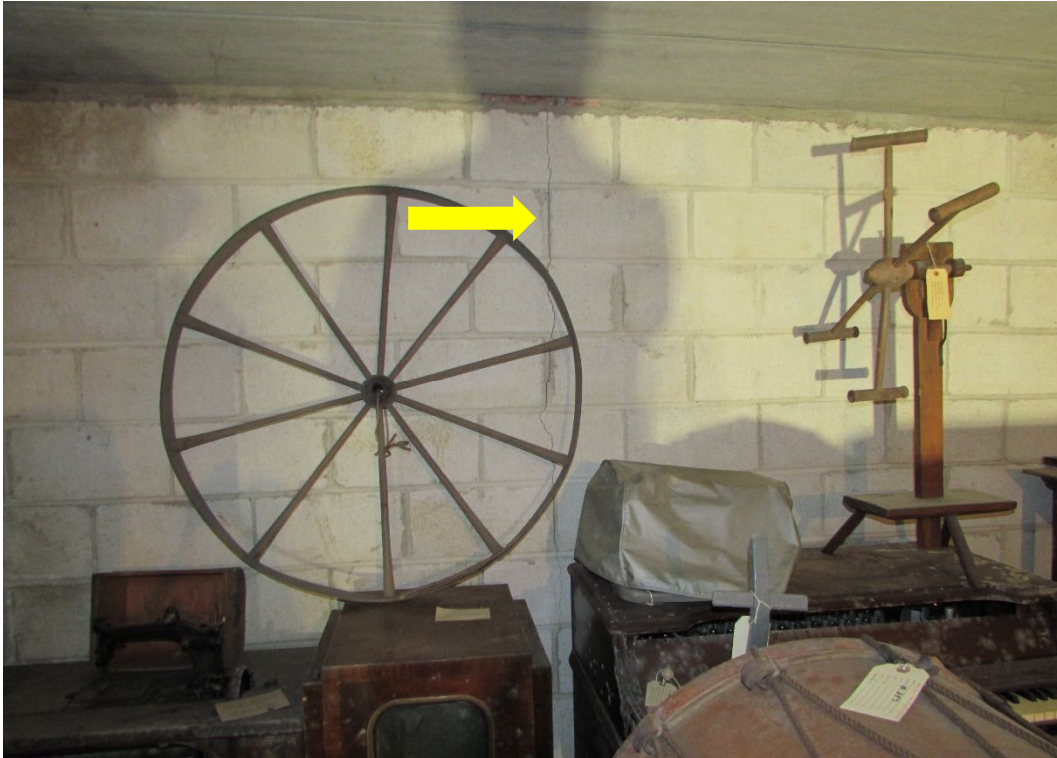
**Photo #19** – Minor cracking at left foundation wall of 1964 addition  
(background of photo #18 above)

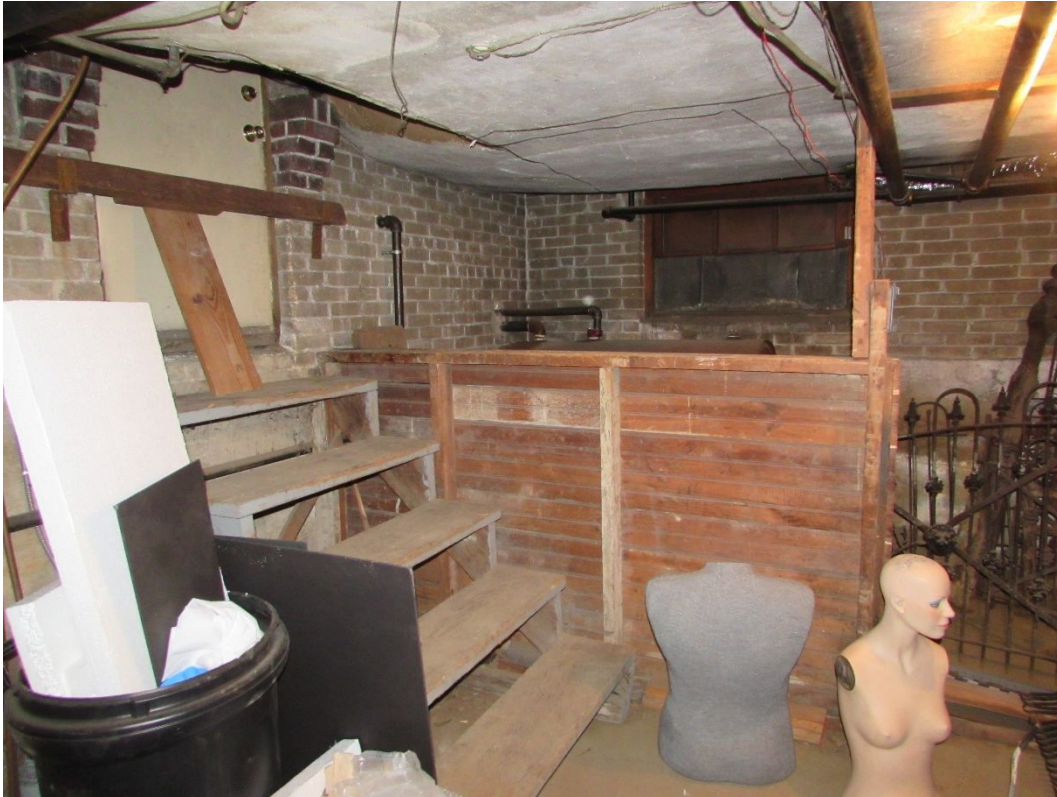
**Photo #20** – Overview of 1931 addition at rear of the building

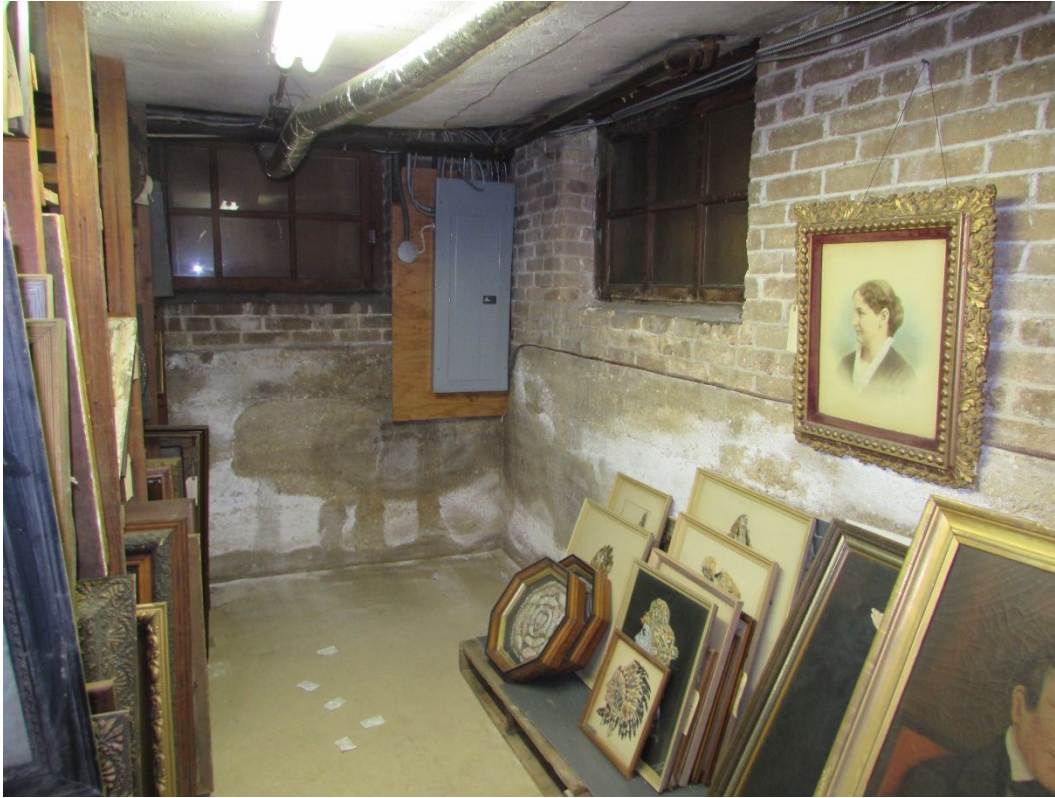
**Photo #21** – Overview of 1931 addition at front of building

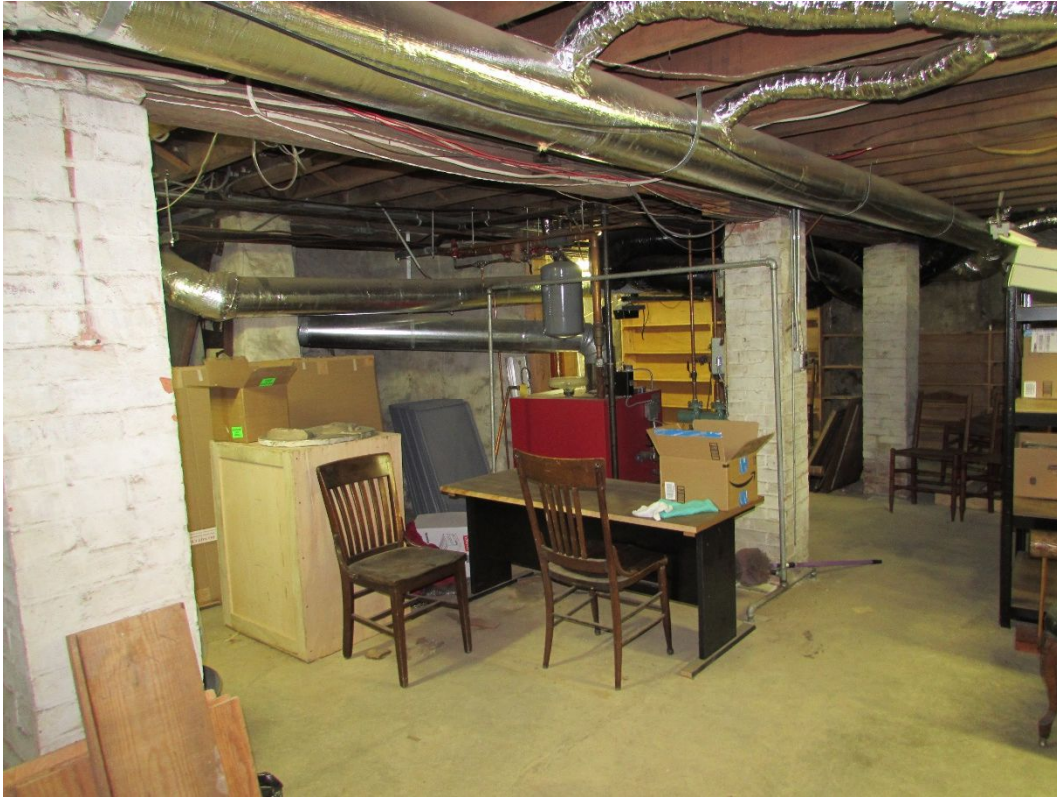
Basement Piers & Columns – The basement below the original structure includes six (6) brick piers that support the floor framing above. The brick piers were generally found to be in good condition with minor evidence of mortar deterioration along their bases.

**Photo #22** – Overview of brick piers

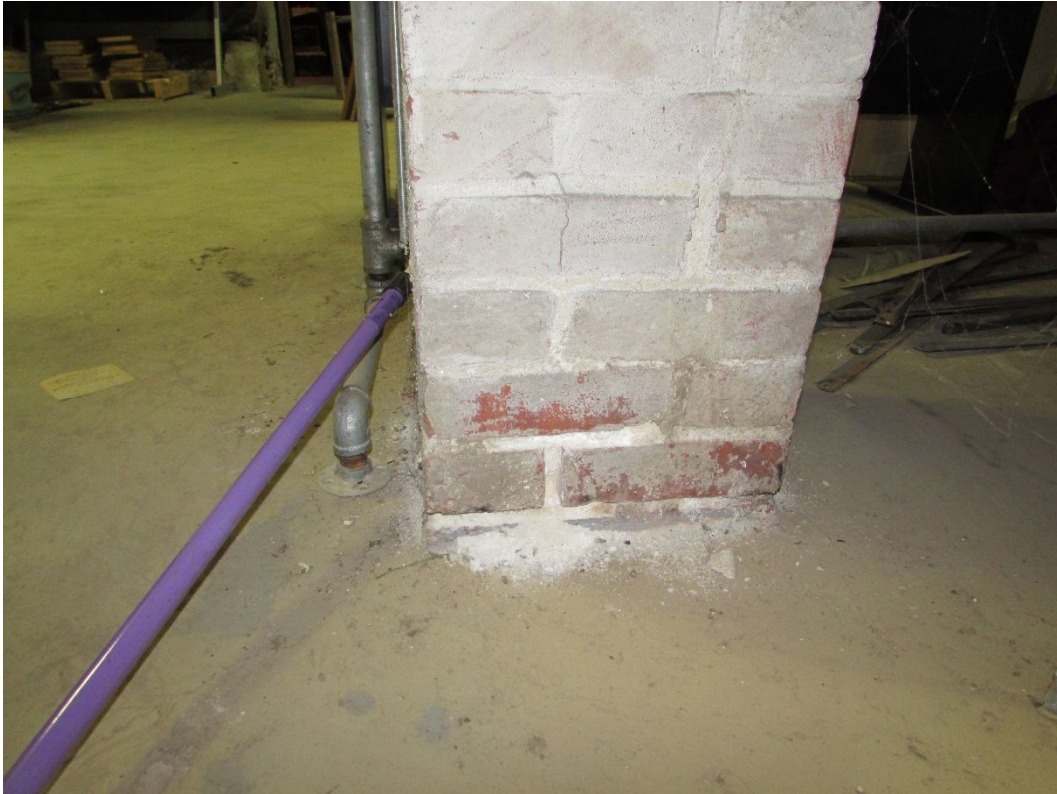
**Photo #23** – Deteriorated mortar at base of pier

5. The brick piers were found to be in good condition. Minor deterioration of the mortar joints was noted at their bases. Cleaning and repointing should be performed.

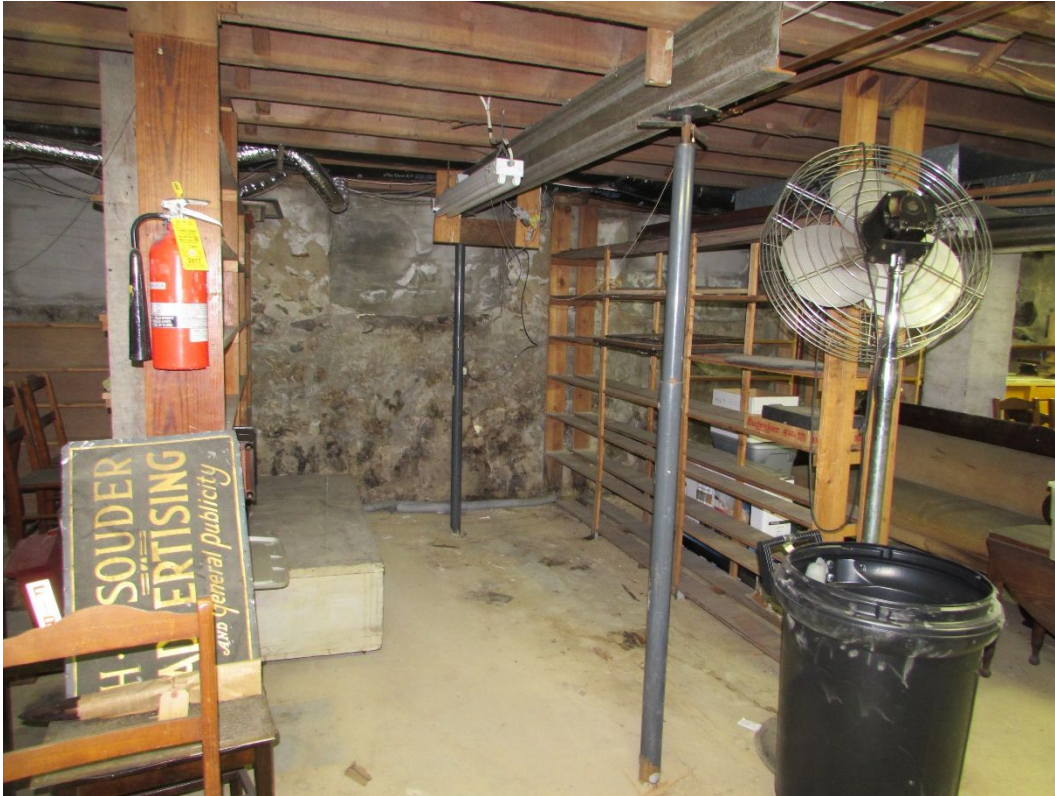
Adjustable Steel lally columns were added at a later date to provide supplemental support to cracked and decayed joists and girders. Supplemental lally columns were also added to support the large safe located in the first floor exhibition room. The steel lally columns were placed directly on the concrete basement floor without concrete footings and the threads of the adjustable ends are fully exposed. Two (2) steel lally columns adjacent to the front foundation wall were found to be severely corroded. The column cap plates beneath the first floor safe were found to be deformed. No evidence of cracking was noted in the concrete floor surrounding the column base plates.

**Photo #24** – Supplemental steel lally columns

6. Lally columns were installed later during the life of the building to provide supplemental support for various reasons. The columns were not installed in accordance with conventional methods. The threads of the adjustable ends are exposed, which may loosen over time. The column bases were placed directly on the floor slab without footings. No negative impacts have been experienced as a result of these improper techniques. However, improvements should be included in your building maintenance program as general good practice.

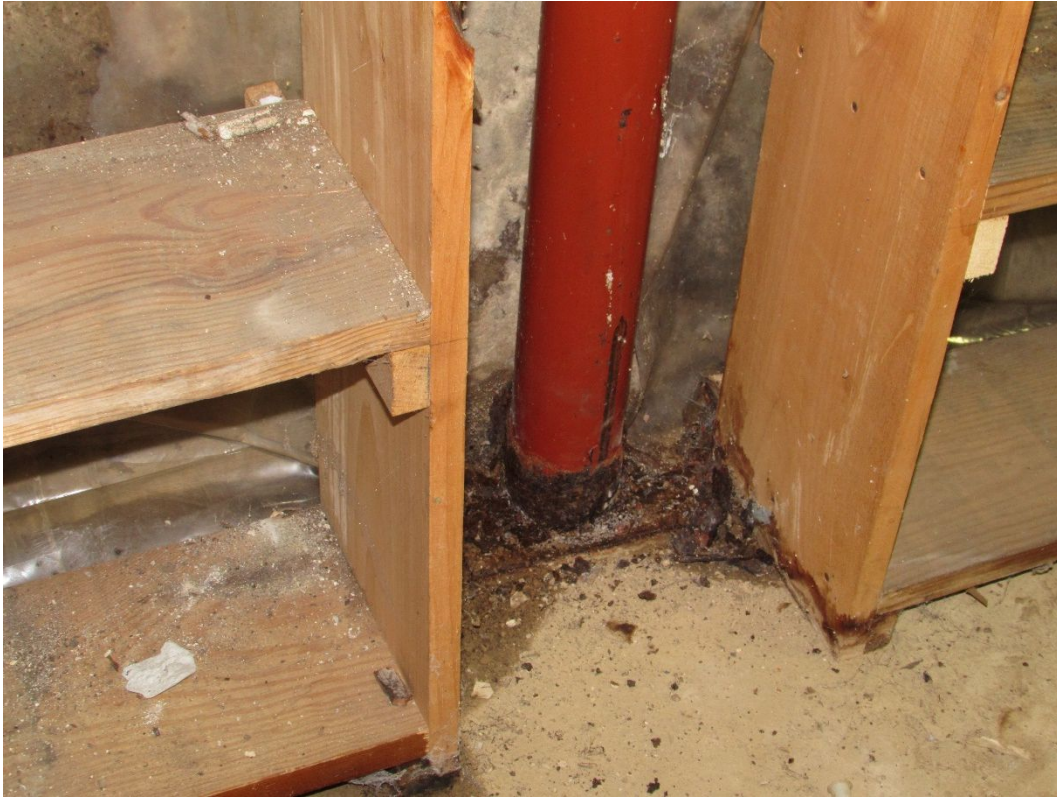
**Photo #26** – Corroded base of column depicted in photo #25 above

Corroded columns must be removed and replaced. Additionally, it is recommended that the column with a deformed cap beneath the first floor safe be removed and replaced with an adequate column and cap plate.
7. A decayed girder has been reinforced and supplemental support has been provided to cracked floor joists. It is recommended that an analysis of the reinforcement and supplemental support methods be performed to verify that the framing is adequate in its present state.

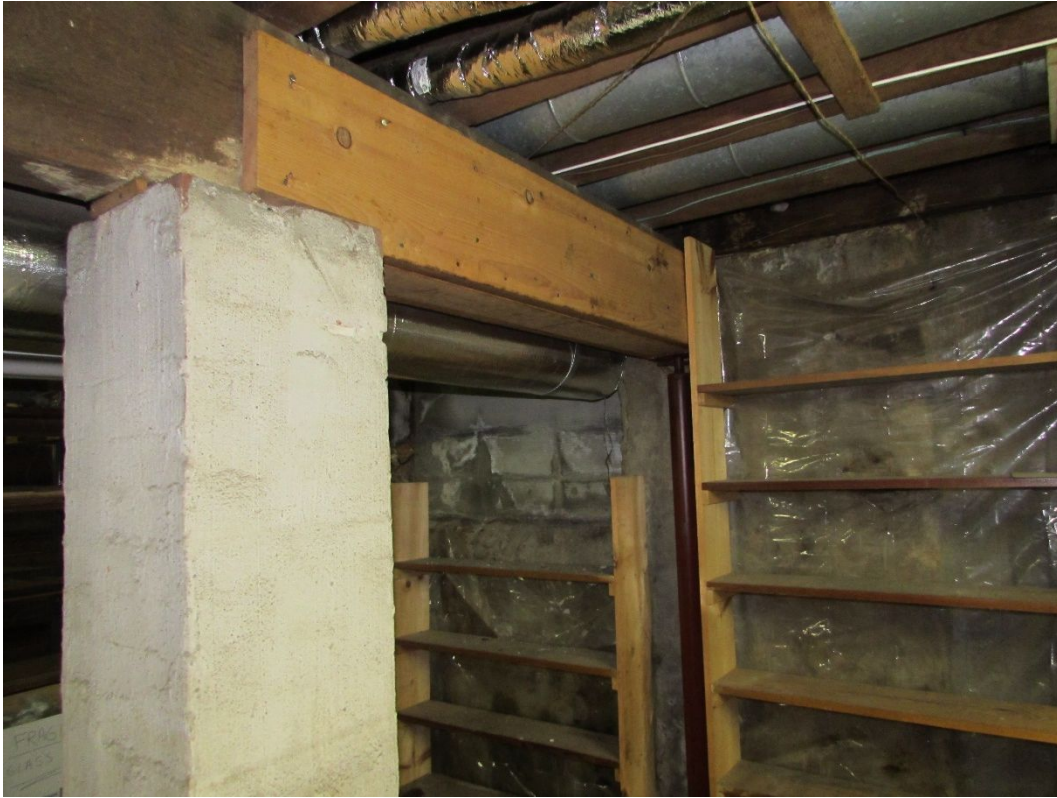
The girder adjacent to the front left building corner has experienced significant decay. The decay is hidden by new lumber that has been placed over the girder in an attempt to provide reinforcement. The girder at the front right building corner is currently experiencing similar decay. Where probed, the remaining girder sections appeared to be sound and in good condition.

**Photo #29** – Decayed girder reinforced by new lumber

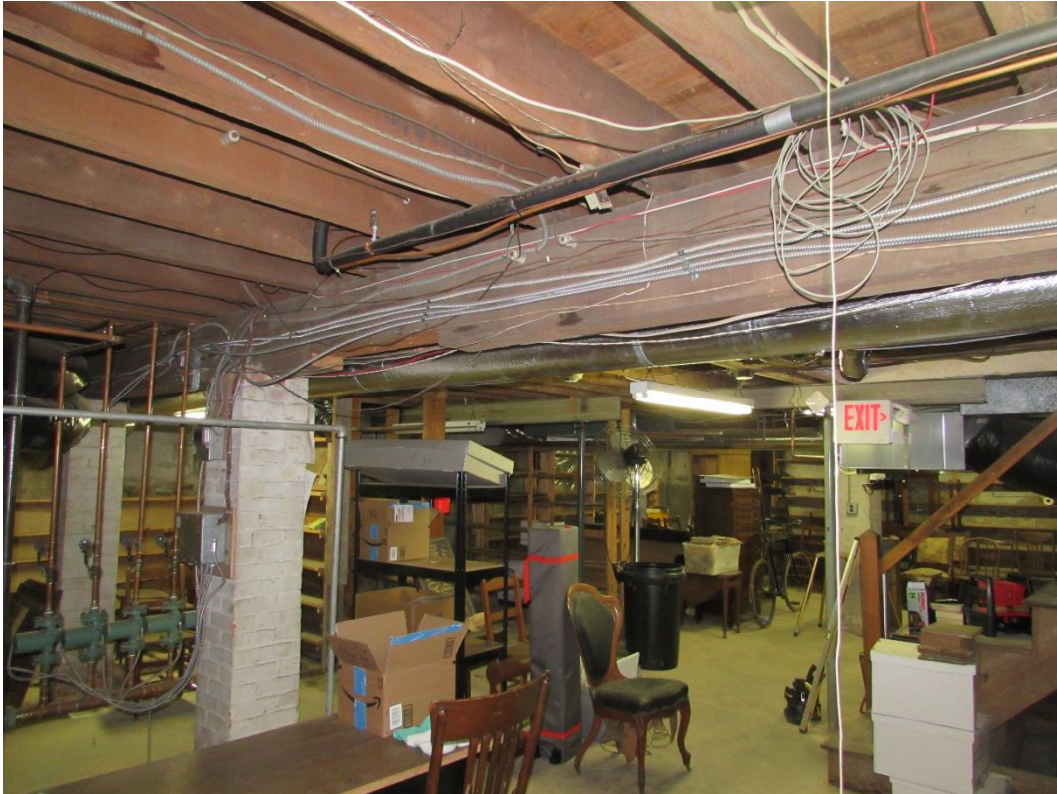
**Photo #30** – Overview of girder and joist framing
