# MARINO STRUCTURAL SOLUTIONS

NICHOLAS MARINO, P.E.

RE: **Building Evaluation**  
Vineland Historical Society  
108 S. 7<sup>th</sup> Street  
Vineland, Cumberland Co., NJ  
**MSS #18167**

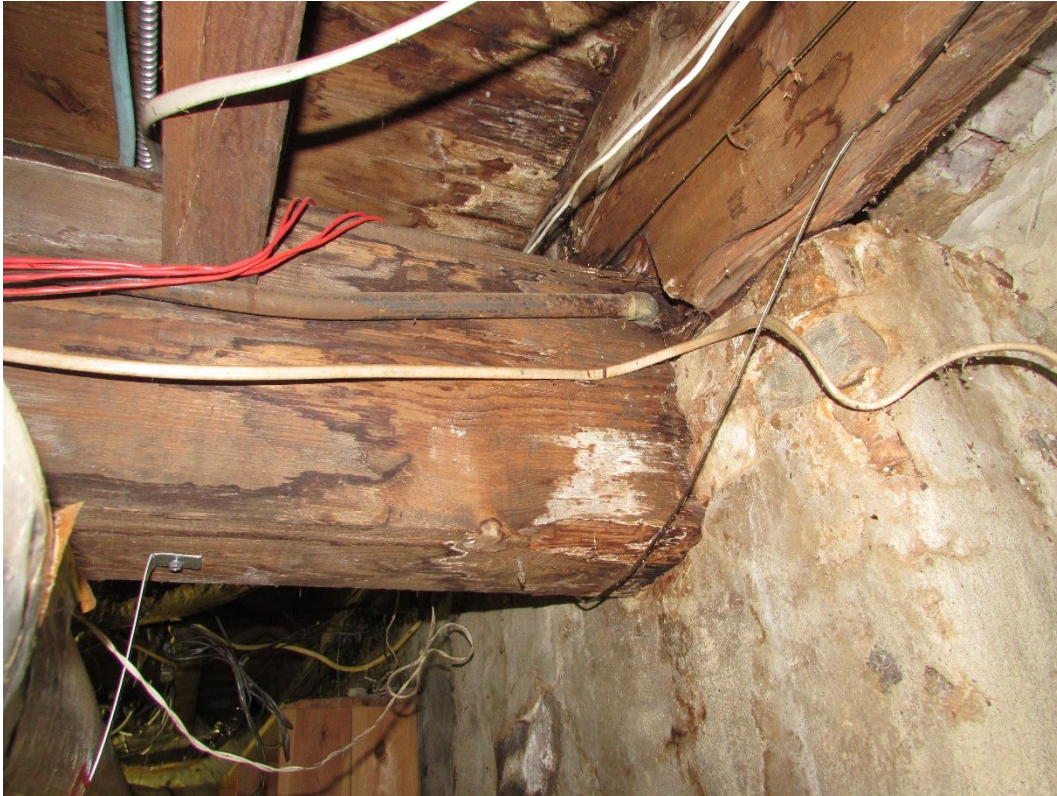
**Photo #33** – Decayed girder and joist at front wall adjacent to right corner

A decayed girder remains at the front right corner of the basement. Repair/reinforcement of this girder is required.
8. Evidence of long-term water intrusion is evident along the front wall of the building extending from the 2<sup>nd</sup> floor ceiling down to the basement framing. Decayed floor joists and wood framing were consistently found in the basement along the front wall. Loose stained plaster was found at the 2<sup>nd</sup> floor level along with corroded tin ceiling members. Removal and replacement of the decayed framing is required to prevent crushing or localized failure; crushing has occurred beneath the 1<sup>st</sup> floor piano. However, it is recommended that a section the hidden second floor members, roof rafters and brick wall surface be exposed to verify that the long-term water intrusion has not resulted in hidden decay/deterioration.

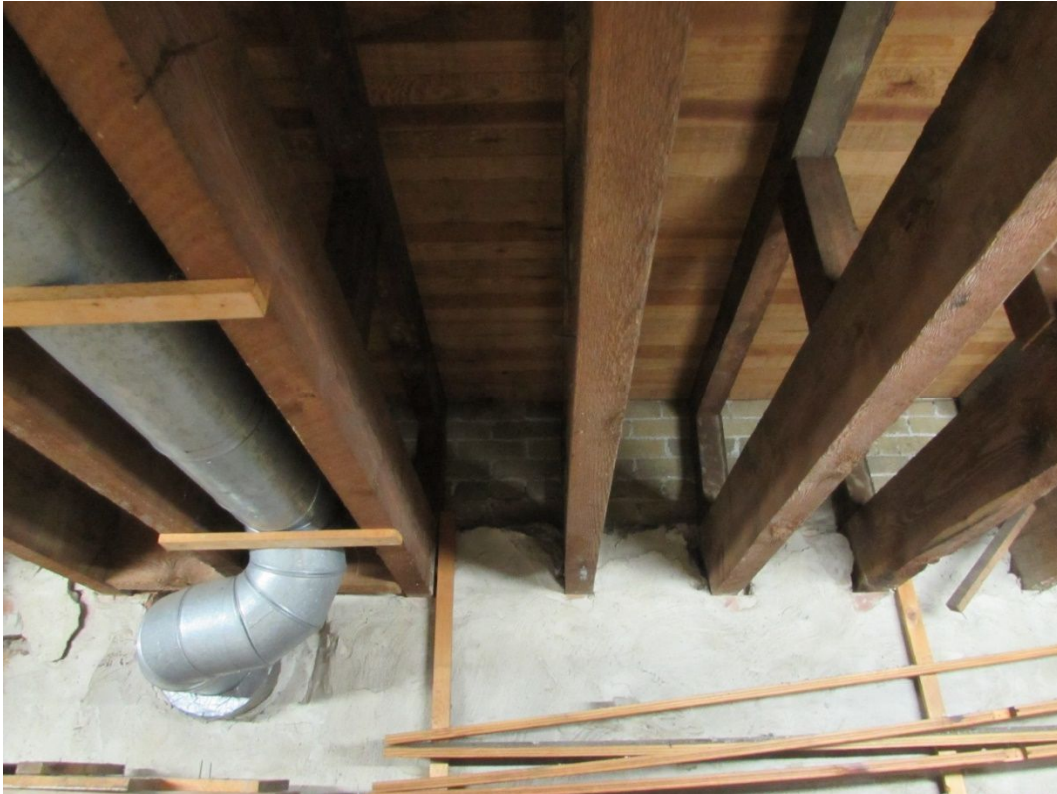
The ends of the floor joists along the left and right sidewalls are embedded in the exterior walls. Moisture staining was observed at the joist ends, several joists were probed at the face of the foundation wall and found to be sound; the condition of the embedded sections is not known. Along the left sidewall, two (2) joists were found to be cracked at natural knots. Two (2) joists were also found to be cracked at the right side of the basement. Approximately 8-10 3” x 12” floor joists were found to be cracked beneath the center of the exhibition room. It appears that a steel beam and column system were installed to provide supplemental support to these cracked floor joists by reducing their span lengths.

**Photo #34** – Floor joists embedded in left sidewall

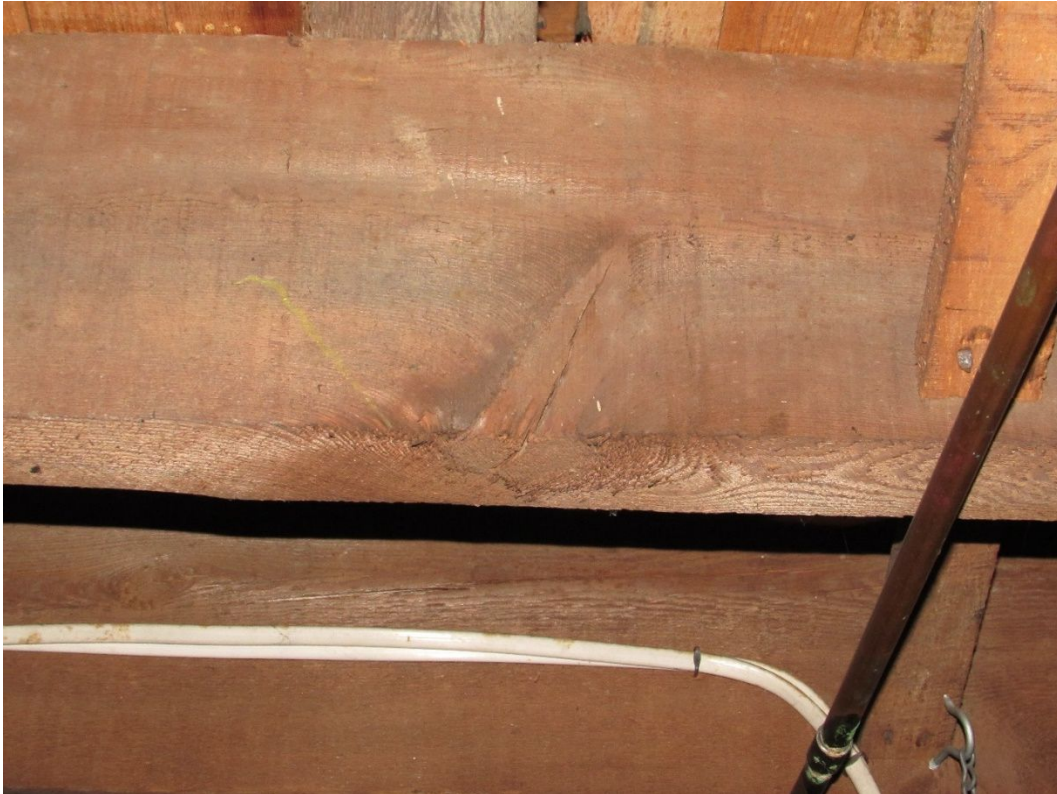
**Photo #36** – Joist cracked at natural knot

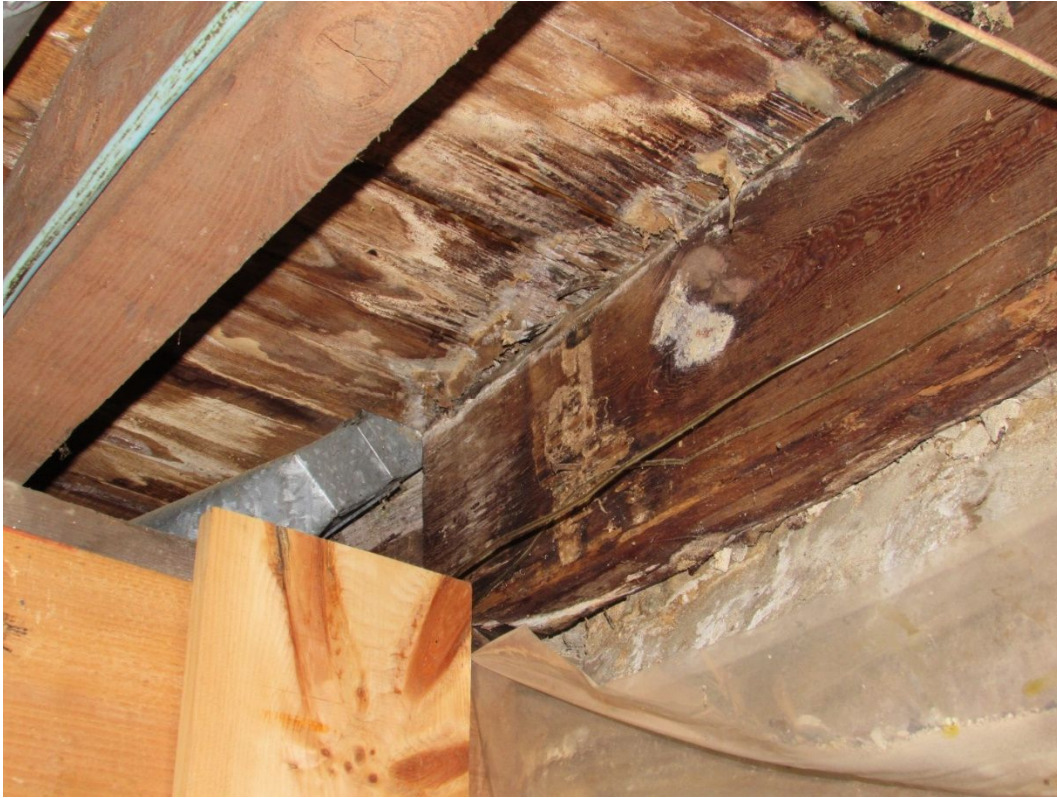
Decay was commonly observed along the front wall impacting both the floor joists immediately alongside the front foundation wall and the hardwood flooring above. Decay was also found at the window header above the basement window on the left sidewall adjacent to the front left building corner.

**Photo #37** – Decayed joist and flooring along front wall

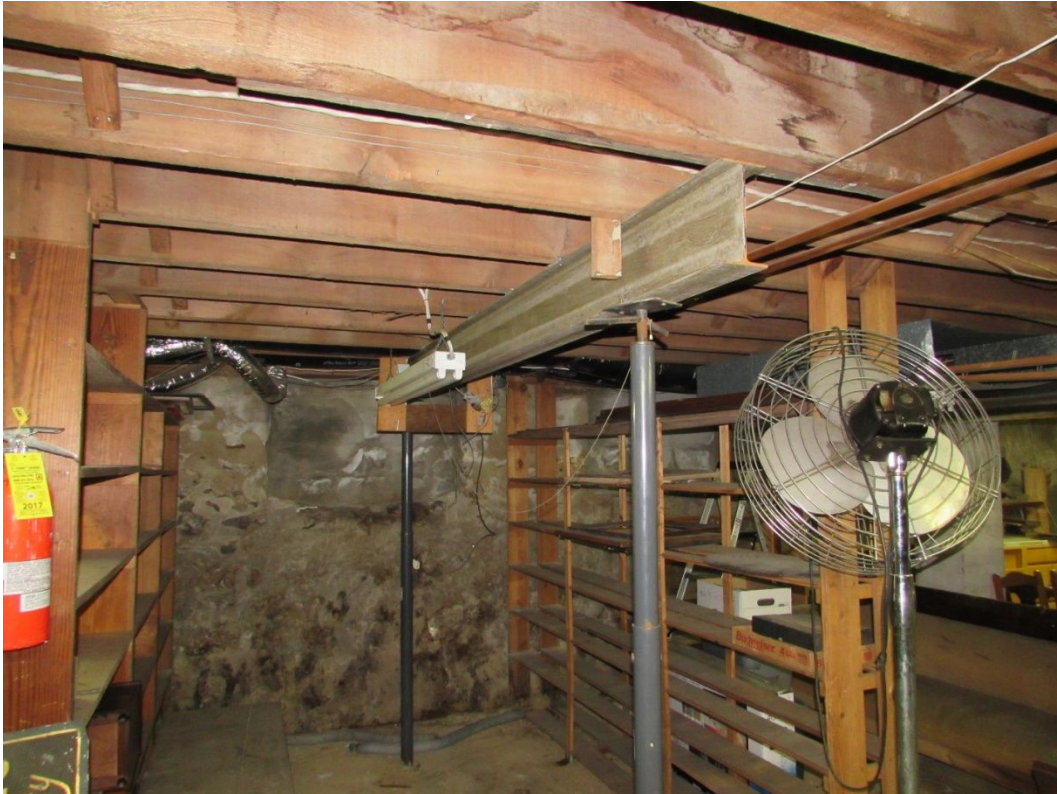
**Photo #38** – Beam and columns installed to support cracked floor joists

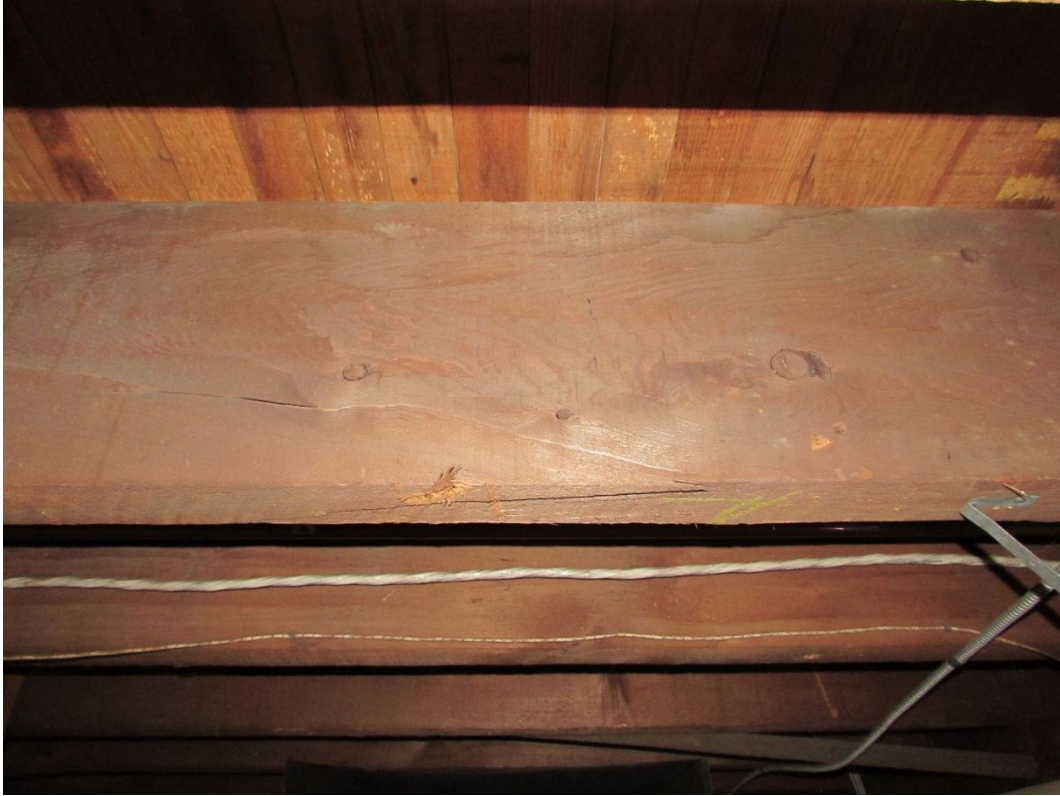
**Photo #39** – Cracked floor joist in photo #38

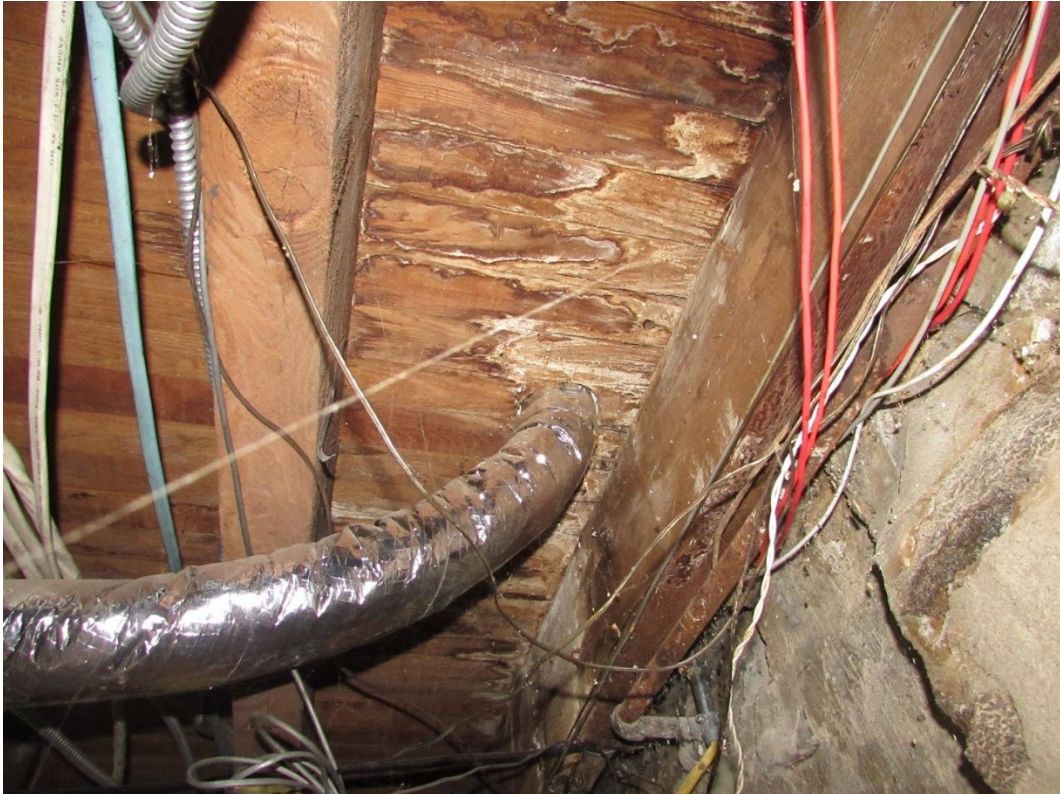
**Photo #40** – Decayed flooring along front wall

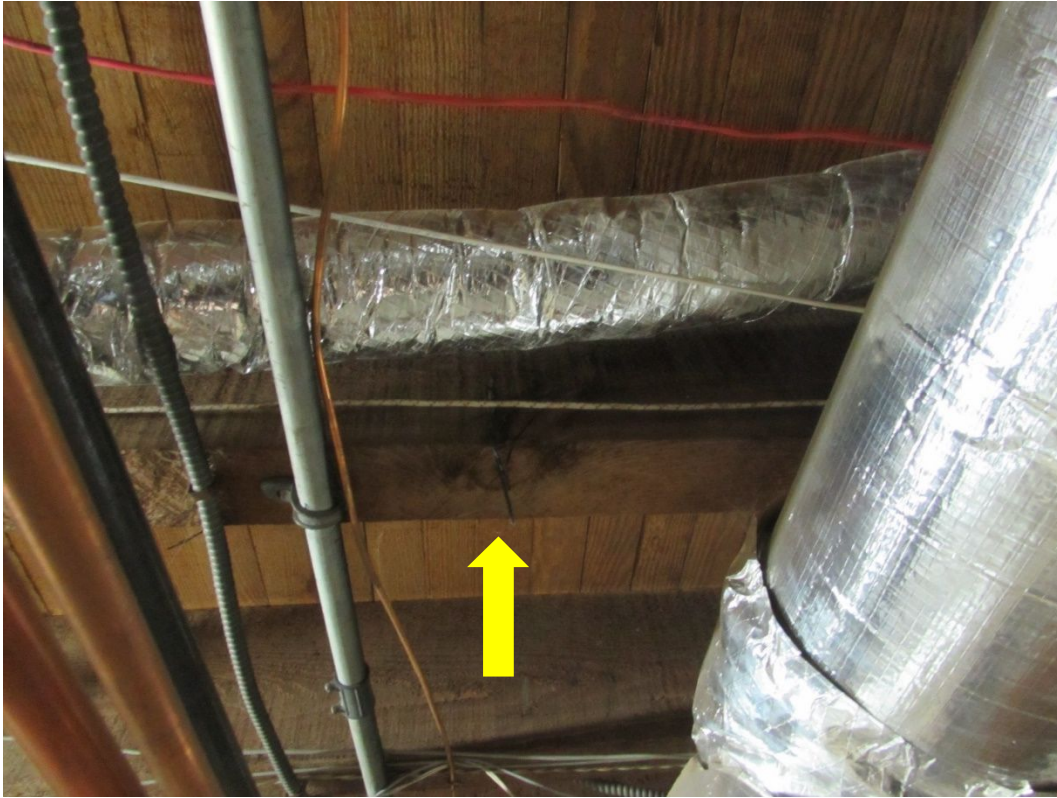
**Photo #41** – Cracked flor joist

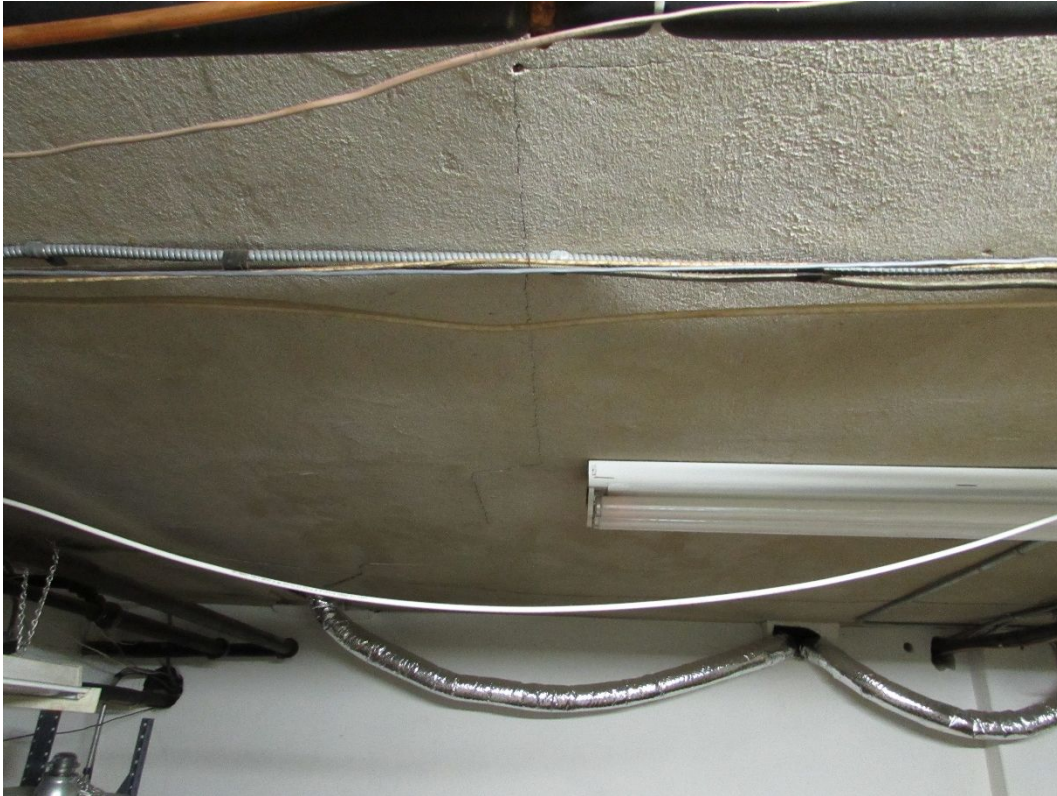
**Photo #42** – Cracked plaster ceiling at workshop

9. Cracked and loose plaster surfaces were found in the basement ceiling and along localized areas of the first and second floors. This condition is the result of both natural aging and water intrusion (exterior walls only). Removal and reconstruction of these

surfaces will be required. These surfaces also provide a degree of fire resistance. For example, the plaster basement ceiling may slow the spread of a fire originating in the basement. Subsequently, it is recommended that openings/penetrations in these surfaces be adequately sealed.

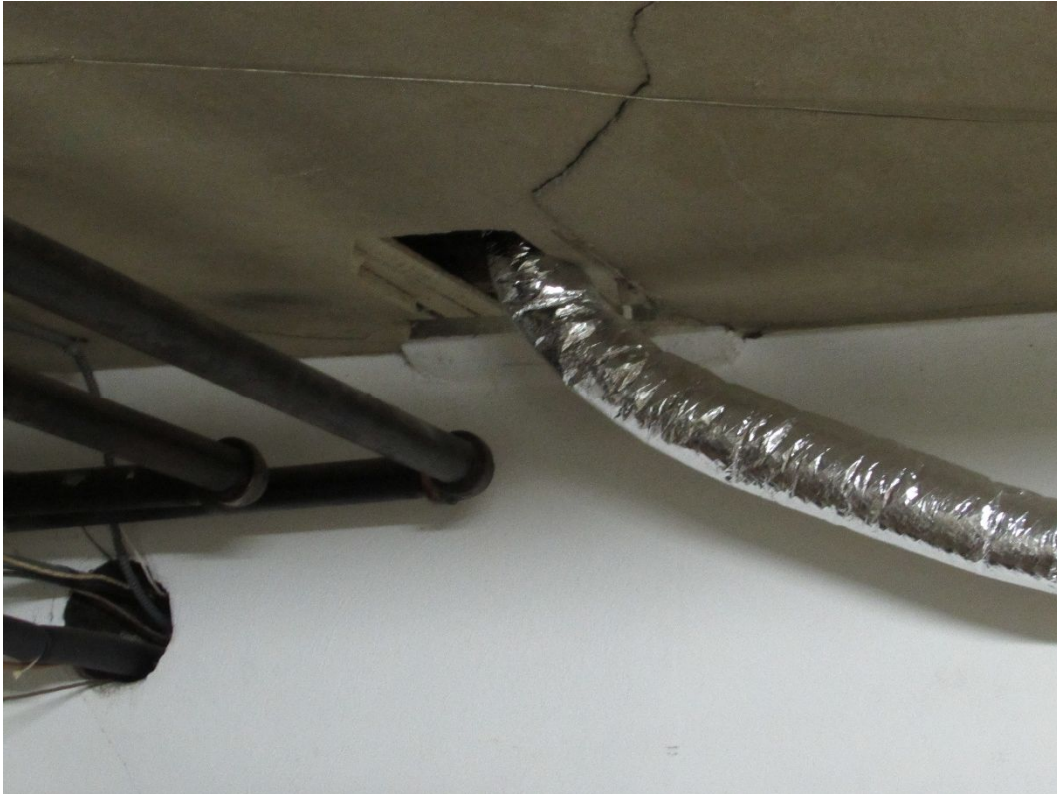
**Photo #43** – Opening in workshop ceiling

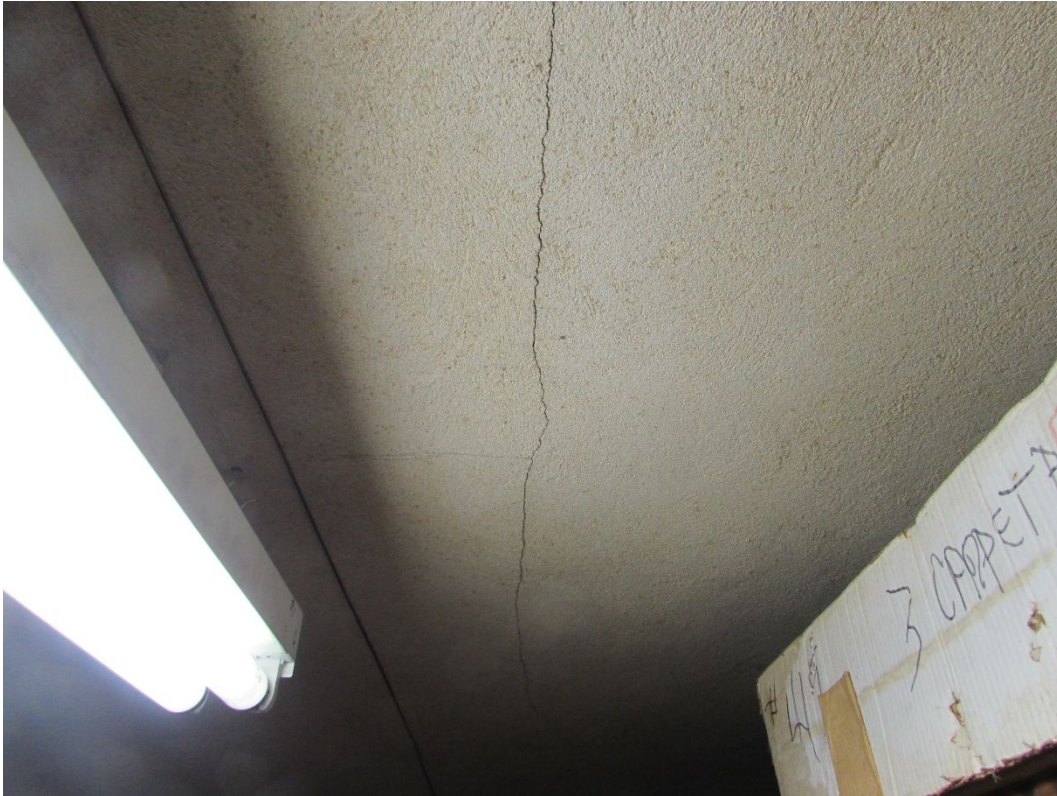
**Photo #46** – Cracked plaster ceiling in photo #45 above

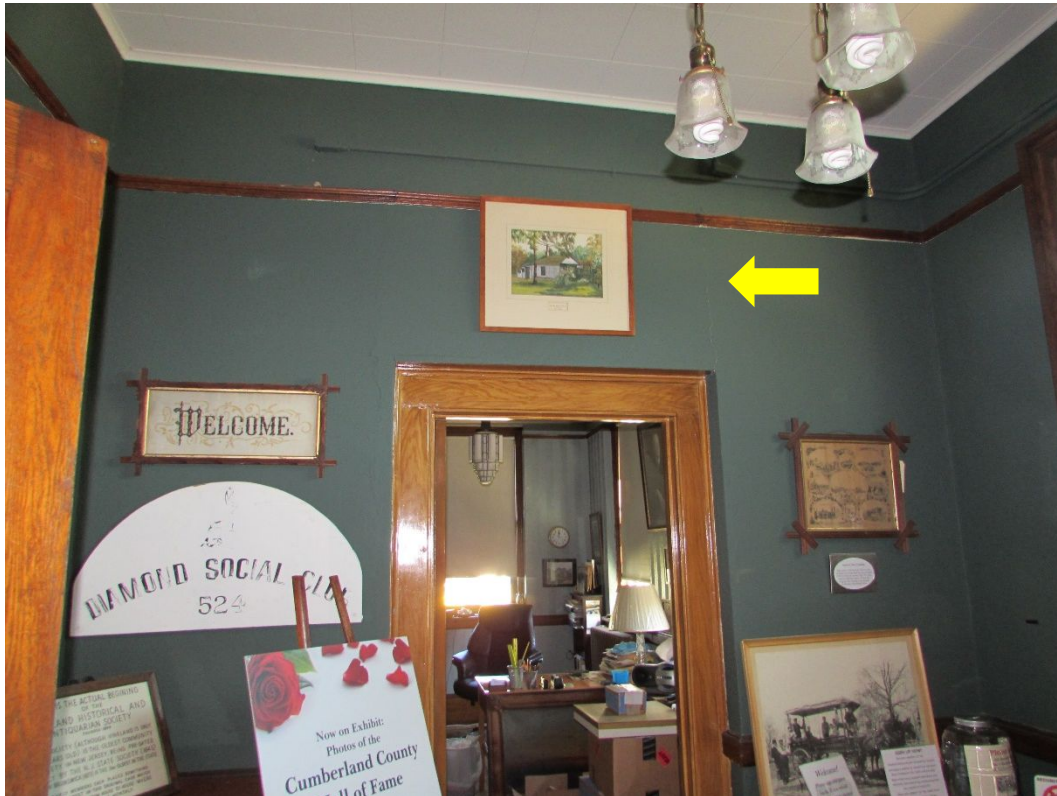
**Photo #48** – Minor cracking at front foyer

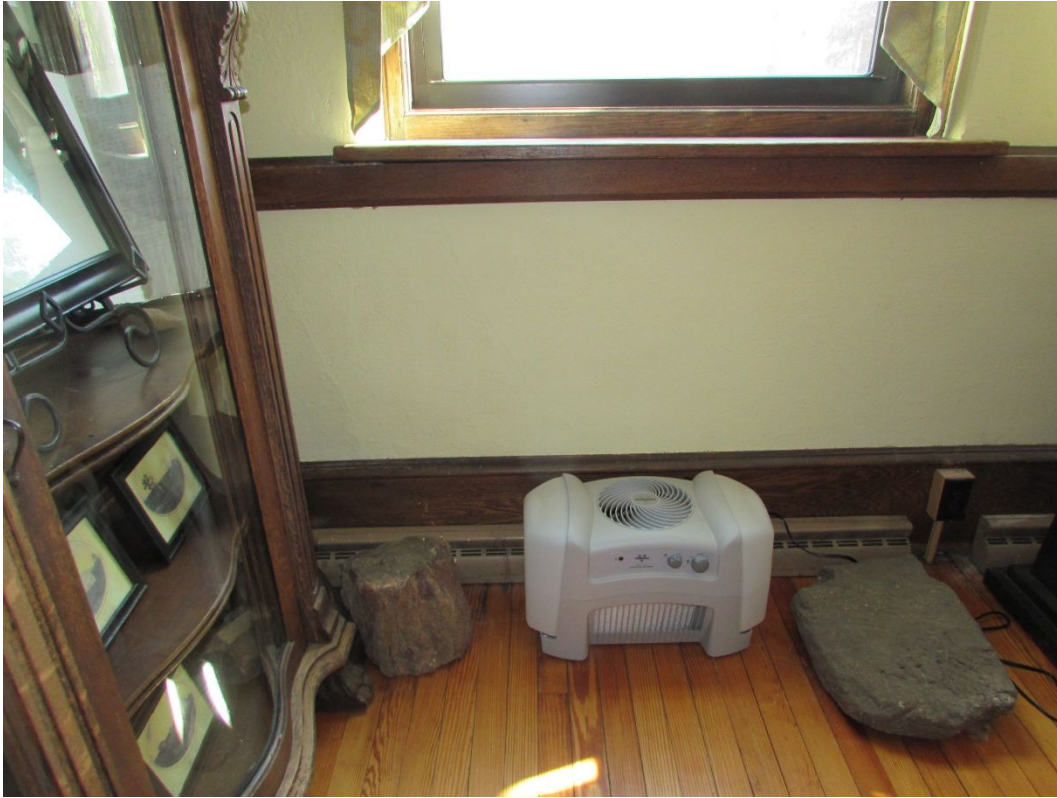
**Photo #49** – Cracking at front wall

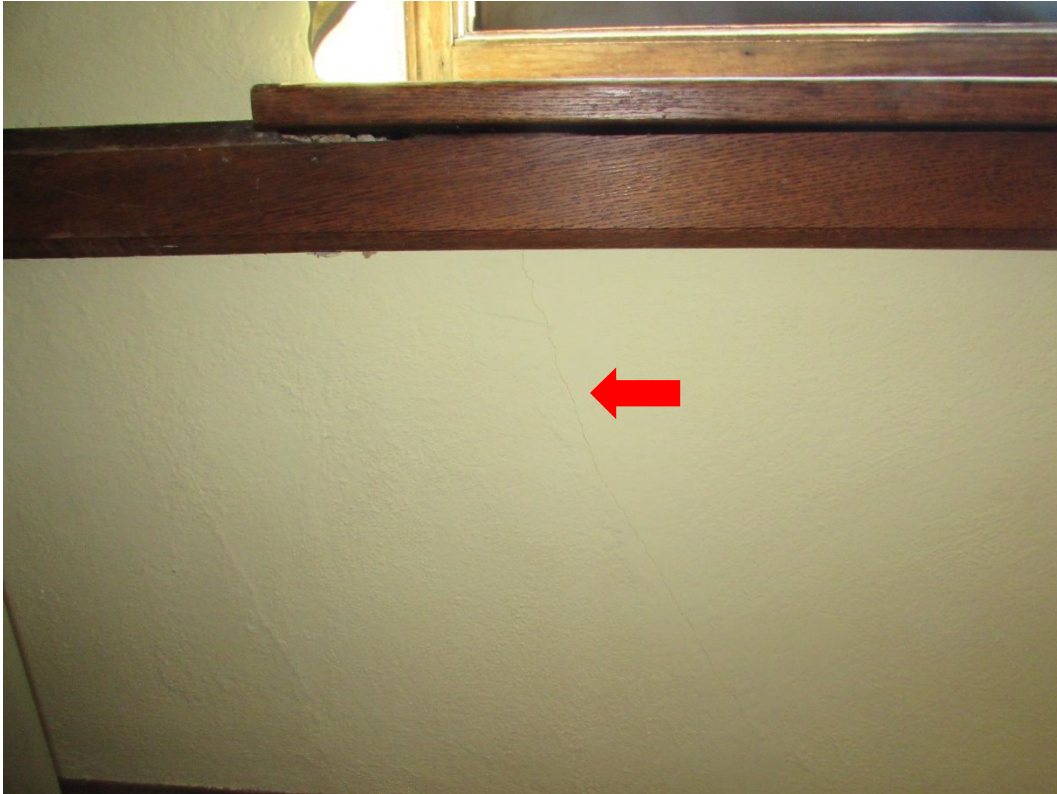
**Photo #50** – Enlarged view of photo #49, cracking noted

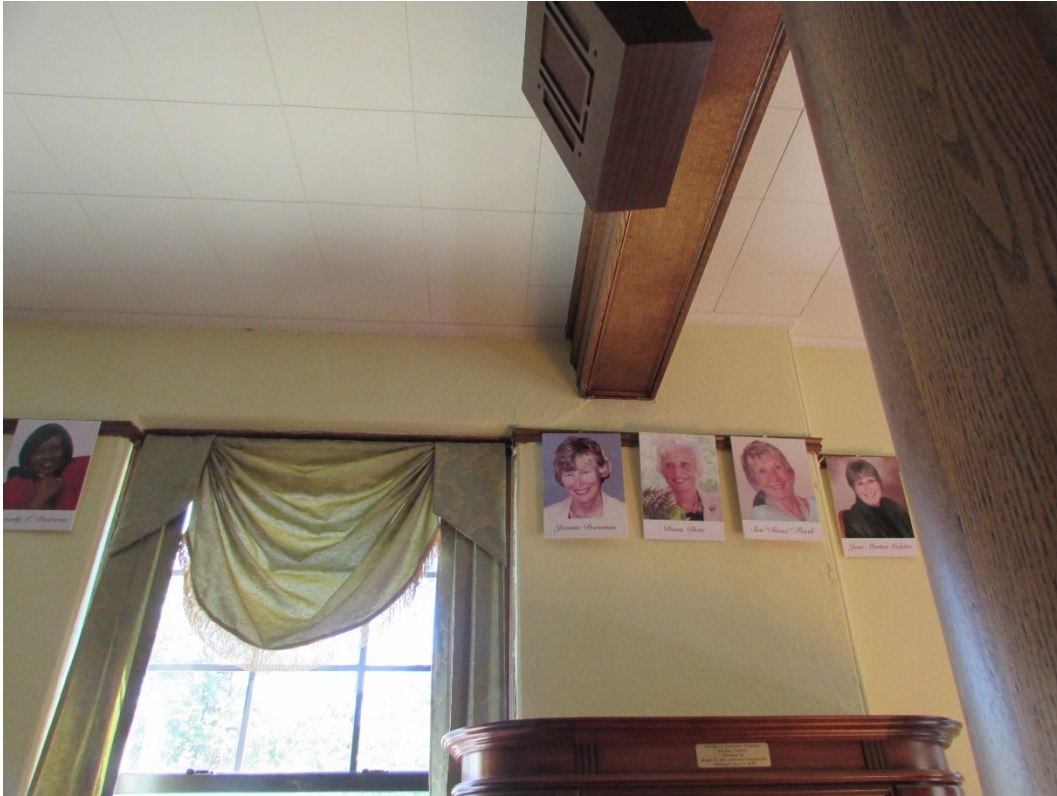
**Photo #51** – Cracking at front wall

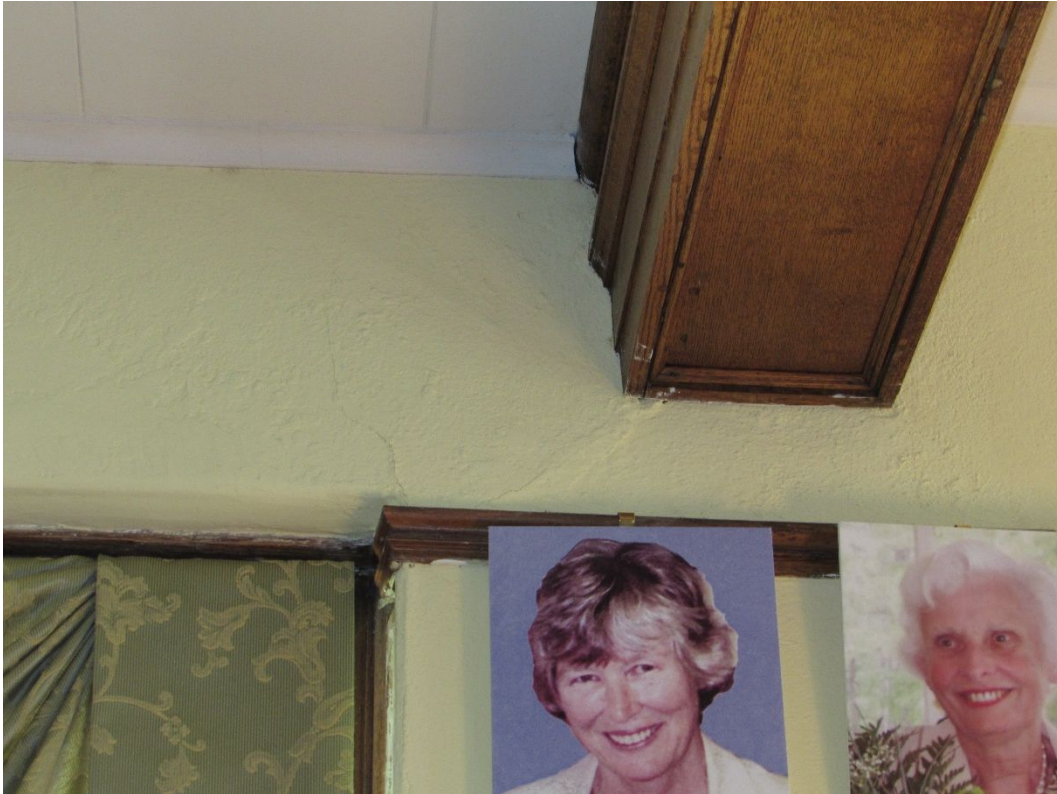
**Photo #52** – Close up view of photo #51

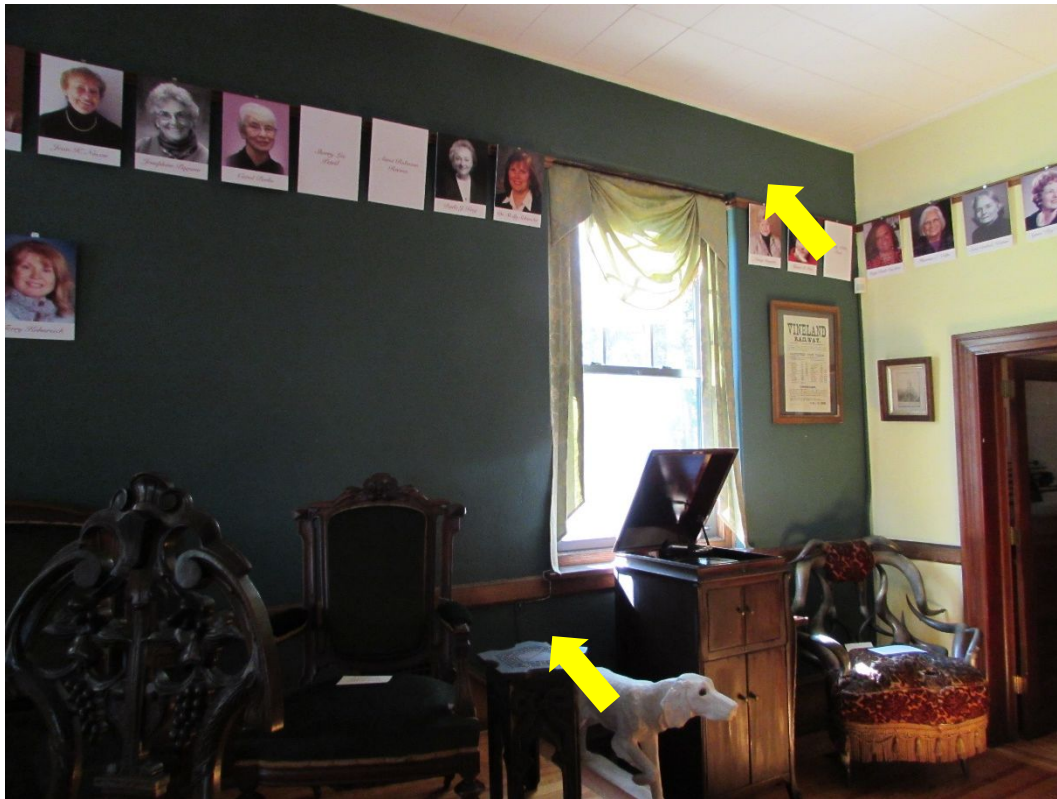
**Photo #55** – Cracking above and below window at left sidewall

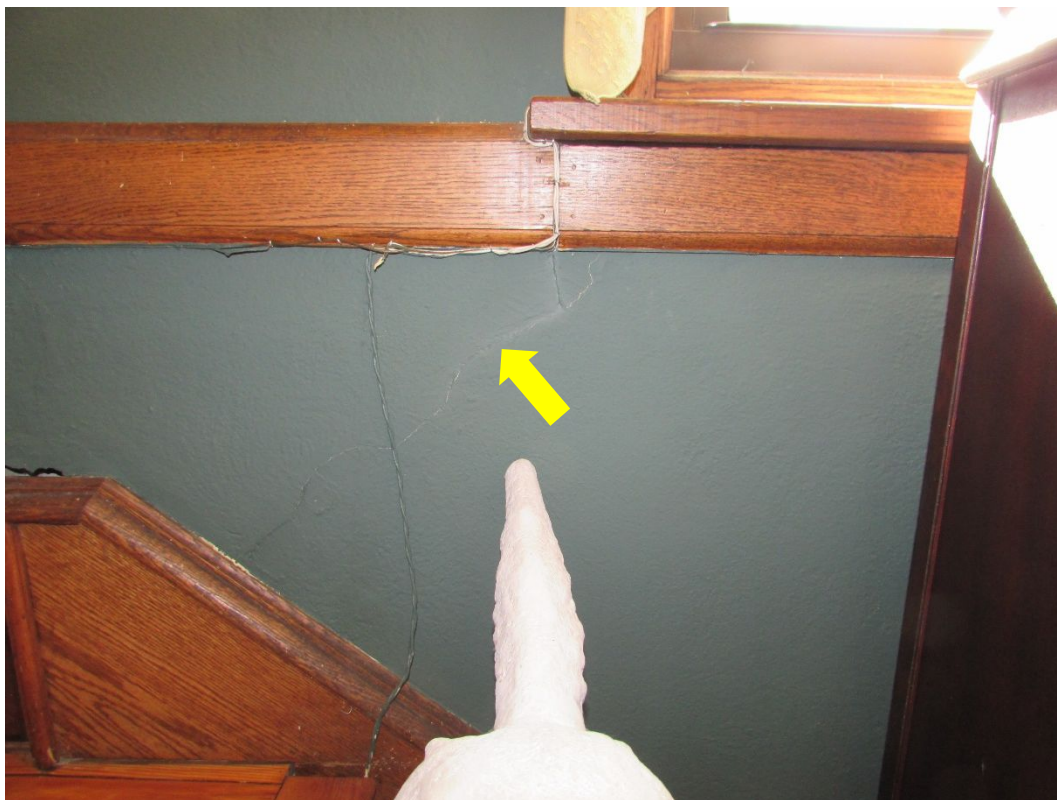
**Photo #56** – Cracking below window in photo #55

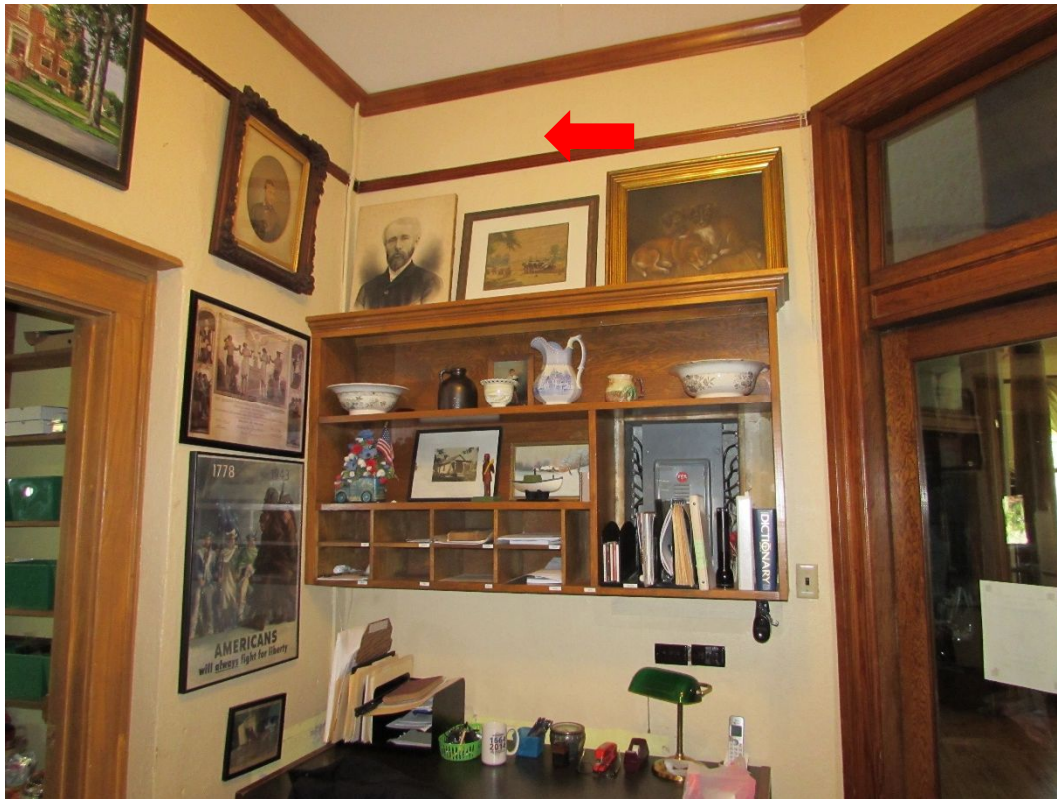
**Photo #57** – Cracking at office wall

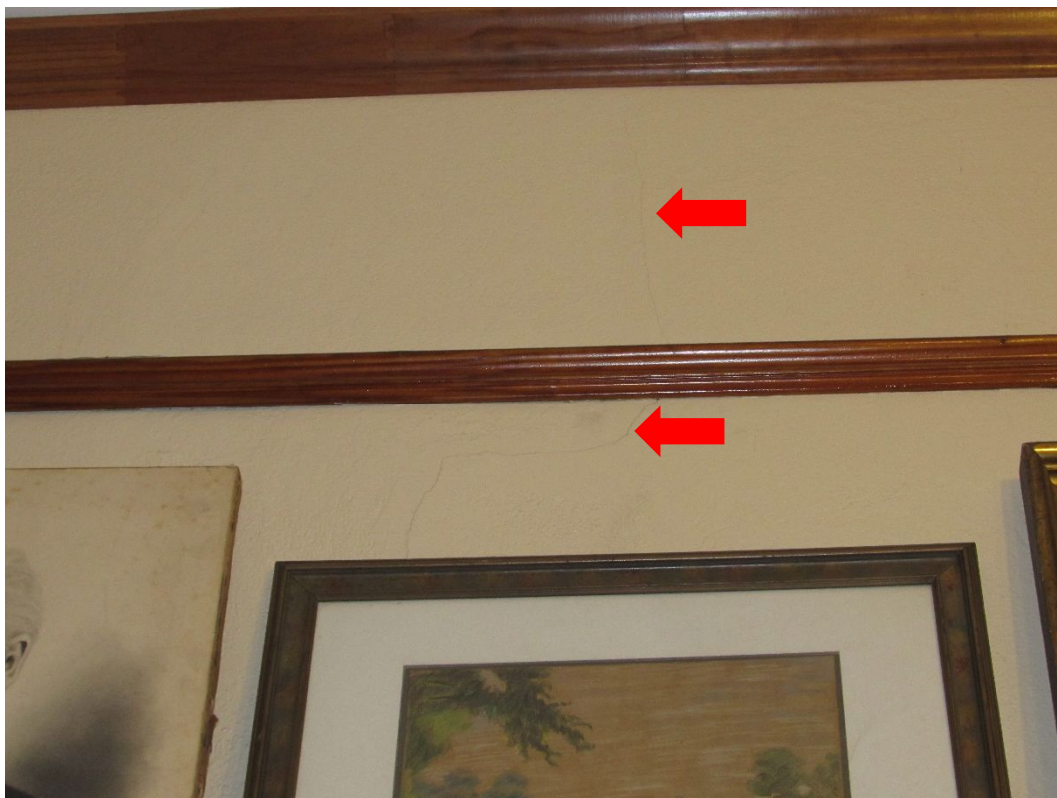
**Photo #58** – Enlarged view of photo #57

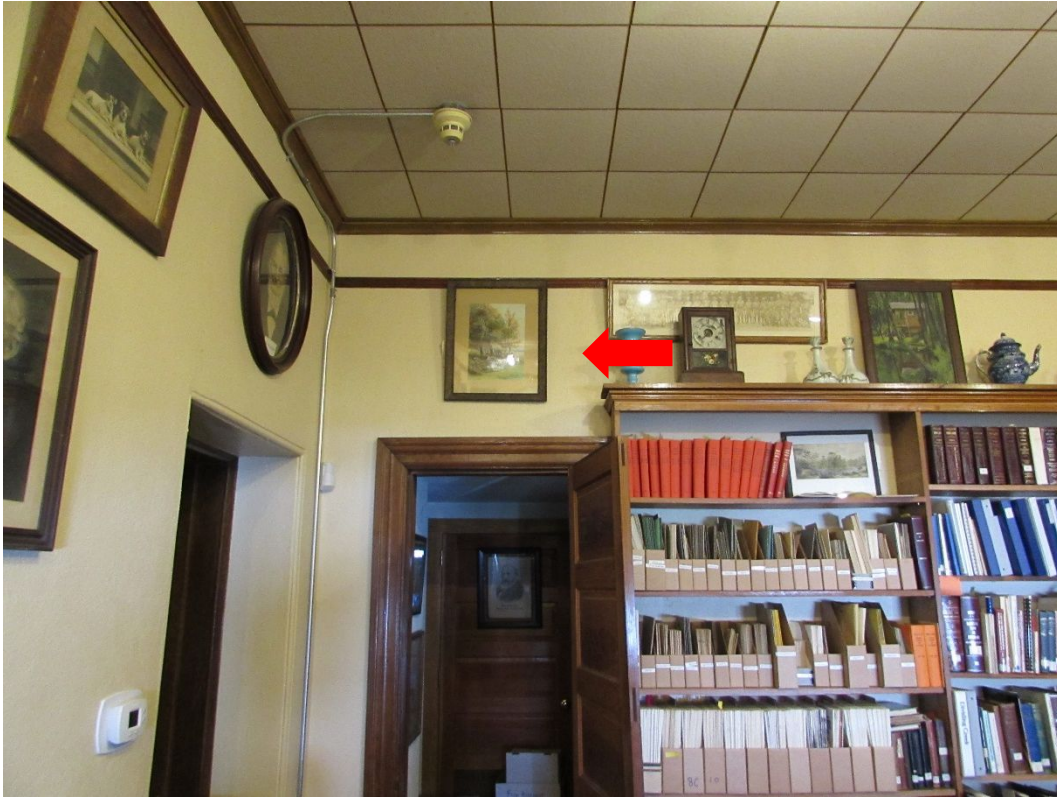
**Photo #59** – Cracking at office wall

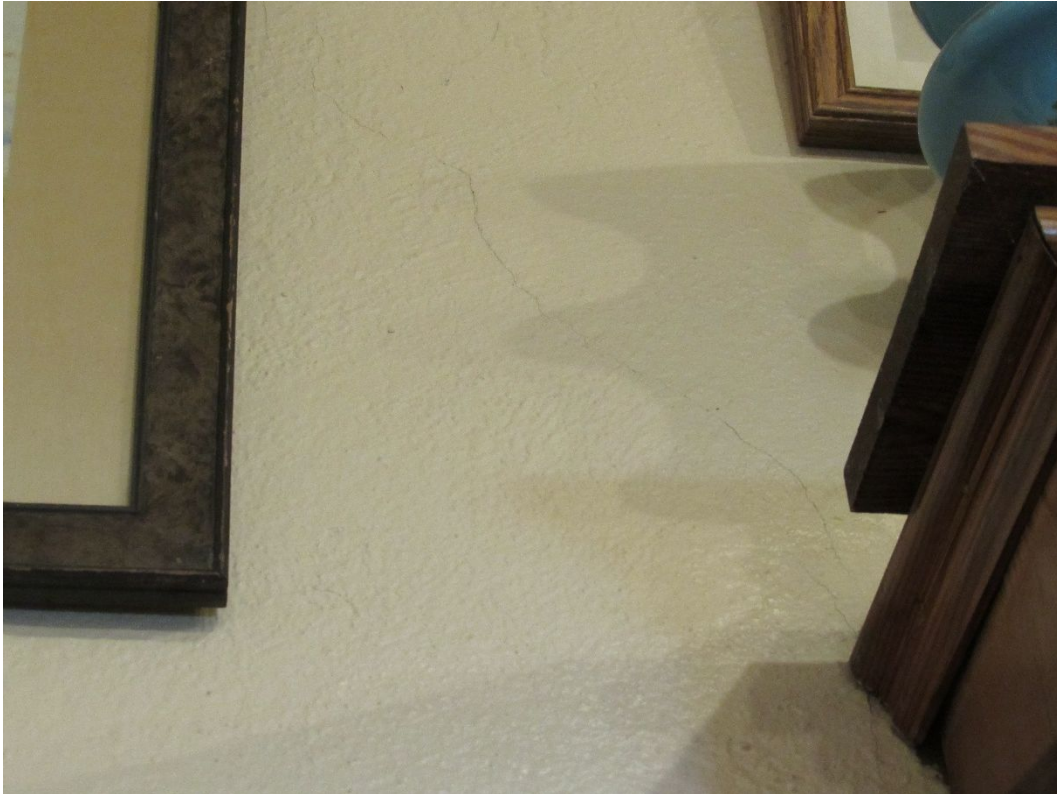
**Photo #60** – Enlarged view of photo #59

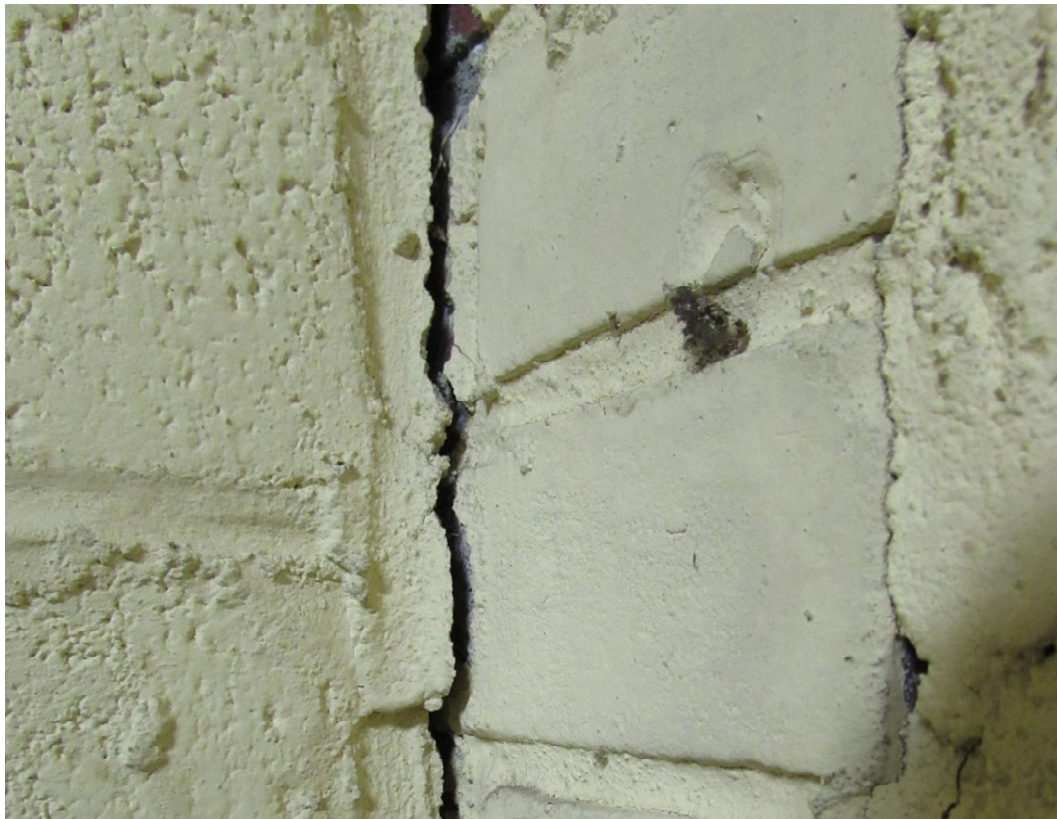
A separation was found where the right sidewall of the 1933 (vault) addition abuts the rear wall of the original structure.

**Photo #62** – Close up view of photo #61

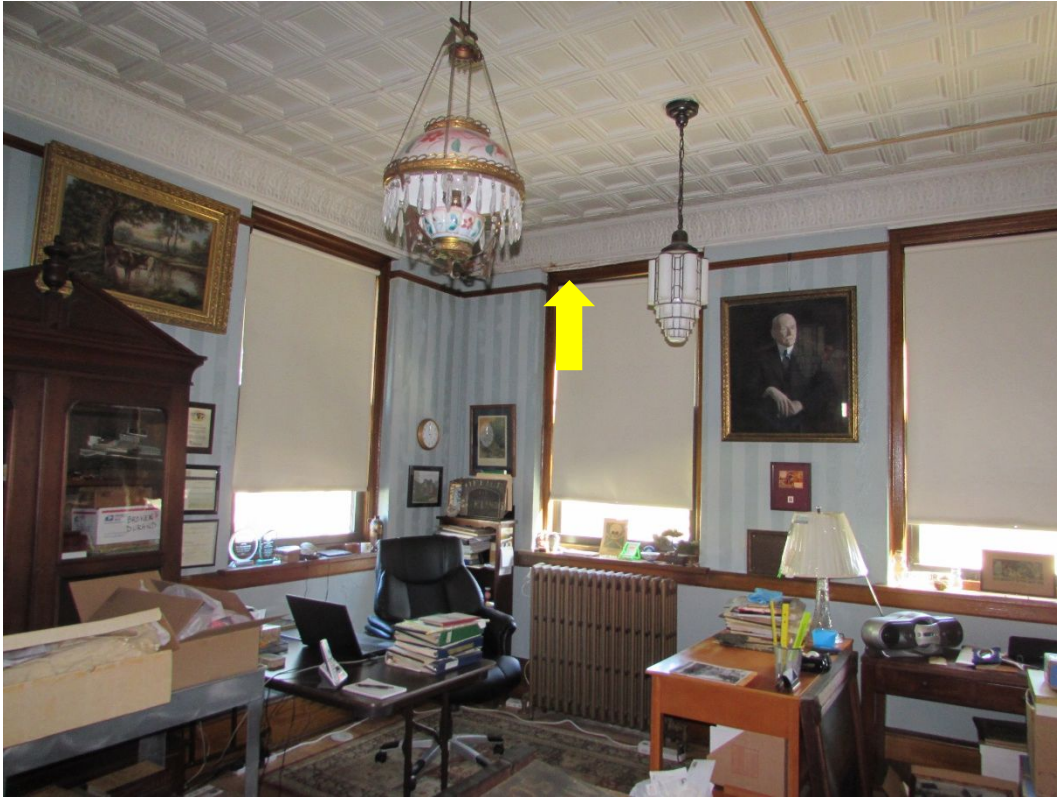
Light corrosion of the ceiling tile and trim was found at the front right corner of the 1931 addition.

**Photo #63** – Location of corrosion at first floor level of 1931 addition

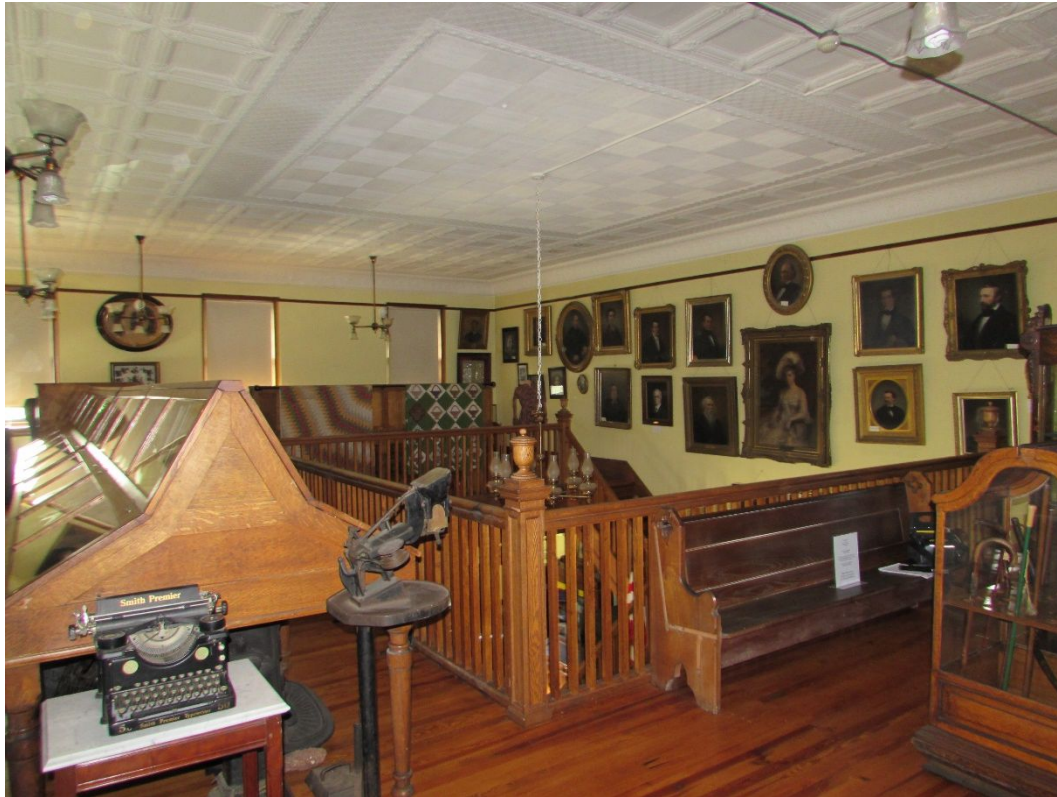
**Photo #65** – Overview of 2<sup>nd</sup> floor main exhibition room, rear left building corner in background
