# MARINO STRUCTURAL SOLUTIONS

NICHOLAS MARINO, P.E.

RE: **Building Evaluation**  
Vineland Historical Society  
108 S. 7<sup>th</sup> Street  
Vineland, Cumberland Co., NJ  
**MSS #18167**

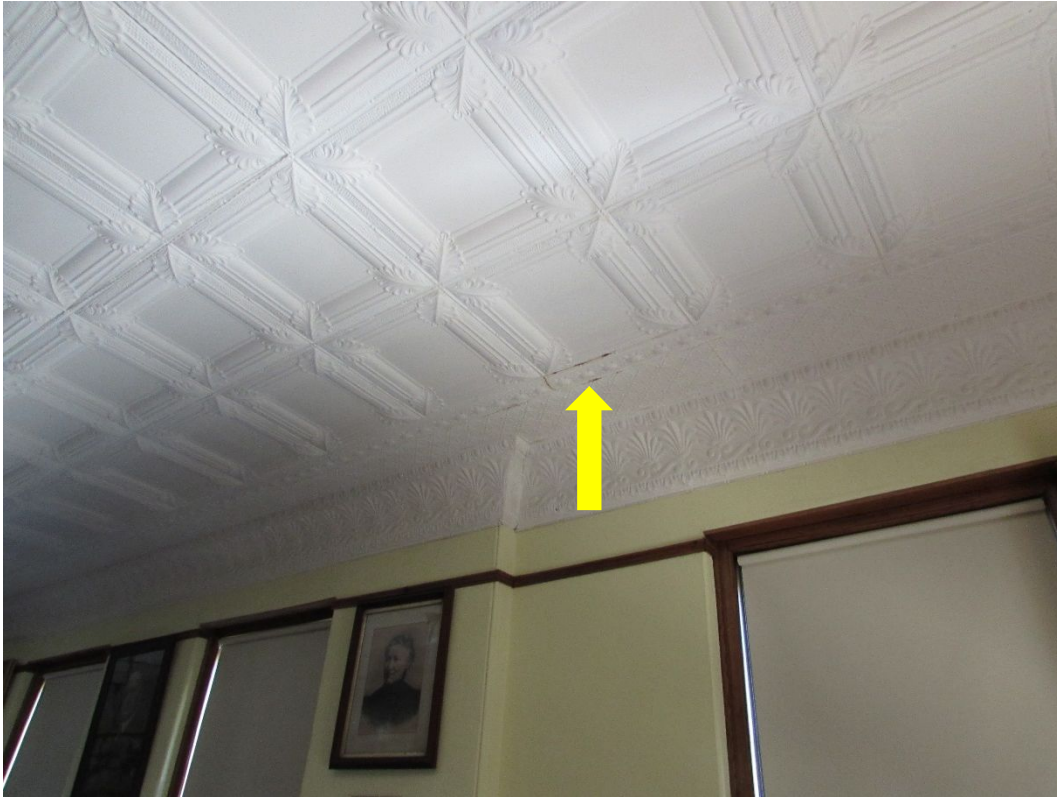
At the second floor main exhibition room, evidence of water intrusion including corrosion of the tin ceiling was observed at several locations; most significantly at the front right corner of the original structure. The plaster wall surface at this location was heavily stained, cracked and loose. Evidence of loose plaster surfaces were also found along the main stairway and the Indian Artifacts Gallery (original structure).

**Photo #66** – Evidence of corrosion and water infiltration

A decayed girder remains at the front right corner of the basement. Repair/reinforcement of this girder is required.
8. Evidence of long-term water intrusion is evident along the front wall of the building extending from the 2<sup>nd</sup> floor ceiling down to the basement framing. Decayed floor joists and wood framing were consistently found in the basement along the front wall. Loose stained plaster was found at the 2<sup>nd</sup> floor level along with corroded tin ceiling members. Removal and replacement of the decayed framing is required to prevent crushing or localized failure; crushing has occurred beneath the 1<sup>st</sup> floor piano. However, it is recommended that a section the hidden second floor members, roof rafters and brick wall surface be exposed to verify that the long-term water intrusion has not resulted in hidden decay/deterioration.

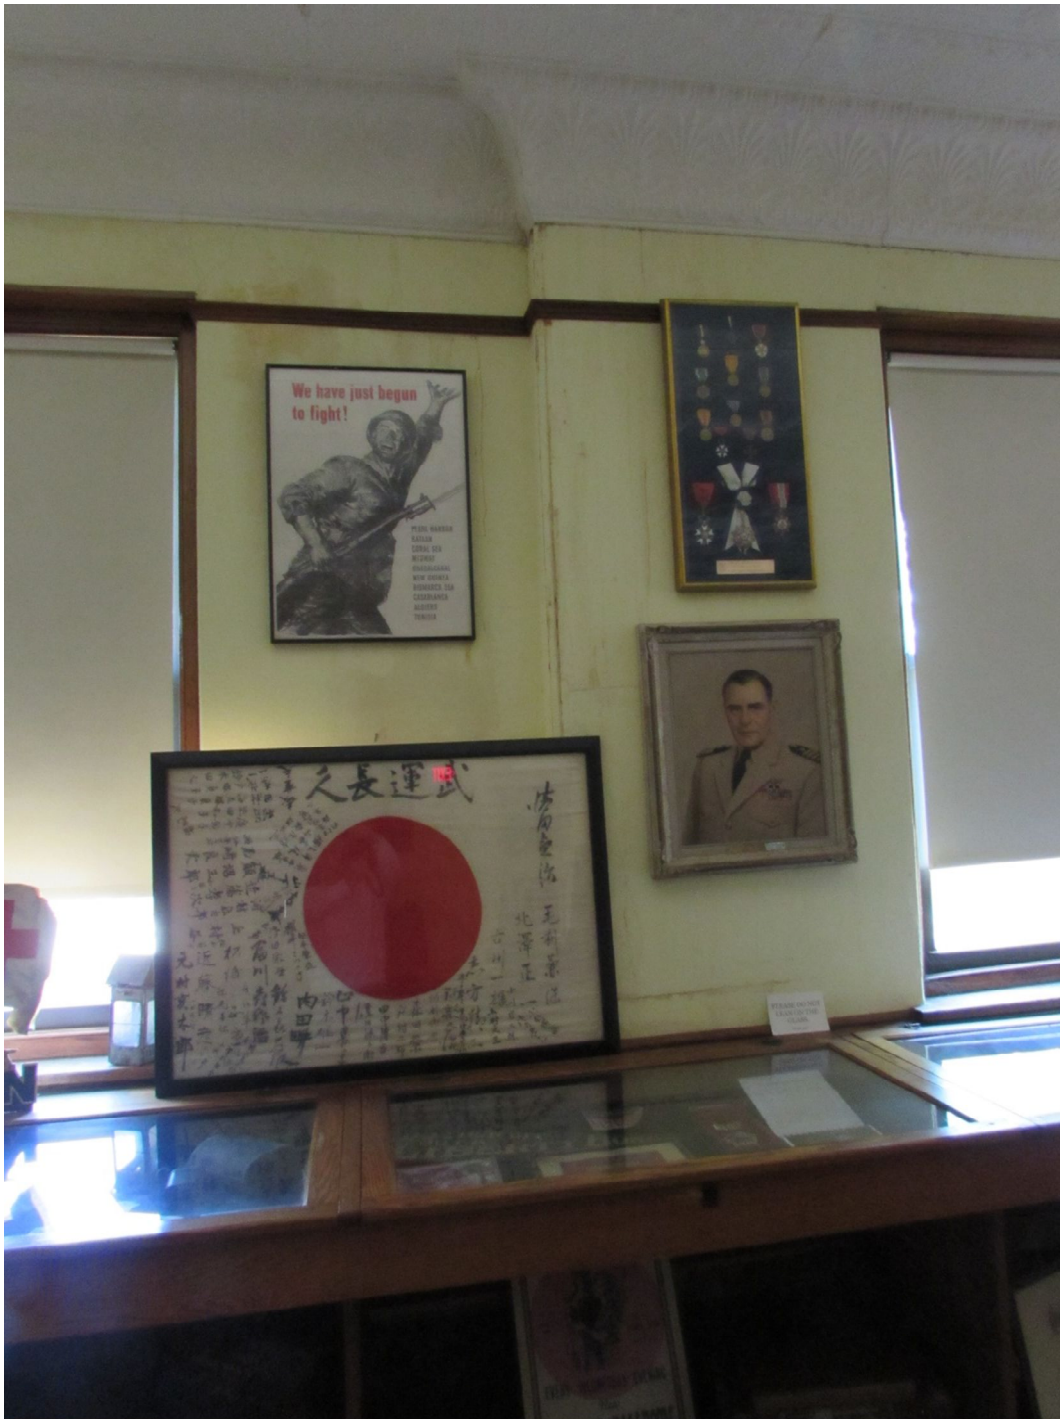
**Photo #67** – Significant evidence of water infiltration and loose plaster at front wall

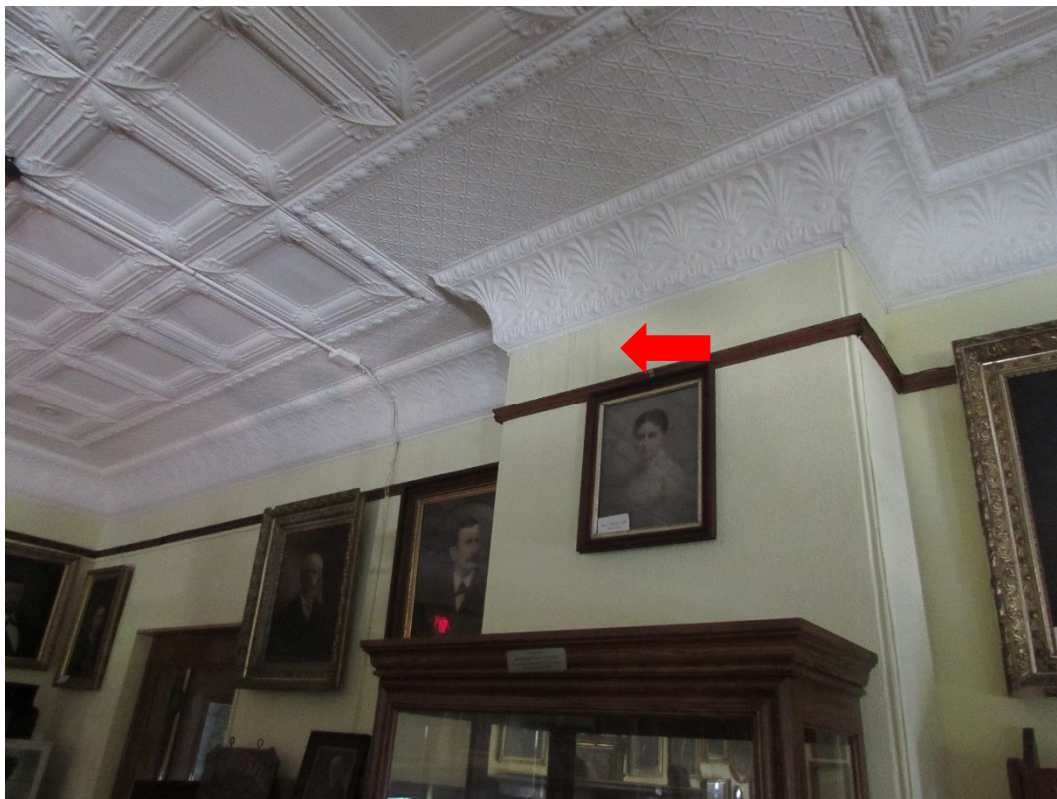
**Photo #68** – Evidence of water infiltration at right sidewall of original structure

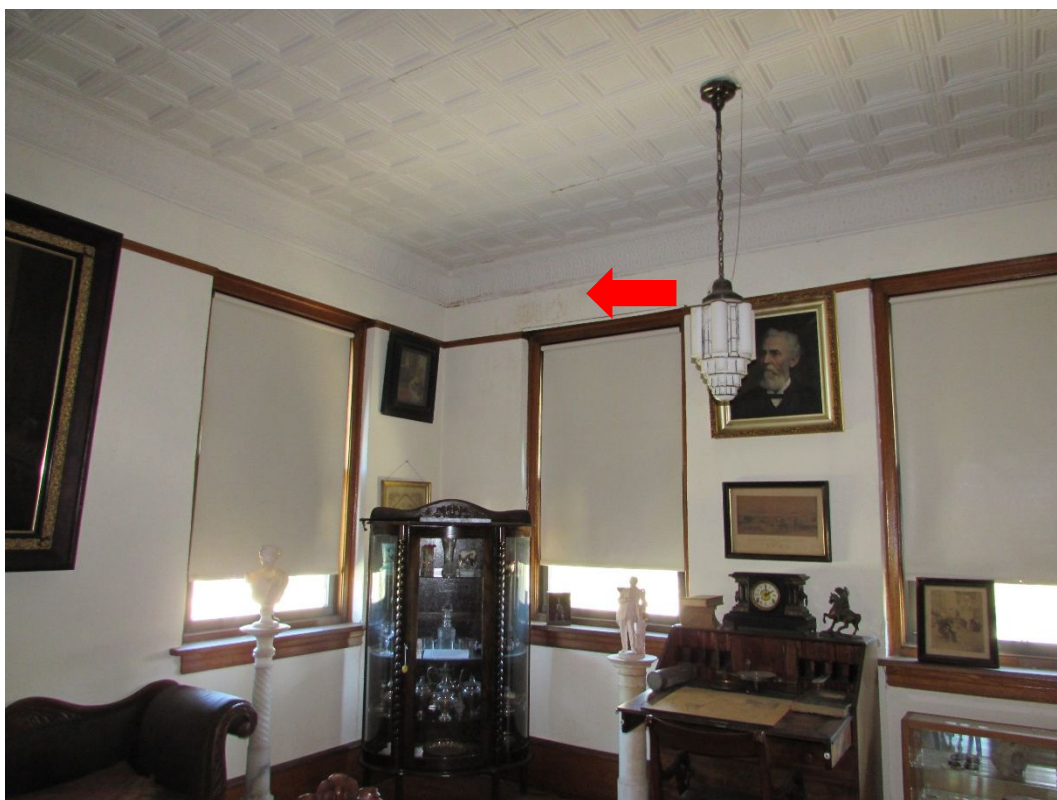
**Photo #69** – Evidence of water infiltration at front right corner of 1933 addition

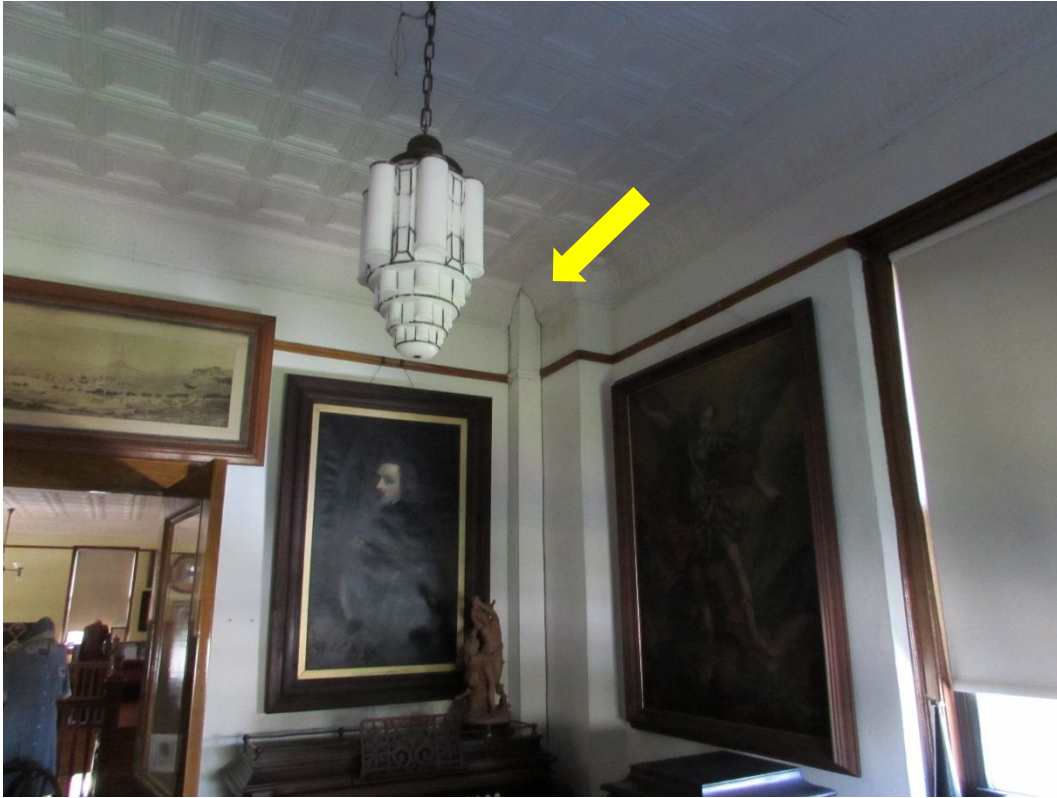
**Photo #70** – Water infiltration at 1933 addition

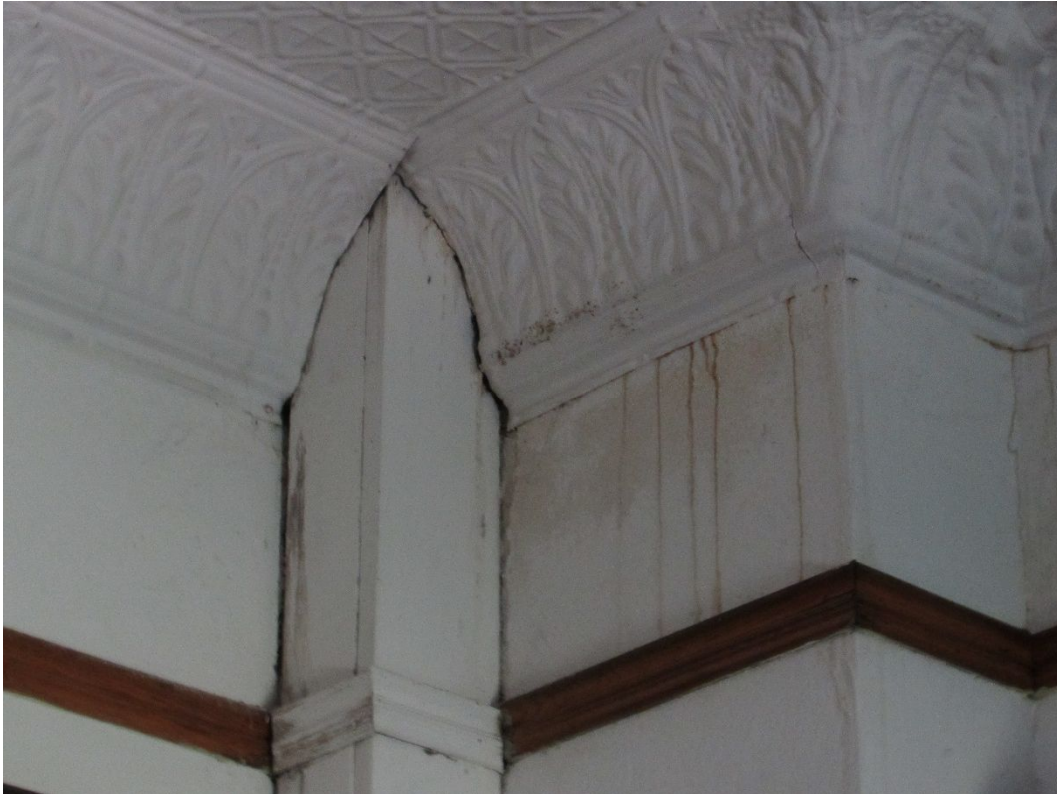
**Photo #71** – Close up view of photo #70

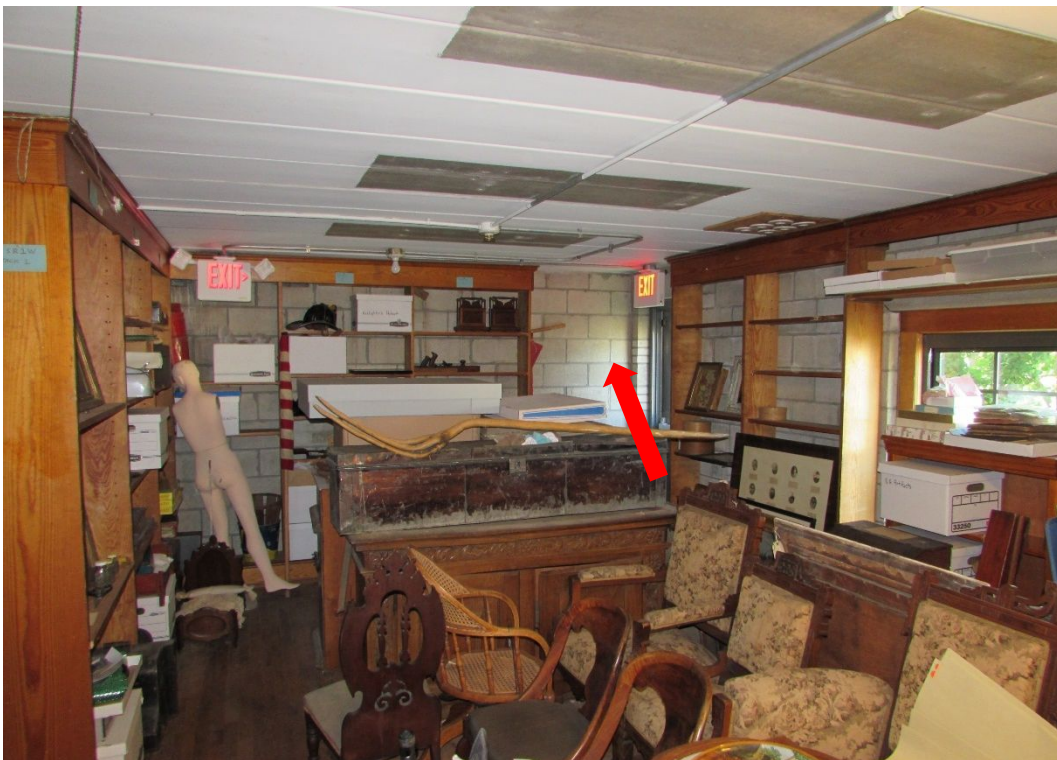
Minor settlement cracks were found on the masonry blocks walls of the 1964 addition at the 2<sup>nd</sup> floor level.

**Photo #77** – Overview of 2<sup>nd</sup> floor level (1964 addition)

Location of settlement cracking noted

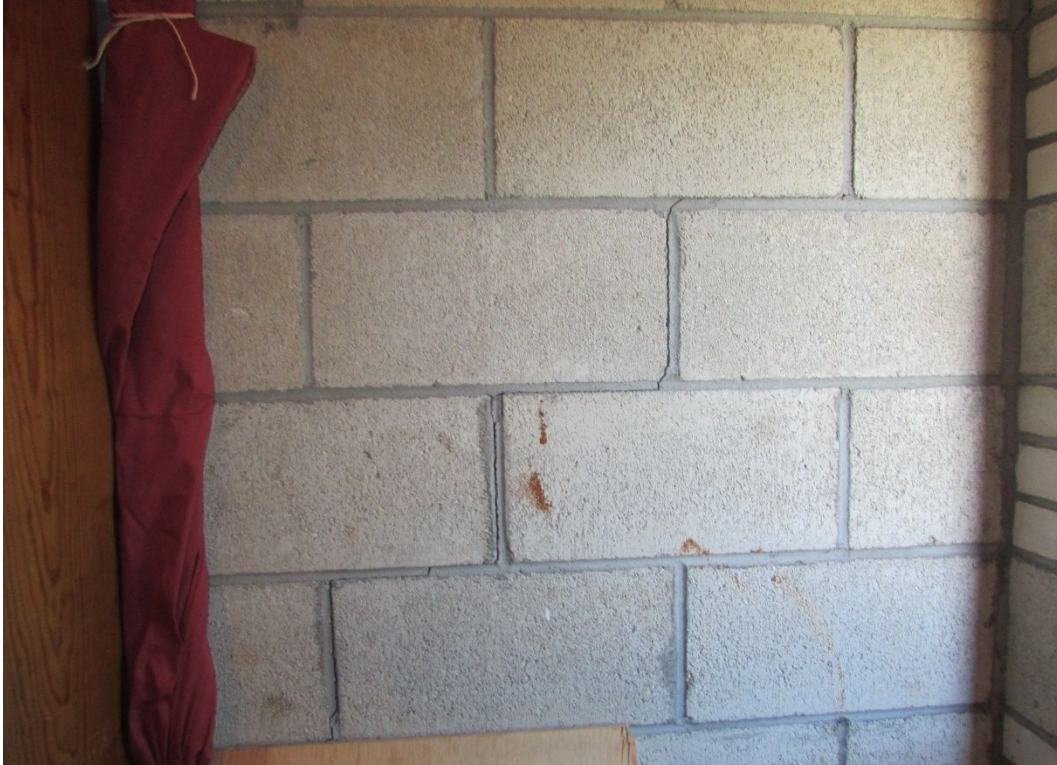
**Photo #78** – Close up view of settlement cracking in photo #77 above

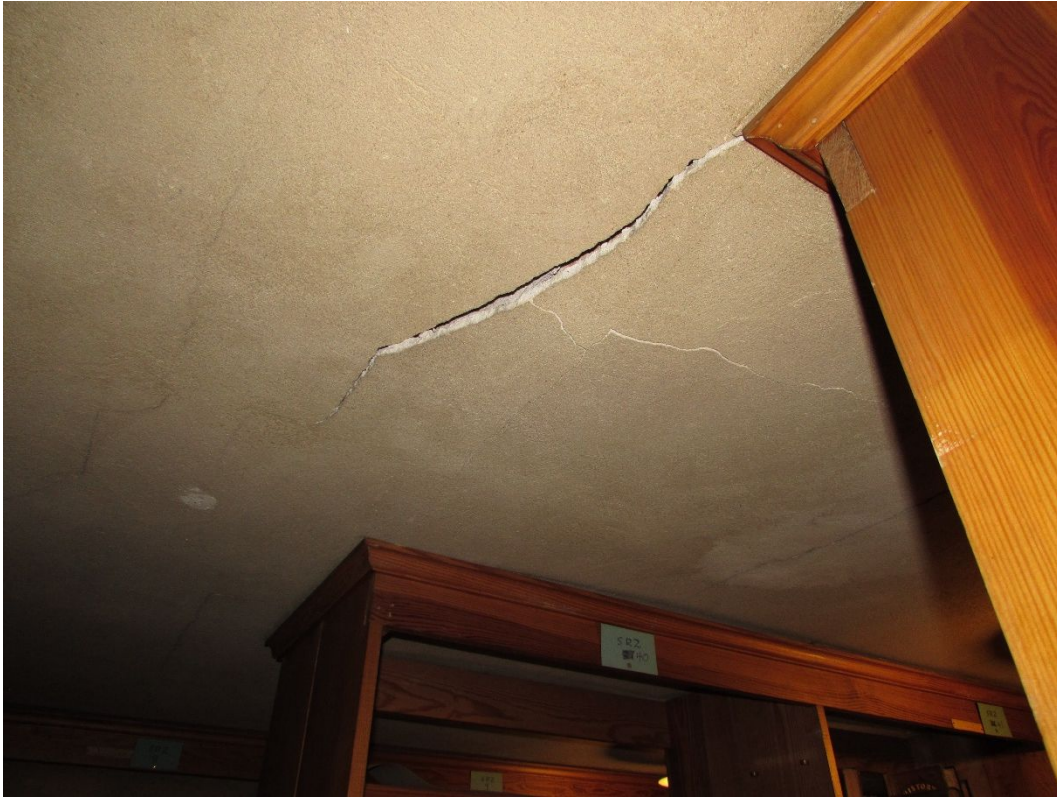
The 3<sup>rd</sup> floor Stack Room of the original structure exhibited a failing plaster ceiling. The ceiling was cracked, separated from the framing and several pieces had fallen. The 3<sup>rd</sup> floor Stack Room also contained an opening in the HVAC Chase.

**Photo #82** – Failing Plaster ceiling at Stack Room

9. Cracked and loose plaster surfaces were found in the basement ceiling and along localized areas of the first and second floors. This condition is the result of both natural aging and water intrusion (exterior walls only). Removal and reconstruction of these

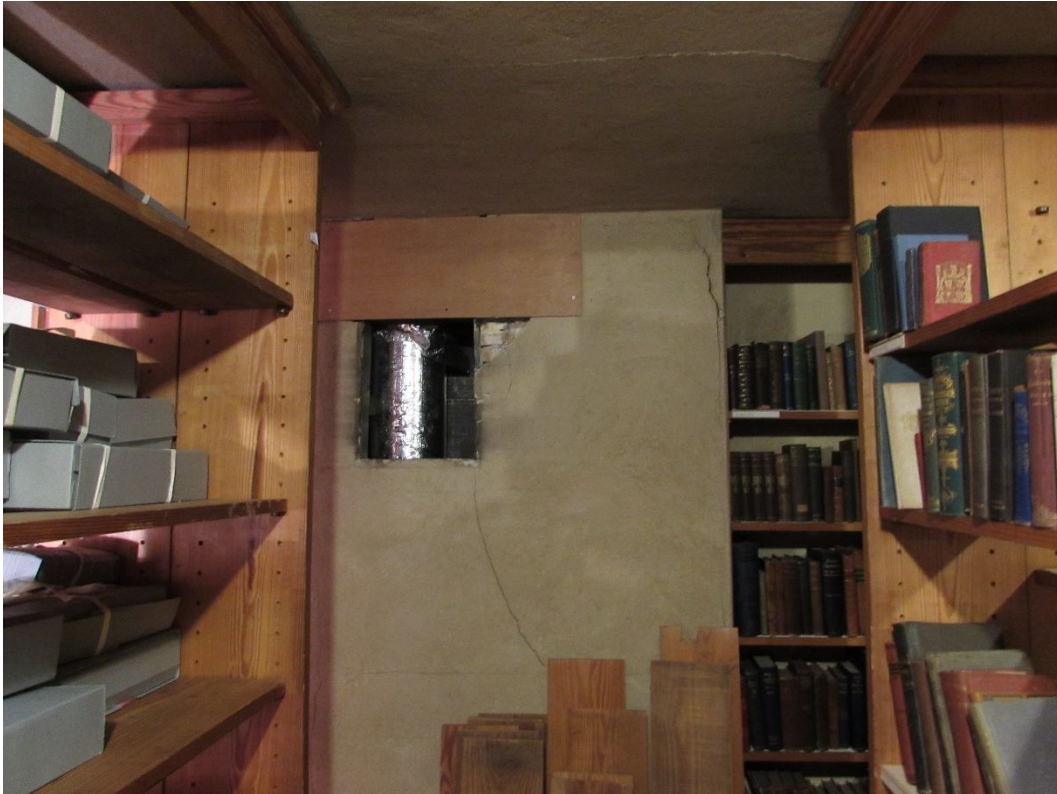
**Photo #83** – Opening in HVAC Chase (3<sup>rd</sup> Floor Stack Room)

Openings in the HAVC chase noted in the Stack Room also provide a means for a fire below to quickly spread to upper levels. It is recommended that a means of draftstopping be investigated for these areas.

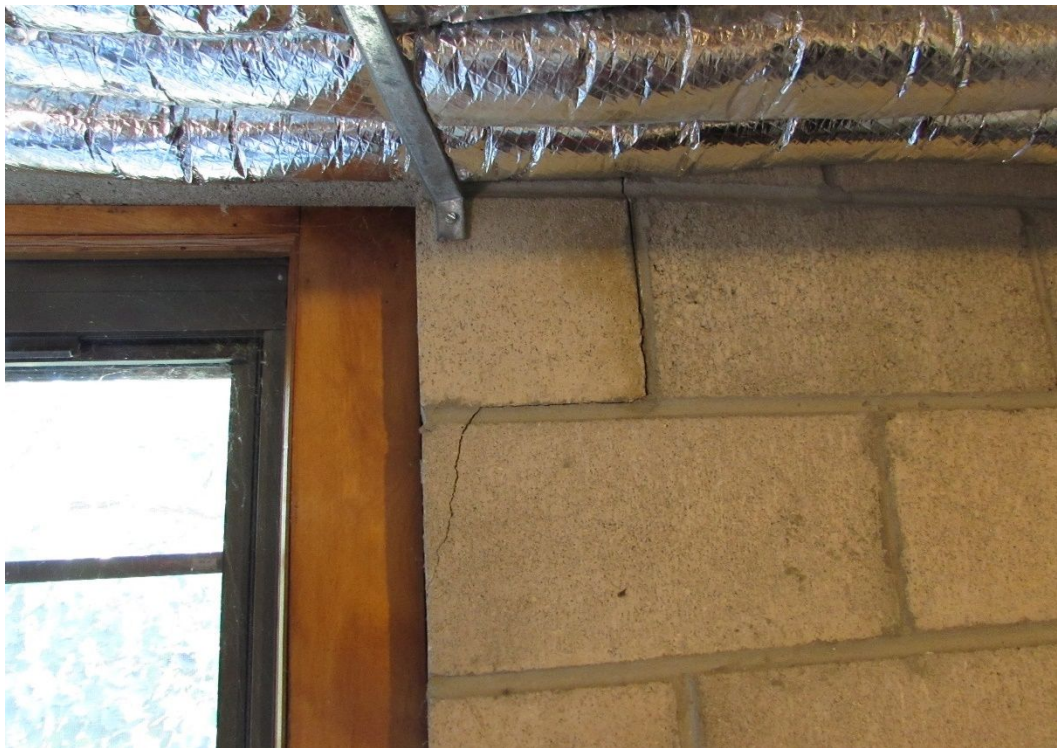
The 3<sup>rd</sup> floor of the 1964 addition was found to be in good condition with the exception of a bearing crack at each end of a window header. Water intrusion was also noted at the emergency exit door.

**Photo #85** – Bearing crack at end of window header

11. These building additions consist of concrete masonry block and precast concrete plank. No evidence of deficiencies were found at the building interior that warrant remedial measures with the exception of the 3<sup>rd</sup> floor level. Cracking was noted beneath the bearing ends of a window header; it is recommended that either the bearings ends be filled solid with mortar, or that the cracks be sealed with an epoxy injection. Improvements should also be made as necessary to ensure that the emergency exit door is weathertight.

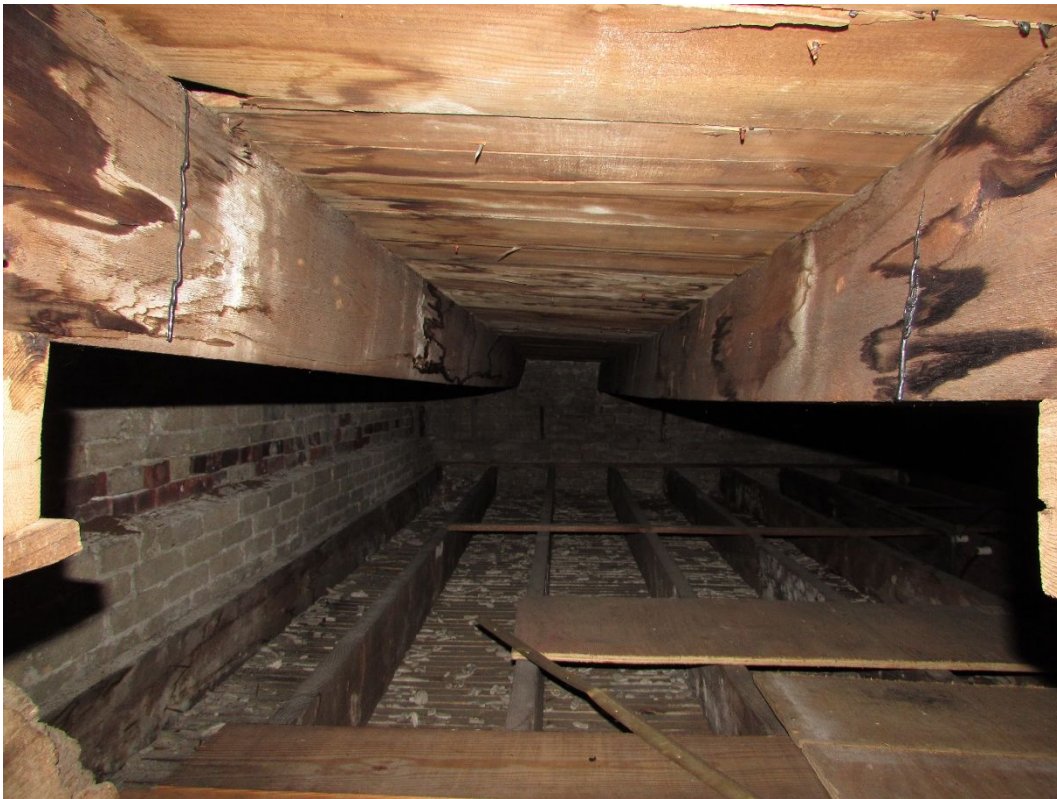
A limited section of the roof framing is visible through the roof hatch. Moisture staining was evident on the framing members. No visible evidence of cracking or decay was observed .

**Photo #87** – Roof framing visible at roof hatch

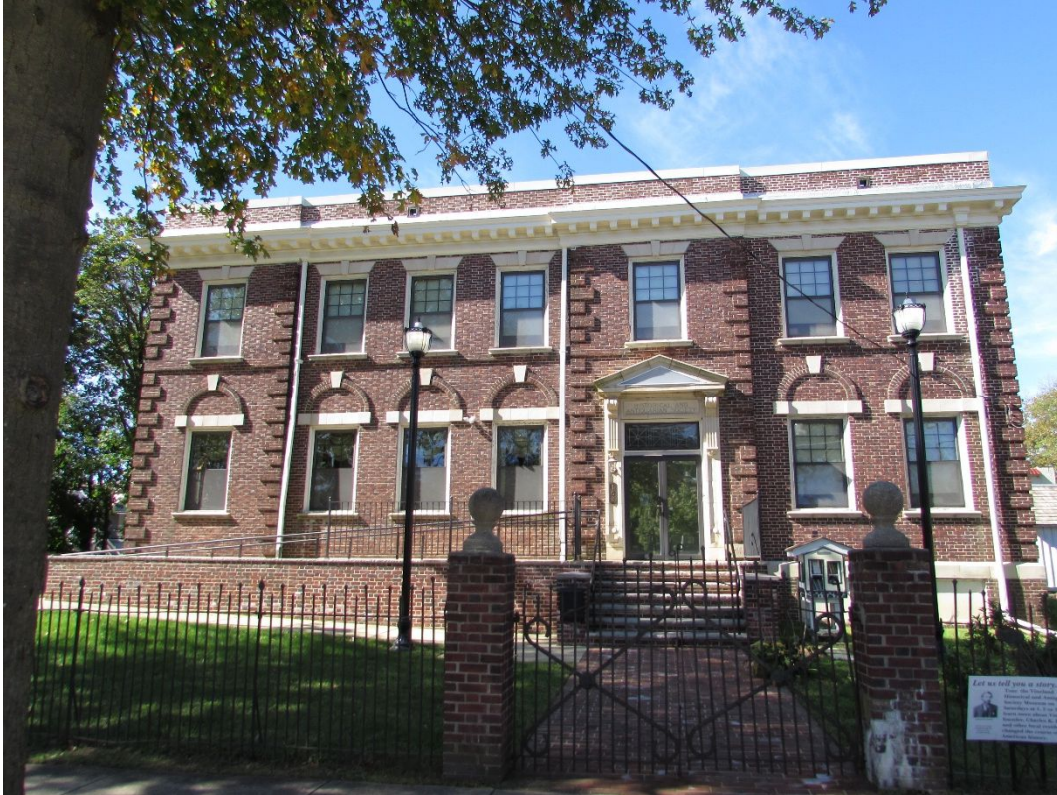
Exterior Façade - The exterior brick façade of the original structure and the right 1931 addition were both found to be in generally good condition. Open mortar joints were noted intermittently along with moderate weathering of the mortar joints. No significant evidence of cracking, bowing, separation or displacement were observed. A separation between the 1931 addition and the original structure was noted at both the front façade and left rear corner of the addition.

**Photo #88** – Front Façade

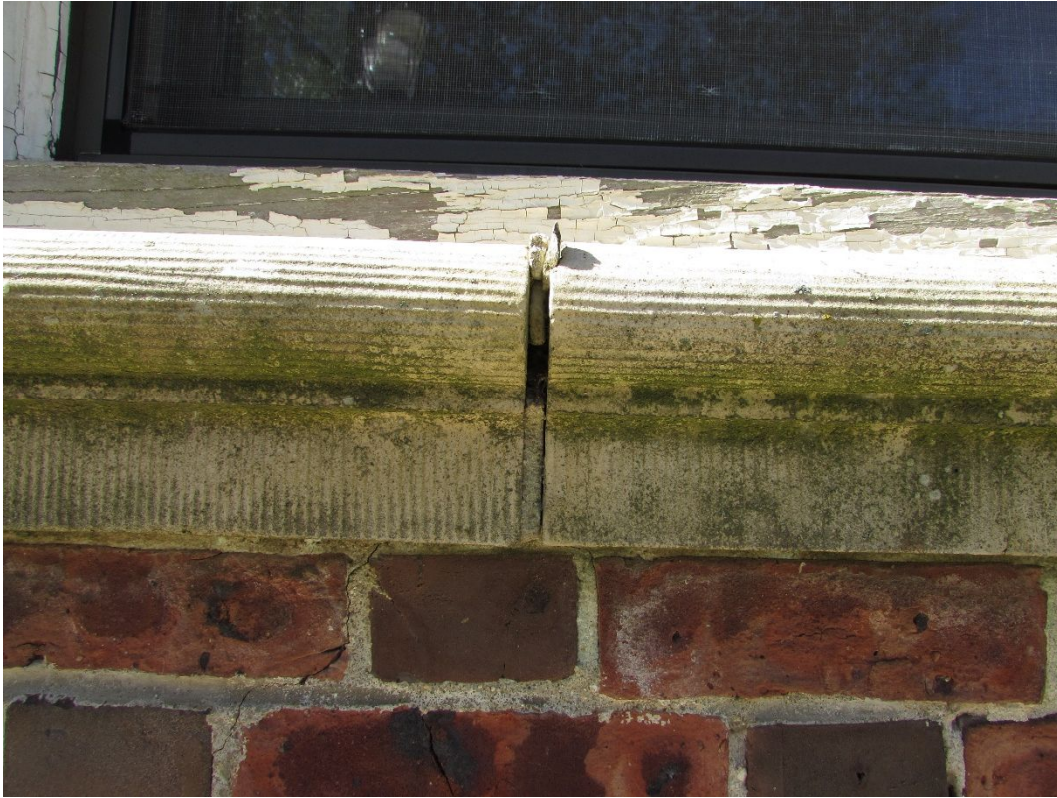
**Photo #98** – Open Joint at precast window sill

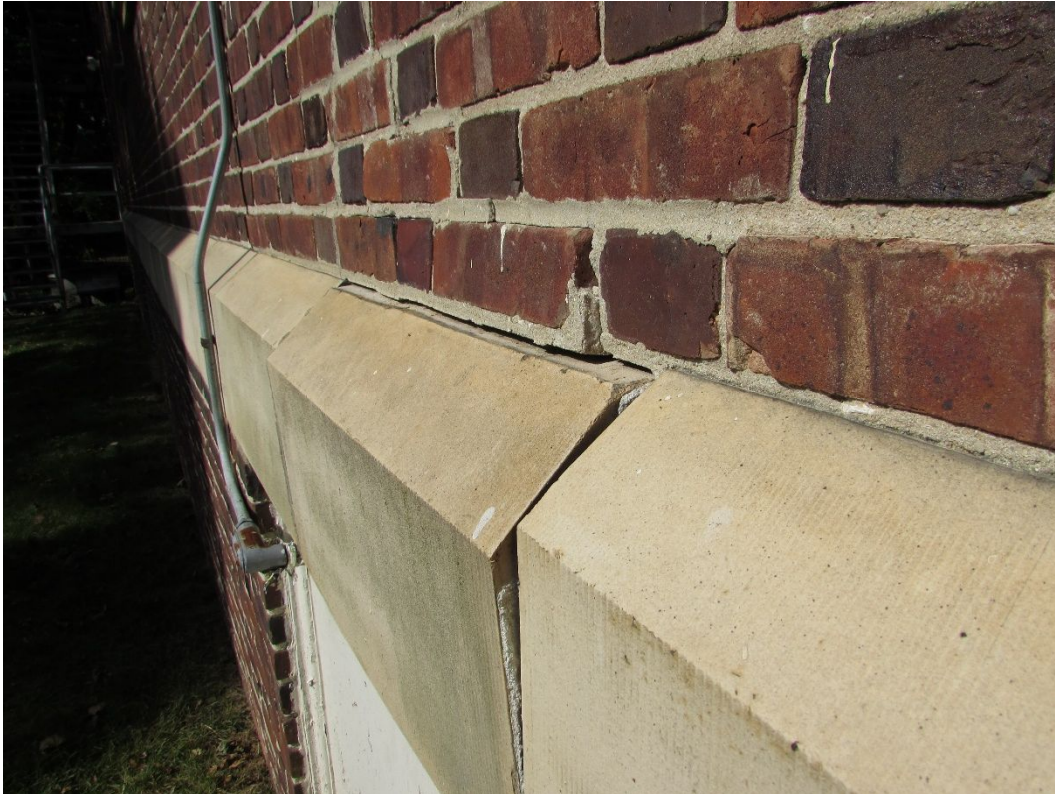
A precast concrete segment on the left façade was found to be dislodged; the location of this precast segment coincides with a decayed wood header above a basement window.

**Photo #101** – Side view depicting movement of segment

12. The exterior brick walls were generally found to be in good condition. No evidence of bowing, bulging, cracking or displacement was readily observed to suggest deterioration of the inner brick wythes due to moisture infiltration and freeze/thaw cycles. Repointing is required to fill various open joints and prevent water intrusion. Repointing of precast segments is also required. A precast segment at the left sidewall has displaced and will require re-setting.

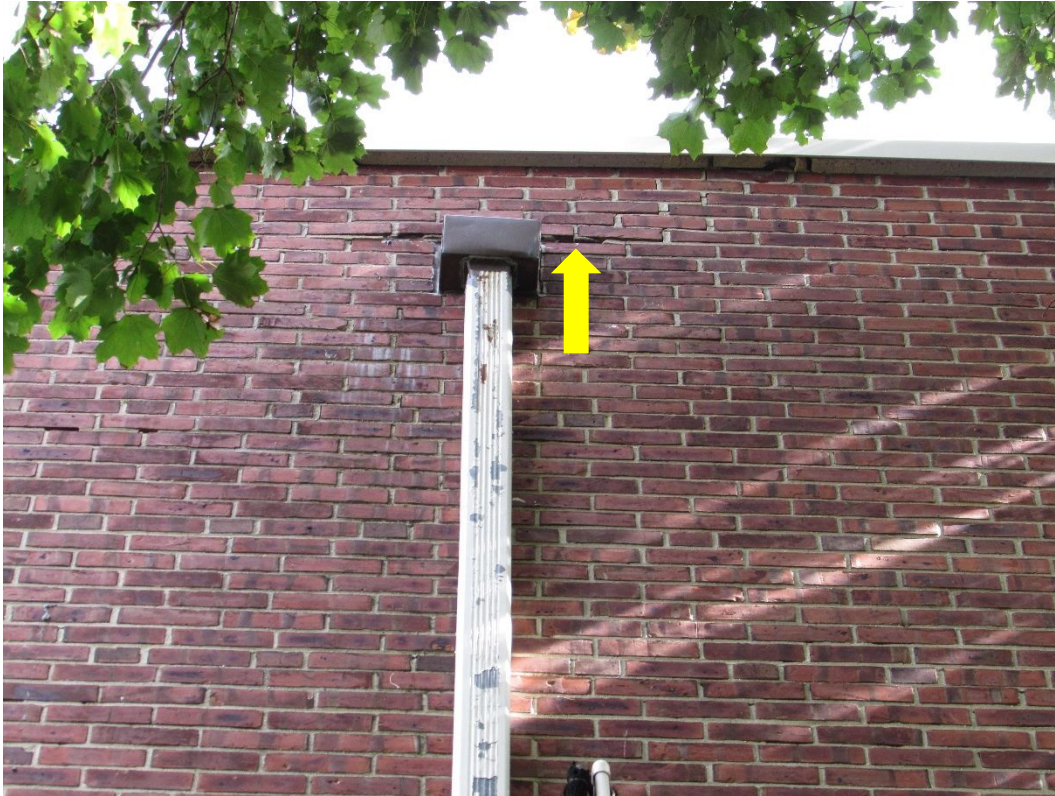
The rear wall of the 1933 and 1964 additions generally appeared to be in good condition. Open joints were noted at steel lintels above window openings. Minor lateral displacement was noted surrounding the roof scupper.

**Photo #108** – Appearance of minor lateral displacement at roof scupper

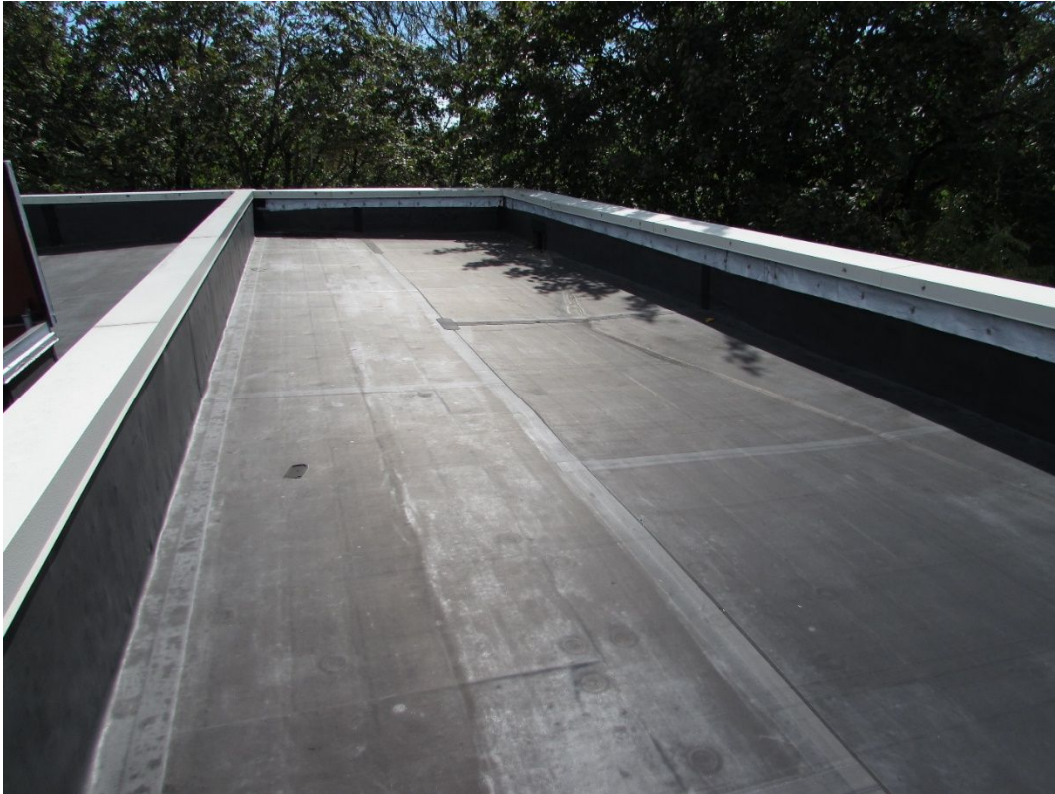
**Photo #113** – Roof Conditions above rear 1964 addition

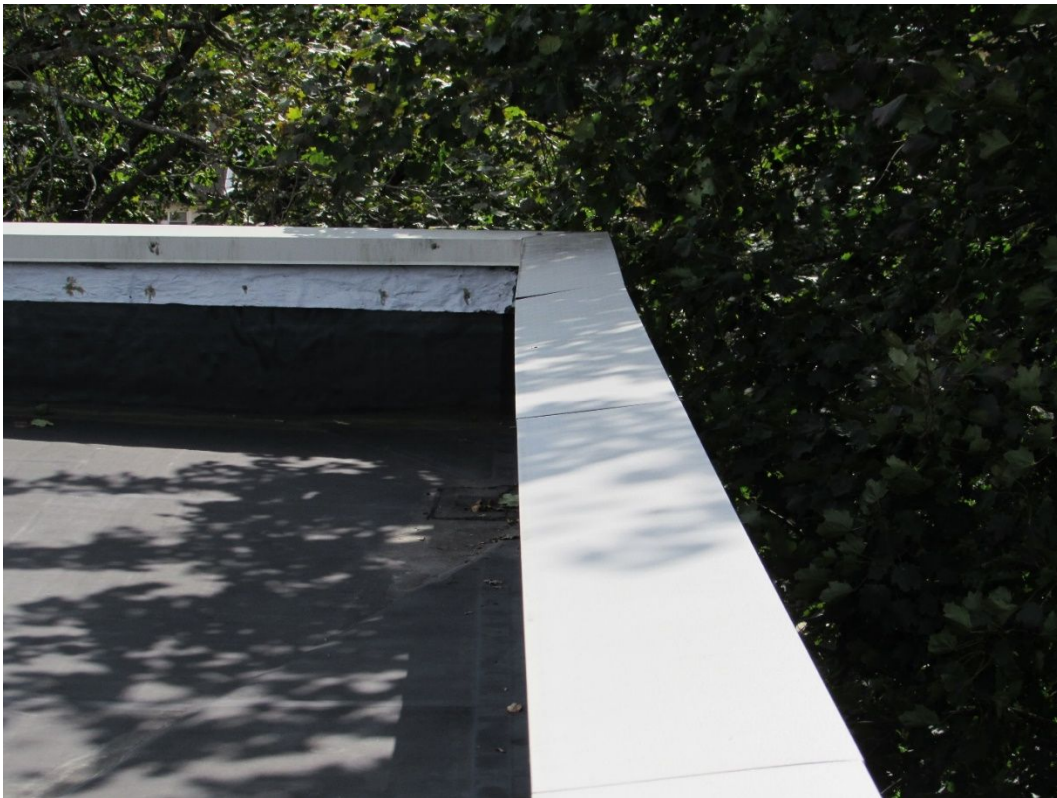
The parapet wall at the rear of the 1964 addition appeared to be rotated and leaning towards the front of the building; no horizontal cracking was readily apparent in the brick façade.

**Photo #115** – Rear parapet wall leaning inward

15. The rear parapet wall of the 1964 addition appeared to be leaning inward. This condition may be the result of thermal expansion of the precast concrete roof plank. No evidence of horizontal cracking was readily observed at the base of the parapet wall. However, it is recommended that a mason examine the area more closely for evidence of cracking. If cracking is discovered, repair or alterations may be required to ensure its long-term stability.
16. It is recommended that open joints at steel lintels be adequately caulked to prevent water intrusion. Corrosion of the steel lintels can result in the development of horizontal and stepped cracks in the brickwork as the steel expands due to corrosion.

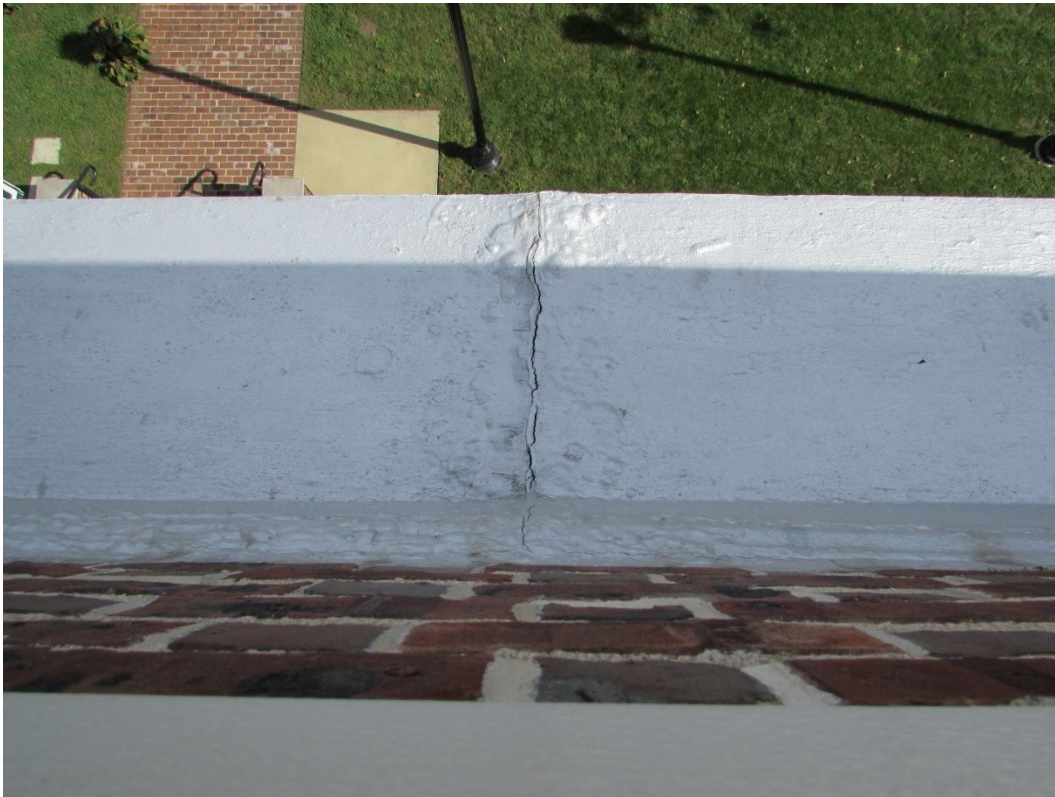
Open joints were noted in the dentil trim surrounding the building.

**Photo #116** – Looking down from roof at open seam in perimeter trim
