Mariners' Alerting and Reporting Scheme

MARS Report No 347 September 2021

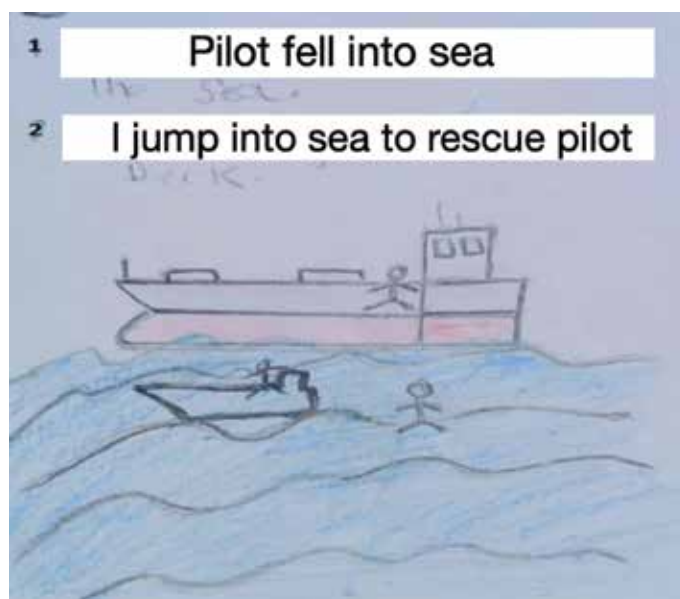
The small pilot skiff (seven metres long and one metre freeboard) came alongside and the pilot descended the ladder – about five to six metres. As he put one foot on the skiff, and the other still on the pilot ladder, the skiff moved away from ship's side due to waves. The pilot lost his balance, released his grip from the ladder and fell into the sea.

- Pilots and crew helping a pilot to the ladder should all wear lifejackets.
- In this case there was a happy ending. But resist the urge to jump into the water even if you have a lifejacket. It could then cause two victims.
- What is your plan if a person falls into the water from the pilot ladder?

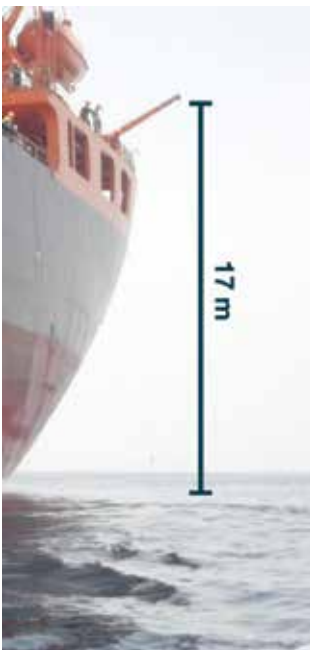
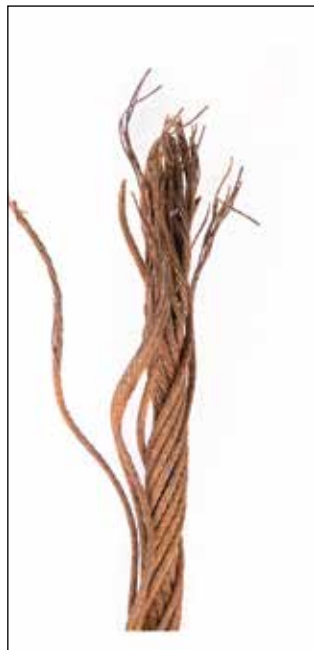
The official report found that the rescue boat davit's wire rope parted because it was corroded to the extent that its load bearing capacity was exceeded when the rescue boat was hoisted. However, the parting of the wire rope was an 'accident event' which could not in itself explain why the rescue boat system failed. Even though the company's Planned Maintenance System (PMS) instructed the officers to inspect and maintain the wire rope, they did not act upon the deteriorating condition of the wire rope. Neither did any of the other officers who continuously inspected, maintained and operated the rescue boat system even when the wire rope was readily visible.

The reason the poor condition of the wire rope was not recognised earlier was a combination of at least three factors:

1. The manufacturer's manual and PMS did not specify how to assess the condition of the wire rope.
2. An absence of training in assessing the wire rope's condition.
3. The PMS activities were compartmentalised. This meant that in practice only one person was assessing each component. All these factors were compounded by the thorough examination performed by service providers which gave the officers a blind trust in the system as a whole.

- Assessing the viability of a wire rope is not an intuitive process. Some wire rope may appear good but be unsafe while others may appear outwardly poor but still be very good. Special training is needed to properly inspect wire rope.
- A wire rope inspection checklist should be used for this task and the checklist should have viability criteria listed as a reminder for the person doing the inspection.
