Mariners' Alerting and Reporting Scheme

MARS Report No 362 December 2022

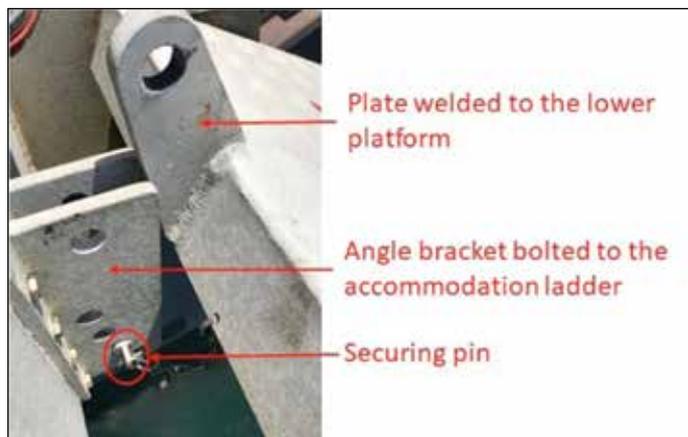
The lower platform is held in position by a securing pin that passes through one of four sets of holes in the angle bracket. The angle of the platform is determined by which set of holes on the angle bracket the securing pin is passed through. Changing the angle of the platform after the accommodation ladder is lowered requires the operator to crouch down to reach and remove the securing pin with one hand while using the other hand to hold onto the rope attached to the platform to reposition it at the intended angle. They can then put the securing pin in the proper set of holes.

While performing this balancing act, the seaman lost his balance and fell overboard. The Bosun immediately reported an MOB on the port side to the bridge with his handheld VHF radio and then ran aft to throw a life buoy. He lost sight of the victim when he was about 100 metres astern of the vessel. Meanwhile, the Master ordered the rudder hard to starboard. In the flurry of events, the lighted MOB buoy mounted on the bridge wing was not released.

- The bridge wing lighted MOB buoy was not released. This should be an automatic gesture by the OOW in any real MOB situation.
- PPE, PPE, PPE. Every time someone works overboard they should be wearing a lifejacket and a well secured safety harness.

- Look after yourself but also look after your mates! The victim decided to go down the accommodation ladder without his lifejacket and safety harness/line. Yet, both the OOW on the bridge watching the work and the Bosun acquiesced to this unsafe act.

- If acrobatic acts are necessary to complete a task, that means the task should probably not be completed under those conditions.

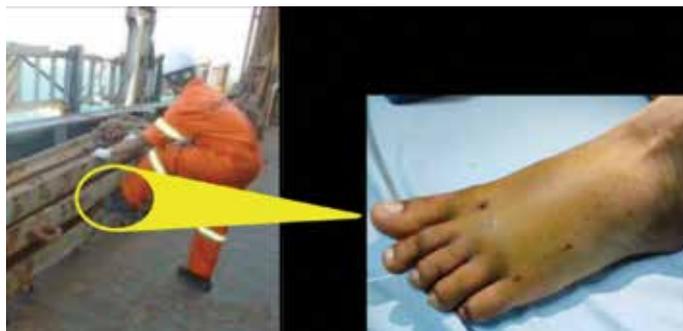
➔ The vessel was preparing to load a cargo of timber. The ship's crew were arranging the stanchions on the ship side that would be used for the timber stow on deck. One upright got stuck and the deck crewman attempted to pull it free, keeping his left foot underneath the upright for leverage. His left foot got stuck between two uprights, resulting in a foot injury. He was taken to the ship's hospital for treatment, put on light duties and recovered completely within two weeks.

Much as in the previous MARS report, an ‘acrobatic’ manoeuvre was attempted with a view to getting the job done. This attitude is very common and easily leads to negative outcomes. We all want to get the job done, and we are usually hesitant to ask for help or fetch the right tool. The ‘ask for help’ reflex should be instilled in crew by the vessel leaders.

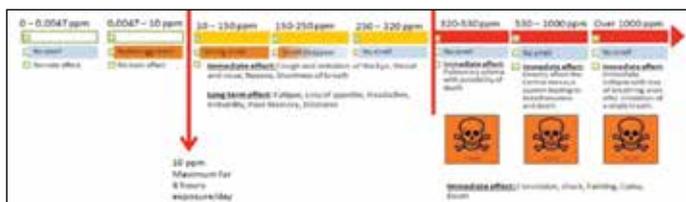
Very! The pictogram below found on the referenced Safety Alert gives an excellent idea of the consequences (see the full alert for full size version). Even 10 ppm is acceptable only if exposure is restricted to eight hours per day.

Anything at or above 320 ppm is dangerous or lethal and cannot be detected by smell.

Any indication of the presence of H₂S should be taken with the greatest urgency.

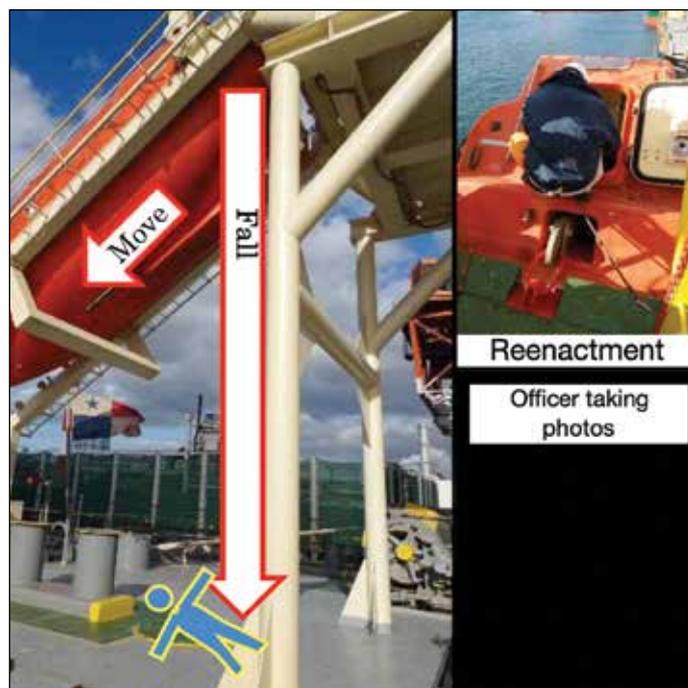
Once the lifeboat was back in position on its launching ramp, a navigation officer entered from the stern door to restore the release system that locks the hook onto the securing ring. Another officer was crouched down taking photos at the door to keep a record of the event, as shown in the reenactment photo.

As the officer inside the lifeboat worked on resetting the release system, he tried to insert the safety pin; the last step in the reset process. He was unable to fully insert the safety pin, and as he was trying to do so the hook was suddenly released and the lifeboat moved down about two metres on the ramp. This sudden movement caused the officer at the doorway to lose his balance. He fell to the deck six metres below, without a safety harness.

- This crew seemed to do everything right, until everything went wrong. Lowering the lifeboat to the sea and recovering it without crew on board reduces risks and bad outcomes. Despite this, an unsafe act with lethal consequence occurred in what appeared to be a secure and safe environment.
- Some environments appear safe yet they really are not so. In this case the lifeboat was recovered and was in its final stowed position. But it was not yet locked in place and the victim was in a precarious location without fall protection.

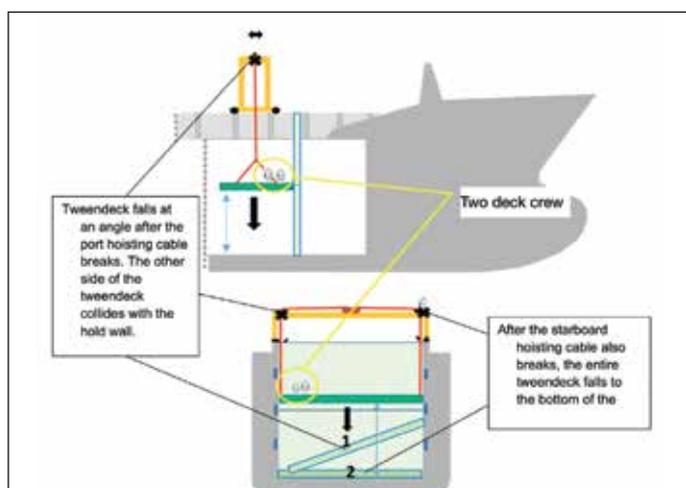
With the officer working the hatchcover crane and the two deck crew standing on the tweendeck, they began filling the gaps. Starting at the top of the hold, the tweendeck was gradually lowered in increments which allowed the deck crew to seal the gaps between the transverse bulkhead and the port and starboard hold walls.

The port hoisting cable broke and the port side of the tweendeck fell to the bottom of the hold, damaging the starboard side of the hold wall and sending the two crew tumbling to one side. The starboard hoisting cable then also broke, and the entire tweendeck fell to the bottom of the hold.

Investigation revealed that both the port and starboard hoisting cables were extremely worn. Neither of them was well coated with lubricating grease to protect against the corrosive maritime environment.

The 'safety coefficient' or safety factor applied to the hoisting cables was 1:5, which is standard for lifting cargo or other loads such as the hatch covers but not for lifting persons, which is usually applied at a 1:10 ratio, or twice as stringent. The hoisting cables had been installed five years earlier and had been successfully tested and examined by a certification body about four years earlier. About nine months before the occurrence they had undergone and passed an annual examination.

- When working at height, always, always wear a safety harness and line that is rigged to protect from a fall.
- Appliances and accessories for lifting humans are usually specially designed for this purpose. The safety factors involved in the design and specifications are normally greater than those used for cargo.

- The wire rope was extremely worn. Cost cannot be a factor for not replacing a wire rope, because good products are readily available and are relatively inexpensive when compared to other vessel costs. In essence, there is no excuse for an old wire rope to be in use.
- Even new wires can be damaged at any time. Careful and regular inspections should be the norm, as should proper maintenance such as lubrication – preferably the penetrating type that goes to the wire rope core and leaves the exterior layer clear for proper inspection.
- As a good practice, companies should strive to integrate manufacturer's specifications and advice for equipment used on their vessels into their SMS procedures.
