Mariners' Alerting and Reporting Scheme

MARS Report No 362 December 2022

Deadly MOB while rigging pilot combination ladder

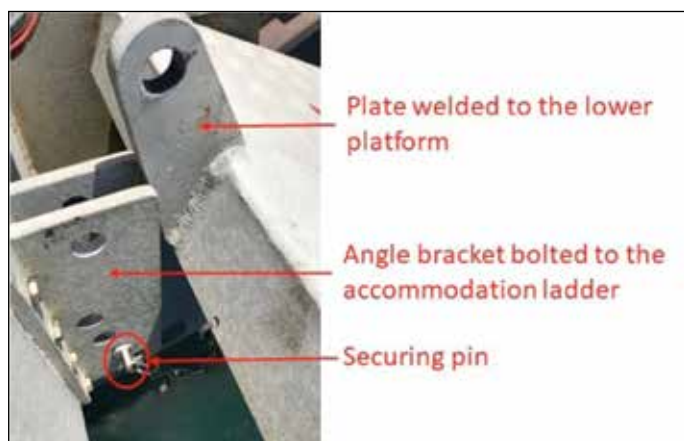
The lower platform is held in position by a securing pin that passes through one of four sets of holes in the angle bracket. The angle of the platform is determined by which set of holes on the angle bracket the securing pin is passed through. Changing the angle of the platform after the accommodation ladder is lowered requires the operator to crouch down to reach and remove the securing pin with one hand while using the other hand to hold onto the rope attached to the platform to reposition it at the intended angle. They can then put the securing pin in the proper set of holes.

While performing this balancing act, the seaman lost his balance and fell overboard. The Bosun immediately reported an MOB on the port side to the bridge with his handheld VHF radio and then ran aft to throw a life buoy. He lost sight of the victim when he was about 100 metres astern of the vessel. Meanwhile, the Master ordered the rudder hard to starboard. In the flurry of events, the lighted MOB buoy mounted on the bridge wing was not released.

- The bridge wing lighted MOB buoy was not released. This should be an automatic gesture by the OOW in any real MOB situation.
- PPE, PPE, PPE. Every time someone works overboard they should be wearing a lifejacket and a well secured safety harness.

- Look after yourself but also look after your mates! The victim decided to go down the accommodation ladder without his lifejacket and safety harness/line. Yet, both the OOW on the bridge watching the work and the Bosun acquiesced to this unsafe act.

- If acrobatic acts are necessary to complete a task, that means the task should probably not be completed under those conditions.

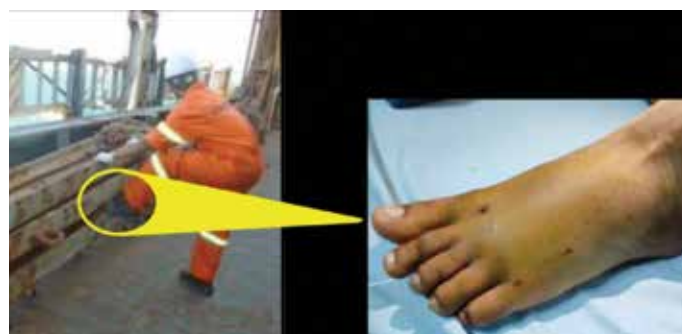
➔ The vessel was preparing to load a cargo of timber. The ship's crew were arranging the stanchions on the ship side that would be used for the timber stow on deck. One upright got stuck and the deck crewman attempted to pull it free, keeping his left foot underneath the upright for leverage. His left foot got stuck between two uprights, resulting in a foot injury. He was taken to the ship's hospital for treatment, put on light duties and recovered completely within two weeks.

Much as in the previous MARS report, an ‘acrobatic’ manoeuvre was attempted with a view to getting the job done. This attitude is very common and easily leads to negative outcomes. We all want to get the job done, and we are usually hesitant to ask for help or fetch the right tool. The ‘ask for help’ reflex should be instilled in crew by the vessel leaders.

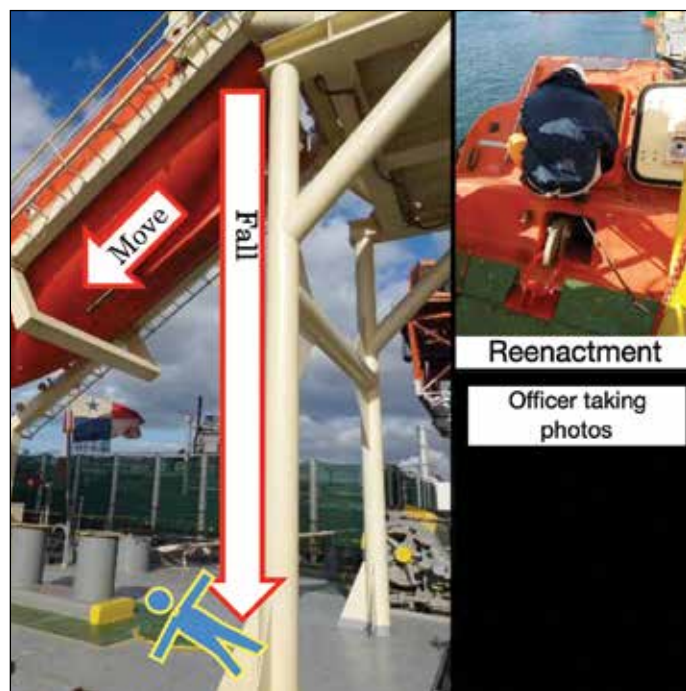
Once the lifeboat was back in position on its launching ramp, a navigation officer entered from the stern door to restore the release system that locks the hook onto the securing ring. Another officer was crouched down taking photos at the door to keep a record of the event, as shown in the reenactment photo.

As the officer inside the lifeboat worked on resetting the release system, he tried to insert the safety pin; the last step in the reset process. He was unable to fully insert the safety pin, and as he was trying to do so the hook was suddenly released and the lifeboat moved down about two metres on the ramp. This sudden movement caused the officer at the doorway to lose his balance. He fell to the deck six metres below, without a safety harness.

- This crew seemed to do everything right, until everything went wrong. Lowering the lifeboat to the sea and recovering it without crew on board reduces risks and bad outcomes. Despite this, an unsafe act with lethal consequence occurred in what appeared to be a secure and safe environment.
- Some environments appear safe yet they really are not so. In this case the lifeboat was recovered and was in its final stowed position. But it was not yet locked in place and the victim was in a precarious location without fall protection.

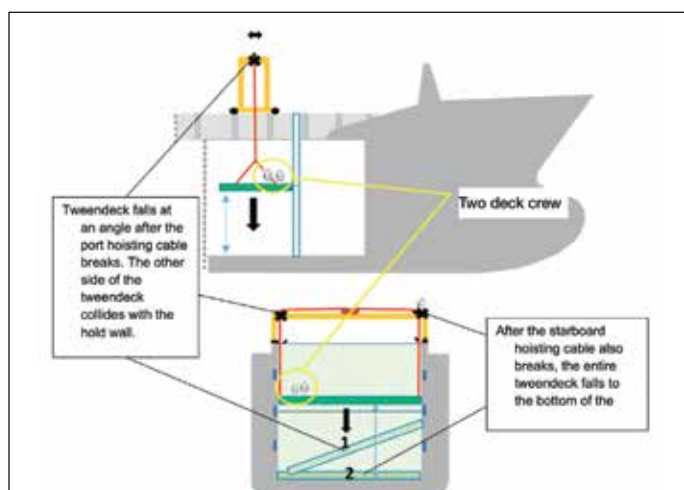
With the officer working the hatchcover crane and the two deck crew standing on the tweendeck, they began filling the gaps. Starting at the top of the hold, the tweendeck was gradually lowered in increments which allowed the deck crew to seal the gaps between the transverse bulkhead and the port and starboard hold walls.

The port hoisting cable broke and the port side of the tweendeck fell to the bottom of the hold, damaging the starboard side of the hold wall and sending the two crew tumbling to one side. The starboard hoisting cable then also broke, and the entire tweendeck fell to the bottom of the hold.

Investigation revealed that both the port and starboard hoisting cables were extremely worn. Neither of them was well coated with lubricating grease to protect against the corrosive maritime environment.

The 'safety coefficient' or safety factor applied to the hoisting cables was 1:5, which is standard for lifting cargo or other loads such as the hatch covers but not for lifting persons, which is usually applied at a 1:10 ratio, or twice as stringent. The hoisting cables had been installed five years earlier and had been successfully tested and examined by a certification body about four years earlier. About nine months before the occurrence they had undergone and passed an annual examination.

- When working at height, always, always wear a safety harness and line that is rigged to protect from a fall.
- Appliances and accessories for lifting humans are usually specially designed for this purpose. The safety factors involved in the design and specifications are normally greater than those used for cargo.

- The wire rope was extremely worn. Cost cannot be a factor for not replacing a wire rope, because good products are readily available and are relatively inexpensive when compared to other vessel costs. In essence, there is no excuse for an old wire rope to be in use.
- Even new wires can be damaged at any time. Careful and regular inspections should be the norm, as should proper maintenance such as lubrication – preferably the penetrating type that goes to the wire rope core and leaves the exterior layer clear for proper inspection.
- As a good practice, companies should strive to integrate manufacturer's specifications and advice for equipment used on their vessels into their SMS procedures.
