Mariners' Alerting and Reporting Scheme

MARS Report No 350 December 2021

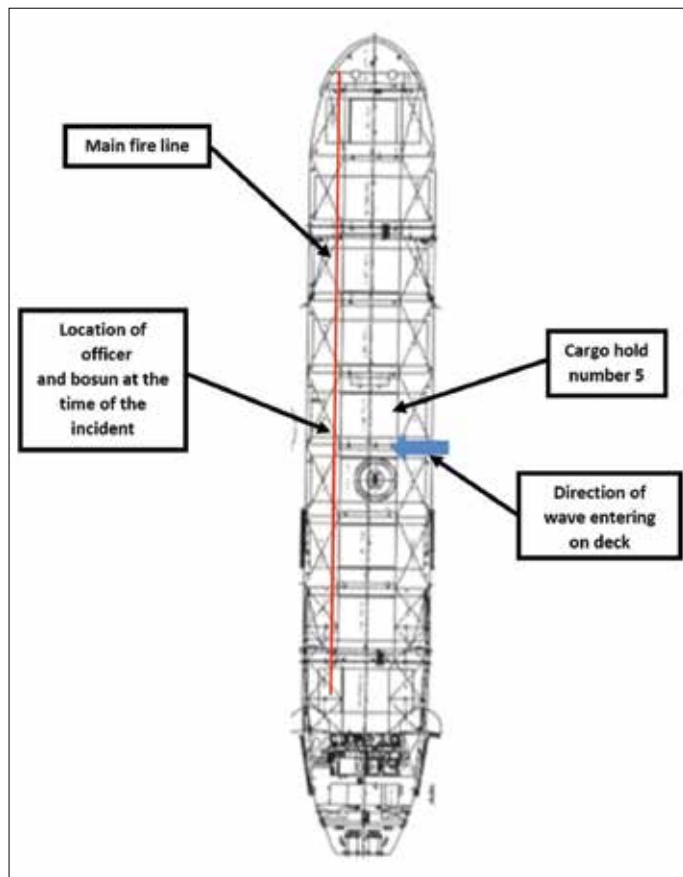
→ A loaded bulk carrier was under way at sea. A leak had been discovered in the main fire line on the main deck near hold five, and the bosun and an officer were tasked to fix it. The fire pump was stopped and the two men started working on replacing the flange gasket in the line. About an hour later, the OOW observed the wind speed and the height of waves increasing. The Master was informed of the deteriorating weather conditions, and contacted the chief officer and asked him to stop work on deck and secure the loose equipment.

By the time the chief officer told the men to stop work on the fire line the job was already completed. It only remained to collect the tools, which they proceeded to do after a rest break for coffee. As the men collected the tools, a heavy wave swept the deck from the starboard side. Both men were caught by the wave; the OOW held on to the railing, but the bosun was swept overboard by the force of the water. The alarm was raised and the crew began search sweeps of the area. Several hours later, with weather deteriorating further and darkness, the search was called off. The bosun was never found.

- Accessing the deck during heavy weather, even on a large vessel, can be very dangerous. Heavy winds and waves can result in a catastrophic outcome.
- No personnel should be allowed to access the deck in heavy weather unless it is necessary for the safety of the crew or ship. If the crew is required to go on deck during deteriorating weather conditions:
 - i) A thorough risk assessment should be performed and appropriate safeguards implemented to mitigate the risk of heavy weather and waves breaking on to the deck, such as taking the weather on the stern.
 - ii) Proper Personal Protective Equipment (PPE) such as a harness, safety line and a flotation device should be worn.

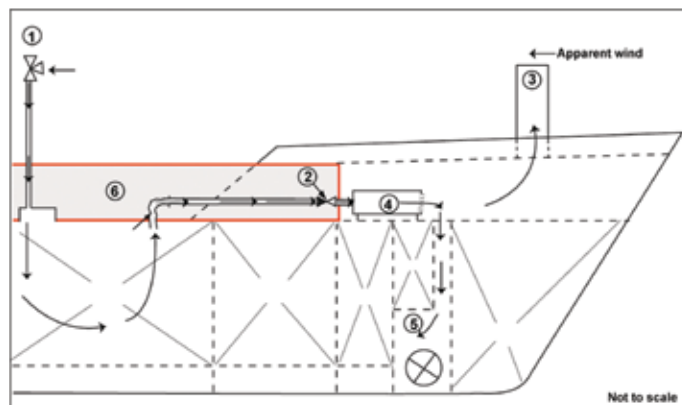
The analysis in the official report describes how, given that the forecastle door was open, the apparent wind across the vessel's bow had created an area of lower pressure in the forecastle. This, coupled with open PV valves, induced a flow of gasoline vapours from the cargo tank into the forecastle through the drying unit and the modified non-return valve, as shown in the diagram. The modifications to the non-return valve had not been approved. Once the heavier-than-air vapours passed through the tank-drying unit, they settled downward and into the bow thruster compartment. The vapours were probably ignited by an automatically controlled heating unit in the bow thruster compartment.

Migration of flammable vapours from cargo tank to bow thruster compartment

- The inappropriate practice of using the tank-drying equipment for cargo tank ventilation allowed the migration of explosive vapours into the bow thruster compartment.
- The modification of the double non-return valve reduced its effectiveness and contributed to the migration of explosive vapours into the forecastle and bow thruster compartment.
- With no formal procedures and training to mitigate the risks associated with tanker operations, the effectiveness of the vessel's safety management system (SMS) was reduced.

- Safety depends on training and good procedures. In this instance, there were no written procedures for safe tank venting and equipment designed for tank drying was being co-opted for tank venting.
- Any modifications to equipment, such as the double non-return valve in this case, should be vetted through the vessel's classification society.

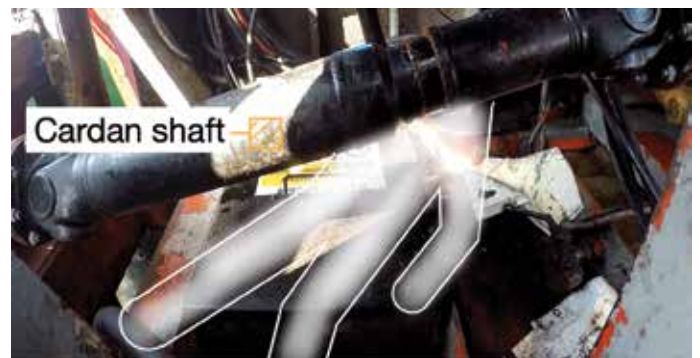
After helping the officer with an associated task, the Master returned to the bridge to inquire about progress with the tugboat. Suddenly, he heard a yell from the aft deck. He rushed back, finding the officer trapped under the cardan shaft. The officer had disconnected the lifting cylinder hose instead of the damaged hose, and the shaft had fallen down on him. The Master immediately searched for tools that could help release the officer. He tried to lift the cardan shaft using a strap and chain hoist, but without success. He then called for an ambulance, and, at the same time, got some persons on the quay to help him; a forklift truck and several crew members came from nearby ships. The forklift succeeded in lifting the cardan shaft, so the Master and another crew from a nearby ship could secure the shaft off of the victim.

Outline of victim under cardan shaft

The official investigation found, among others, that since the ship's crew (Master and officer) did not possess advanced mechanical engineering skills, they did not recognise that this repair might present special risks.

- On small vessels, the reduced crew can be tasked with duties that go beyond their competencies. This can bring unintended consequences that, as with this case, can prove fatal.
- If there is an emergency the first priority is to raise the alarm and solicit help. In this case, although well meaning, the Master lost valuable time rigging a strap and chain hoist for an improvised rescue before calling for help.
- Some perceived urgent situations can be, upon calm consideration, less urgent than initially assessed. In this case the vessel was nonetheless in a safe position near the berth and there was no need to undertake a hasty repair of the starboard propulsion.
- Mariners are often endowed with 'can-do' personalities; they wish to fix the problem in quick order. Resist this temptation and make a calm assessment of the situation before acting.

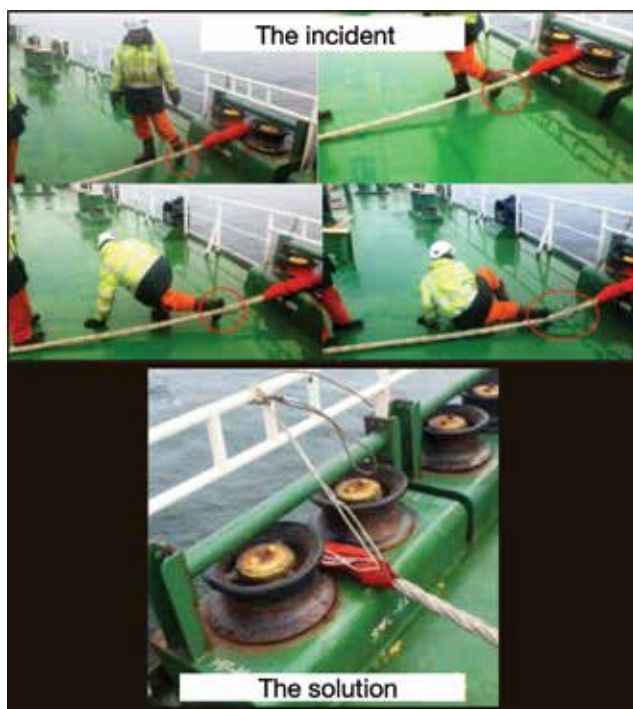
→ A vessel was in the process of berthing. A crew member carrying out his work at the forward berthing station tripped over the lanyard securing the spring line's chafing sleeve to the vessel's railing. The victim did not think he was injured but, when trying to stand he felt severe pain at his left hip.

- Even the most minor incident can lead to serious consequences. All incidents should be investigated and opportunities for risk reduction sought.
- A clean and unobstructed deck is a safe deck. In this case a small lanyard left adrift on the deck was enough to cause a repatriation.
