Mariners' Alerting and Reporting Scheme

MARS Report No 350 December 2021

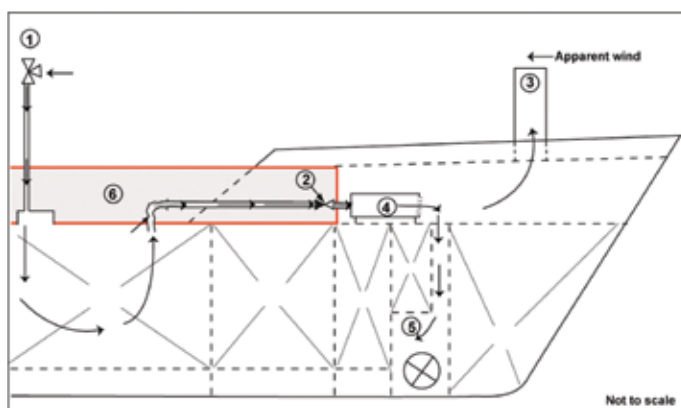
The analysis in the official report describes how, given that the forecabin door was open, the apparent wind across the vessel's bow had created an area of lower pressure in the forecabin. This, coupled with open PV valves, induced a flow of gasoline vapours from the cargo tank into the forecabin through the drying unit and the modified non-return valve, as shown in the diagram. The modifications to the non-return valve had not been approved. Once the heavier-than-air vapours passed through the tank-drying unit, they settled downward and into the bow thruster compartment. The vapours were probably ignited by an automatically controlled heating unit in the bow thruster compartment.

Migration of flammable vapours from cargo tank to bow thruster compartment

- The inappropriate practice of using the tank-drying equipment for cargo tank ventilation allowed the migration of explosive vapours into the bow thruster compartment.
- The modification of the double non-return valve reduced its effectiveness and contributed to the migration of explosive vapours into the forecabin and bow thruster compartment.
- With no formal procedures and training to mitigate the risks associated with tanker operations, the effectiveness of the vessel's safety management system (SMS) was reduced.

- Safety depends on training and good procedures. In this instance, there were no written procedures for safe tank venting and equipment designed for tank drying was being co-opted for tank venting.
- Any modifications to equipment, such as the double non-return valve in this case, should be vetted through the vessel's classification society.

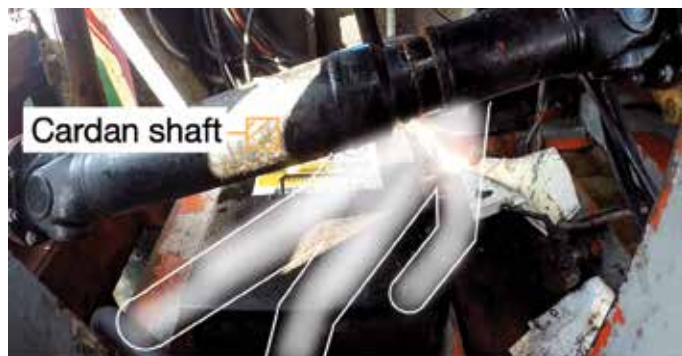
After helping the officer with an associated task, the Master returned to the bridge to inquire about progress with the tugboat. Suddenly, he heard a yell from the aft deck. He rushed back, finding the officer trapped under the cardan shaft. The officer had disconnected the lifting cylinder hose instead of the damaged hose, and the shaft had fallen down on him. The Master immediately searched for tools that could help release the officer. He tried to lift the cardan shaft using a strap and chain hoist, but without success. He then called for an ambulance, and, at the same time, got some persons on the quay to help him; a forklift truck and several crew members came from nearby ships. The forklift succeeded in lifting the cardan shaft, so the Master and another crew from a nearby ship could secure the shaft off of the victim.

Outline of victim under cardan shaft

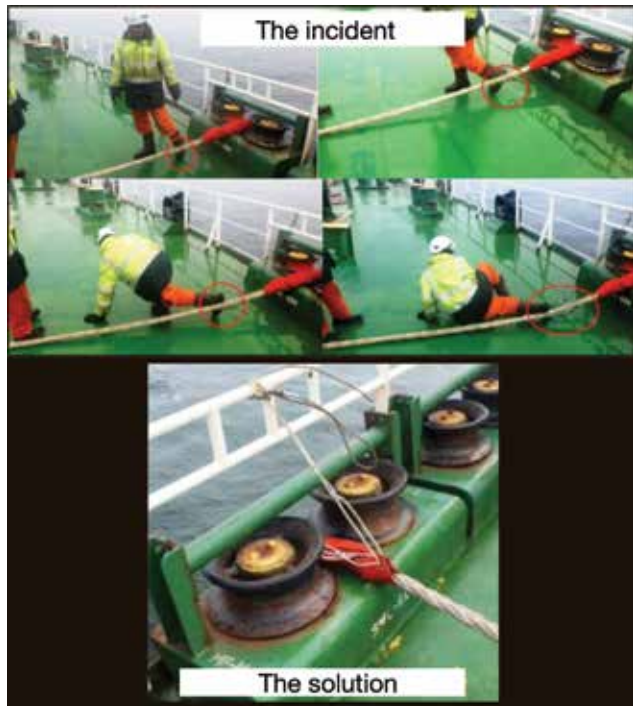
→ A vessel was in the process of berthing. A crew member carrying out his work at the forward berthing station tripped over the lanyard securing the spring line's chafing sleeve to the vessel's railing. The victim did not think he was injured but, when trying to stand he felt severe pain at his left hip.

- Even the most minor incident can lead to serious consequences. All incidents should be investigated and opportunities for risk reduction sought.
- A clean and unobstructed deck is a safe deck. In this case a small lanyard left adrift on the deck was enough to cause a repatriation.
