Mariners' Alerting and Reporting Scheme

MARS Report No 352 February 2022

Fishing for lessons learned!

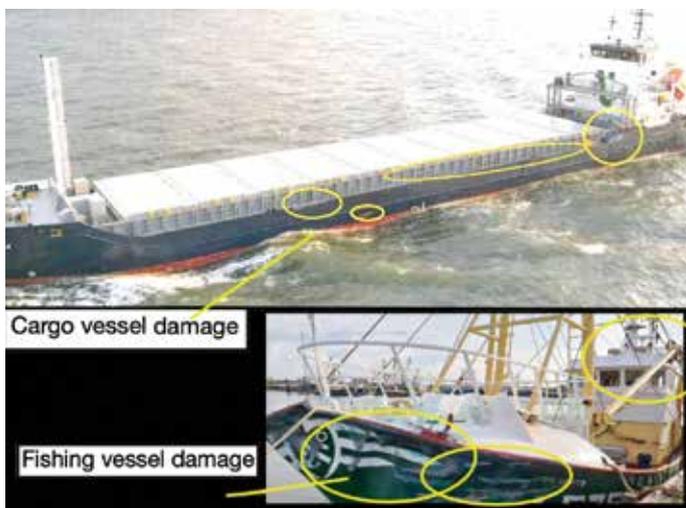
Two of the other fishing boats, A and B, kept a course of approximately 006 degrees. At one point, fishing boat B altered course slowly towards 011 degrees to pass astern of the cargo vessel, but fishing vessel A did not follow this move. Its CPA to the cargo vessel was approximately .05 nm. In the following minutes, the OOW of the cargo vessel noticed that the CPA of fishing boat A had decreased to zero.

By this time another officer had arrived on the bridge of the cargo vessel for the change of watch. Before the handover could be accomplished the OOW on duty realised that fishing vessel A was not taking avoiding action. The OOW sounded the horn to warn fishing vessel A and then put the rudder hard to starboard. About 40 seconds after sounding the horn, the two vessels collided. Fishing vessel A ran into the port side of the cargo vessel amidships and then slid aft. Both vessels sustained structural damage but there were no injuries.

It was discovered during the investigation that the lone watchkeeper on board fishing vessel A did not realise the cargo vessel was there until it was too late. The investigation also found that the 'apparent intentions' of the four fishing vessels contributed to the accident. Some of the fishing vessels did take action to avoid the cargo vessel but in the end, one did not. The OOW on the cargo vessel assumed all the fishing vessel crews had observed his ship, but he was wrong.

- When in doubt and always when a very small CPA is detected, establish early communications with the other vessel and ensure everyone knows what actions are to be taken.
- Sound navigation practices and a good lookout would have avoided this accident as the Master of the fishing boat would have realised there was a stand-on cargo boat on his course with a zero CPA.

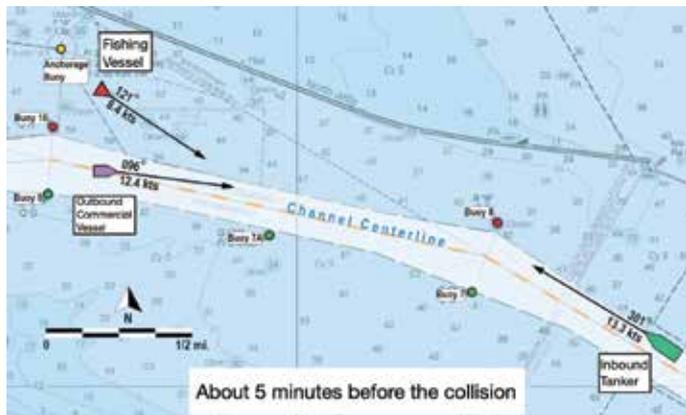
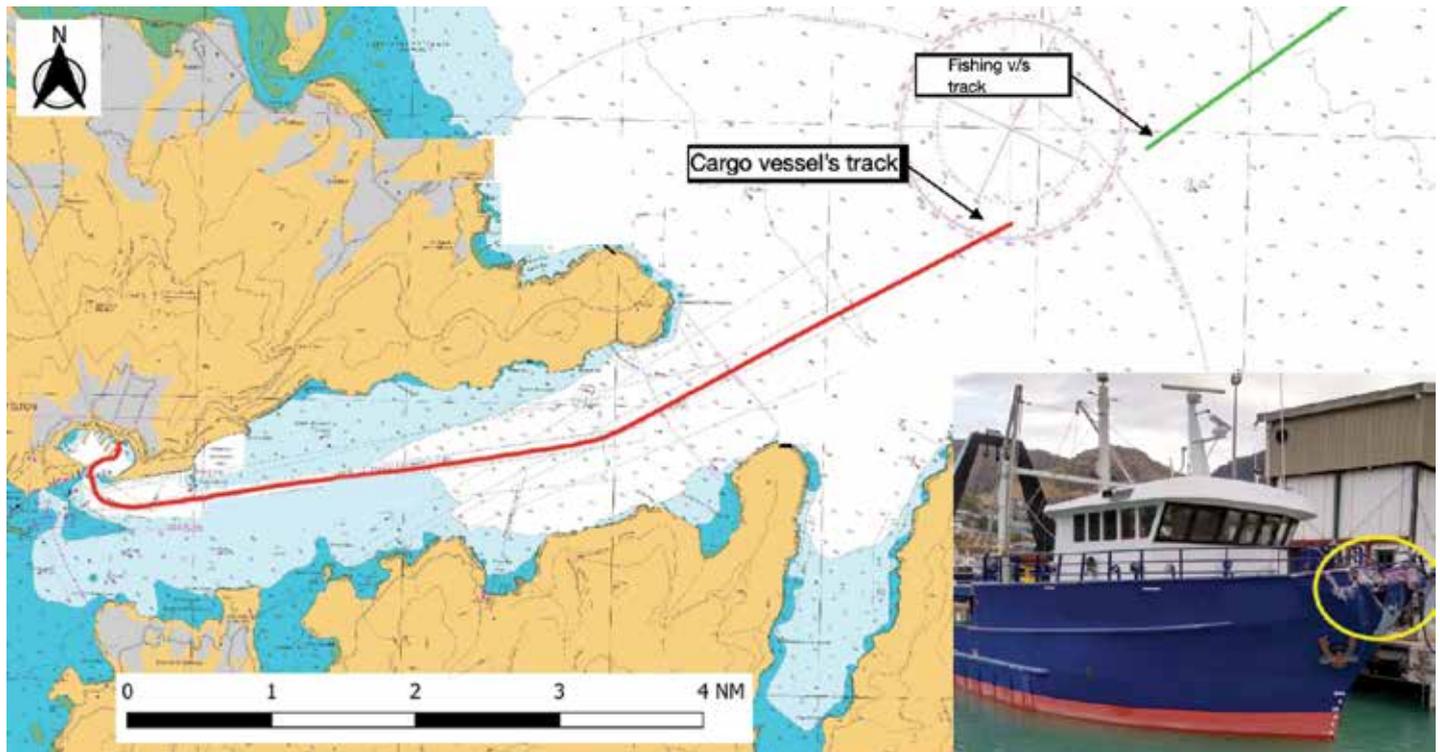
About 90 seconds after the first danger signal and some 10 seconds after a second danger signal, the tanker collided with the fishing vessel, which capsized almost immediately. One crew member from the fishing vessel was rescued from the water alive. Another crew member was recovered from the water and pronounced deceased. The bodies of two other crew members were found within the wreck.

The subsequent official investigation could not determine why the fishing vessel's operator did not slow or take substantial action to avoid transiting into the channel directly in front of the tanker, or what the captain of the fishing vessel was doing in the minutes leading up to the collision. It is possible the captain was away from the conn, was distracted, fell asleep, was unsure of what action to take, or was otherwise unable to respond to the developing situation. The captain's failure to slow his vessel, act on his ARPA's information or respond to the tanker pilot's communications may have been due to a medical event.

- Much as in the previous MARS report, early communication can be an effective measure in averting close quarters situations. The use of VHF radio can help to dispel assumptions and provide operators with the information needed to better assess each vessel's intentions.

- Never assume the actions of another vessel will be coherent or logical. Many jurisdictions still do not require small vessel operators to pass competency requirements. Small boats should be watched carefully by professional mariners.
- In near zero visibility, slow down. The resultant approach speed of the tanker and the fishing vessel was nearly 22 knots.
