# Mariners' Alerting and Reporting Scheme

MARS Report No 352 February 2022

## Fishing for lessons learned!

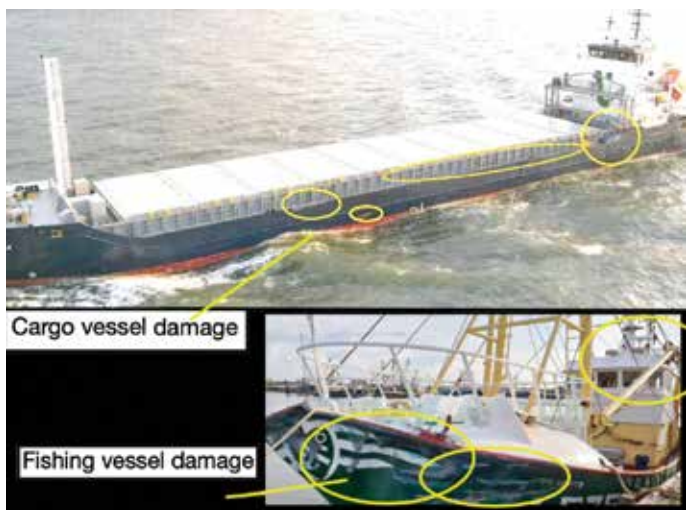
Two of the other fishing boats, A and B, kept a course of approximately 006 degrees. At one point, fishing boat B altered course slowly towards 011 degrees to pass astern of the cargo vessel, but fishing vessel A did not follow this move. Its CPA to the cargo vessel was approximately .05 nm. In the following minutes, the OOW of the cargo vessel noticed that the CPA of fishing boat A had decreased to zero.

By this time another officer had arrived on the bridge of the cargo vessel for the change of watch. Before the handover could be accomplished the OOW on duty realised that fishing vessel A was not taking avoiding action. The OOW sounded the horn to warn fishing vessel A and then put the rudder hard to starboard. About 40 seconds after sounding the horn, the two vessels collided. Fishing vessel A ran into the port side of the cargo vessel amidships and then slid aft. Both vessels sustained structural damage but there were no injuries.

It was discovered during the investigation that the lone watchkeeper on board fishing vessel A did not realise the cargo vessel was there until it was too late. The investigation also found that the 'apparent intentions' of the four fishing vessels contributed to the accident. Some of the fishing vessels did take action to avoid the cargo vessel but in the end, one did not. The OOW on the cargo vessel assumed all the fishing vessel crews had observed his ship, but he was wrong.

- When in doubt and always when a very small CPA is detected, establish early communications with the other vessel and ensure everyone knows what actions are to be taken.
- Sound navigation practices and a good lookout would have avoided this accident as the Master of the fishing boat would have realised there was a stand-on cargo boat on his course with a zero CPA.

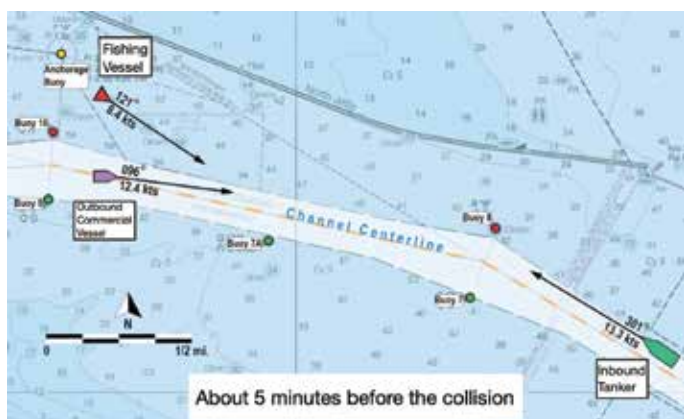
About 90 seconds after the first danger signal and some 10 seconds after a second danger signal, the tanker collided with the fishing vessel, which capsized almost immediately. One crew member from the fishing vessel was rescued from the water alive. Another crew member was recovered from the water and pronounced deceased. The bodies of two other crew members were found within the wreck.

The subsequent official investigation could not determine why the fishing vessel's operator did not slow or take substantial action to avoid transiting into the channel directly in front of the tanker, or what the captain of the fishing vessel was doing in the minutes leading up to the collision. It is possible the captain was away from the conn, was distracted, fell asleep, was unsure of what action to take, or was otherwise unable to respond to the developing situation. The captain's failure to slow his vessel, act on his ARPA's information or respond to the tanker pilot's communications may have been due to a medical event.

- Much as in the previous MARS report, early communication can be an effective measure in averting close quarters situations. The use of VHF radio can help to dispel assumptions and provide operators with the information needed to better assess each vessel's intentions.
