Mariners' Alerting and Reporting Scheme

MARS Report No 363 January 2023

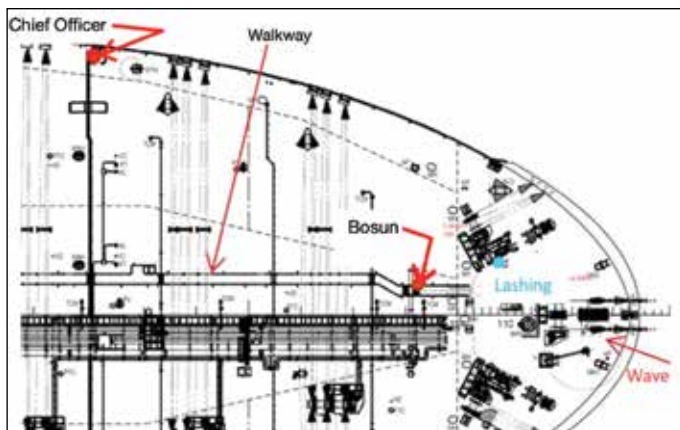
The Bosun was seen lying on the walkway near the port anchor winch, but the Chief Officer was still not visible. The general alarm was sounded and an announcement was made. The vessel was slowed yet further and manoeuvred to have the waves astern, at which point a rescue team went forward. The rescue team found the Chief Officer and Bosun as indicated on the diagram and the victims were brought to the ship's hospital.

The investigation found that a wave, significantly higher than the observed waves, hit the vessel while the Chief Officer and the Bosun were at the bow. The investigation also found, among other things, that communication by portable satellite phone was not possible from the ship's hospital. Radio Medical Advice (RMA) was received by satellite phone on the bridge, but the hospital was five decks below. Immediate and critical medical treatment of the victims based on communications with RMA had to be relayed verbally from the bridge satellite phone to the caregiving personnel in the hospital either by internal phone, or in person. The report did not speculate on whether having communications directly to the ship's hospital would have made a difference in saving lives.

- Even when a wave pattern is coming from what appears to be one direction, it can combine with other wave patterns and occasionally create a wave that is significantly higher than the observed average.
- When observed average wave height is approximate to the vessel's freeboard, extreme caution should be taken when going on deck. An errant wave could sweep the deck with terrible consequences.

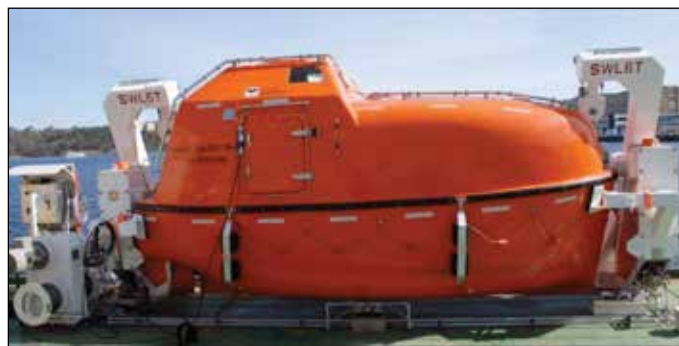
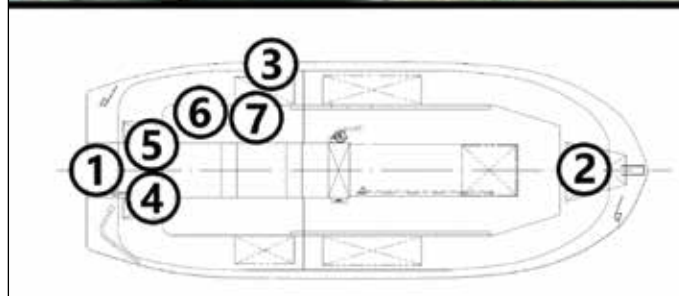
- 1 Instructor (fell into water immediately).
- 2 Person standing, legs wide apart, with the upper body coming out through the forward hatch.
- 3 Person sitting down with the upper body out of the port side hatch. (Dived into water immediately).
- 4&5 Persons standing up in order to let Person 7 pass.
- 6 Just climbed down from the helm: standing on the floor to let Person 7 pass.
- 7 New helmsman standing ready to climb to steering position seat.

The lifeboat complied with applicable IMO stability requirements. Nevertheless, the investigation shows that, under certain conditions, this type of lifeboat has limited reserve stability. Consequently, relatively small forces are able to generate large angles of heel. Under certain conditions, for example when lightly loaded to about one quarter capacity as in this case, lifeboats of this type can take on water and heel over if the side hatches are open. It is reasonable to assume that other lifeboats of similar types and sizes may have similar stability properties.

- Notwithstanding the limited stability under certain conditions, the lifeboat complies with the stability requirements of international standards.
- Small enclosed lifeboats with side openings near the gunwale can comply with the established standards while simultaneously having loading conditions that have a small reserve stability. This is especially the case when the lifeboat is lightly loaded with few persons on board.

- This event illustrates the importance of rigorously complying with the manufacturer's instructions for use. In this case, the occupants of the lifeboat were not sitting in their respective places nor secured with their seatbelts, contravening manufacturer's instructions of use.
- International performance standards for emergency gear on vessels are a bulwark for safety but even these can and do require improvement when deficiencies are revealed.
