MARS – Lessons Learned

MARS Report No 368 June 2023

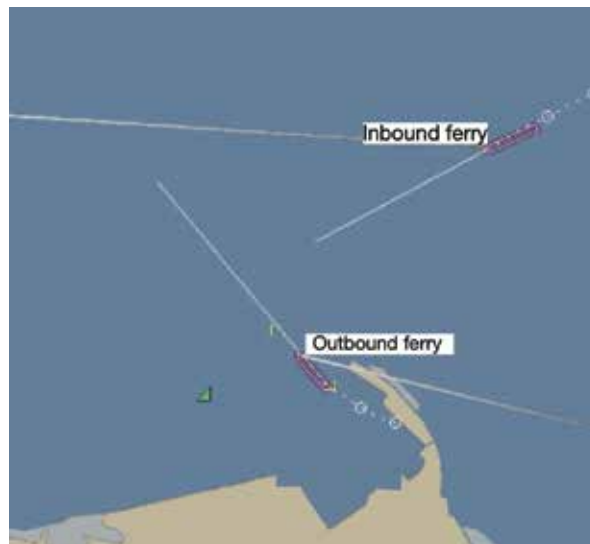
About 18 minutes later, port VTS called the inbound ferry to advise that the outbound ferry was singling up and would be leaving in the next minute or two. This was acknowledged by the inbound ferry. However, instead of holding position, they continued inbound at a reduced speed of about six knots. On the departing ferry, the bridge team were not monitoring traffic prior to departure; instead, they relied on information from VTS regarding the position of the inbound vessel. The OOW stated that the ECDIS and radar were checked only after all lines were clear and they had lifted off the berth. They were surprised to see the inbound ferry, now very close, and only quick manoeuvres and last-minute communication between the vessels helped avoid collision.

As it transpired, a relieving Master was bringing the inbound ferry into port as a training exercise under the supervision of the Master. Poor communication between the Master and the relieving Master contributed to the close quarters situation developing.

With or without a pilot, always ensure you have an accurate picture of the traffic situation before departure. In constrained waterways, it is easier to hold the berth while traffic passes than be obliged to manoeuvre.
