Mariners' Alerting and Reporting Scheme

MARS Report No 346 August 2021

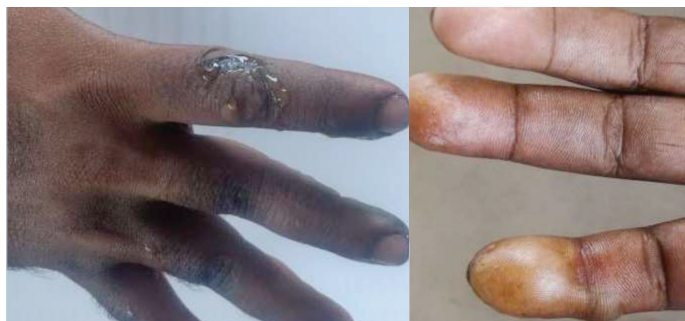
→ Two engine room crew were attending to the main engine fuel backwash filter alarm. They suspected the problem was a clogged pipe or air trapped in the line to the differential pressure cell. As one crew slackened the copper pipe ferule connection to purge the line, the pipe came free, releasing hot fuel on his hands. The victim was wearing cotton gloves, which became soaked with hot oil. It was later observed that the skin on his thumb was peeling off and blisters had developed. First aid was administered and he was sent to a shore facility at the next port for followup medical care.

The company investigation found, among things, that the system being worked on had not been isolated and vented to release the pressure.

- Proper isolation and lockout ('lockout/tagout', LOTO) must be completed before carrying out maintenance on any equipment. Ask yourself 'Is there any potential energy in this system?'
- Work permits, properly completed before the task begins, are the basis for safe and successful outcomes.
- Cotton gloves are not the best protection against work injuries.

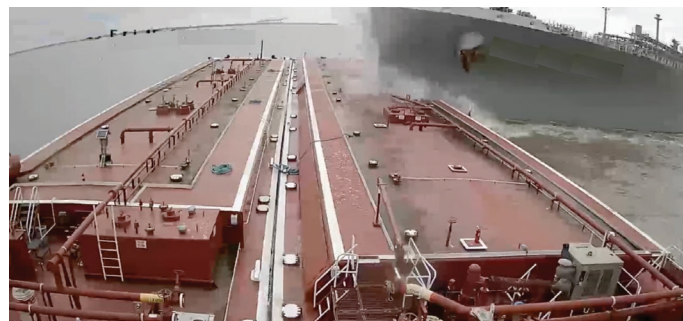
The tug Master complied and gave full port rudder, but within minutes the LPG vessel's bow struck one of the barges midship on the starboard side, penetrating the double hull and breaching two cargo tanks in that barge. The force of the collision capsized the second barge although no tanks were breached.

The official investigation found, among other things, that the combined effect of the speed of the LPG vessel passing another large vessel in the asymmetrically shaped channel resulted in an uncontrollable sheer to port by the LPG vessel, initiating the chain of events that led to the collision.

- Research on hydrodynamic interaction indicates that if the speed of the ship near a bank is too high, the rudder may be less able to cope with the forces induced and control will be lost.
- Proceeding at full sea speed in a restricted channel not only increases the risks of an uncontrolled shear due to hydrodynamic effects, but leaves the mariner with few options to mitigate or control the situation.

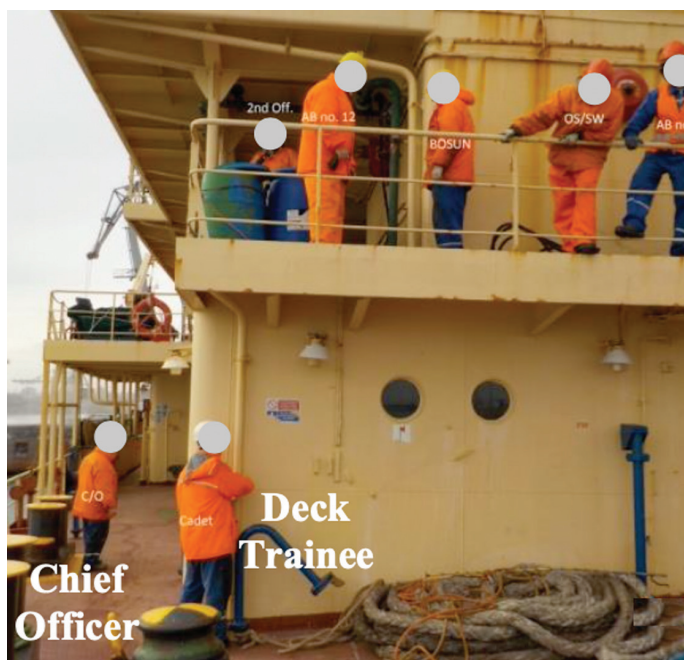
Simulation of the event

Three more deck crew arrived on deck 1 to assist. Some ropes were brought on board and untangled, with some crew working on deck 1 and the chief officer and a trainee on the poop deck. Suddenly, a large wave washed over the poop deck from starboard. Within seconds of the first wave, a second larger wave washed on board from the same direction. The two crew on the poop deck were swept overboard.

The official investigation found, among other things, that neither victim was secured to the vessel with a lifeline when the waves washed over the poop deck. Additionally, the crew members were not wearing lifejackets while working on the exposed deck in adverse weather conditions.

- Hindsight is always 20-20, but most vessels loaded to maximum draught are susceptible to breaking waves in heavy weather, even on the poop deck. Lifelines must always be considered for emergency deck work in heavy weather, as must lifejackets.
- Before undertaking an unusual or undocumented task, take a few minutes to do a risk assessment among the team members, even if only verbally.
