Mariners' Alerting and Reporting Scheme

MARS Report No 348 October 2021

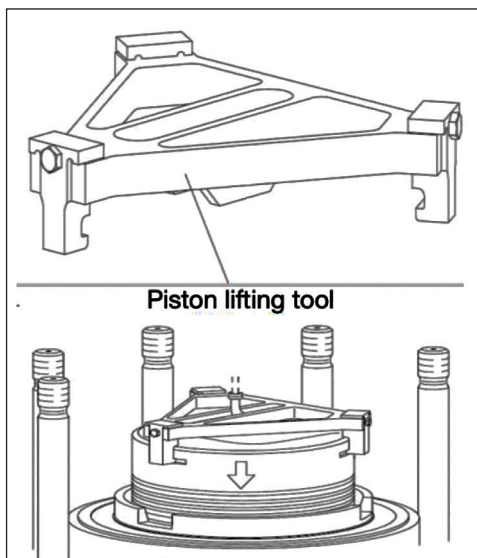
The task had been started in the morning, and in the late afternoon, the crew commenced the re-installation process. This last but critical phase of the overhaul would take about an hour, and included using the piston lifting tool. The lifting tool has two stationary claws and one adjustable claw. The claws sit in the piston lifting grooves on the top of the piston.

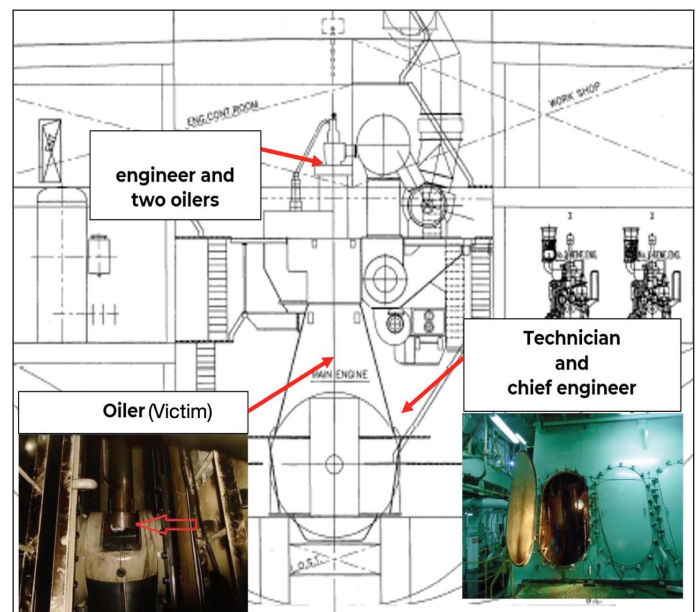
Soon after, the chief engineer instructed an engineer to turn the engine using the turning gear. The other engineer dropped the piston lifting tool. A loud noise was heard; the piston had dropped inside the crankcase. The oiler who had remained inside the crankcase was found unresponsive in the sump tank of the main engine. Emergency procedures were taken but the oiler was declared deceased before his arrival at the hospital.

- The existing risk assessment for this job indicated that crew should take the engine manufacturer's instruction manual into account while planning the operation. However, in this case the manual was not discussed beforehand and several steps mentioned by the manufacturer were not followed by the crew members during the operation.
- The chief engineer was the supervisor of the operation. However, he did not have a portable VHF radio with him while the task was being carried out. Furthermore, the communication between the two other engineers was in a language not understood by the chief engineer.

- Before carrying out any high-risk operation, such as overhauling and maintenance of the main engine, the manufacturer's instructions must be discussed and incorporated in the planning of the operation.
- A thorough review of the risk assessments for any high-risk operation must be carried out to identify the hazards and risks associated with every stage of the operation. Appropriate safeguards to eliminate those risks should be put in place.
- Effective communication should be established while carrying out any operation onboard. The supervisor of the operation and all involved crew members should be equipped with the appropriate communication devices and communicate in the vessel's working language throughout the operation.

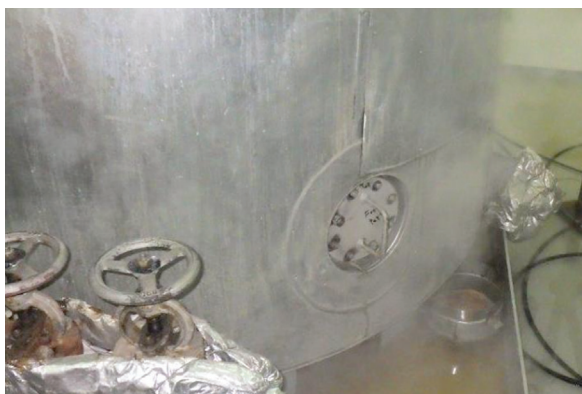
Assuming it was safe, he then decided to remove the upper section of the maintenance hole, followed by the lower part. Suddenly, a mix of water and steam came out of the orifice and hit his body. The victim was admitted to the shore hospital with first and second degree burns on his legs, arms, belly and feet.

The company investigation revealed, among other things, that the boiler indicator habitually did not go lower than a certain level, a quirk that could give an uninitiated crewmember the impression it was empty when it was not. This vital information is not mentioned in the boiler manual and was only known by the more experienced engineers on board, not the victim. Additionally, the company found that the job scope had not been properly communicated to the victim and no permit to work was issued to carry out the job on the boiler that day. Finally, no Lock-out/Tag-out (LOTO) was applied.

- The supervision of junior employees remains a vital element of safety, especially for non-routine tasks and particularly when it is the first time the person is attempting that task.
- Remember – the large skill and experience gap between senior and junior officers may lead to misunderstandings and assumptions.

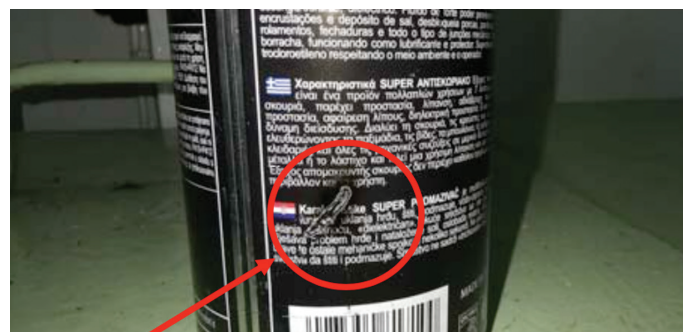
welding process came into contact with a small can of spray lubricant. The spark punctured the pressurised can, immediately generating a flame burst that injured the crewmember.

Hole where welding spark initiated a flame burst

- Welding is a dangerous business and the job site should be clear of all combustibles, debris and other non-essential items.
- Complacency is often a contributing factor in accidents. We must encourage an approach where each task is approached with caution – as if it were the first time it was being undertaken.
- Supervision and safety leadership are critical. Where improper routines or unsafe practices are noted, intervene and arrange for appropriate instruction and/or training.

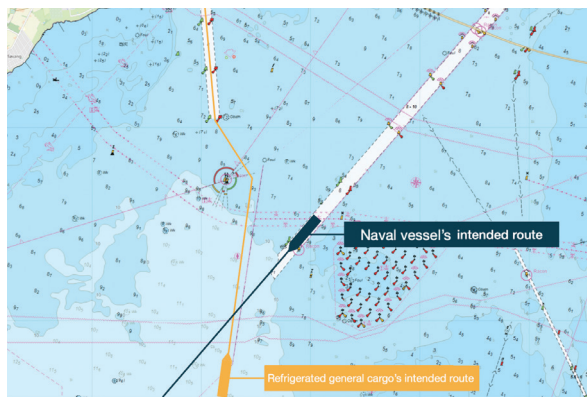
Shortly afterward, the other vessel appeared abeam and slammed into their starboard side. The Master and OOW saw that this was another naval vessel similar to the one that had passed ahead a few minutes earlier.

Shortly after the collision, the cargo vessel dropped anchor to better assess the situation. The damage incurred was above the waterline and there was no risk of pollution. In the meantime, the naval vessel was adrift and was assisted by the other naval vessel which had returned to the area.

The official investigation found, among other things, that several coinciding factors contributed to the bridge team not recognising the risk of collision until the naval vessel was at close quarters. These included the layout of the bridge, the configuration of the X-band radar and the division of work between the Master and OOW. The investigation was not able to determine the sequence of events on the naval vessel.

- In this instance, the bridge teams of both vessels made the classic mistake of not sufficiently reducing speed to give more time to assess the situation and/or increase the CPA. In any event, given the restricted waterway no other manoeuvre was even possible in this situation.
- In restricted visibility the rules of the road are clear. Rule 19 applies, stating: Every vessel which cannot avoid a close-quarters situation with another vessel forward of the beam, shall reduce speed to minimum steerage. If necessary take all way off and in any event navigate with extreme caution until danger of collision is over.

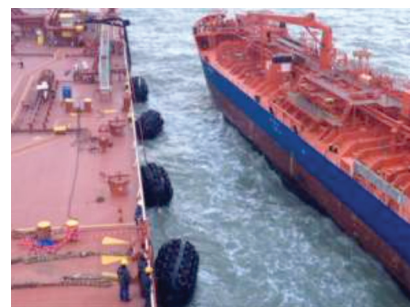
The STS supervisor first requested the discharging vessel to heave up five shackles and remain anchored with four shackles in the water. Unmooring then commenced. Within 10 minutes the receiving vessel started moving away from discharging vessel using her bow thruster and main engine. When the distance between the vessels was about 15-20 metres, the STS supervisor thought that the bow thruster of the receiving vessel was sucking a fender rope, so he stopped the thruster. Within seconds, the prevailing current caused the bow of the receiving vessel to drift towards the discharging vessel. The two vessels came into slight contact.

The unmooring manoeuvre was suspended and the discharging vessel was instructed by the STS supervisor to heave up her anchor fully. Once the anchor was retrieved, the unmooring operation was resumed underway and the vessels successfully separated. Except for paint scratches, no damage or deformation to vessel's side shell was observed.

- Weather conditions were optimum, and as such the unmooring operation could have been carried out safely with both vessels underway – which is how it was accomplished after the incident. A well-coordinated STS unmooring while underway gives more 'leverage' over external forces such as current.
- Fenders may be secured on either vessel, but contacting an unprotected portion of the hull is less likely if the fenders are rigged on the manoeuvring ship.
