Mariners' Alerting and Reporting Scheme

MARS Report No 353 March 2022

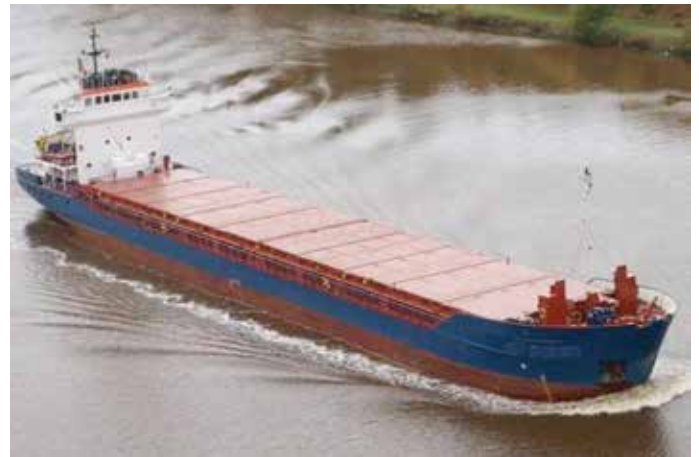
→ A small general cargo vessel with seven crew berthed to load a cargo of corn in bulk. Loading commenced after preparation and cleaning of the hold. The gas tight integrity of the hold was not tested before loading, even though it was intended to undertake in-transit fumigation after loading.

- By the time the vessel accommodation's forced ventilation was stopped, there was a positive pressure of fumigation gas in the hold. Stopping the ventilation and closing the ventilation flaps resulted in positive pressure being lost in the accommodation, allowing the fumigant to enter the accommodation via the sanitary ventilation system and, to a lesser extent, other entry points.

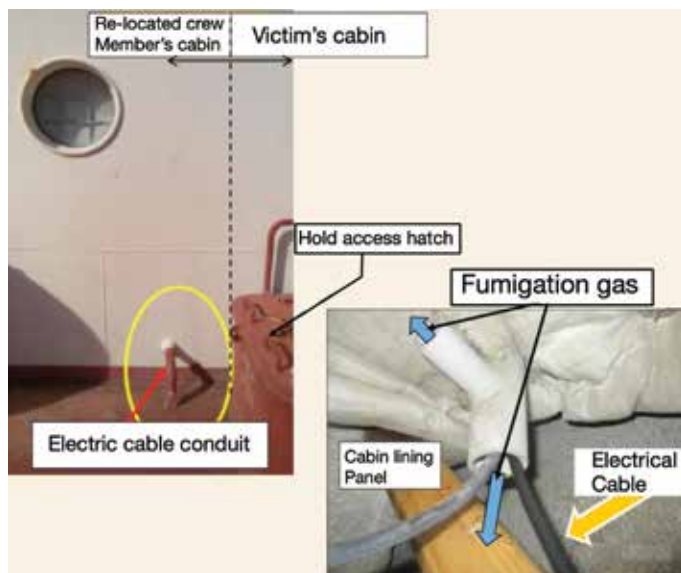
The next day, a phosphine gas reading of 2 ppm was measured at the upper deck alleyway. The Master called muster stations and instructed all crew to evacuate their cabins at once. The engine cadet did not appear at muster, so two crew went to his cabin where he was found in a state of partial paralysis. The victim was taken outside for care. A phosphine gas reading of 9 ppm was measured in his cabin, which was

The official investigation found, among other things, that a permanent access light for the aft access ladder of No. 5 cargo hold had been installed during construction. A conduit was used to run the electric cable between the accommodation and No. 5 cargo hold. The conduit ends were not sealed, contrary to best practices and classification rules. This defect allowed the phosphine gas to infiltrate the accommodation area and enter the crew cabins.
