Mariners' Alerting and Reporting Scheme

MARS Report No 354 April 2022

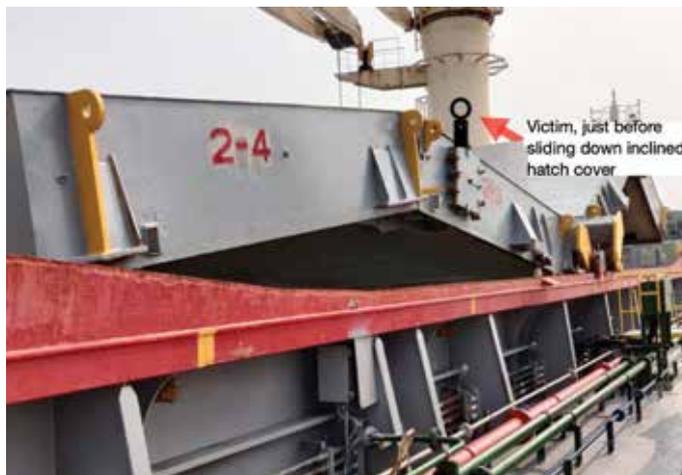
to the aft panel No.2-3 (indicated by an arrow in the photograph), and started cleaning at the starboard side of panel No.2-3. While moving toward the port side, out of sight of the crewmember tending the hose, he slid down the incline, through the gap in the hatches, and fell at least 17 metres to the hold tank top. A cry was heard and the crewmember tending the hose began searching, only to see his colleague lying on the tank top of the hold in the middle of the hatch area.

The official investigation found, among other things, that there was no responsible officer supervising or assessing the safety of the work. The Bosun was supposed to supervise both teams of two crew, who were working at different places. Instead, the Bosun went down to hold 1 with one of the teams. The Chief Officer was busy in the deck office preparing the loading plan for the next port, so there was no effective supervision of the team washing the hatch covers.

Additionally, crew did not use fall arrest equipment while working and climbing on top of the partially opened hatch covers.

- In an environment dominated by a weak safety culture, even such a dangerous situation as standing at the top of an open inclined hatch without fall protection does not dissuade people from 'getting the job done'.

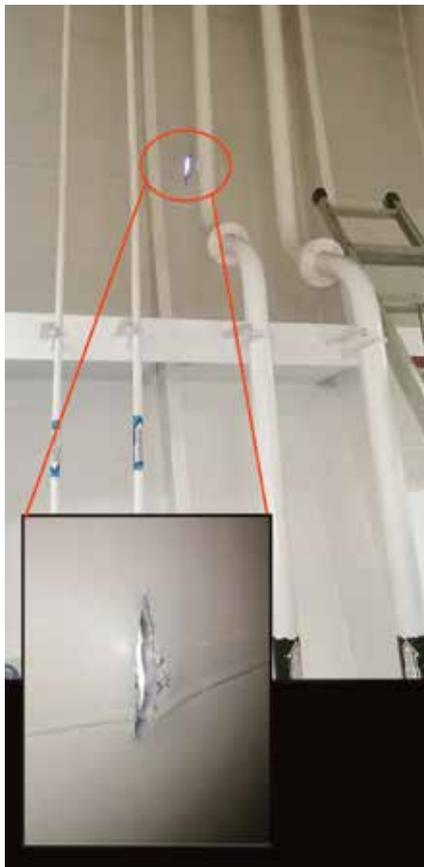
➔ A tanker discharged its cargo and left the berth without apparent incident. While drifting near the harbour and awaiting orders, routine inspections discovered a puncture in the hull above the waterline.

After investigation, it was deduced that the damage had occurred during the previous berthing and remained unnoticed since.

During that berthing, two tugs were used to push the vessel on the jetty's fenders during the mooring operation. Although everything appeared normal at the time, it was later suggested that the upper edge of the fender was unprotected. Although the impact while berthing and from the tugs pushing was so minor that no one noticed, it was still enough to pierce the hull.

- An inspection of the fendering after berthing to ensure proper cushioning is a good practice.

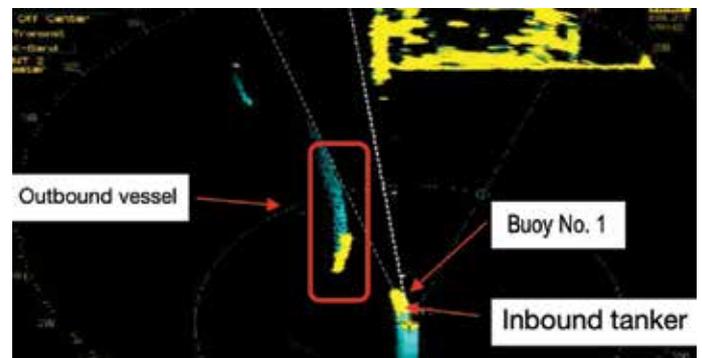
As the inbound tanker was conned more to starboard by the pilot to allow the outbound vessel to safely exit the port, it approached the righthand side of the channel and, due to weather and lack of manoeuvrability at slow speed, made soft contact with buoy number 1. The tanker continued its inbound passage and safely berthed thereafter.

- When entering port, the bridge team and Master often have little time to evaluate the proposed manoeuvre suggested by the pilot. In this case, although not immediately evident as unsafe, the meeting of the two vessels at the narrow port entrance was less than optimal.
- Be aware that in some jurisdictions, pilots can disembark before the vessel has actually exited the port due to various factors such as weather conditions on the outside rendering departure there too dangerous.

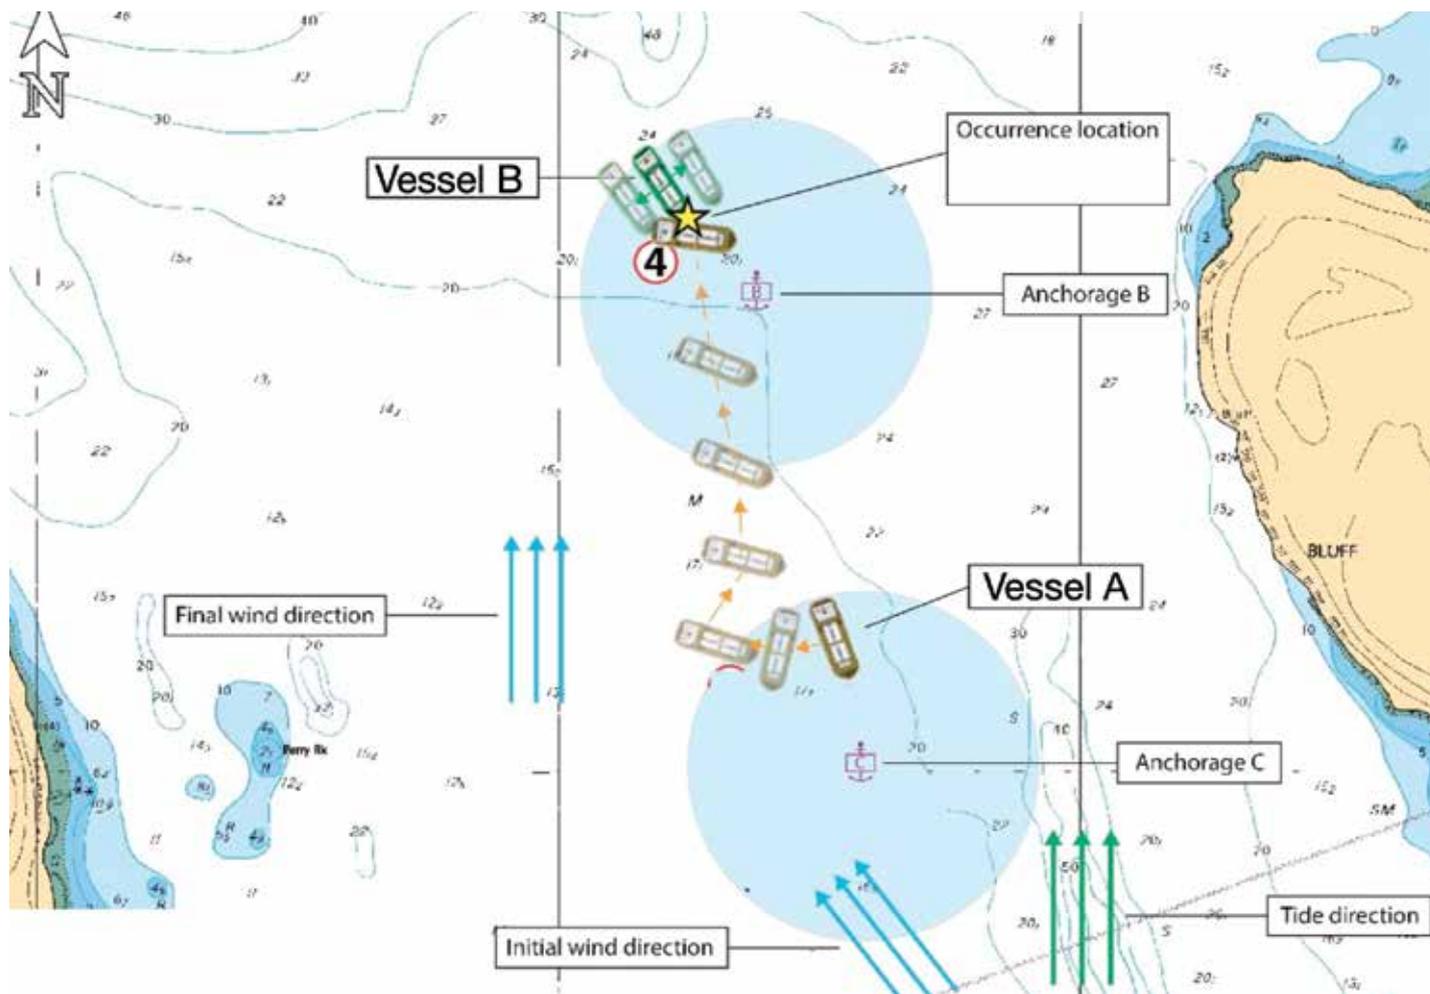
Vessel A's dragging anchor alarm activated, and the officer of the watch (OOV) noticed on the radar that his vessel was drifting towards vessel B. The Master and the engine room were informed of the situation and the anchor team went forward. An additional two shackles were released on the starboard anchor chain and the team attempted to deploy the port anchor too, but it would not release.

By now, vessel A was drifting towards vessel B at a speed of about 1.4 knots under the influence of the wind on its high freeboard and the tidal flow. Meanwhile, vessel B's crew were informed of the oncoming vessel A. They paid out a total of 11 shackles on the anchor chain in order to allow more room and avoid contact between the vessels.

The anchor team on vessel A eventually managed to release the port anchor from its stowed position and deployed about 12 shackles. By now, the main engine was also available and was used in an attempt to move away from vessel B. Nonetheless, vessel A's port mid-section collided with the starboard bow area of vessel B (position 4 on diagram).

The official investigation found that, among other things, the crew of vessel A had not collected the local weather forecast for the day of occurrence from the VHF radio, weather fax, and MF broadcast, nor had they obtained an up-to-date weather warning from local authorities. As a consequence the vessel and crew were unprepared for the impending adverse weather conditions.

- This is not the first MARS report where a lack of situational weather awareness has led to a vessel dragging anchor. Weather awareness should be a priority of all OOWs and Masters while at anchor.
- Even with engines and anchors, limited space in some anchorages can easily trump these options when winds are strong. Vessels are safest at sea in these circumstances.
